RED LBP PRE-PURCHASE REPORT

PRE-PURCHASE BUILDING REPORT

Property Address	16B Marere Avenue Paraparaumu
Client	Kim Winter
Date of Inspection	22nd January 2026
Time	8:00 am
Inspector	Trevor Garrett MSc, LBP, Advanced Trade Cert Carpentry, Nat Diploma Construction Management. Member of NZIOB.
LBP Number	131790
People Present	Owner
House Occupied	Yes

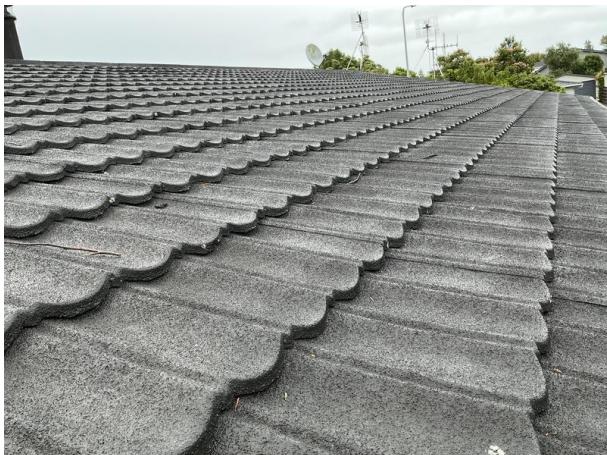
Photo 3

Roof is in serviceable condition.

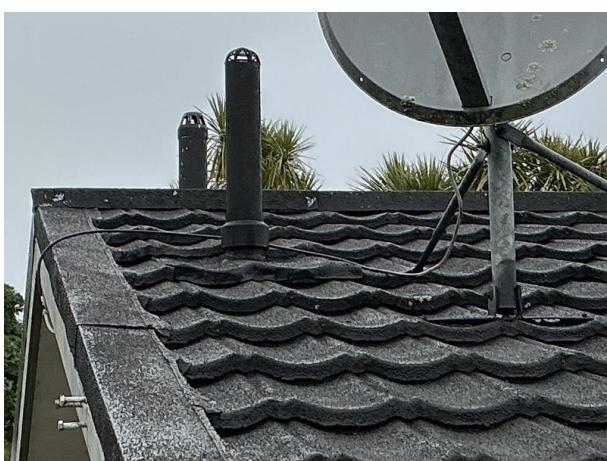
Photo 4

North side penetration.

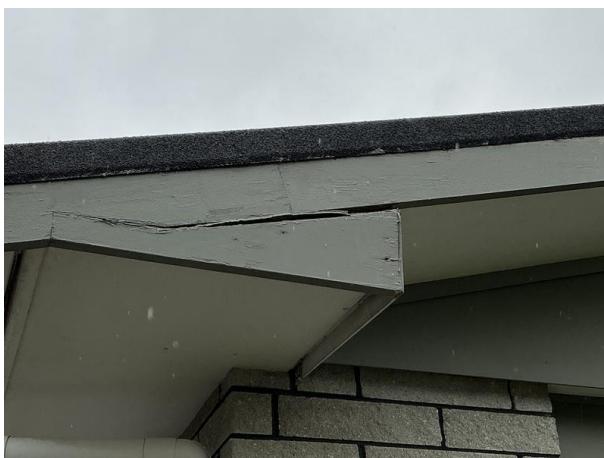
Photo 6
South side fascia joint is detached.

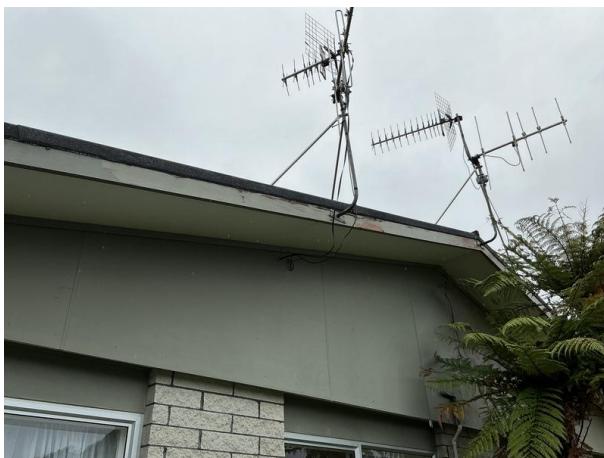
Finish - Paint - Paint flaking and missing.

Photo 7
Paint flaking to the fascia.

Recommend painting the fascias.

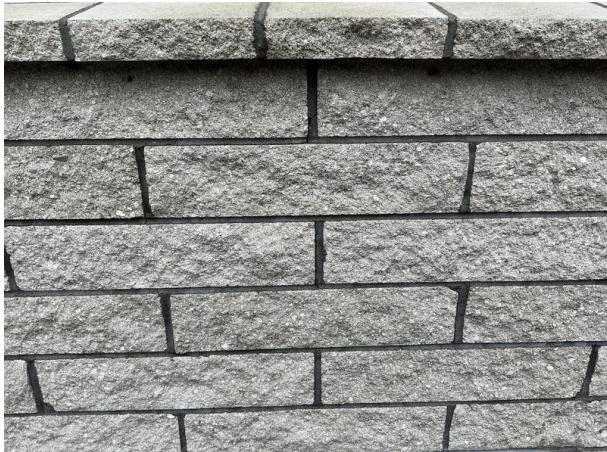
Photo 9

Cracking - Cracking to mortar.

West side cracked mortar.

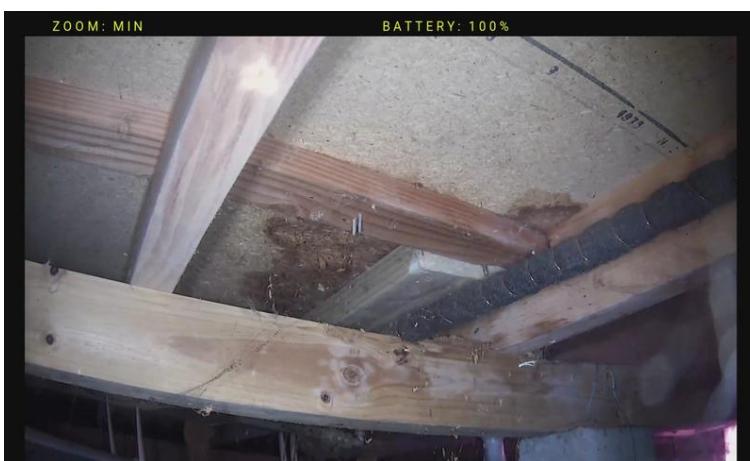
Photo 15

Flooring - type and condition - Particle board and plywood flooring - Moisture stains visible.

Moisture stains visible under the bathroom/toilet area.

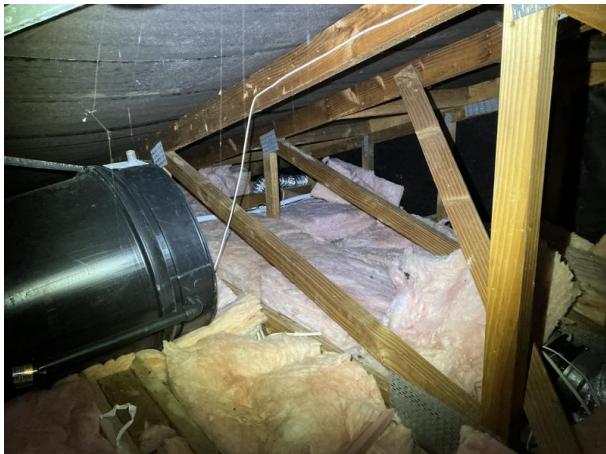
Photo 17

Disturbed insulation over the kitchen.

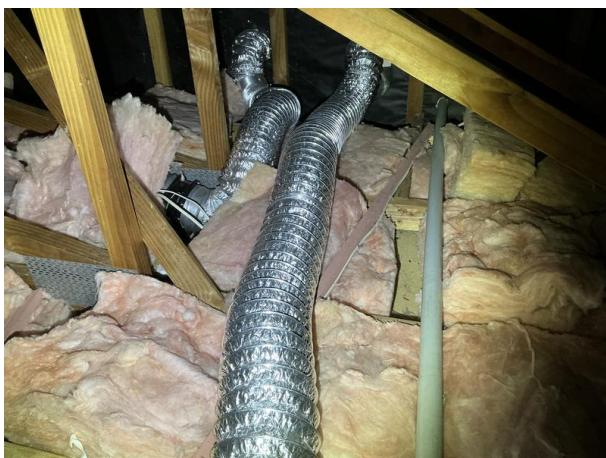
Photo 18

Disturbed insulation over the bathroom
toilet area.

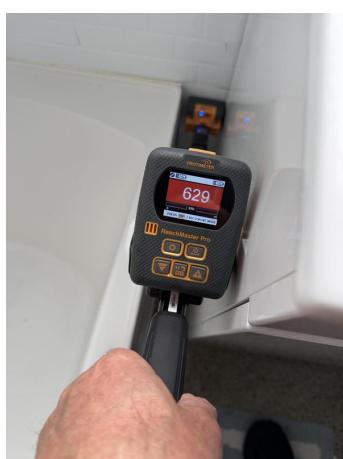
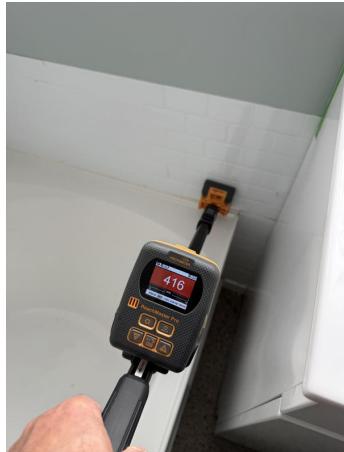
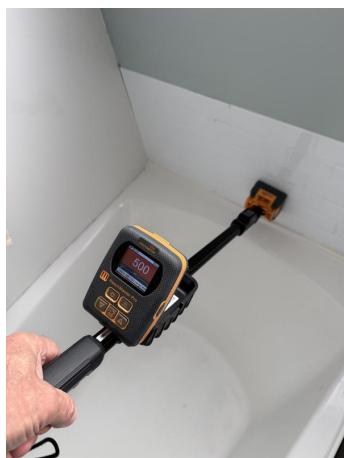
Indications of elevated moisture readings were detected to the end of the bathtub.

End of the bathtub has indications of elevated moisture.

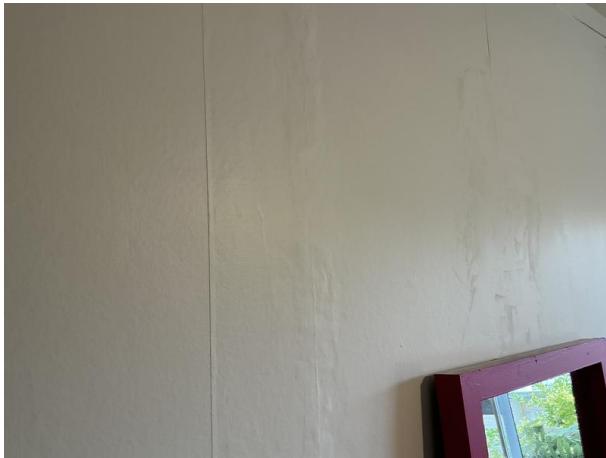
Photo 28
Cosmetic issues to wall linings.

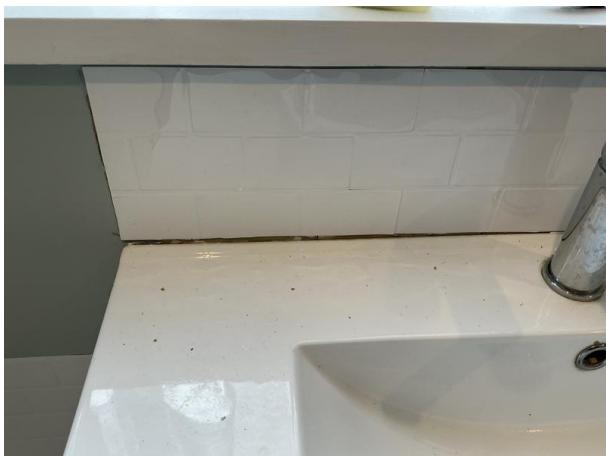
Photo 33
Upstand is not sealed to the vanity.

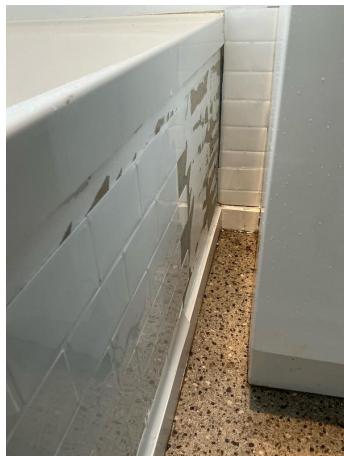
Photo 34
Peel and stick linings are missing in the corner.

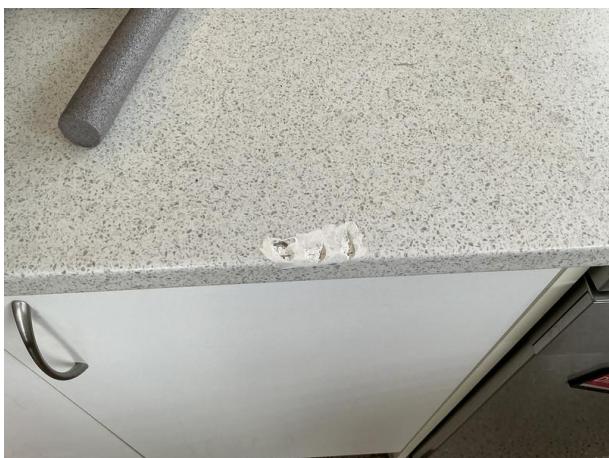
Damage - Yes.

Photo 40
Damage to bench top.

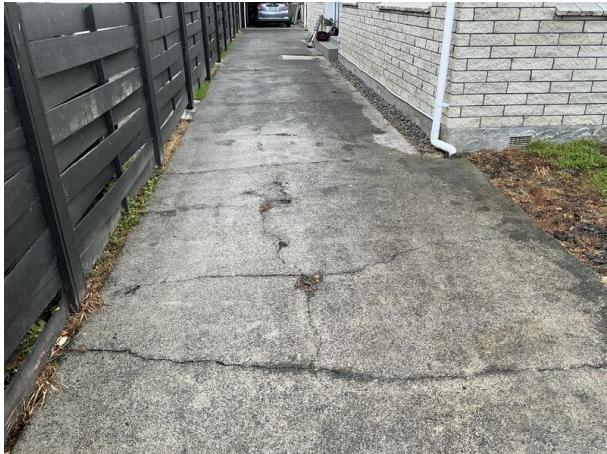
Photo 43

Driveway is cracked however, functional.

General upkeep and maintenance of driveway by cleaning and keeping free of debris.

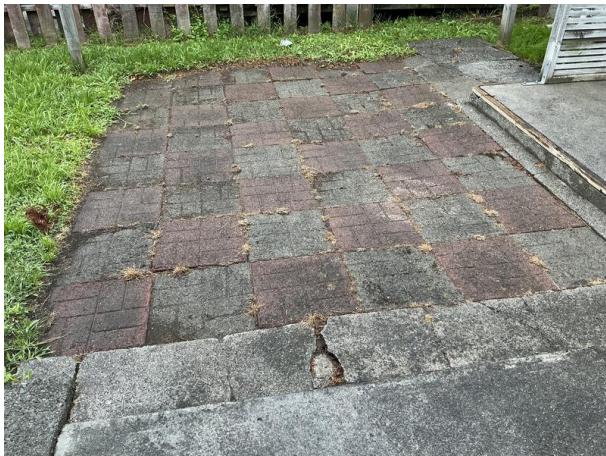
Photo 48

North side concrete pavers are undulating.

General upkeep and maintenance.

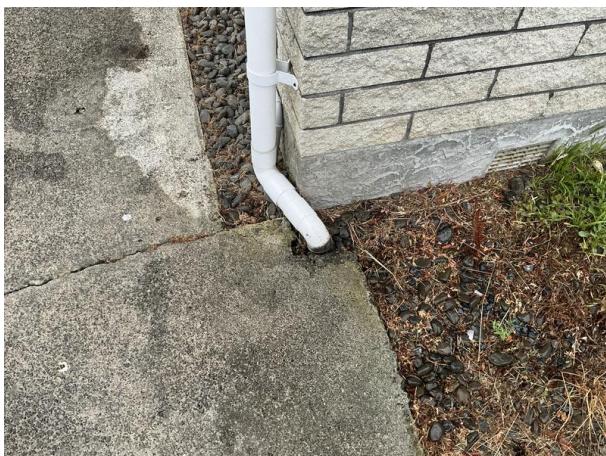
Photo 50
West side downpipe connection not visible.

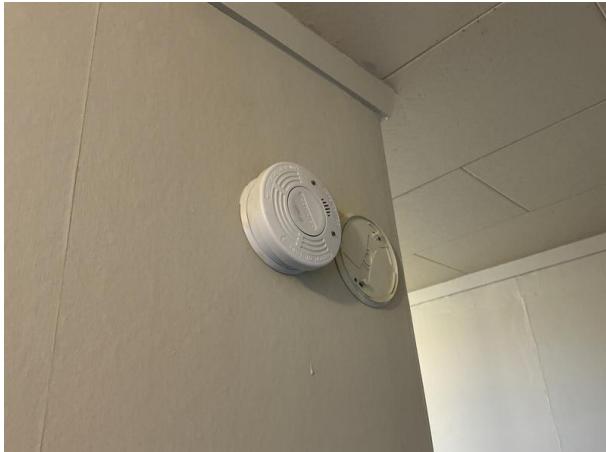
Photo 59

Smoke detector is located in the hallway, this would perform better if it was fixed to the ceiling.
