Inspection Report

TWINSPECTORS
BUILDING & PEST INSPECTIONS

9/50 Ferndale Street Annerley QLD 4103

Building Inspection

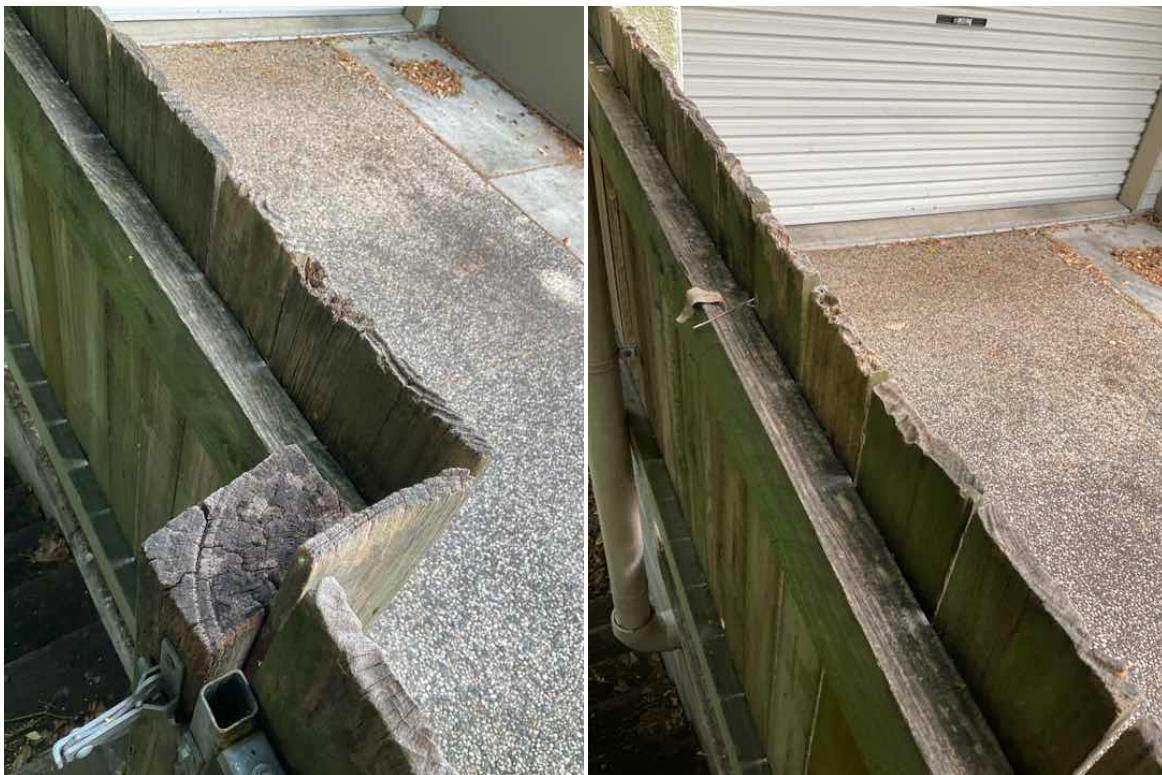
General age to fence components. General upkeep and maintenance required. A qualified fencing contractor should be engaged for repairs.

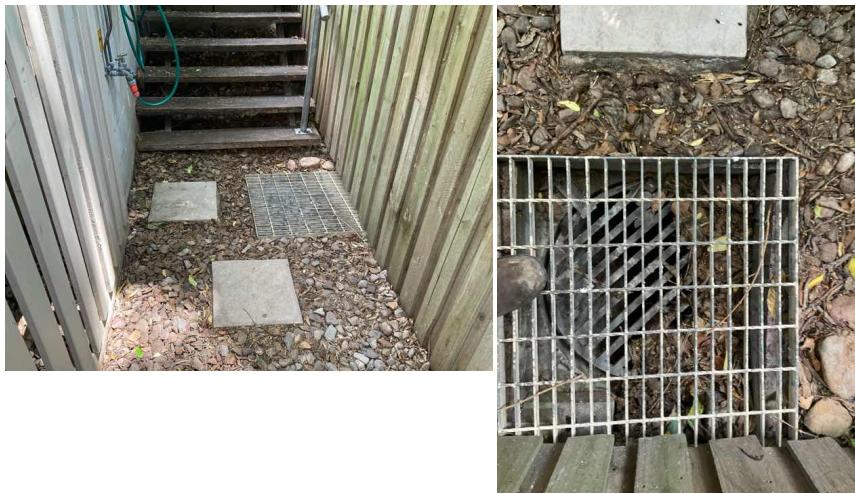
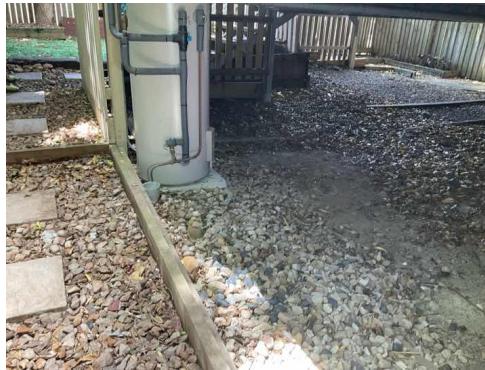
#1. The ground levels along the perimeter walls at the side of the home did not appear to fall away from the property walls sufficiently due to the natural landscape and contour. This will need to be assessed during a period of rainfall and if surface water appears to be entering the sub floor if applicable or ponding against the perimeter walls, engage a plumber or landscaper to assess and rectify as required. All drains should be regularly checked by a plumber and kept clean of debris to allow surface water to be carried away from the dwelling.

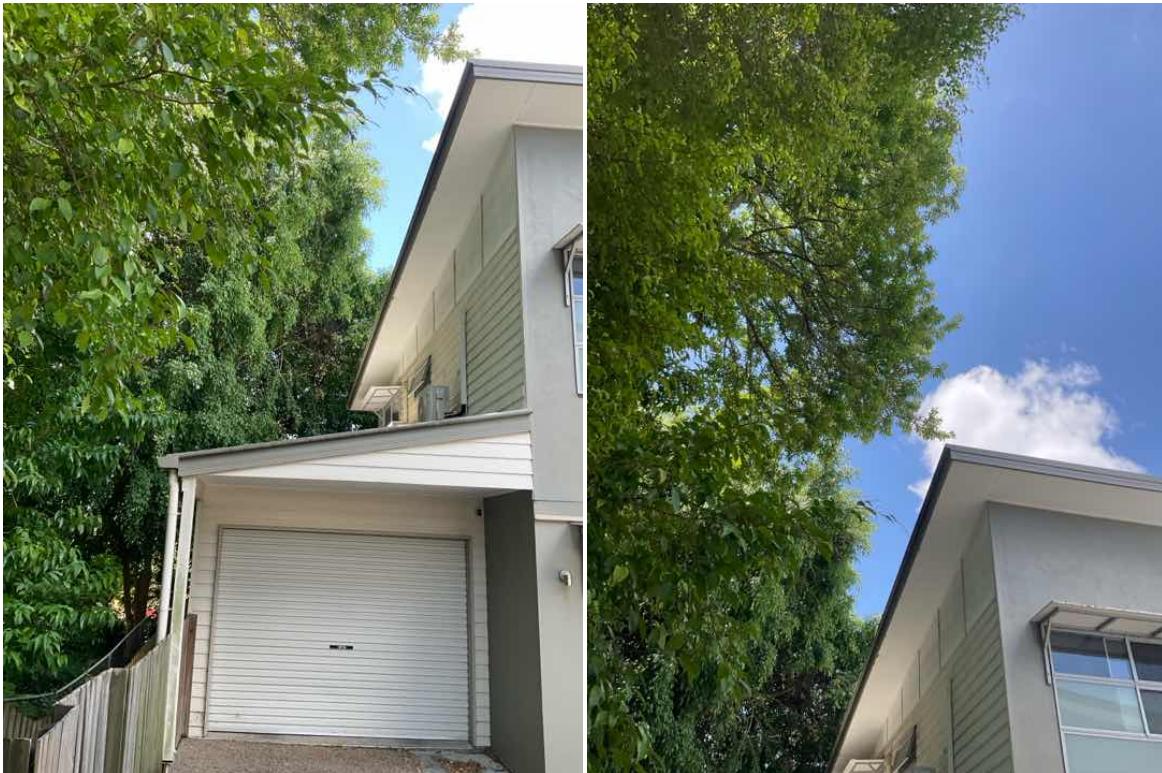
Trees are overhanging roof areas. These should be cut back away from the roof line and gutters.

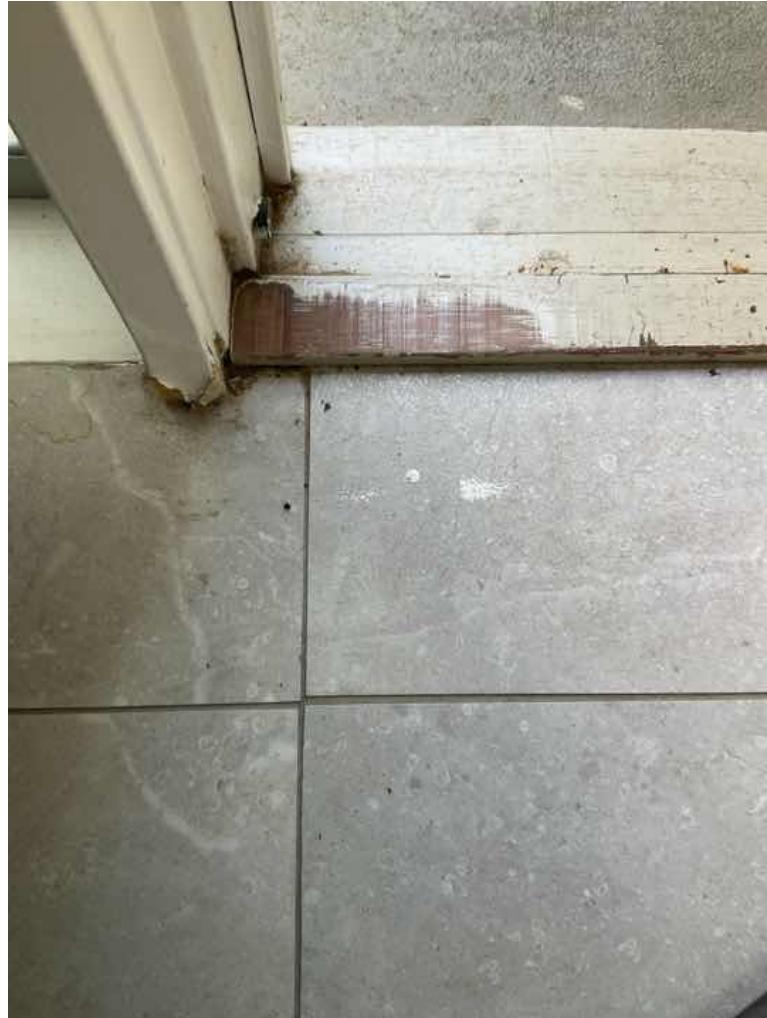
#2. Binding entry door - Doors that bind on the frame can relate to some differential settlement, frame movement, age, expansion, shrinkage or poor hanging. A qualified carpenter should be engaged for repairs.

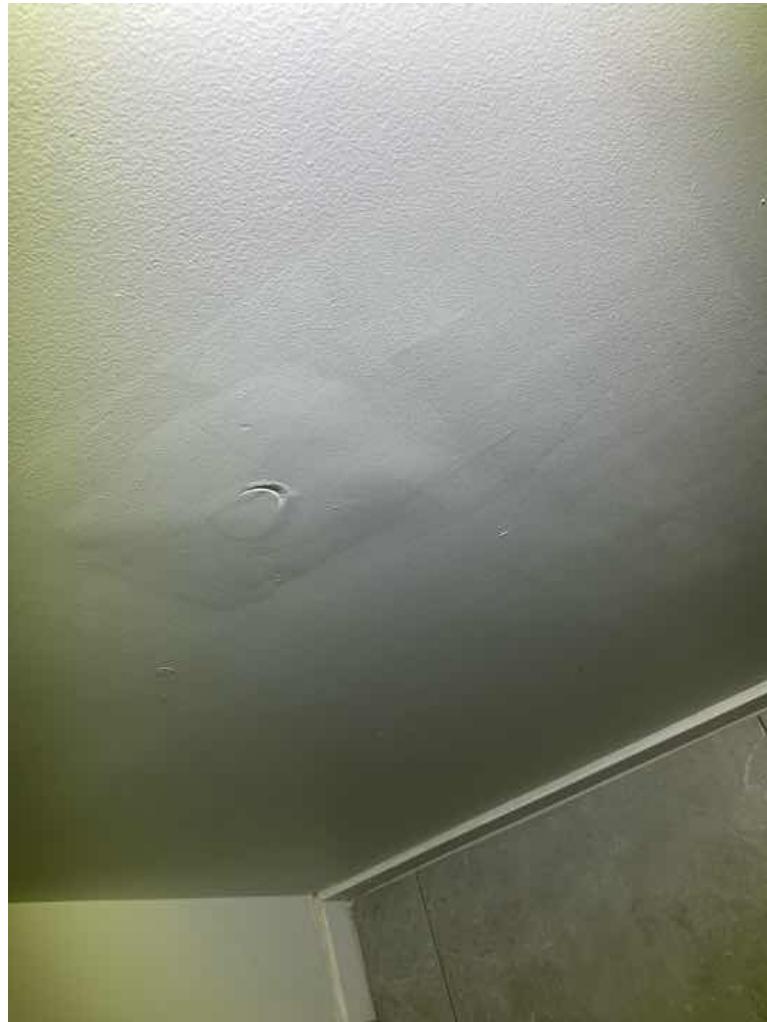
#3. General ageing and/or denting and the like is evident on wall linings - Recommendations: A qualified painter should be engaged to assess and repair as required.

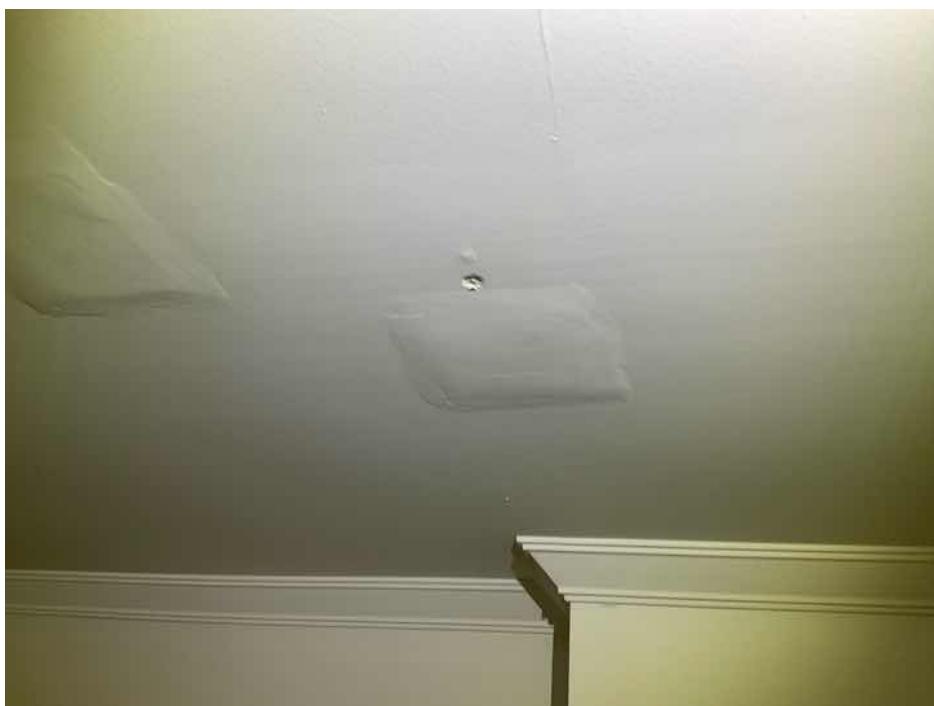
Incomplete patch/paint repairs noted. I recommend you contact a qualified painter for repairs.

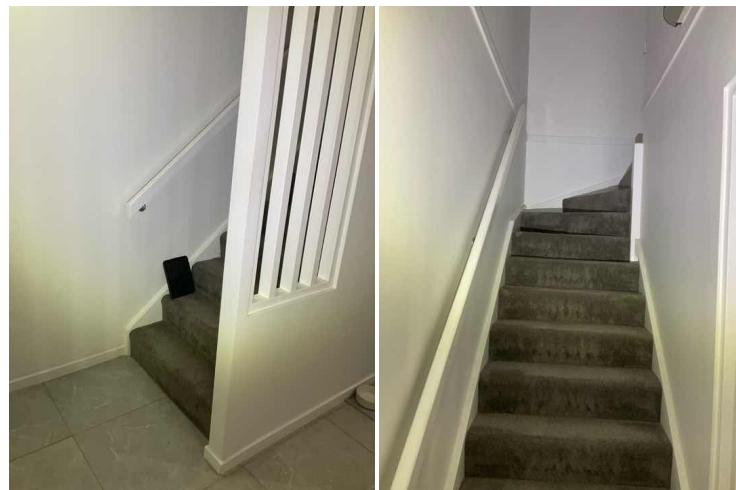
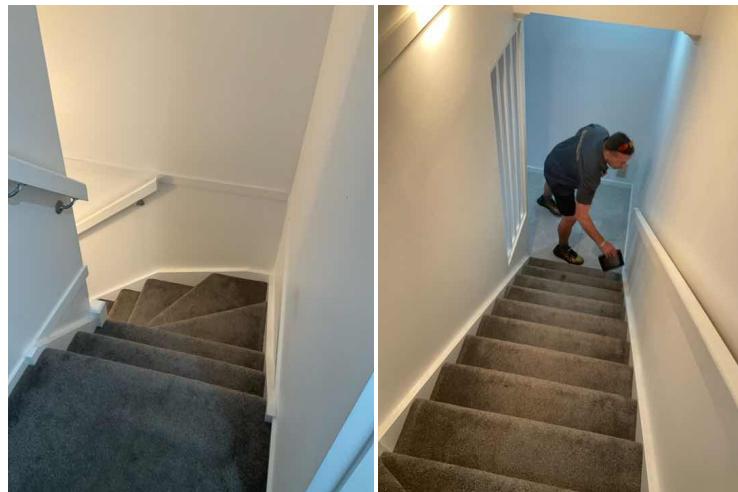
Squeaky floor at landing noted. Re-fixing the floor boards may fix this issue.

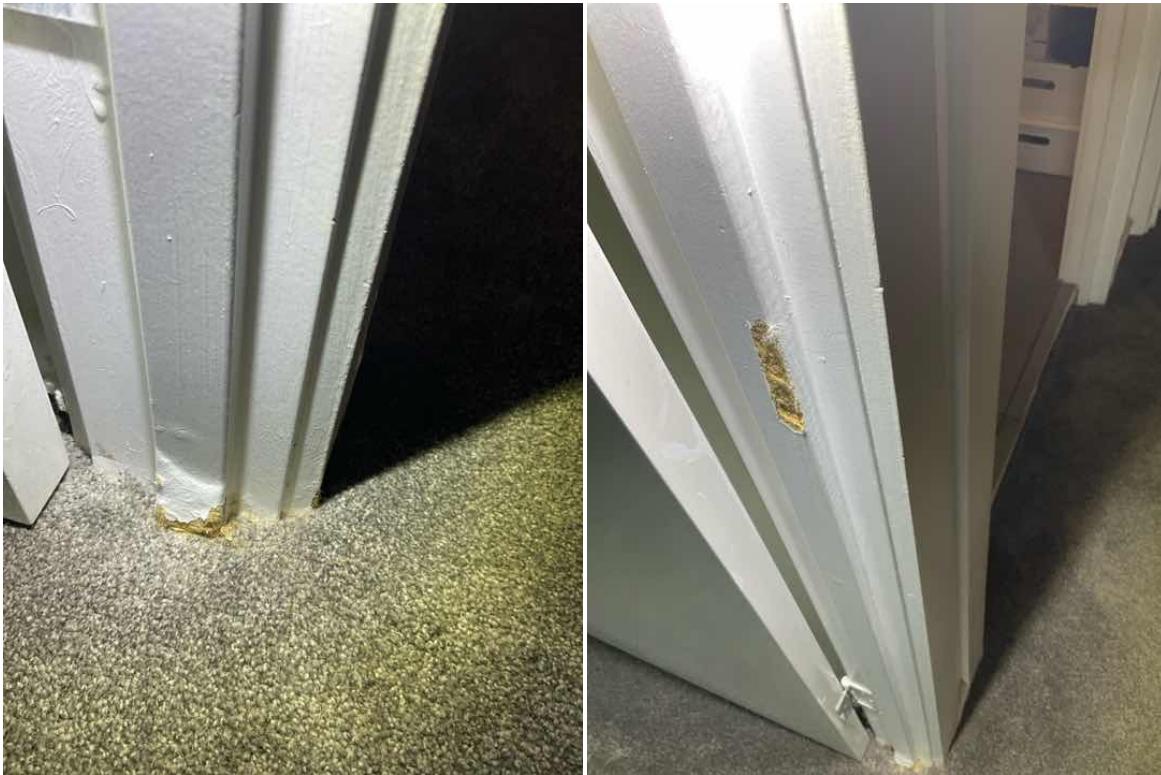
#4. The architrave to the door is Swolen/damaged. Contact a qualified carpenter for repairs

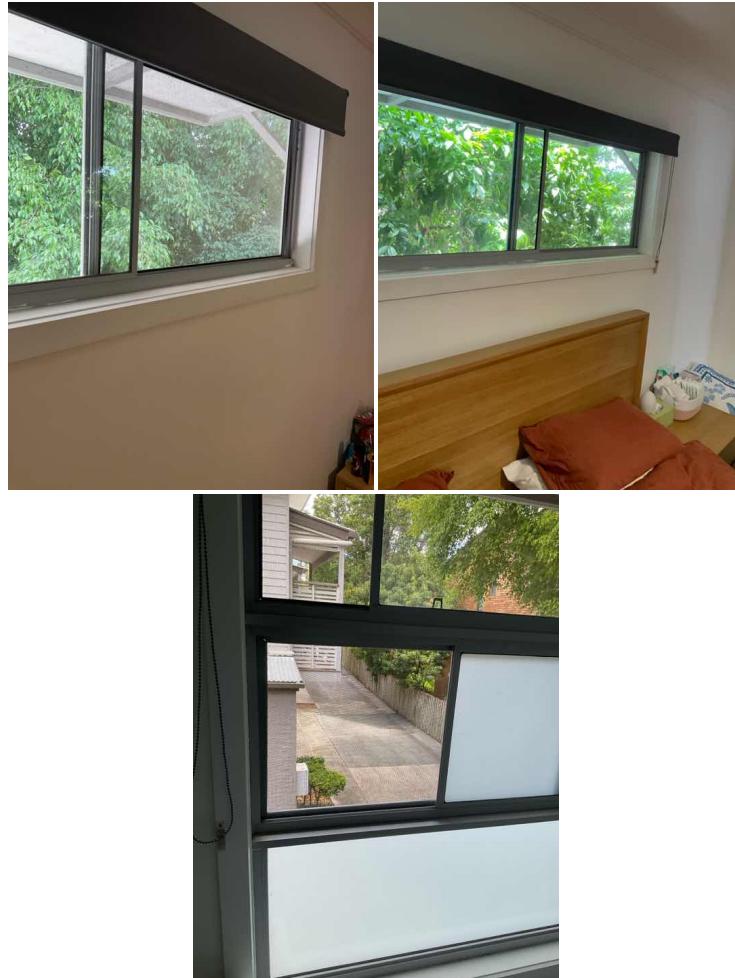
#5. The opening limiter/restrictor is missing. Ensure one is installed to every window with accord to state requirements.

Window openings should not exceed 125mm. In some circumstances, this regulation was non-existent depending on the age of the dwelling and technically there is no requirement to rectify. However, we strongly advise you to rectify to comply with safety concerns to young children. This is the same in bedroom one and two

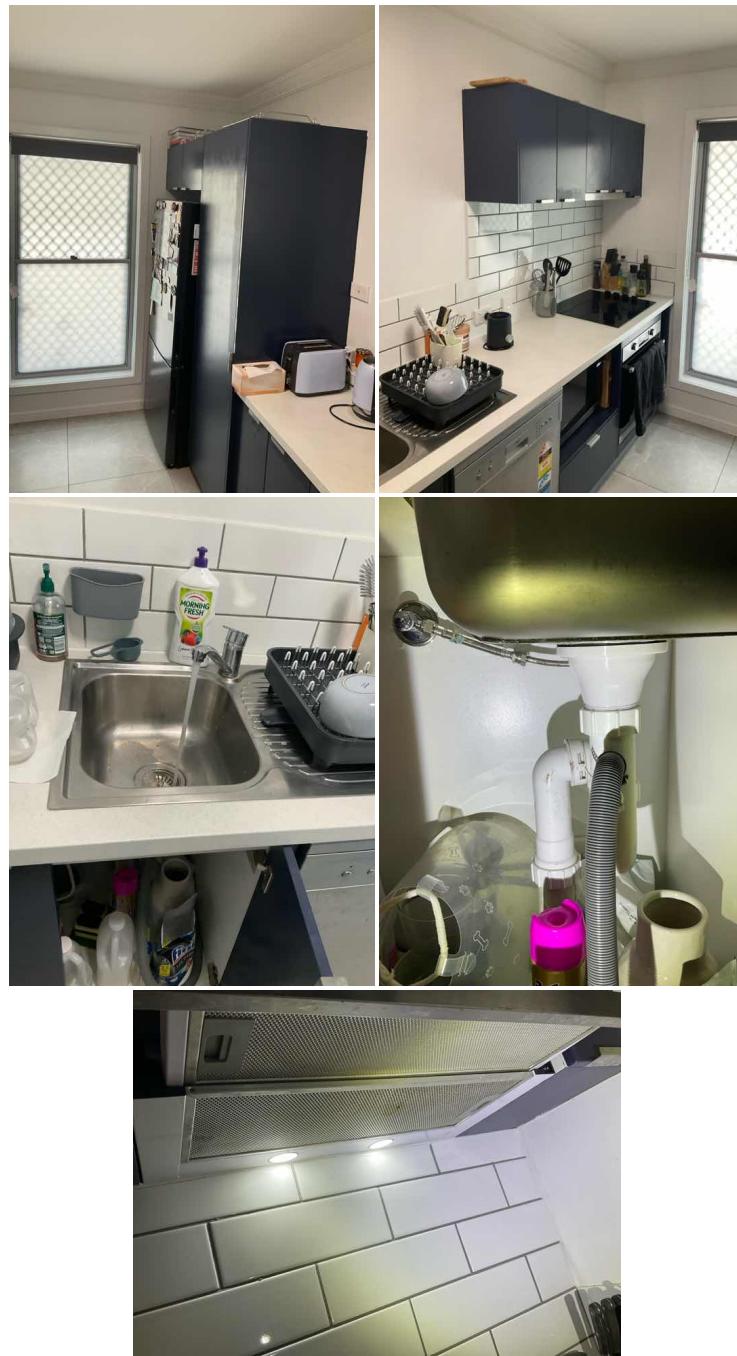
Squeaky floor boards noted. Re-fixing the floor boards may fix this issue.felt underfoot beneath tiles floor flexing .

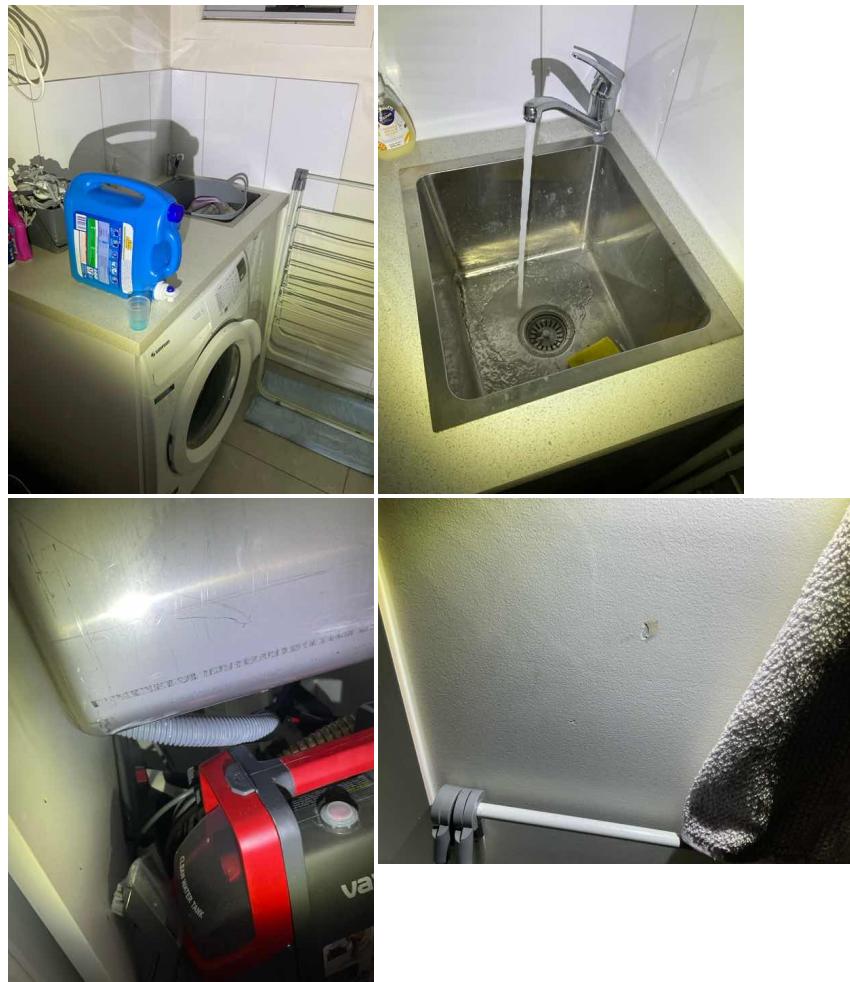
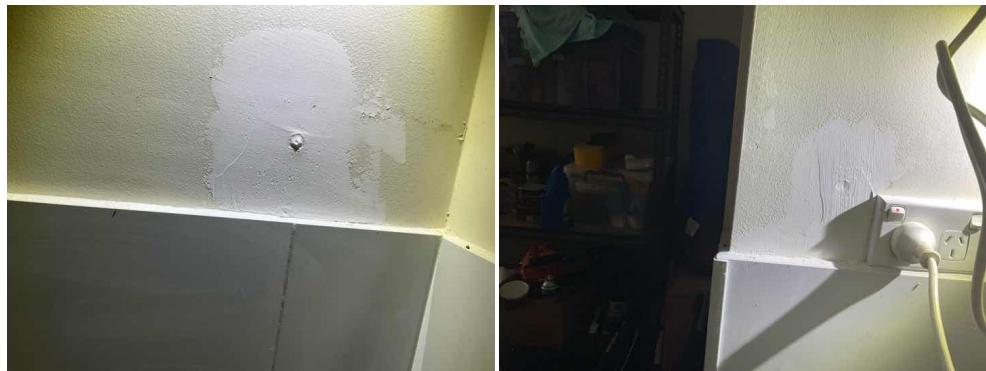
#6. General ageing and/or denting and/or wear and/or previous wall patching and the like is evident on wall linings - Recommendations: A qualified painter should be engaged to assess and repair as required.
