Timber Pest Inspection Report

9/50 Ferndale Street Annerley QLD 4103

Report/Agreement #	1401260356311
Inspection Date:	15 Jan 2026
Inspection Time:	01:00 pm

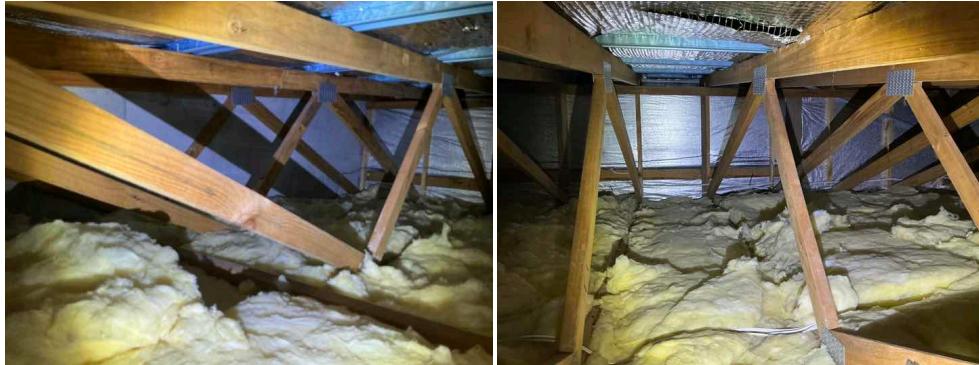
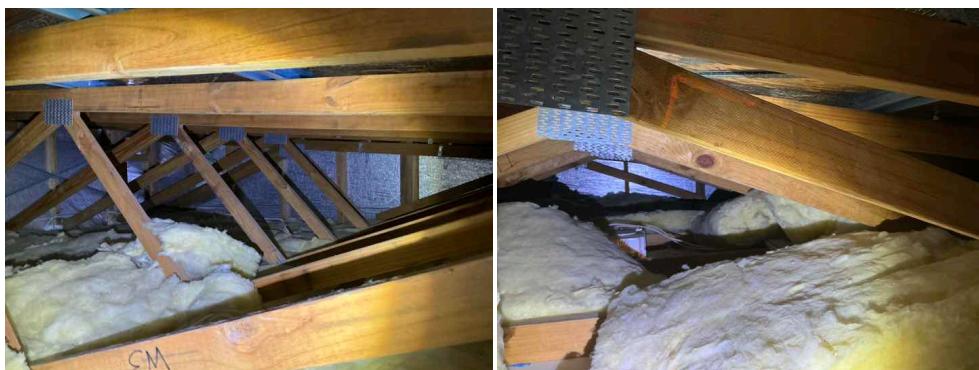
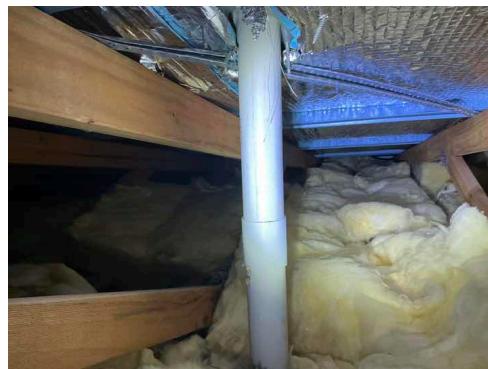
No inspection of low inaccessible area of roof was possible. Receding trusses makes access difficult or impossible.

Insulation restricted full inspection of roof cavity. Full inspection is not possible unless insulation is removed.

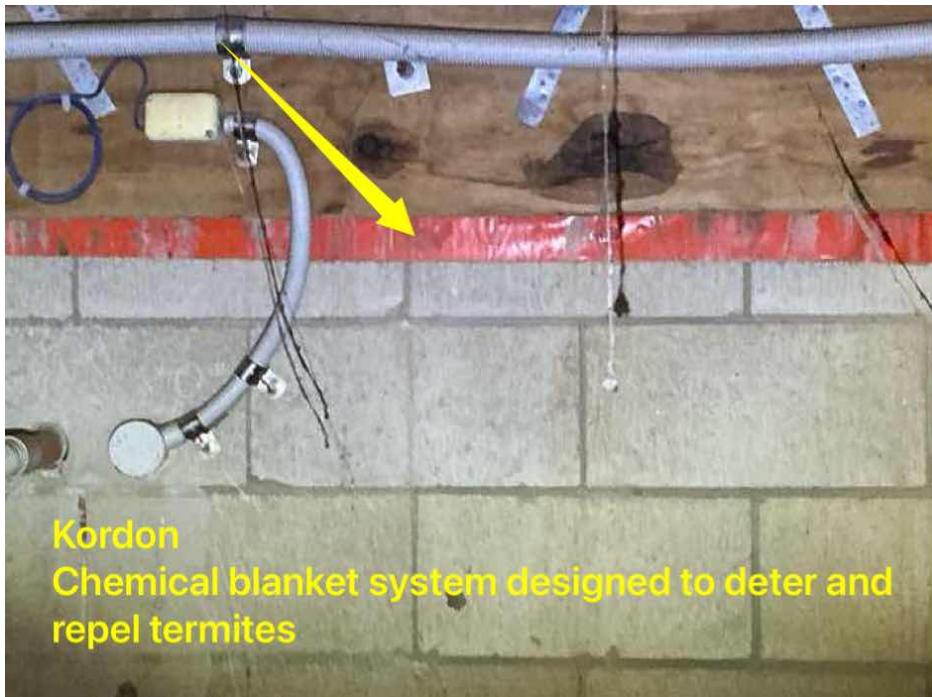
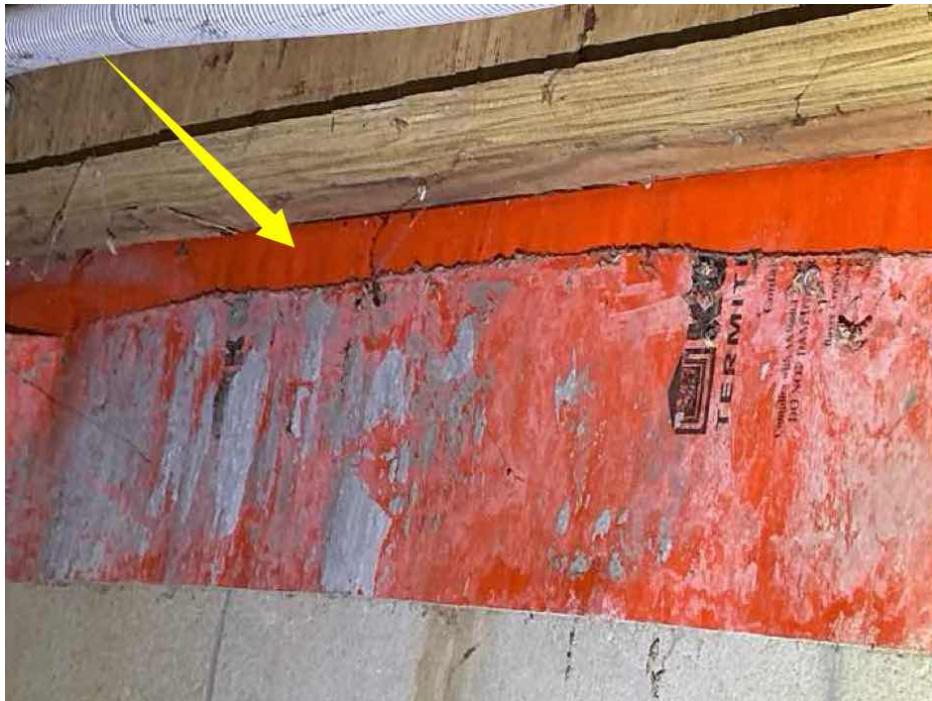
Part a to Australian standard was completed at time of construction, insure that part B was completed and is maintained

Kordon blanket has been installed as the barrier for termites, you must insure the structure has regular inspections

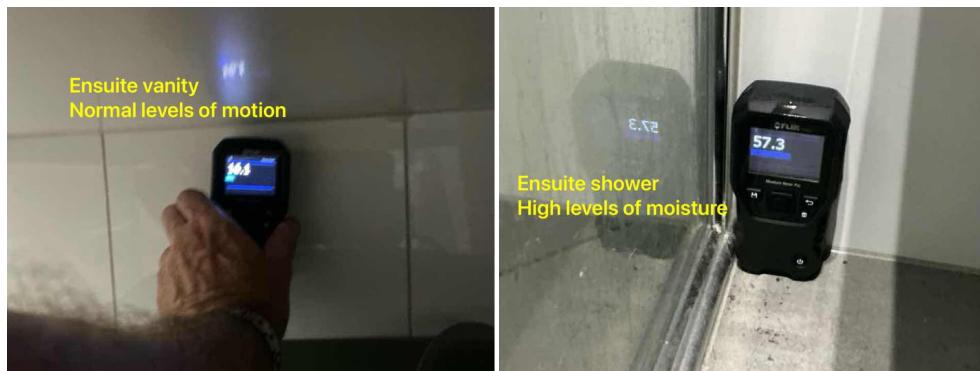
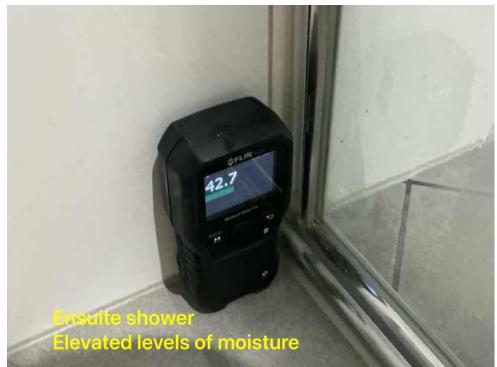
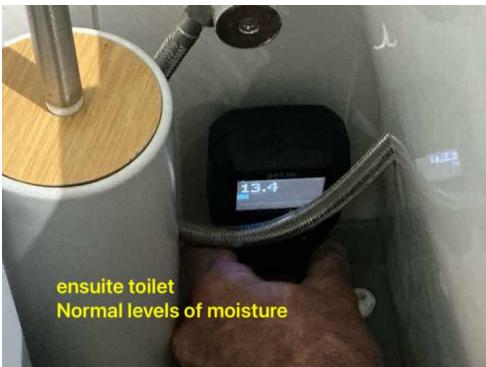
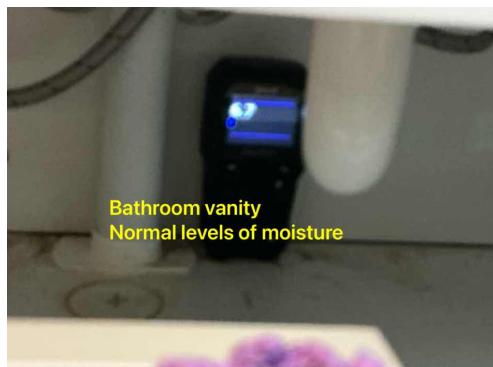
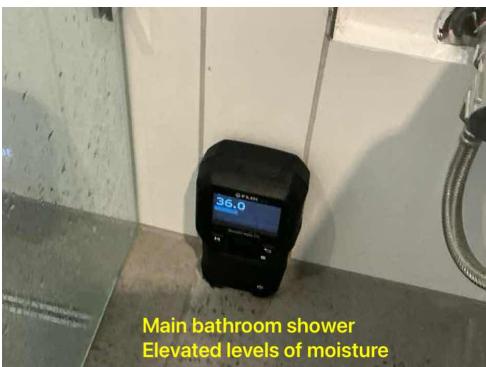
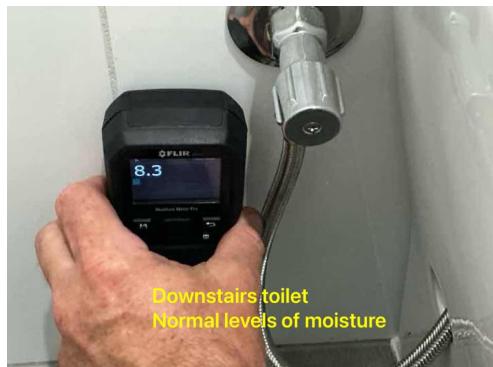
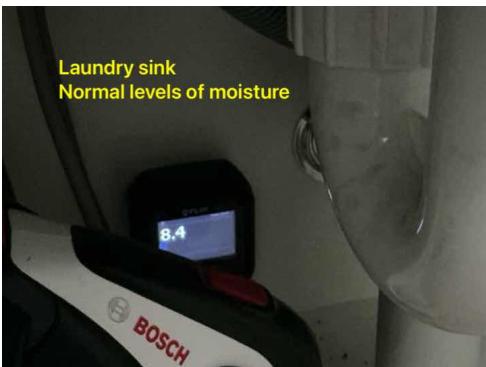
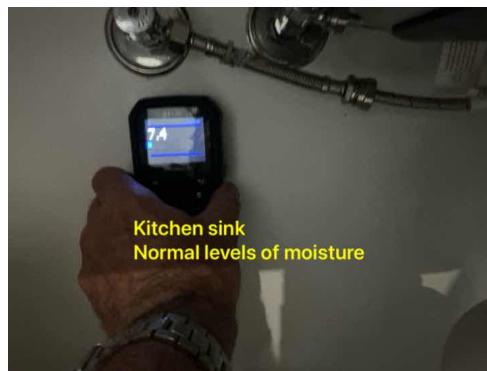
Section	Location	Name	Comment
CONDUCIVE CONDITIONS	4.2 Moisture Readings	Was There Any Excessive Moisture Readings?	#1. At the time of the inspection moisture readings were high. Ensuite shower, only. All other areas in normal range.

#1. At the time of the inspection moisture readings were high.

Disclaimer: If elevated moisture levels are reported, a suitably qualified building professional must be engaged to investigate the source of the moisture, assess the extent of any resulting damage, and provide an estimate for necessary repairs.
