Independent Builders Report

Total Home Inspection Services Porirua City Ltd

Wed 28 Jan 2026

5 Miro Rd, Raumati South, Paraparaumu, 5032, New Zealand

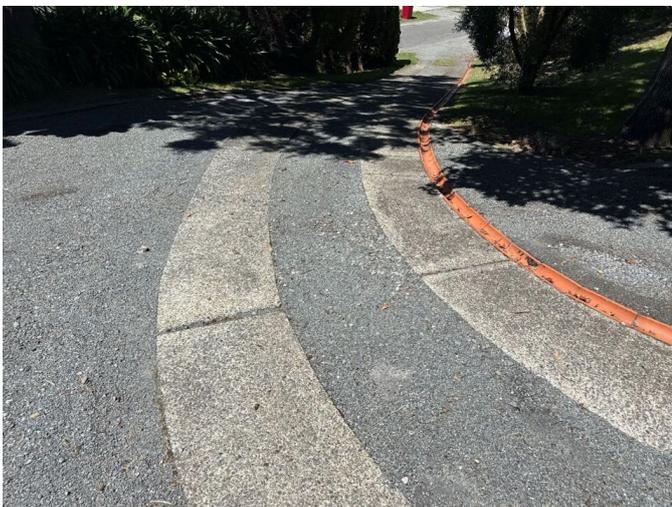
The surface condition of the sloping driveway is generally good

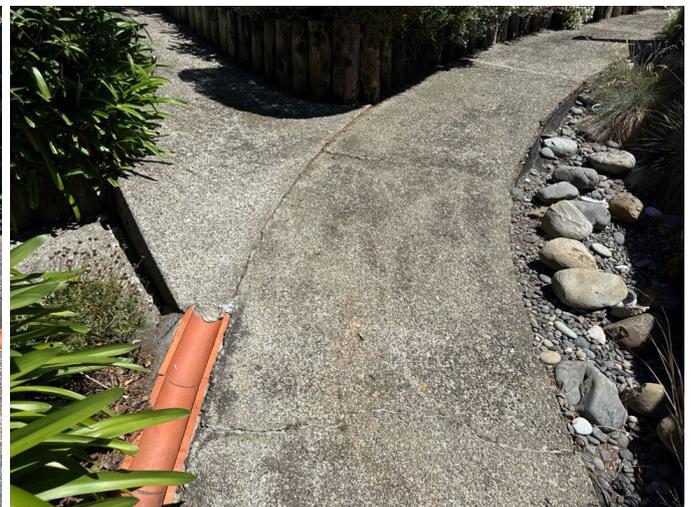
The paths are tidy and functional

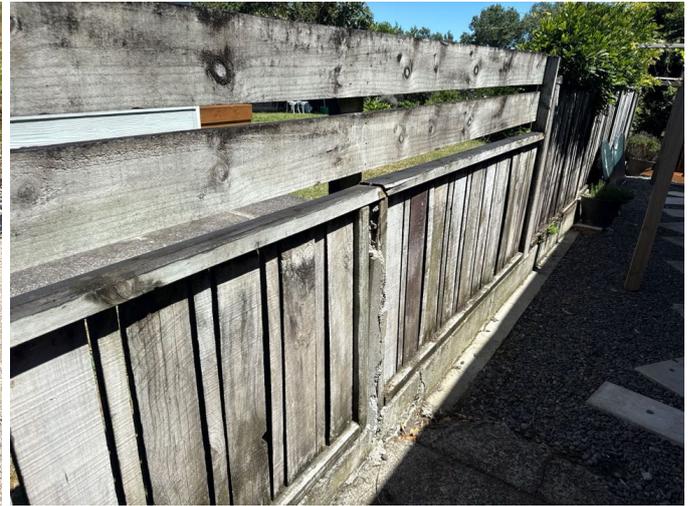
The timber fencing is deteriorating in some areas. Mostly intact at the time of inspection. Maintenance required to some areas in the future.

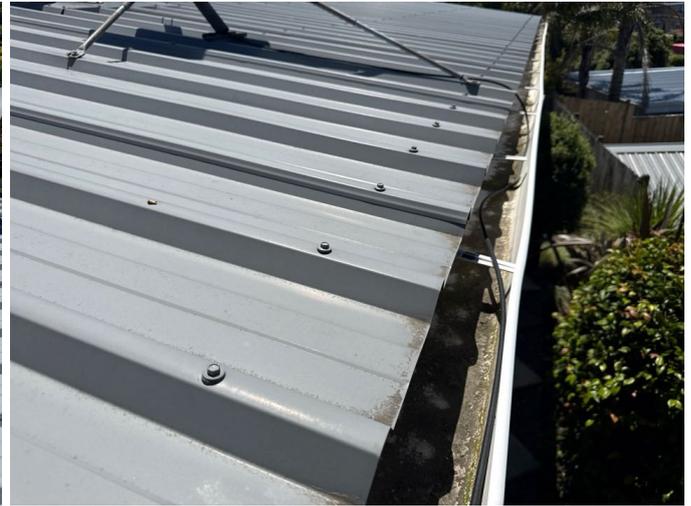
The spouting is in an average condition and was clear on the day of the inspection. The effectiveness of the spouting will need to be checked during rainy periods. Due to the dry conditions that were evident on the day of our inspection we cannot comment on any leaks that maybe evident to the spouting or down pipes.

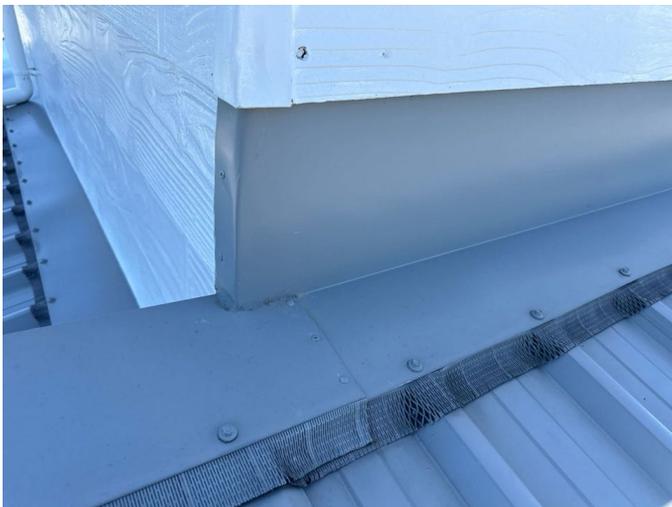
The roof flashings appear to be secure, intact and are effective. No sign of failure could be found beneath where accessible to view.

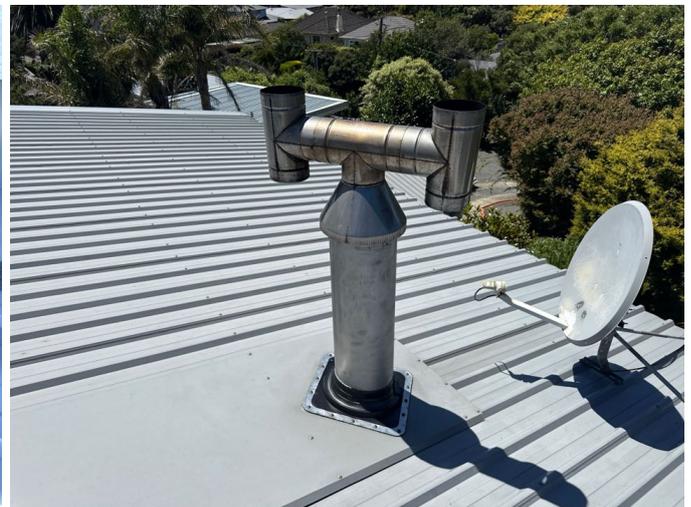
The steel flue is in good condition and is effectively flashed

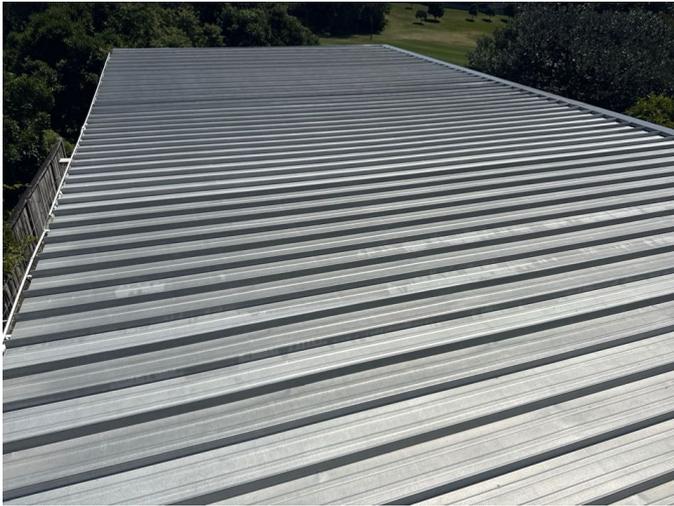
The west roof appears to be aluminium. This is a good material for the coastal environment.

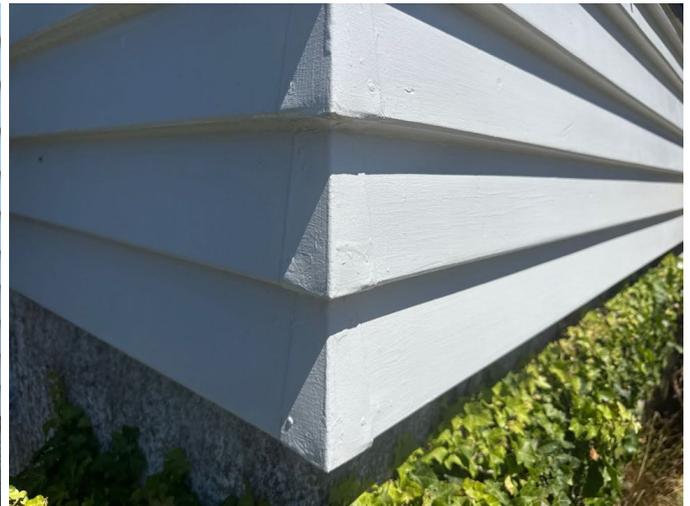
Corner soaker detail to the external weatherboard junctions. These help protect the corners from moisture ingress and deterioration.

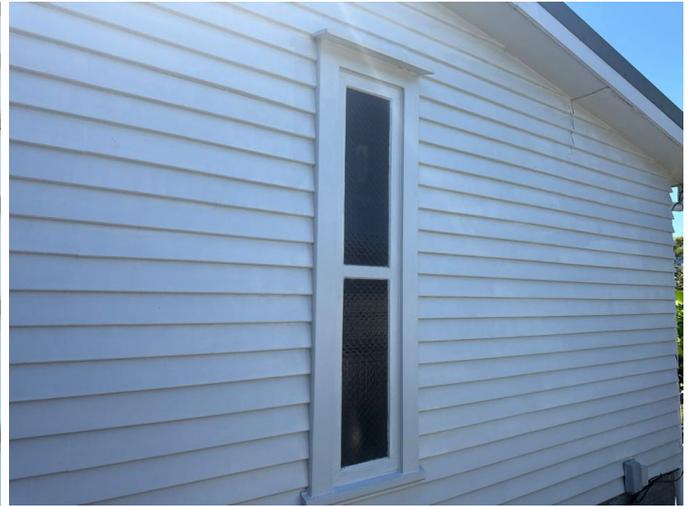
Reasonable paint quality to the timber windows and doors. Head flashings, facings, sill and scribes installed.

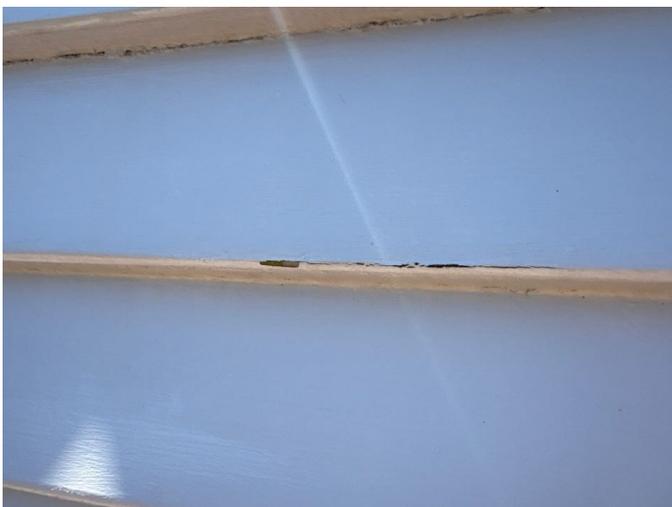
Early stage paint wear will need to be monitored and maintained accordingly

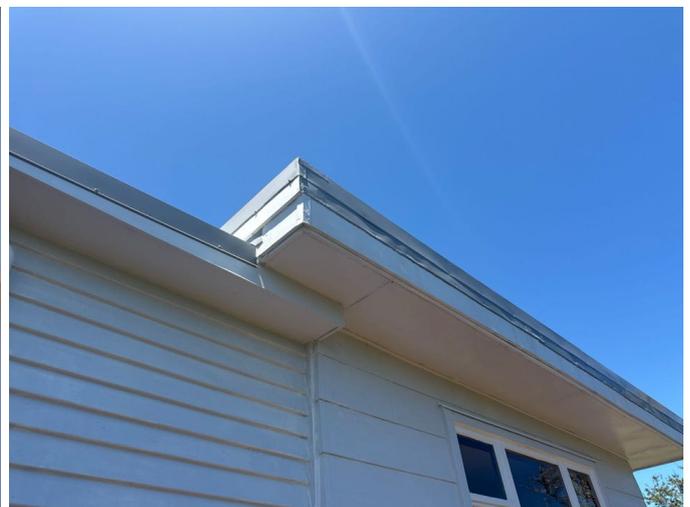
Average paint quality to the timber fascia and fibre cement soffit linings

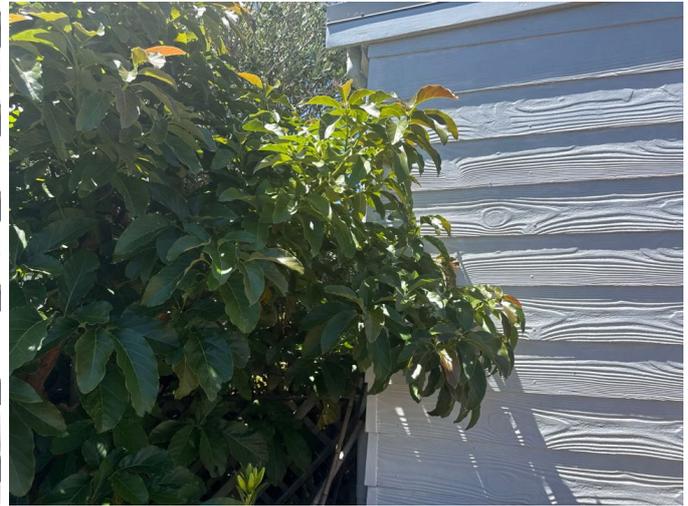
Plants in close contact with the cladding should be trimmed back to prevent the risk of premature deterioration

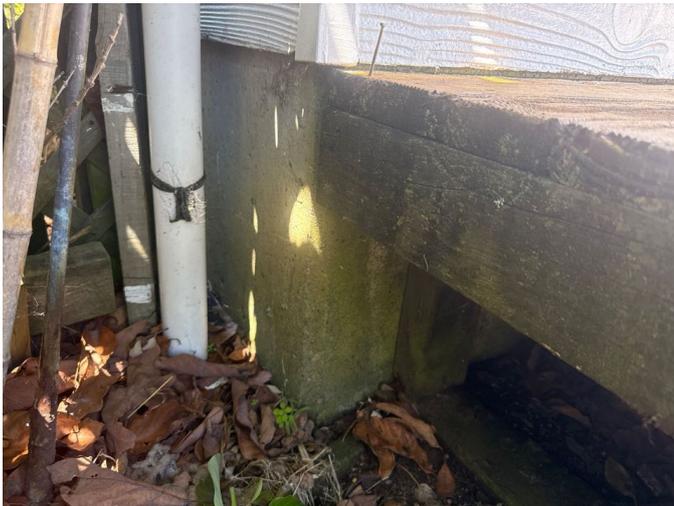
Good ground clearance around the perimeter. The current building code requires a 150mm clearance between the internal floor height and the sealed ground and 225mm to unsealed ground.

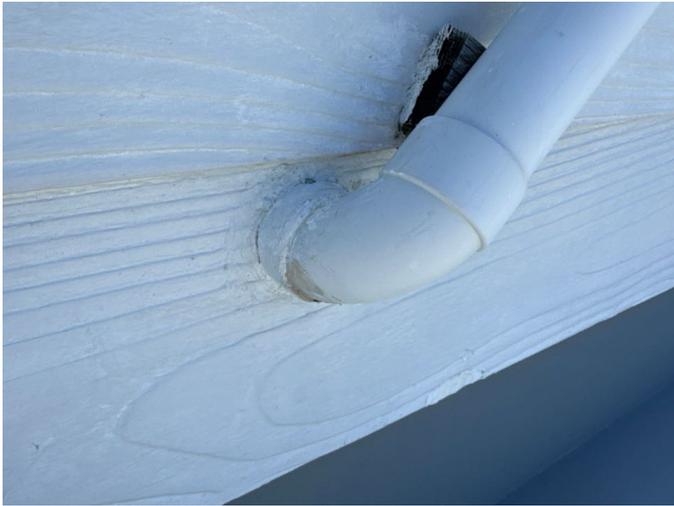
Cladding penetrations in general are a weather tightness risk area. Penetrations such as taps, screw fixings, gas or water pipes etc. A good seal must be maintained around all cladding penetrations over time to prevent issues.
No evidence of failure could be found.

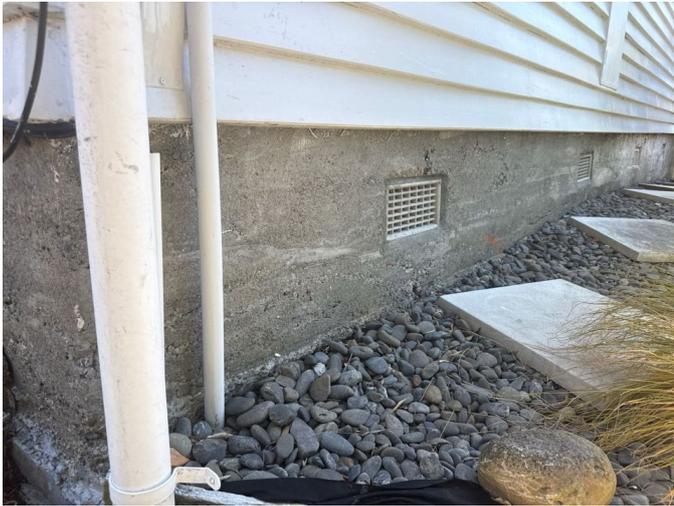
The concrete ring foundation is in a typical condition for the age. No sign of cracking or significant stress.

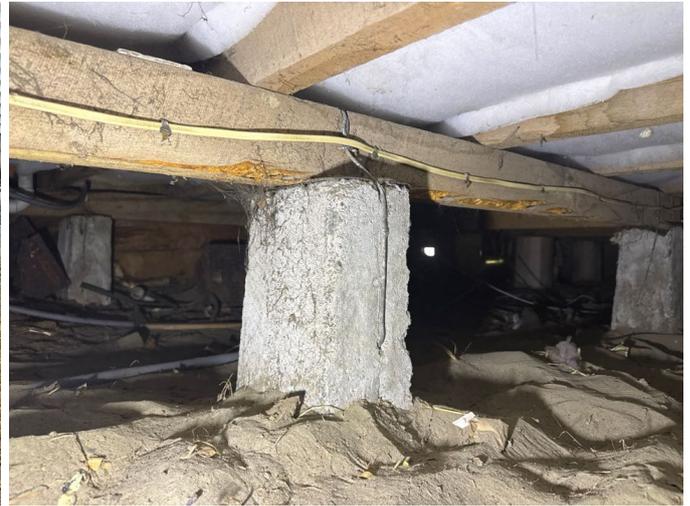
The concrete piles are solid at the time of inspection. Galvanised wire connects the bearers to the piles and anchors the structure to the ground.

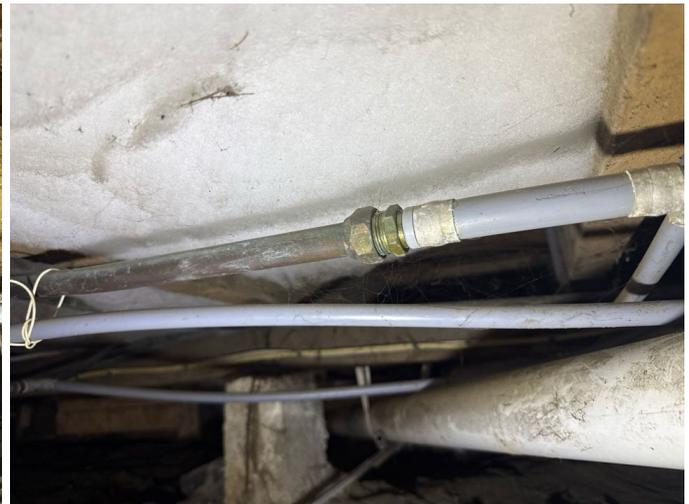
Only Buteline and Copper pipes sighted during the inspection

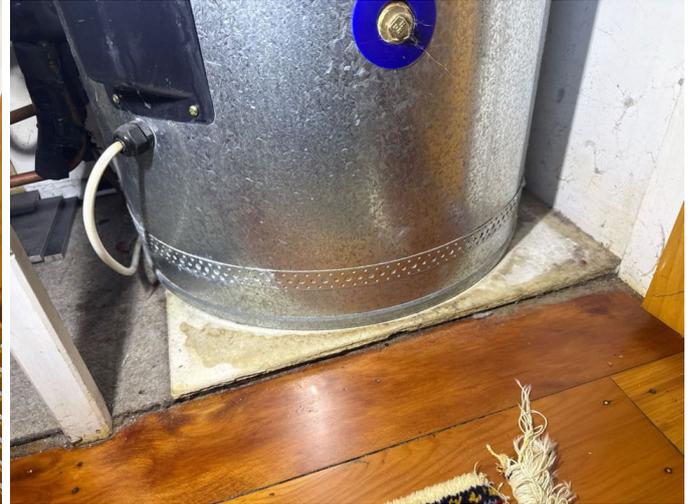
There was no evidence of current leaks around the base of the cylinder

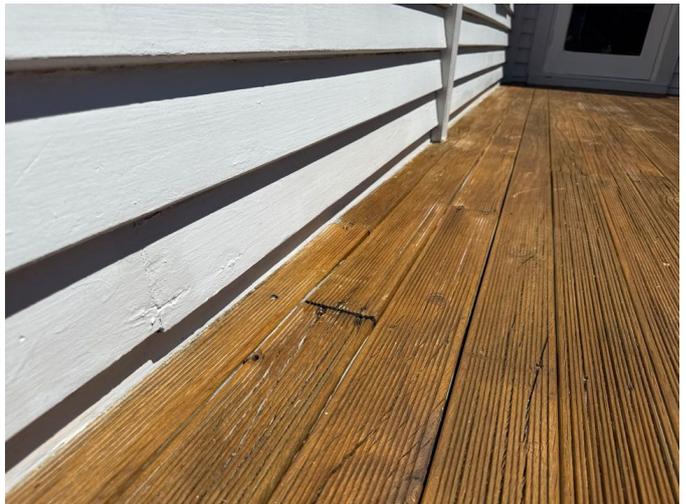
The decking has some age related wear but no significant damage. The main deck struts could not be fully accessed or inspected due to the lack of space.

The deck has been directly fixed through the cladding which was common at the time of construction. There is a risk that the timber will eventually rot out therefore ongoing monitoring will be required. If installed now there would need to be a clearance gap of approximately 12mm to allow water to escape. No current concerns found.

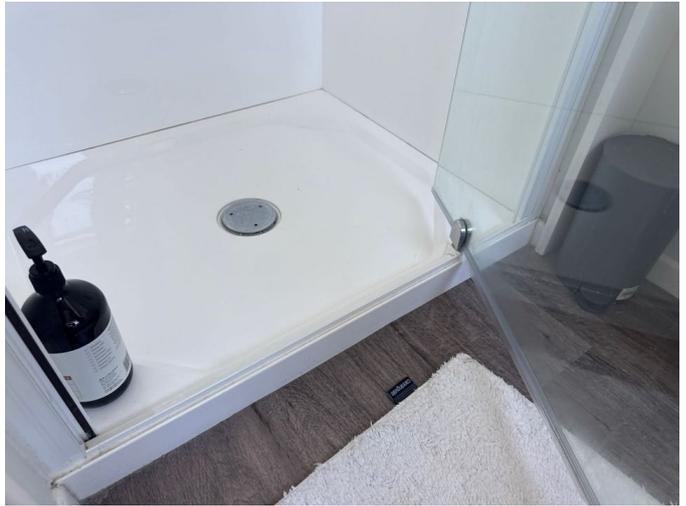
The base of the shower is well sealed. There was no evidence of damage to the shower base at the time of the inspection.

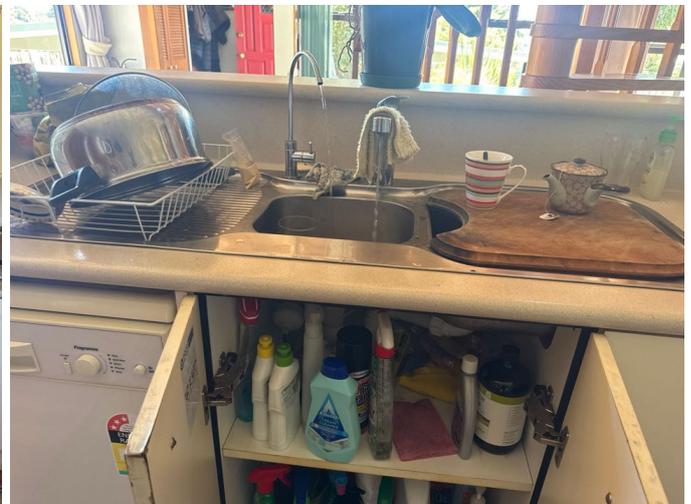
The rear edge of the bench top is well sealed. The taps are functional. No concerns with the water feeds or waste pipes under the sink. Water filtration system installed. Regular servicing recommended to ensure a clean water supply is maintained.

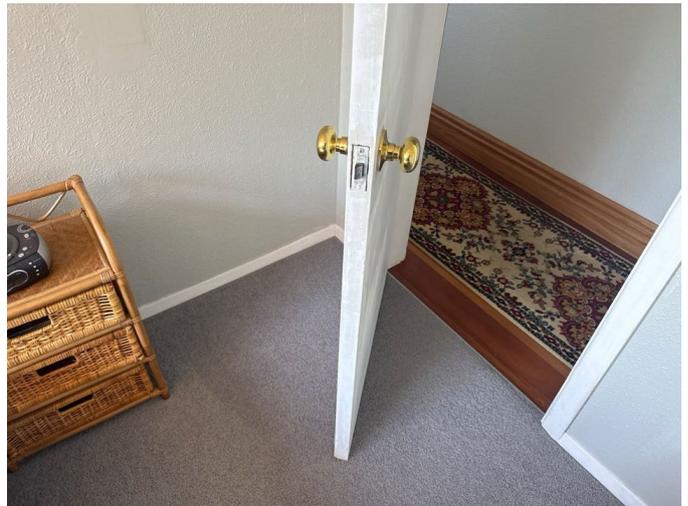
The internal doors are functioning well. Door stops should be installed where missing to prevent the risk of damage to the wall linings.

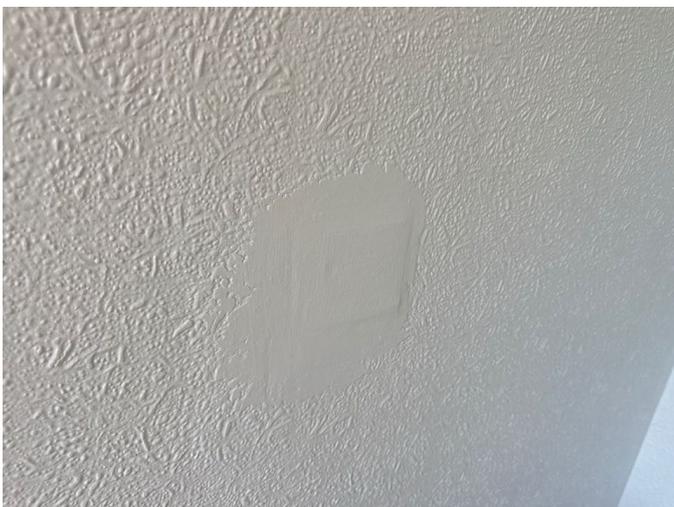
Minor cosmetic defects noted

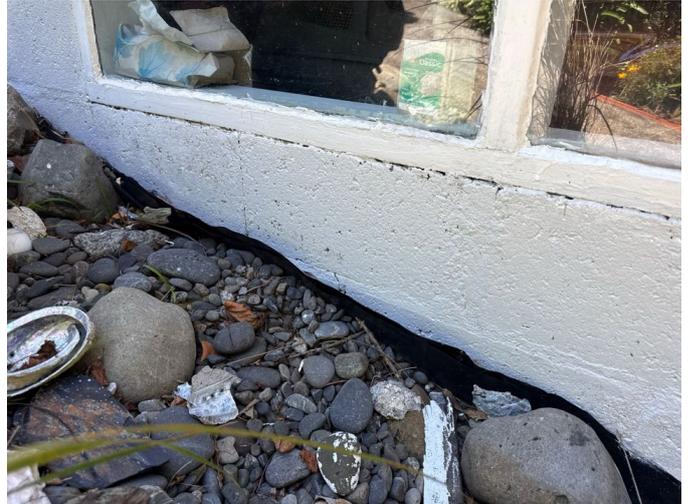
Concrete block walls on the base. There is some waterproofing to the walls visible.

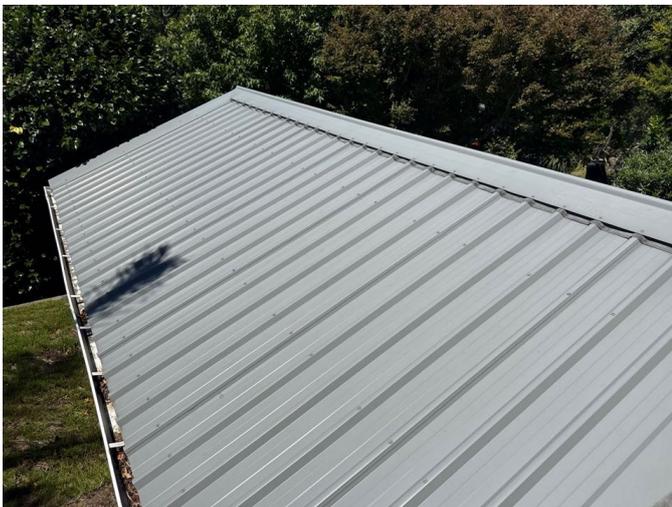
The lightweight steel trapezoidal profile roof is in good condition and appears to be new

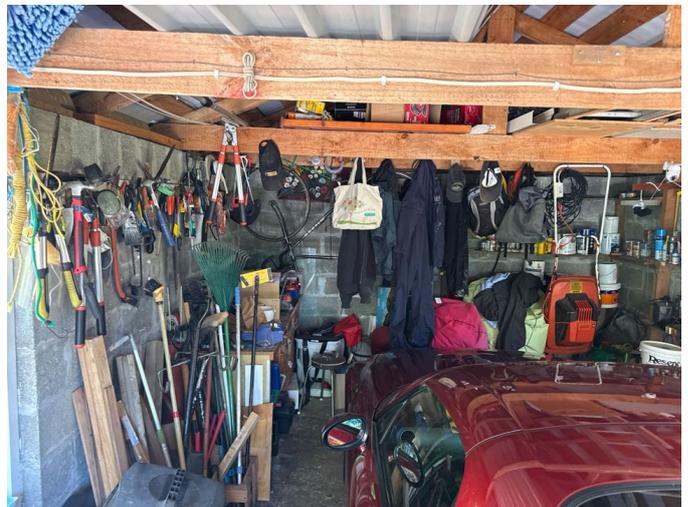
Not all areas of the garage could be fully inspected due to the presence of stored items. A full inspection is recommended once cleared. This applies to all concealed locations throughout the house. There were no previous moisture ingress issues disclosed by the owner and none found by T.H.I.S.
