**All Building Inspections Limited**  
PO Box 532 | Waikanae 5250 | New Zealand  
**T** 04 905 9707 **M** 021 979 707  
**E** [info@allbuildinginspections.co.nz](mailto:info@allbuildinginspections.co.nz)  
**W** [allbuildinginspections.co.nz](http://allbuildinginspections.co.nz)

## Building Report

105 Winara Avenue  
Waikanae

**Date/s of inspection:** 20-Jan-2026

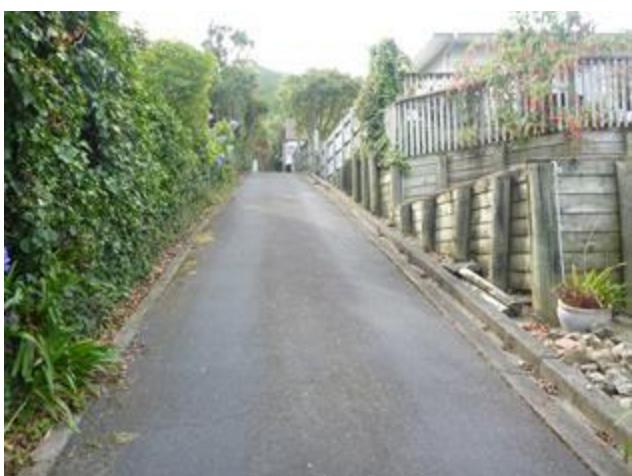
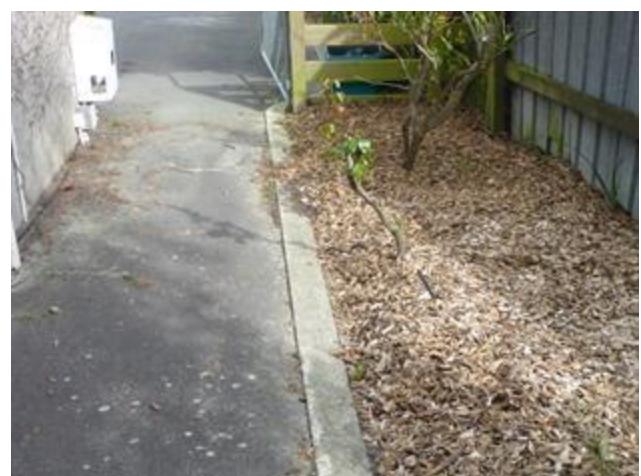
Side of the dwelling

The path to the side of the dwelling was showing its age and will require repair to some sections as the deterioration continues.

The handrail to the access stairs of the front door and to the deck from the master bedroom is not compliant with modern standards. The handrail would require alteration to meet today's standards. The top of the handrail should now be 1000mm above the deck and have vertical rails to stop climbing access. This is more of a peace of mind issue and a safety requirement if any little people will visit the dwelling. A carpenter could reconfigure the handrail easily.

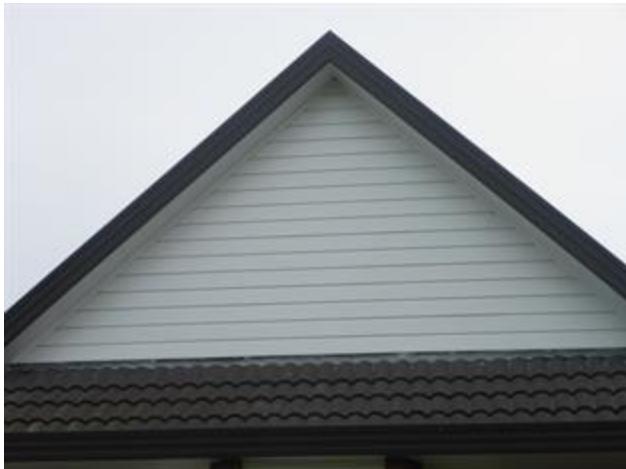
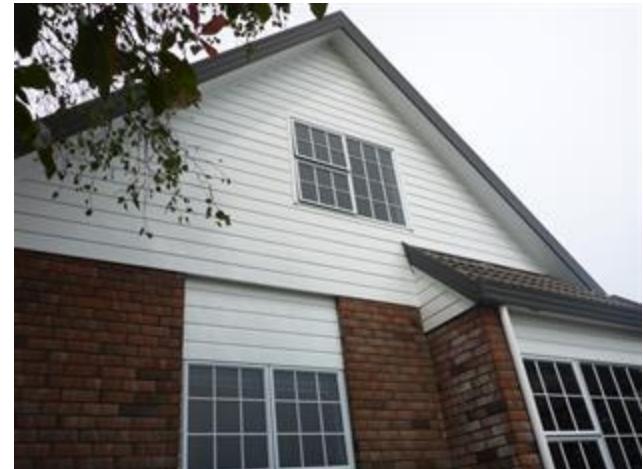
Gable ends

The gable ends and above the window joinery has a rusticated weatherboard with a paint finish. The weatherboard cladding was in good condition with no visible signs of decay.

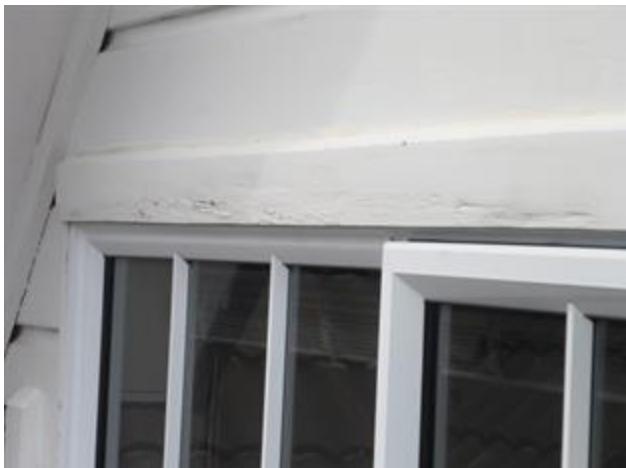
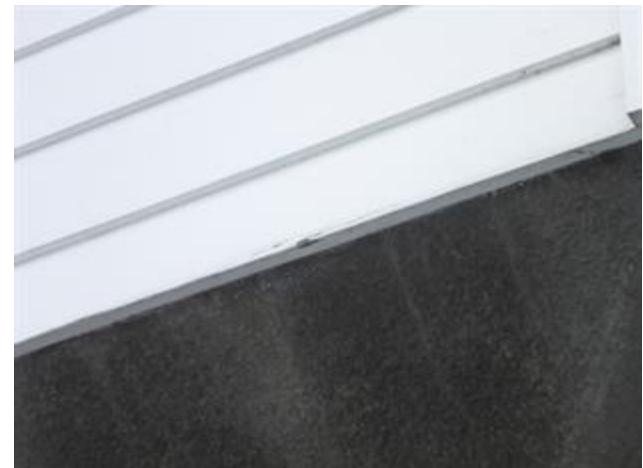
Generally, the paint finish was of a good standard with only some small touch-ups recommended as part of the dwelling's maintenance planning.

Touch ups recommended

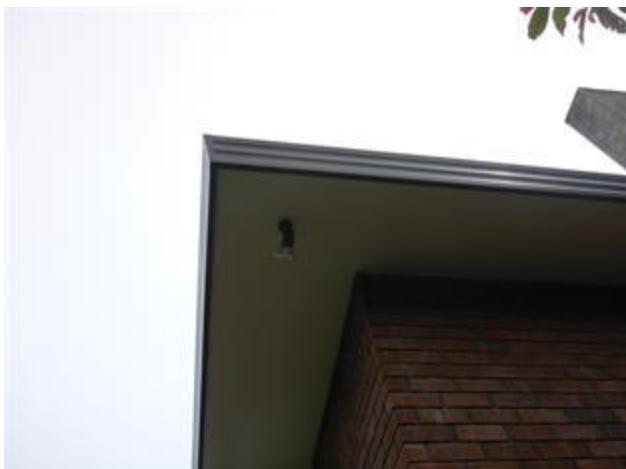
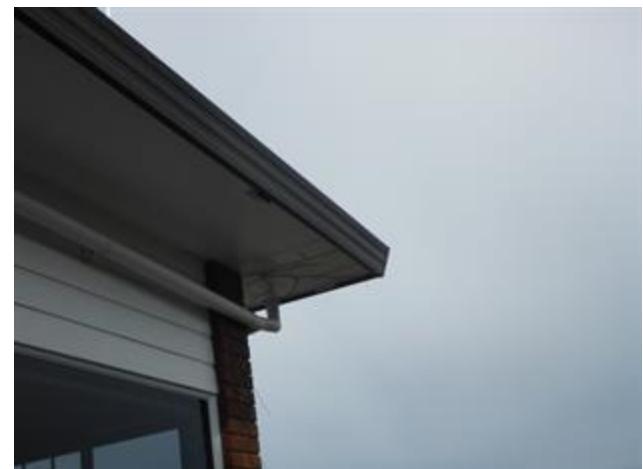
Cement board soffits/metal fascia

The cladding was in good condition. Cement board's maintenance requirement is to ensure a good level of paint finish to protect and seal the cladding and the paint finish was of a good standard.

The fascia is known as Gerard Klass fascia. The fascia is designed to complement the pressed steel roof while it provides support for the spouting system. The fascia is pre-painted with corrosion-resistant coatings.

Regular cleaning of the fascia especially the lower edge where it meets the soffit is recommended as corrosion can form where the fascia doesn't get rain-washed.

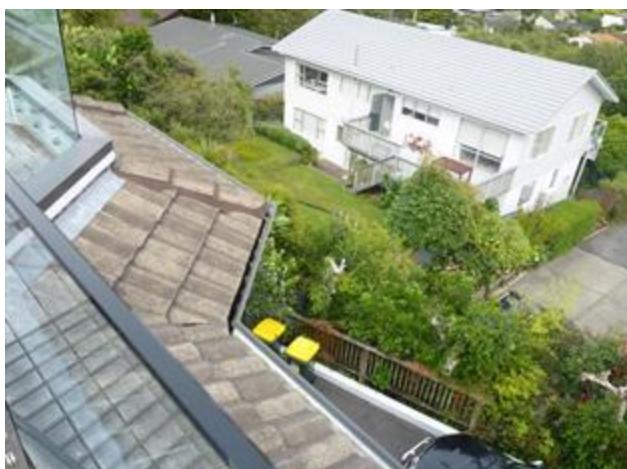
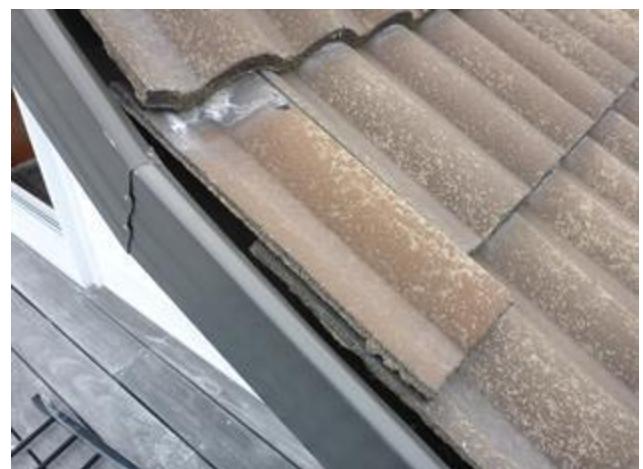
Loose tile

No significant deterioration or cracks was observed within the tiles. One loose tile was sighted to the left side of the top deck that requires re-fixing.

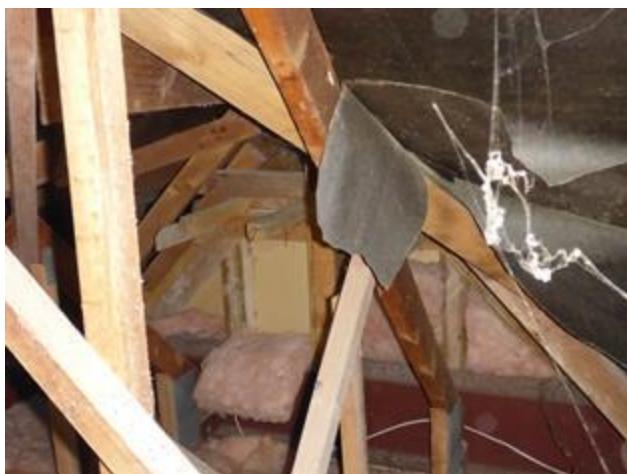
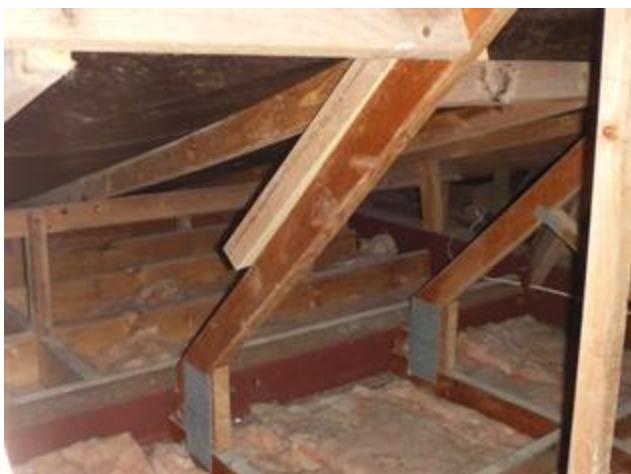
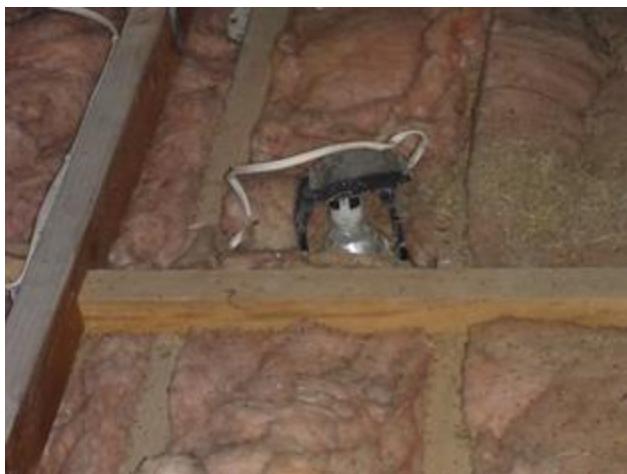
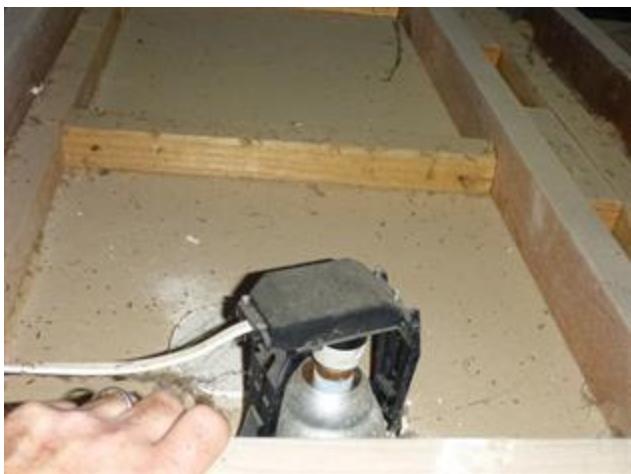
There were small areas identified in the attic space where the insulation could be fitted better. To gain maximum benefit from the insulation it needs to cover like a blanket as any gaps will cause heat loss. Filling the gaps would benefit the dwelling and the occupants.

As part of the maintenance planning, I recommend consultation with a registered electrician about replacing the ten existing recessed downlights that require clearances from insulation with new recessed types that can be safely covered with insulation.

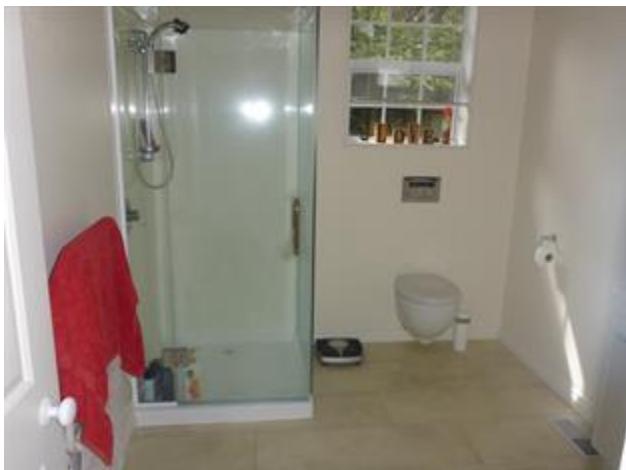
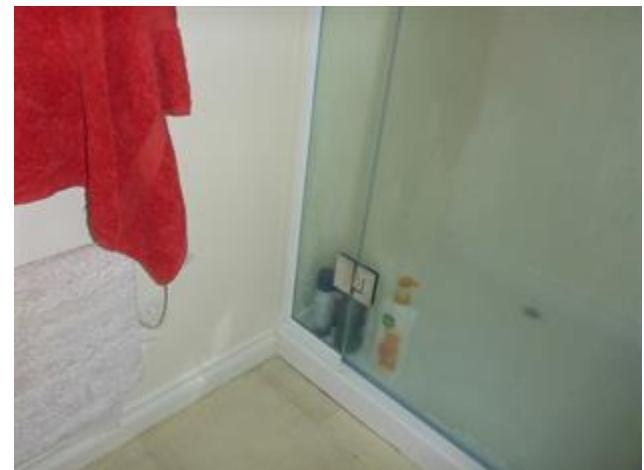
All moisture readings were within acceptable parameters except to the wall lining to the left side of the en-suite shower and to the flooring in front.

The vendor stated there had been a leak to the shower mixer that had been repaired with the skirting board removed for appraisal. The insulation below the shower restricted any inspection of the floor lining. Further appraisal is recommended as chip board flooring has a poor tolerance to moisture.

High moisture levels

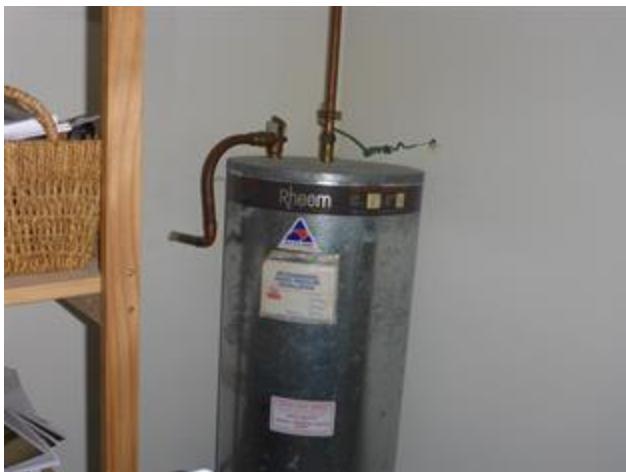
The hot water supply to the flat is via a 135 litre Rheem mains pressure electric cylinder manufactured 2/1991. The cylinder is located in a cupboard. Due to the age of this cylinder I recommend that an appropriate sum be set aside for the replacement of the cylinder as and when necessary.

Restraint recommended

It is recommended that the flat's cylinder be secured to prevent rupturing during an earthquake and an insulation jacket fitted to prevent heat loss. There are kits available from most hardware stores that are inexpensive and relatively easy to fit.
