BUILDING INSPECTION REPORT

26 Jan 2026 / 26 Taumutu St

Pre-Purchase/Sale Visual Non-Invasive Property Inspection

Eye Spy Property Inspections
Pre sale building report
26 Taumutu St, Southbridge

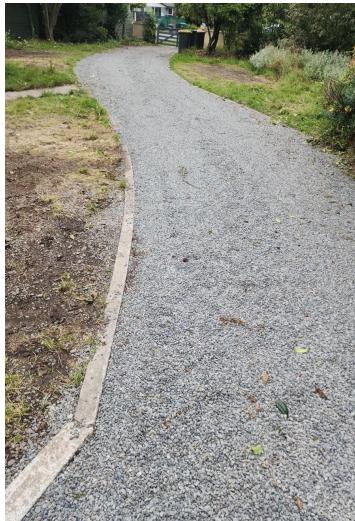
Photo 17

Stone chip driveway appears in sound usable condition

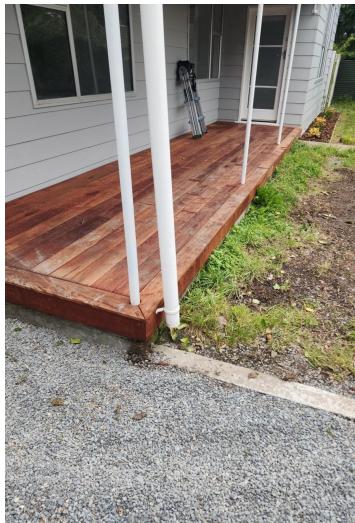
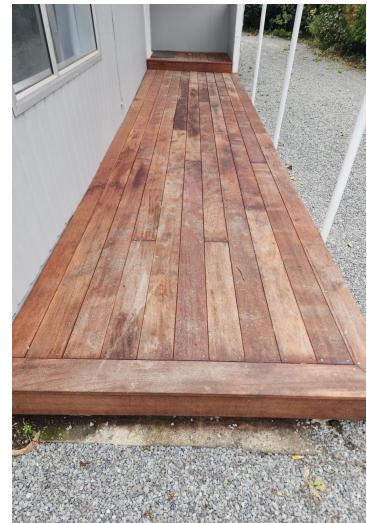
Photo 19

Relatively new timber decks appear in sound usable condition.
Older concrete appears in average but usable condition with cracking and movement typical for age

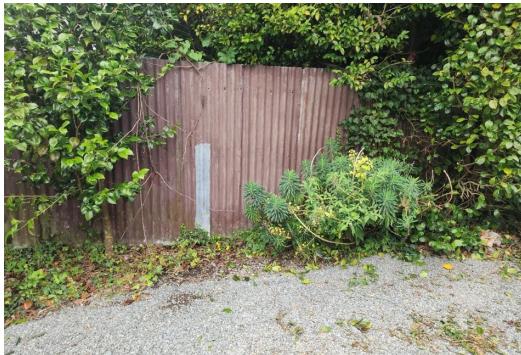
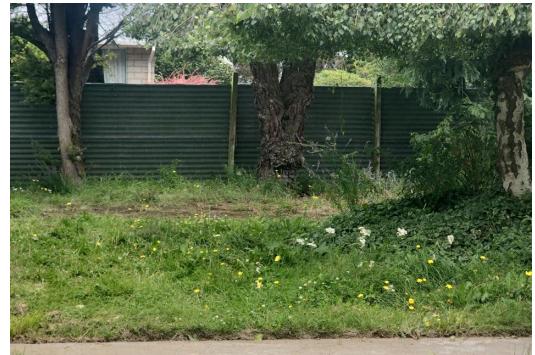
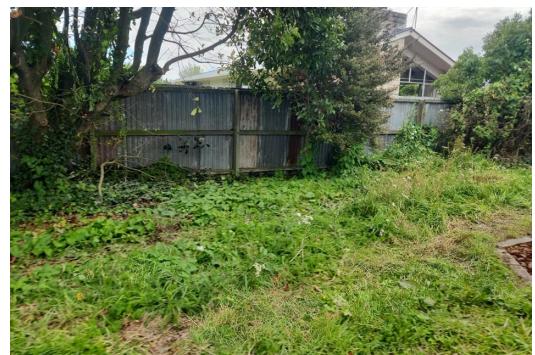
Photo 25

Timber & tin appear in average condition with wear and tear typical for age

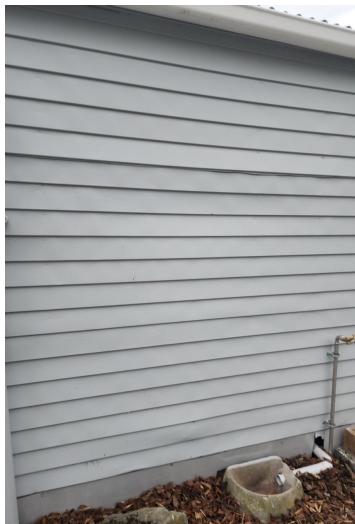
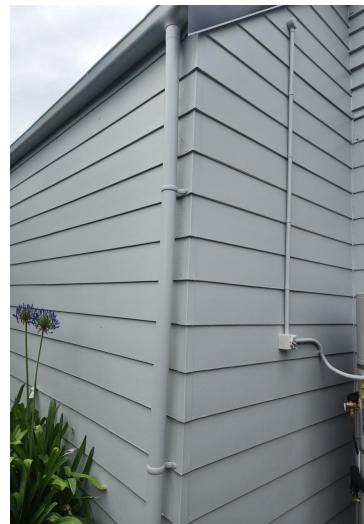
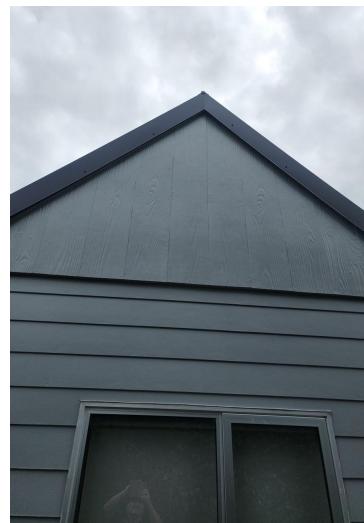
Photo 32

Painted timber weatherboard appears generally sound typical for age.

Painted steel cladding appears generally sound typical for age

Painted fibrecement weatherboard appears generally sound with wear and tear typical for age

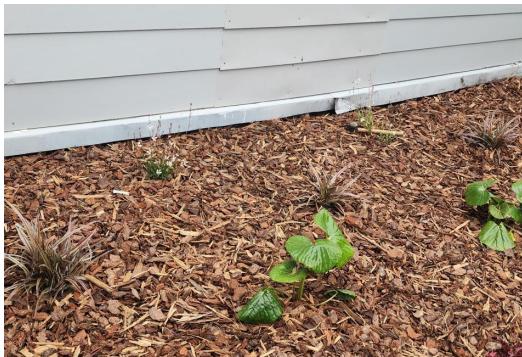
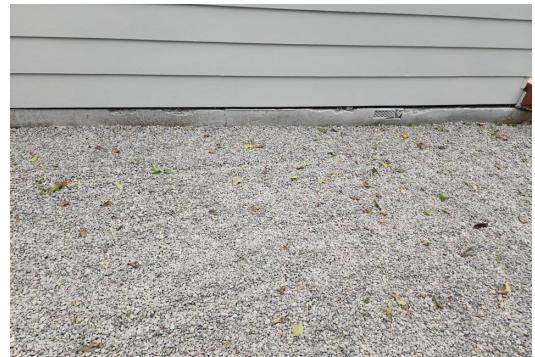
Photo 39

Some concrete foundation appears in average condition with some cracking and movement typical for age. Otherwise piles to exterior

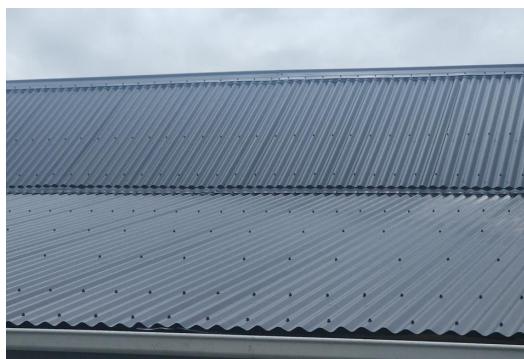
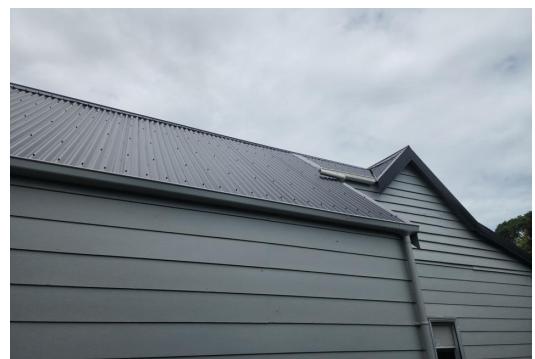
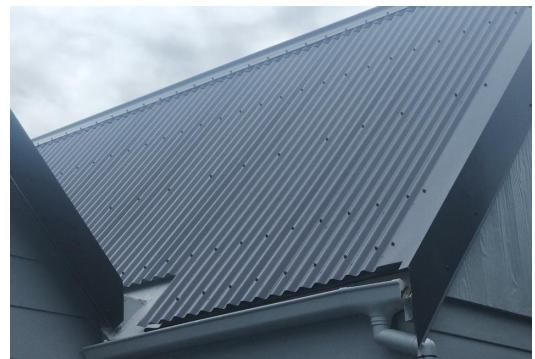
Photo 59

Relatively new coil coated corrugated iron roof fixed with tek screws appears in good condition

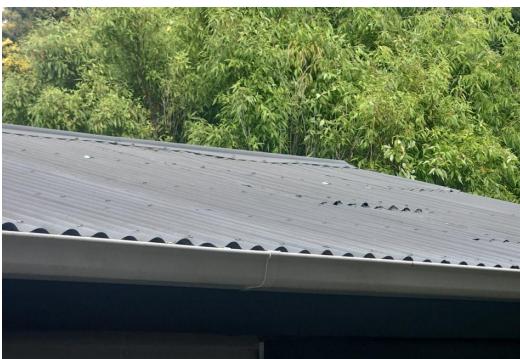
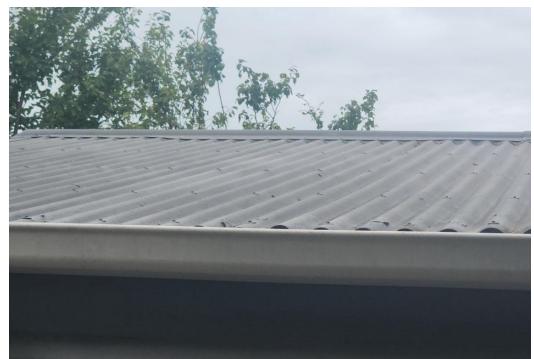
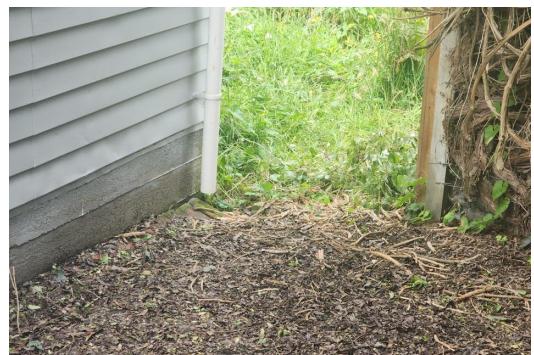
Photo 95

Corrugated iron roof fixed with spring head nails over silver foil over timber framing appears in average condition with wear and tear typical for age

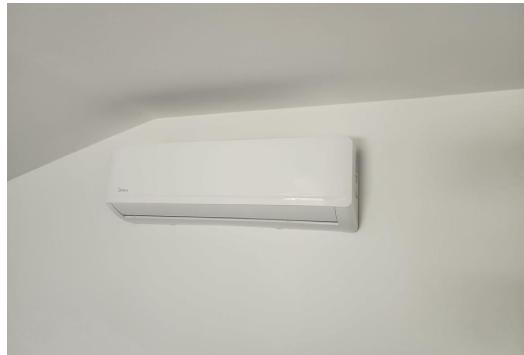
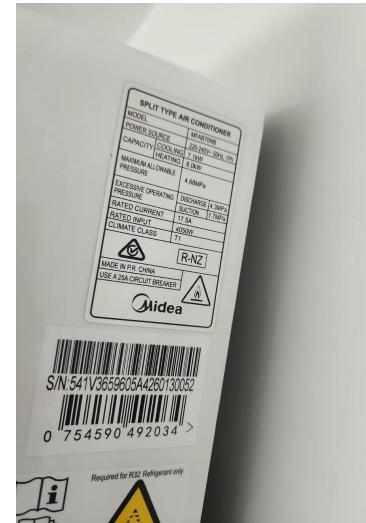
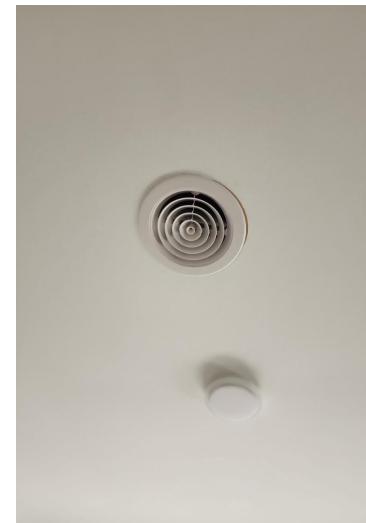
Photo 118

Wall mounted heatpump appears in sound usable condition. Untested.
Heatpump vent in ceiling untested
