RESIDENTIAL PROPERTY INSPECTION

Inspection Address: 33 Nancy Avenue, Christchurch

Inspection Date: Tuesday, 20 January 2026

Inspector Name: Kelvin Johnston

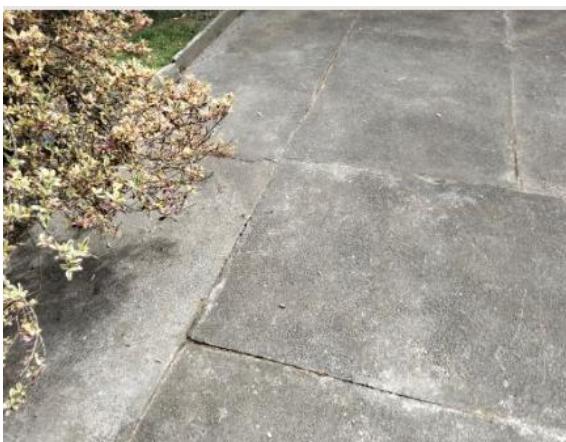
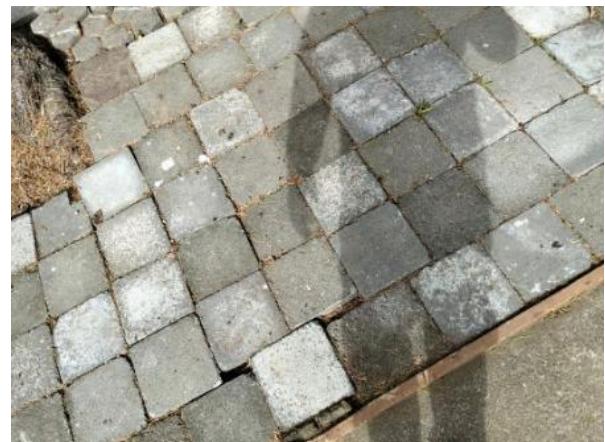
- Some slightly uneven slab joins on the paths around the dwelling and concrete area at the rear of the property, some minor/insignificant cracks

Uneven paths

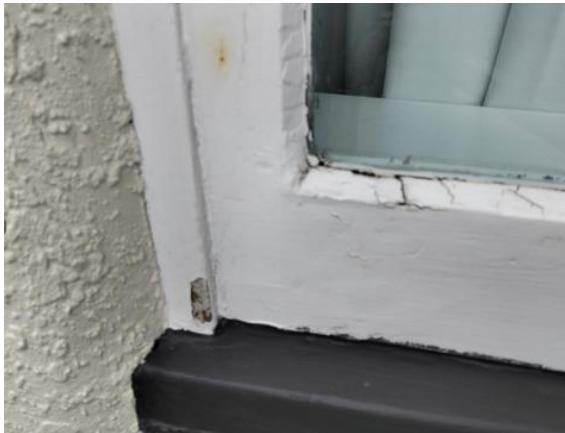
Some paint maintenance required on the timber windows

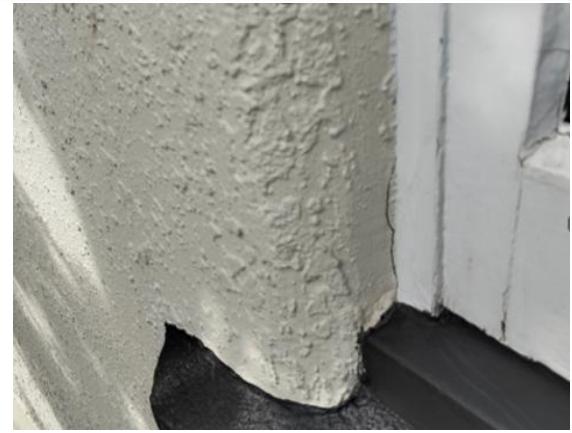
Small crack in the plaster adjacent to the window on the front elevation of the dwelling

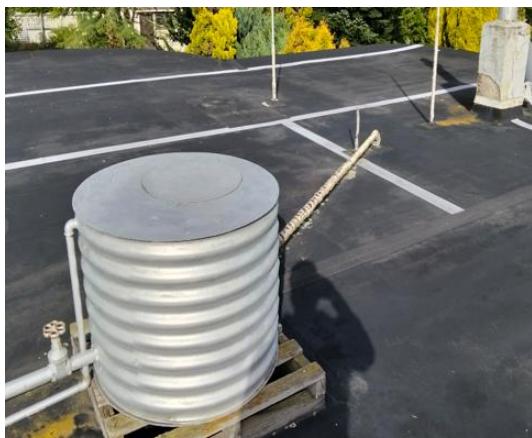
Header tank is likely redundant, given the gas hot water system

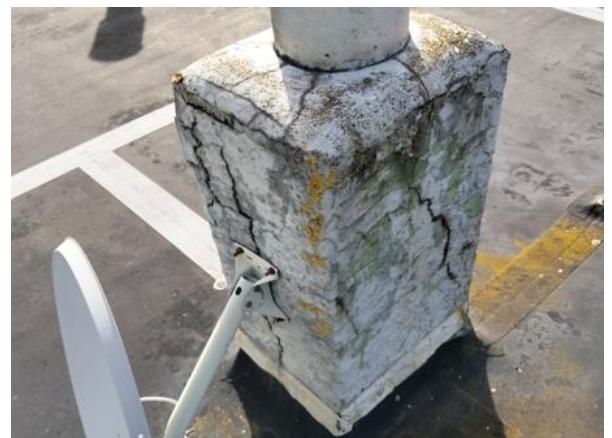
Plaster on the chimney is cracked/broken

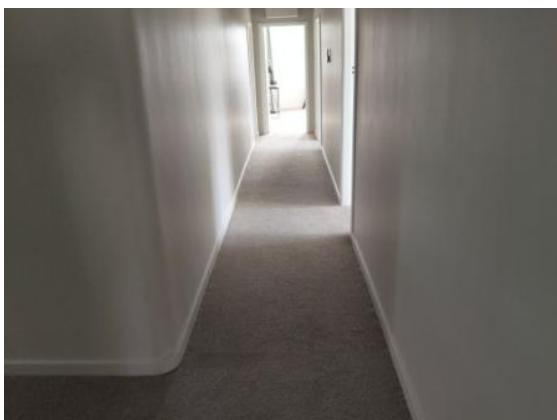
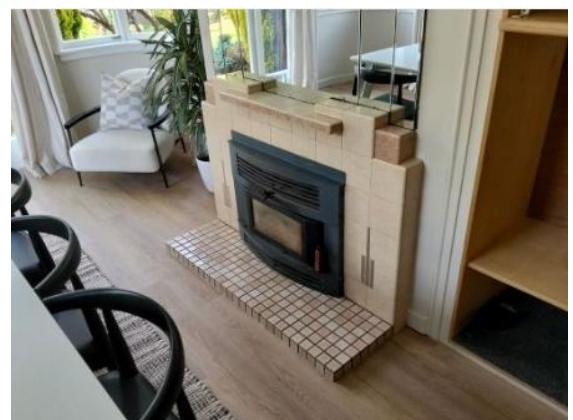
The substrate/concrete below the flooring is uneven

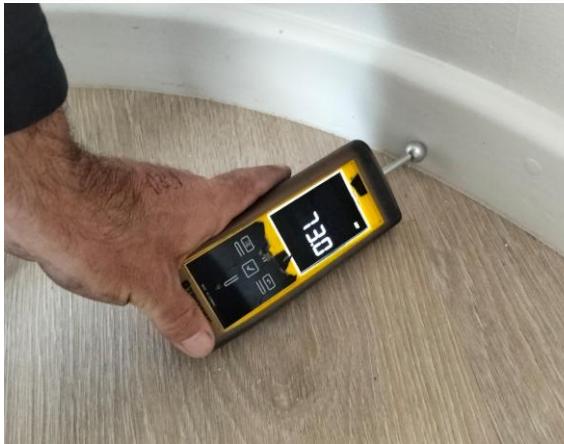
NOTE: - the walls are plaster over masonry, and the moisture tester has detected the intrinsic moisture level in the walls. Not a defect.

Elevated moisture readings taken on the exterior walls, being masonry walls the readings are not accurate/relevant.

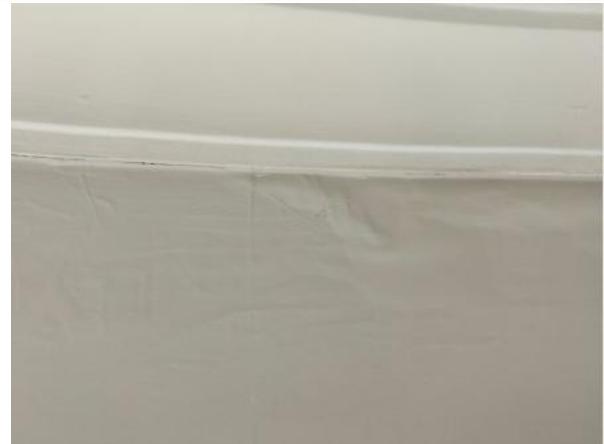
Loose plaster just below the cornice in the bedroom at the end of the hallway

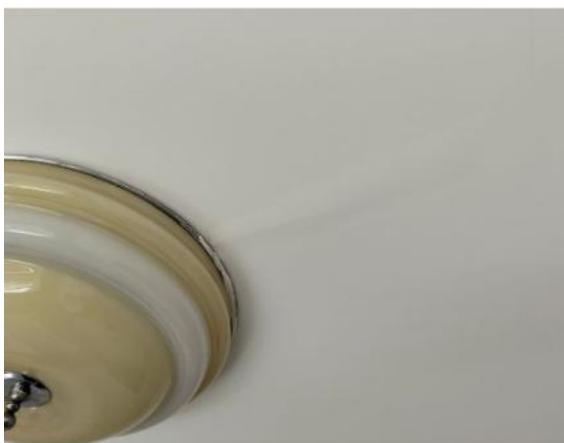
Crack in the ceiling in the bedroom at the end of the hallway

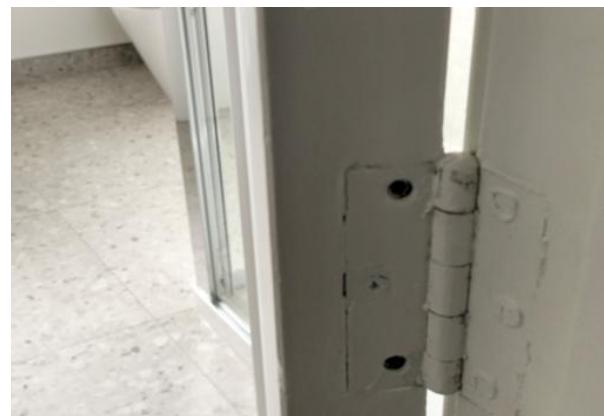
The bathroom door hinges are missing several screws

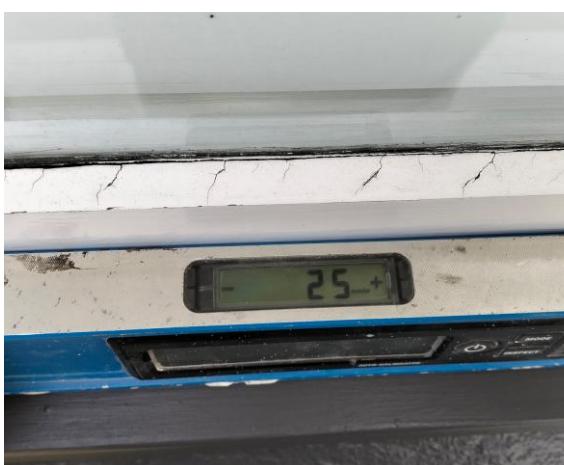
Windows and doors are out of level and/or plumb

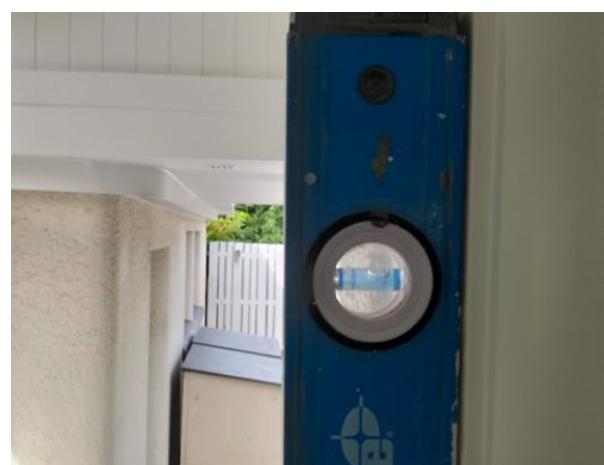
Windows and doors are out of level and/or plumb
