**RE: 33 Nancy Avenue, Mairehau – Differential Floor Levels**

SA Build has been engaged by Sarah Marwick to provide a qualitative damage assessment for their residential property at 33 Nancy Avenue. A builders' report by Inspected Residential, dated 31<sup>st</sup> October 2023, identified floor level variation across the building footprint close to 250mm, which is well in excess of limits within MBIE guideline 'Repairing and rebuilding houses affected by the Canterbury Earthquakes'. Our qualitative report discusses the likely cause of this settlement and its' impact on the building structural stability.

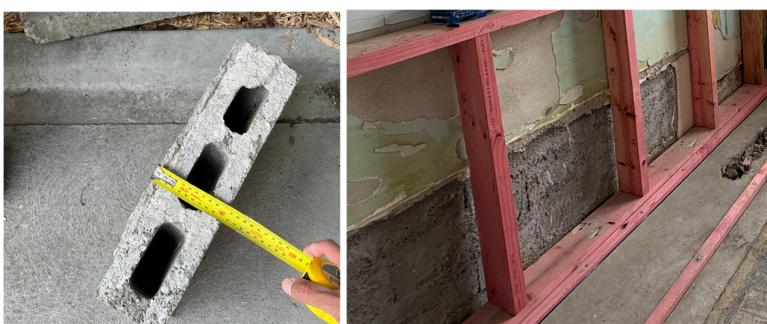
The building is a single storey heavy unreinforced masonry structure, built circa 1950's. The exterior walls are plastered over double layer concrete block with cavity, and the internal partitions are rendered single layer concrete block. The concrete blocks used are 400x200x100 thick, as shown in the photo below. They are understood to be not reinforced or grout filled. However, we believe that there is a reinforced concrete bond beam on top of all walls. The building has a flat roof of butanol glued over timber substrate, supported by timber joists. The ground floor is concrete slab on grade. It is understood to have a perimeter ring beam and possible internal thickenings to support the heavy masonry walls.

Figure 2: Concrete block used in walls (left), Eastern internal bathroom wall during recent refurbishment (right)

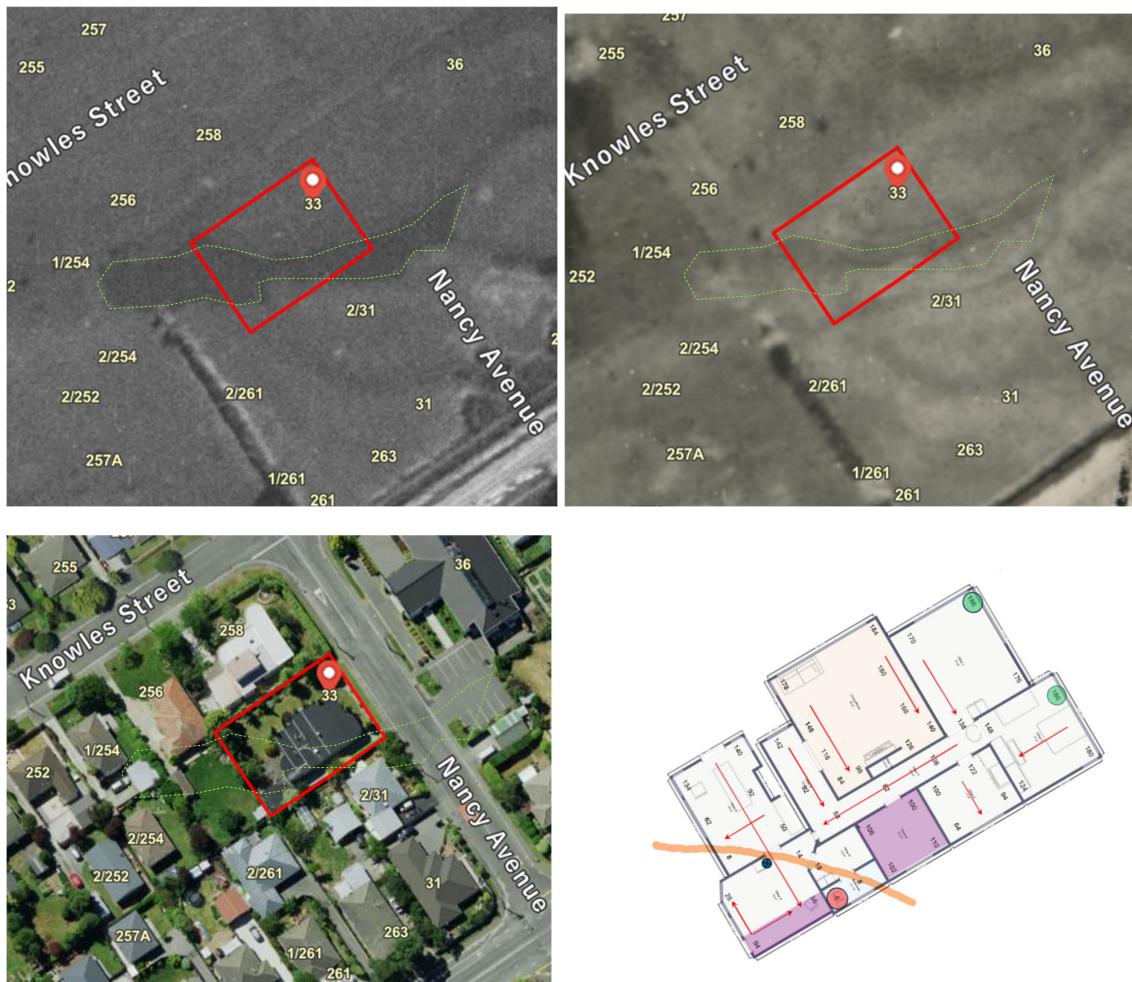
Figure 3: Locality Aerials: 1940-44 (top left), 1945-49 (top right), current (bottom left), house plan showing area of lowest floor levels (bottom right)

The combination of such large floor level differential with only cosmetic cracking post CES suggest that the floor was out of level pre-earthquakes. The second comment by EQC inspector identifies the floor slope as being an intentional design feature, however we disagree with this notion. The magnitude and dispersion of floor slopes is not even and certainly not something one would expect in an internal 'dry' area. We have reviewed historical photos of the location, where 33 Nancy Ave is built, see Figure 3. It is understood that there was small pond (depression) at the location of the house. It is

likely that the fill that was used to level this depression has experienced settlement. The location of the depression correlates closely with the location of lowest floor levels recorded. It is difficult to say, 'when' this settlement occurred. The owner reinstated all floor coverings between 2023-2024. She stated that no signs of cracks or repaired cracks were observed in the concrete slab. This indicates that most of the settlement likely occurred during or immediately after construction. Any damage that occurred was likely covered up by architectural rendering/plastering, while applying finishing touches to the building.

While not a stability issue, the recorded floor levels and slopes are well outside the serviceability limits of a residential space. This could potentially create a risk for the elderly and running children. Hence, it is our recommendation that consideration is given to re-levelling the floor to MBIE guidance. Possible repair strategies include jacking using engineered resin or low mobility grout, and formation of a new slab above the existing. Input from an experienced re-levelling contractor should be sort to develop and implement the most feasible repair solution.

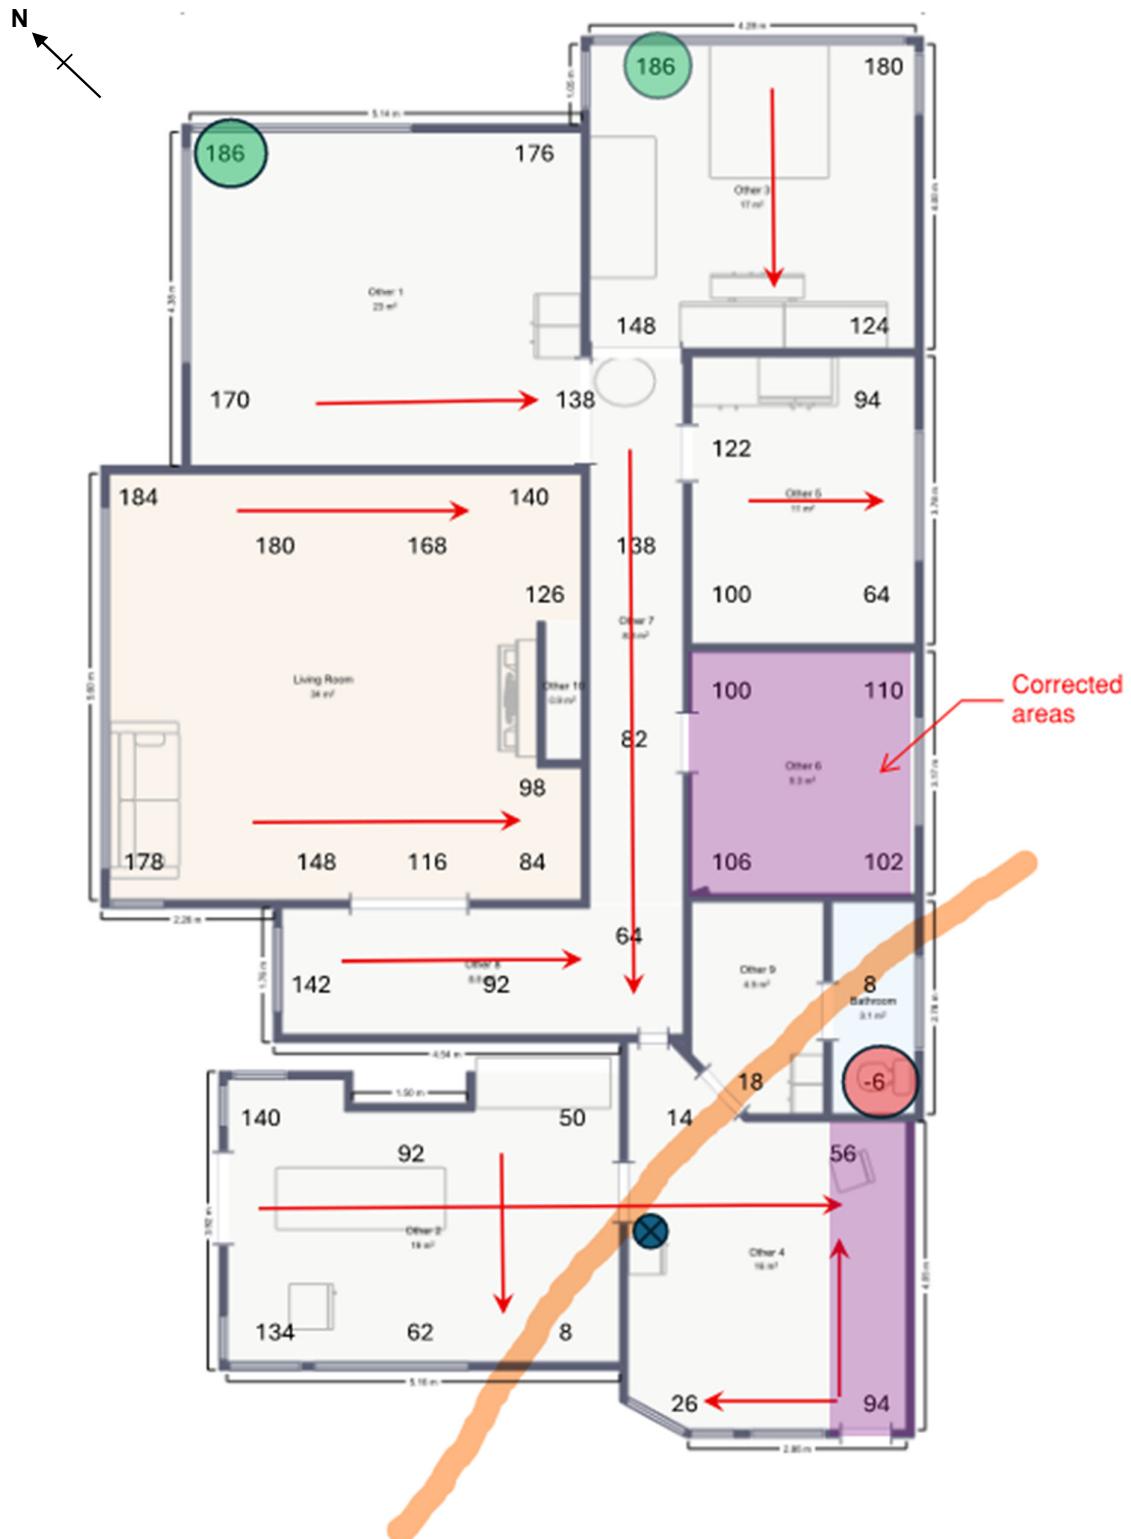
**Appendix A – Floor level survey provided by client (Raw – uncorrected for floor coverings)**

The ground floor of the property is observed to have a differential level, close to 250mm between the north eastern and south western corner of the building. Refurbishment of the property has been undertaken recently (between 2024-2025), which included localized floor re-levelling within the bathroom and kitchen areas. This has reduced the overall differential below 200mm; however, it still remains well outside the 50mm limit of MBIE guidance. The slopes within the floor are in the order of 1:30-1:60, which also exceeds the 1:200 limit of MBIE guidance. Despite these differential floor levels and slopes, the super-structure is observed to have minimal damage from the Canterbury Earthquake Sequence (CES). The EQC scope of work records '*There are minor cracks in all the areas, but nothing serious. A few cracks need racking out and epoxy filling*'. The records also make a comment that '*The fall is built into the whole house from the foundations, and floors.*' While no floor level survey is found within the EQC records, this one comment confirms that the current floor level variation was noticed during December 2011 inspection as well.
