Independent Builders Report

Total Home Inspection Services Porirua City Ltd

Thu 15 Jan 2026

5 Puriri Rd, Waikanae, Kāpiti, 5036, New Zealand

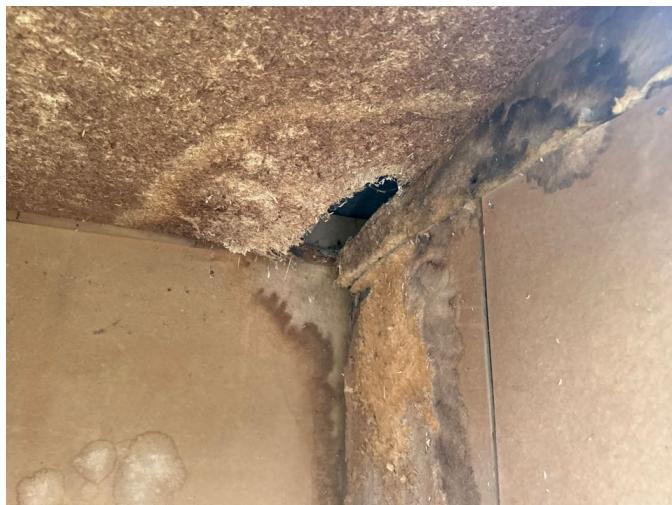
There is some water damage to the linings in the storage area of the carport which requires further investigation and remediation.

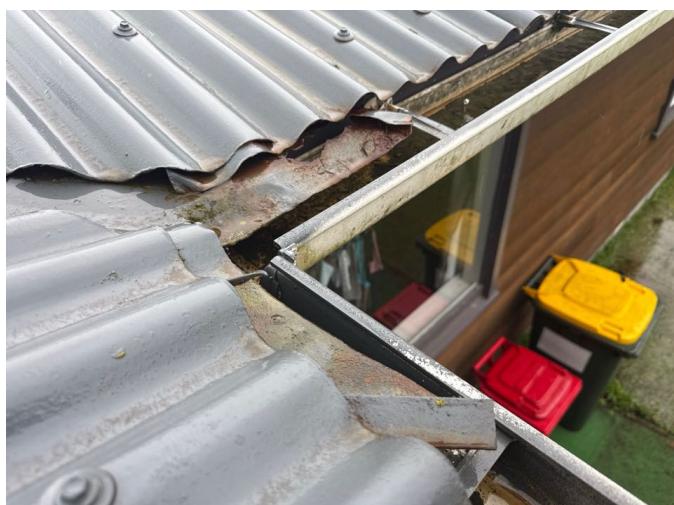
Rust is affecting some areas. Rust should be treated with rust converter and painted to slow the deterioration.

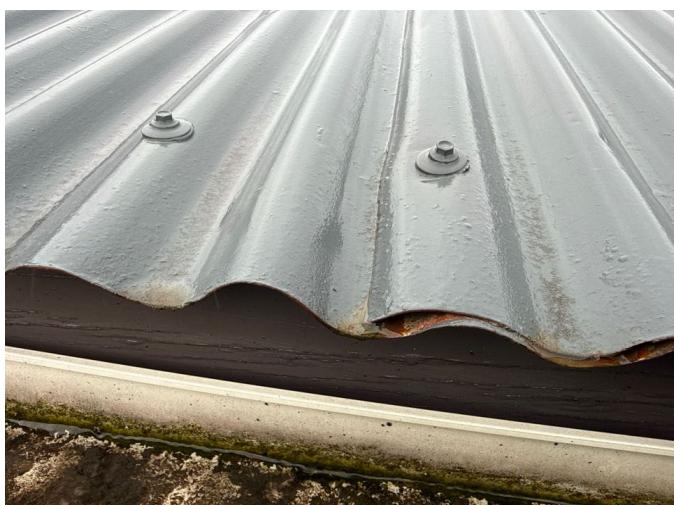
Another example of the surface rust at the base of the sheets

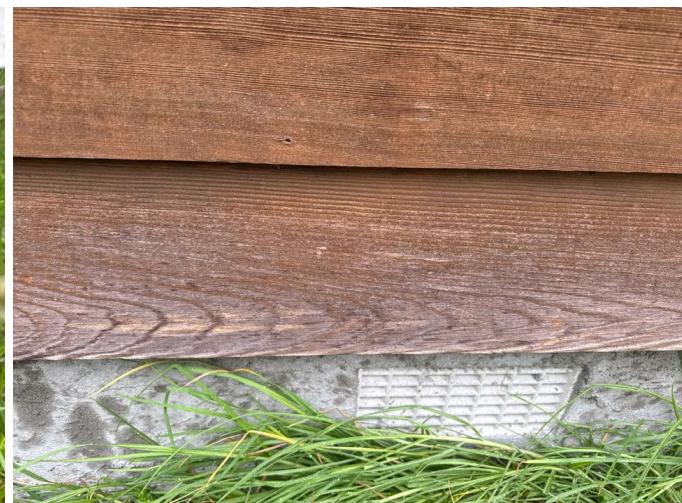
Surface wear to the weatherboards indicates that a stain/oil upgrade is required

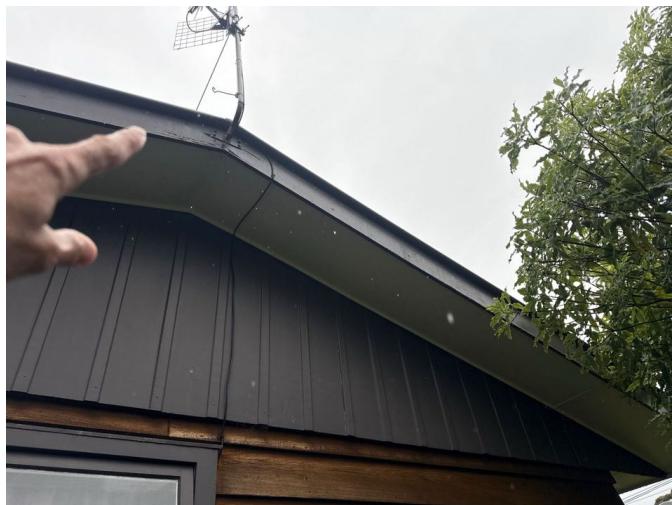
Paint deterioration to the timber barge boards

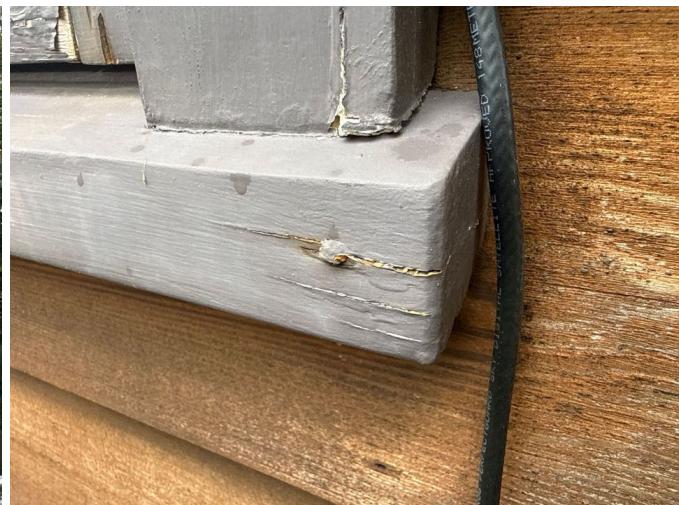
Rust affected nails need to be treated with rust converter and painted

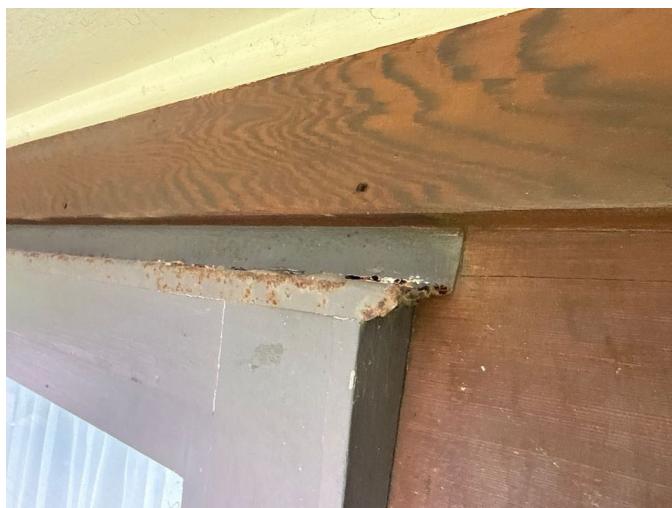
Some of the homes head flashings have superficial corrosion. This will get worse if left and requires the corrosion to be removed before sealing with rust converter and painting. Risk of water ingress issues if left to deteriorate.

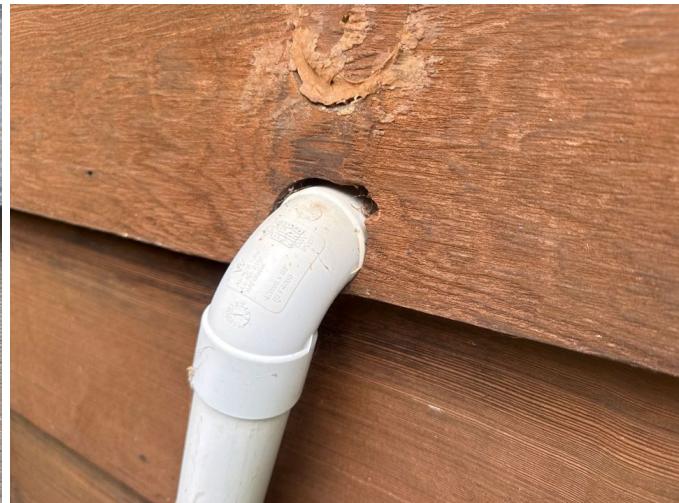
The hole in the cladding should be waterproofed

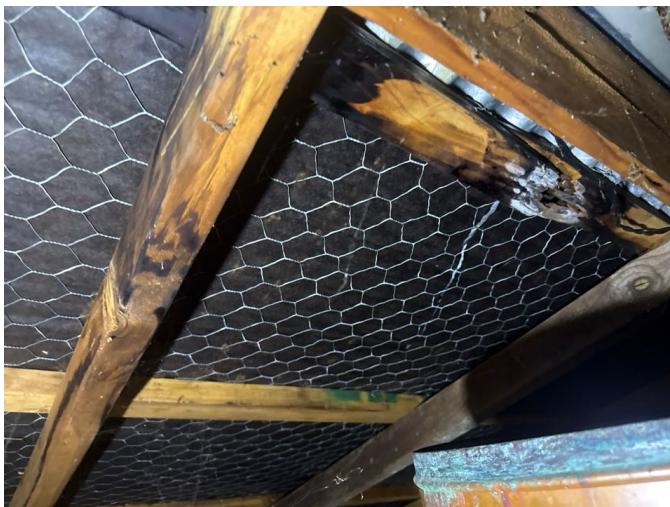
Historic water damage to the purlins above the header tank. There is a risk of failure if this area is walked on from the top. Additional support should be installed by a builder.

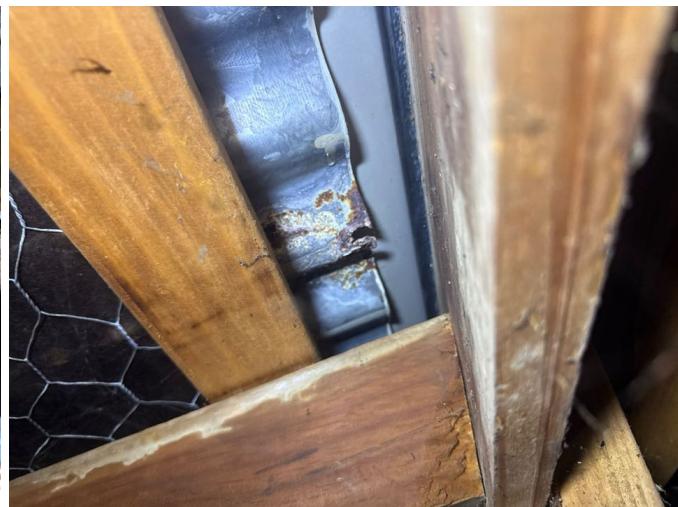
Example. Rust is affecting the underside of the roofing at the top. Note the top edges have not been upturned and the underlay is short. There will be an ongoing risk of wind blown moisture entering the area. There was no evidence of recent water ingress found.

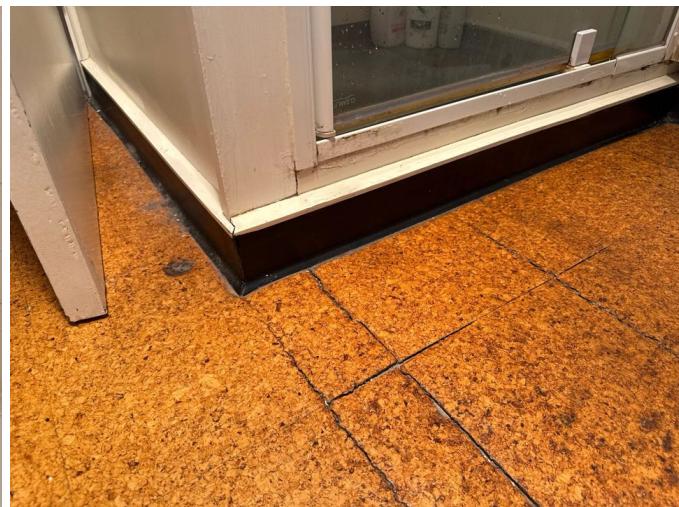
The flooring is deteriorating and should be replaced to prevent the risk of damage to the floor beneath

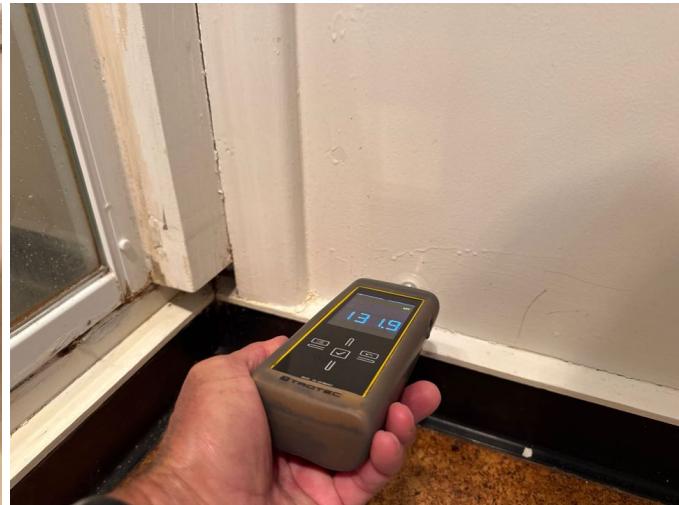
Elevated moisture readings to the external wall by the shower.

Please note this was a visual inspection inspection using a moisture meter which has limitations. The only way to determine the condition of the internal framing is by way of invasive investigation which involves the removal of linings.

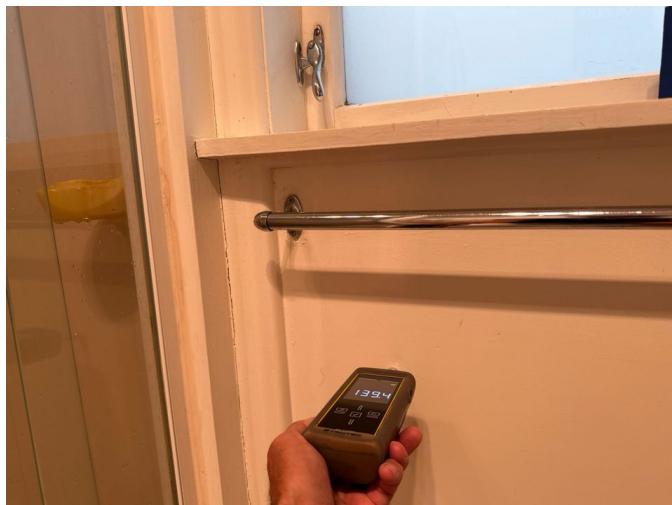
Elevated moisture readings in unusual locations.

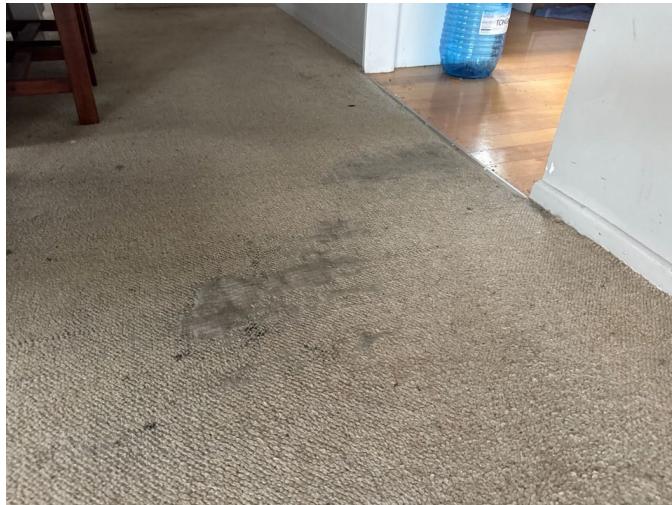
The carpet is very worn and is due for replacement

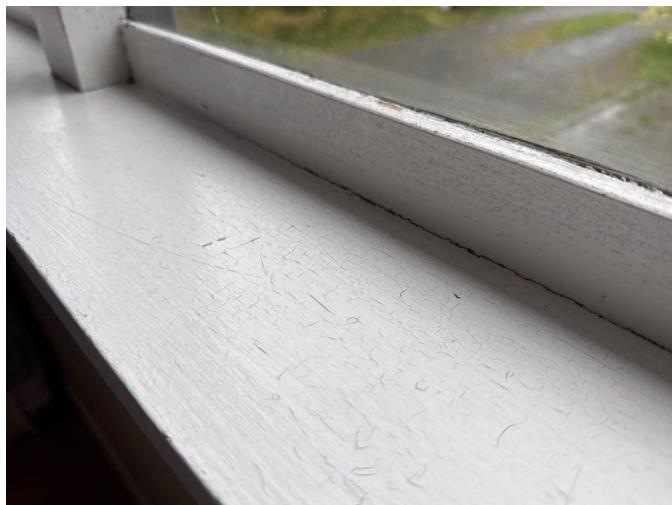
Early stage paint deterioration to the window frames in some areas. Paint improvements recommended where surface wear is present.

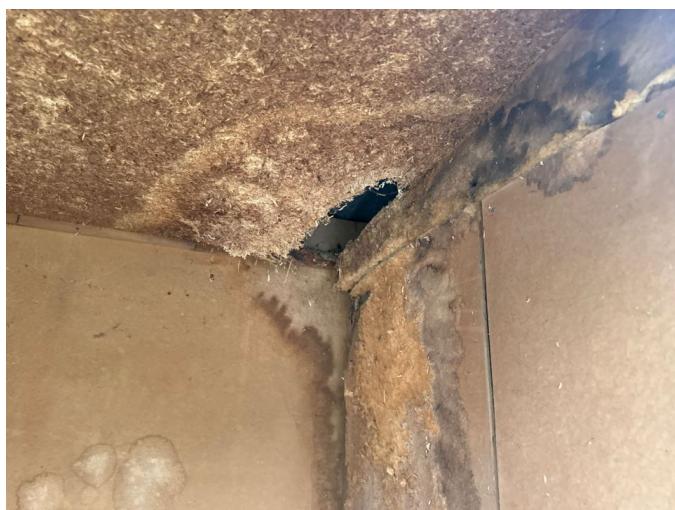
There is some water damage to the linings in the storage area of the carport which requires further investigation and remediation.

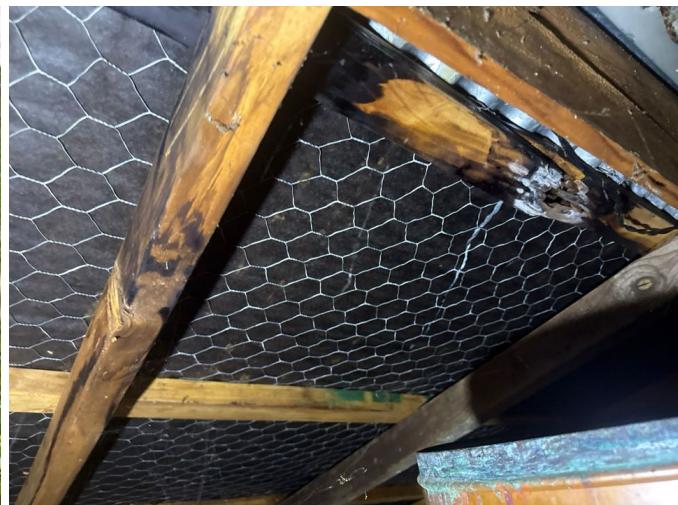
Historic water damage to the purlins above the header tank. There is a risk of failure if this area is walked on from the top. Additional support should be installed by a builder.
