Building Report

73A Ngaio Road
Waikanae

Date/s of inspection: 17-Dec-2025

Type of inspection: Building Inspection

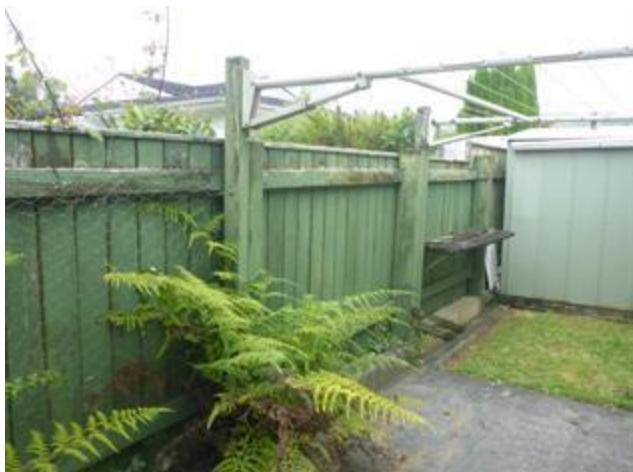
The property has a variety of fence types, which were generally in reasonable condition where visible and in terms of maintenance planning, areas would benefit from a coat of paint or stain to protect the integrity of the timber. Sections of the fencing have cement board panels that may have an amount of asbestos present.

May contain asbestos

Although there are no perceived health issues with this product when sealed, there are precautions with working with asbestos such as no dry sanding or scraping. You should not grind, waterblast, cut or remove asbestos sheet and contacting professionals is recommended.

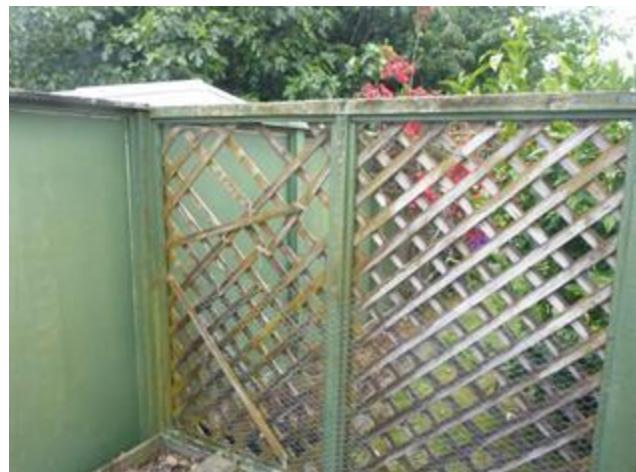
The trellis fence to the side of the dwelling would benefit from some repair as part of the dwelling's maintenance planning.

Trellis

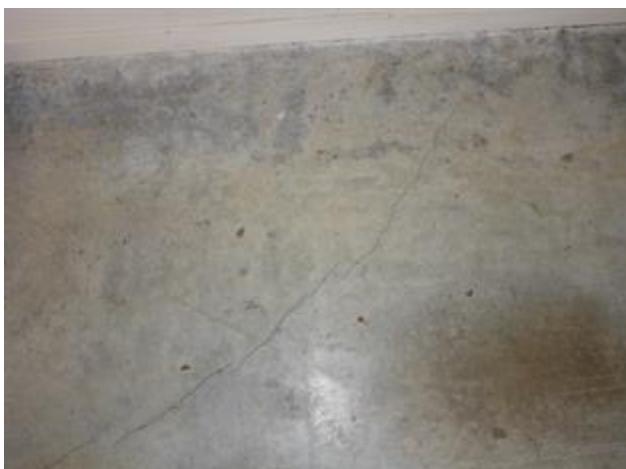
Garage

A crack was noted to the garage floor slab. It appeared that the crack had not separated or moved. This type of cracking in a continuous concrete floor is not uncommon and can be due to past earthquakes or settling.

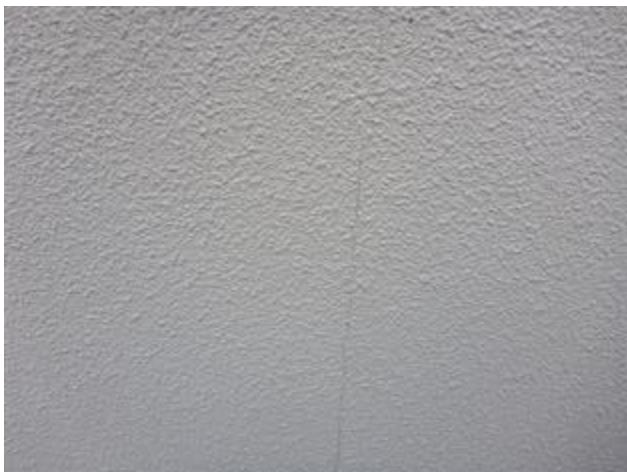
Cladding cracks were sighted to the front and rear of the dwelling.

Cladding crack to the front

My recommendation is that the cladding now have further specialist appraisal to give you advice about the crack's repair requirements, the areas with indications of high moisture levels, the small area of impact damage, joinery transitions and for an indication of costs.

My recommendation is that the exterior wall cladding now have further specialist appraisal to give you advice about the crack's repair requirements, the area with indications of high moisture levels, the small area of impact damage and the joinery transitions, and for an indication of costs.

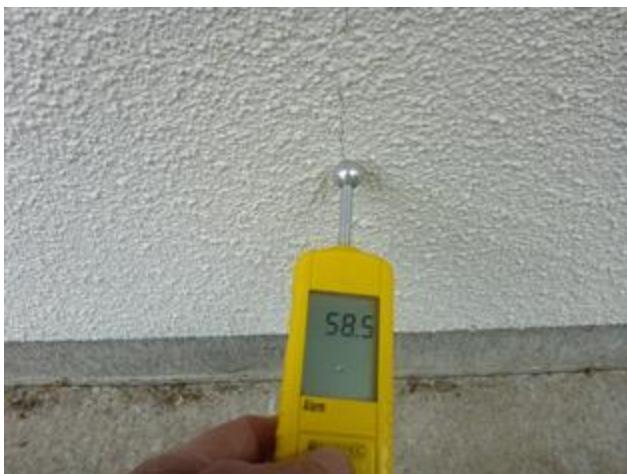
Cladding crack to the rear

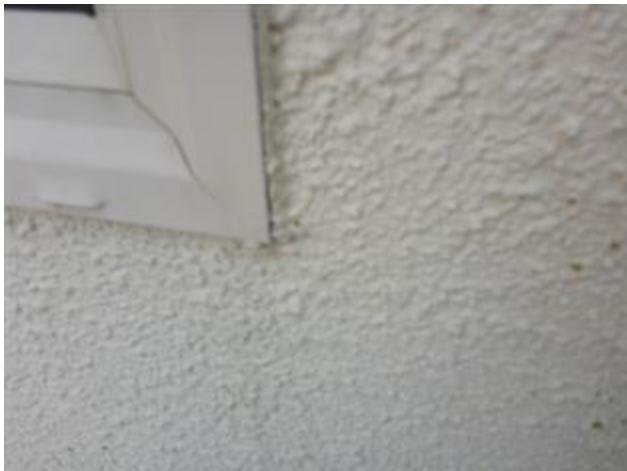
With this type of cladding, it is possible to use my moisture meter on the exterior. At the time of inspection moisture levels to the base and sides of the joinery penetrations were within acceptable parameters except to the right side of the master bedroom window.

High moisture levels master bedroom

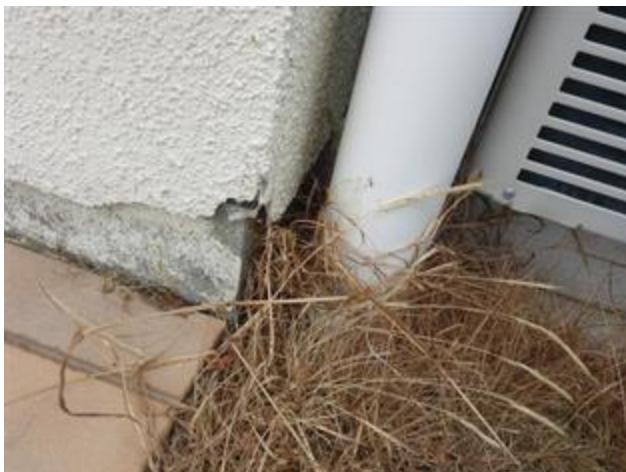
I also noted a small area of impact damage to the southwestern corner.

Small area of impact damage

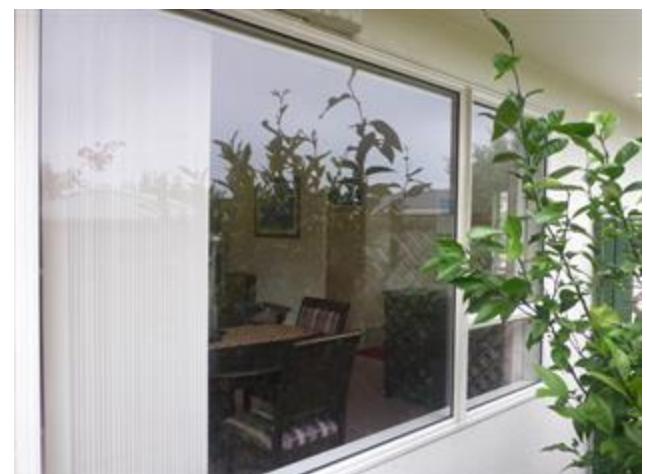
I noted that the keep to the ranch slider requires re-fixing.

Ranch slider keep

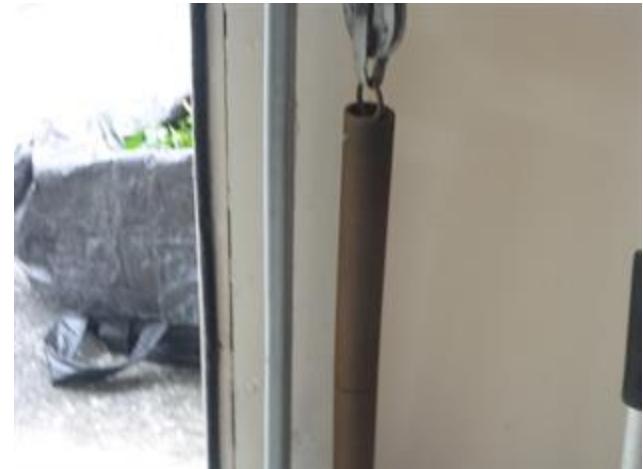
The garage door operates with a spring system. Usually there is a cover to the springs to ensure there is no damage if the spring breaks. Fitting covers is recommended.

Garage door springs

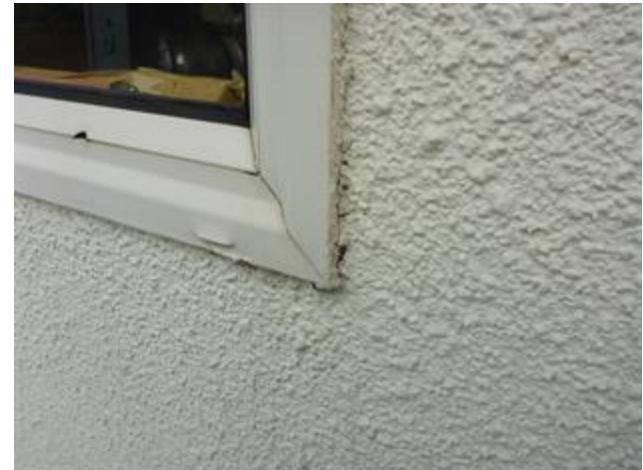
Some of the seals between the transition from the monolithic cladding to the joinery require renewing. Wind drive moisture ingress has the potential to breach these transitions.

Poor seals to the joinery/cladding junction

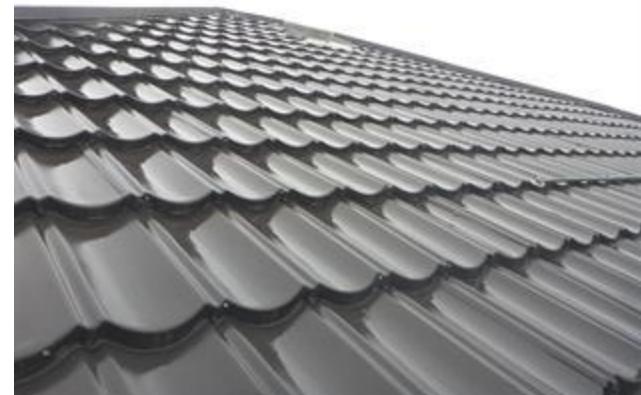
The colour tile roof cladding appeared in good condition bar one dented tile, the factory finish on the tiles showed no signs of deterioration or corrosion.

Tile dent

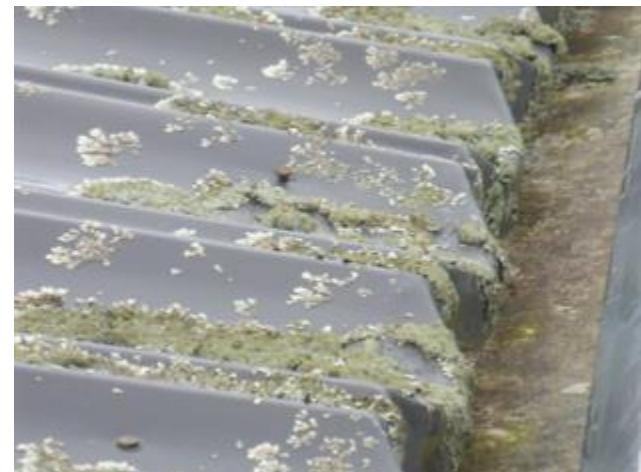
There were some loose or damaged fasteners that I recommend are pulled and replaced with new fasteners to secure the roof cladding and to prevent moisture ingress.

Also, the tiles of the lower run above the spouting have been fixed through the tops of the tiles without rubber washers. This would have been compliant at the time of construction but does not meet today's standards as this can allow moisture ingress issues.

Lower run/ loose fastener

I recommend that the roofing material have further appraisal by a licensed roofer to give you advice on the degree of fastener replacement, washer upgrades and costs for maintenance planning.

I also recommend that the roofing material have further appraisal by a licensed roofer to give you advice on the degree of fastener replacement, washer upgrades and costs.
