EQC CLAIM DOCUMENTATION

EARTHQUAKE RECOVERY (EQR) DOCUMENTATION

NZ Residential Property Inspection Report

Canterbury Claims – Drainage Assessment Report

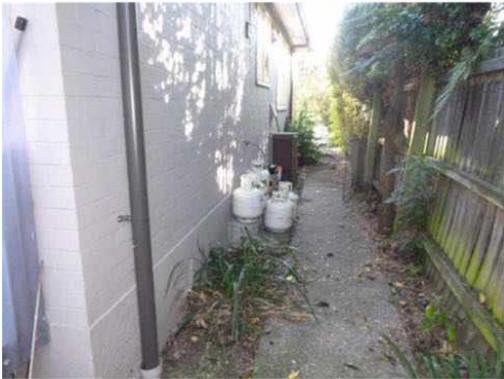
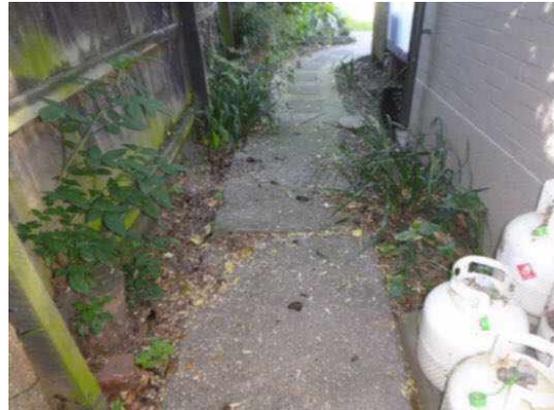
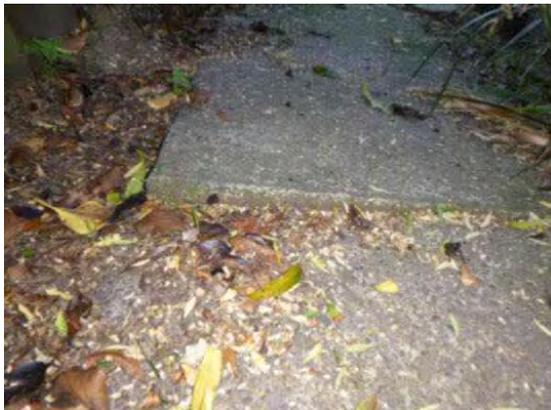
Building: Main Building
Location: Yard - Side > Centre
Finding: Concrete - Path - Settlement
Information: The path in this area has minor settlement creating a trip hazard. One solution is to grind the high points level to the lower section this will eliminate the trip hazard alternatively the affected sections can-be replaced.

This can-be carried out by a qualified concrete placer at the clients discretion.

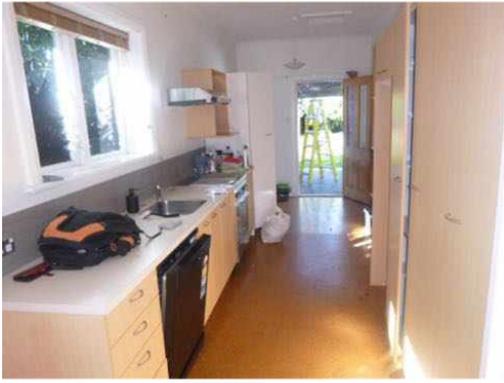
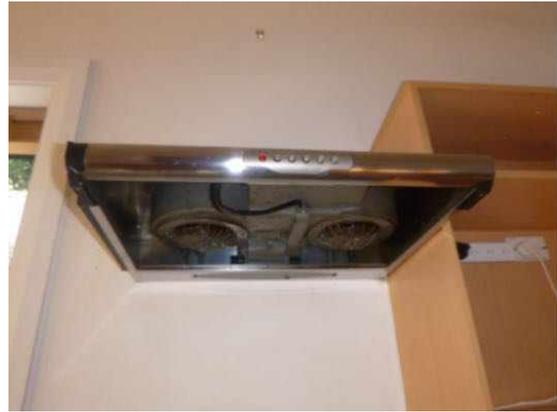
Defects 3.02

Building: Main Building
 Location: Kitchen > Centre
 Finding: Rangehood - Light not working
 Information: While the range hood appears to be working at a satisfactory level, the light to the appliance was not working at the time of inspection.

A licensed electrician should be appointed to replace the light on the range hood to restore it to a fully operational state.

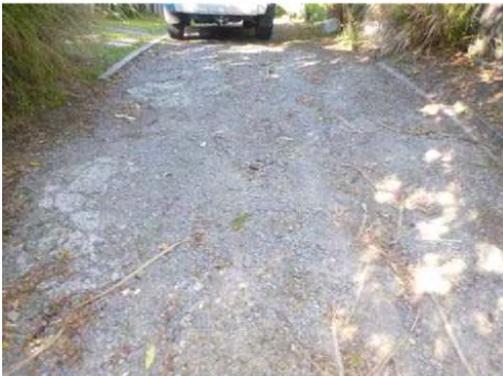
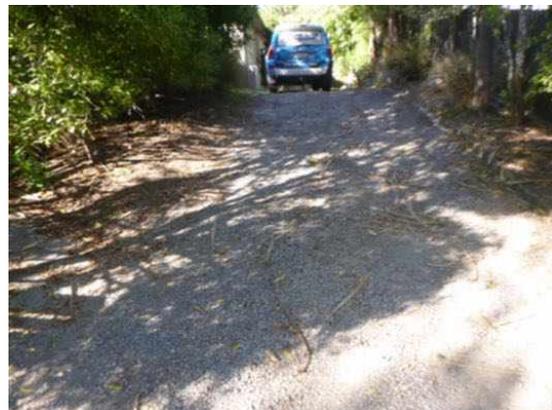
Building: Building 1
Location: All Areas > Centre
Finding: Driveway - Uneven
Information: The driveway is uneven this could be rectified by placing stone chip in the low sections. This can-be carried out by a general handy person at the clients discretion.

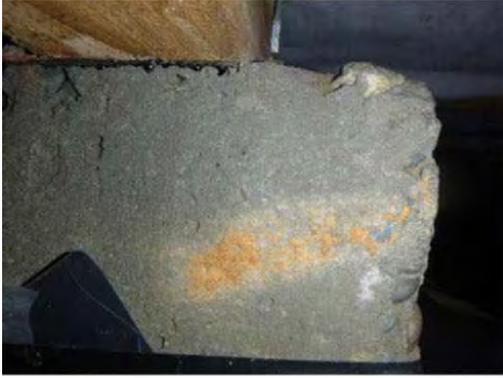
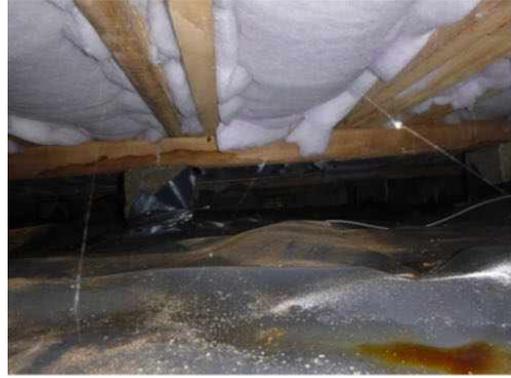
Building: Main Building
Location: All Areas > All Areas
Finding: Subfloor
Information: At the time of inspection the concrete piles appeared to be in good condition and visually plumb. It does appear that the piles observed were fixed to the structure.

Basic floor levels were checked and within MBIE tolerances and guidelines.

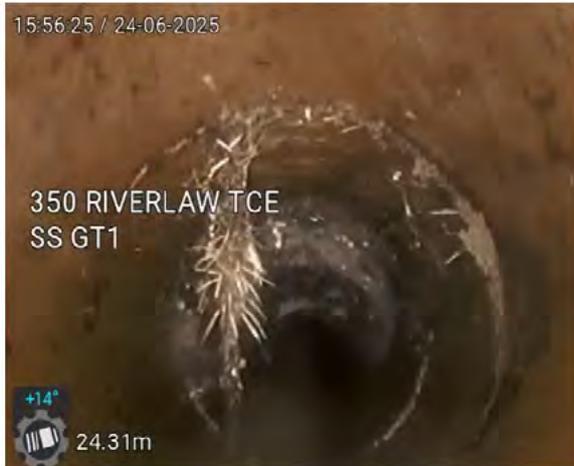
Cracking – Sewer

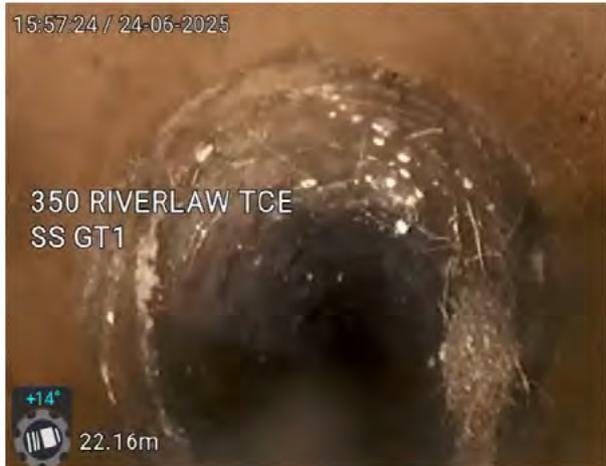
Cracking – Sewer

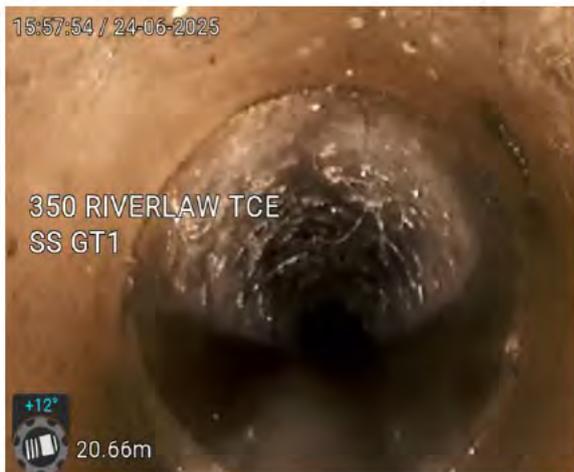
Displaced joint and cracking – Sewer

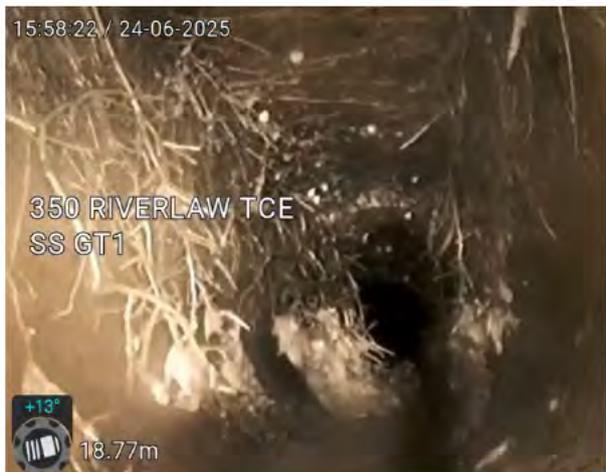
Root intrusion through IP – Sewer

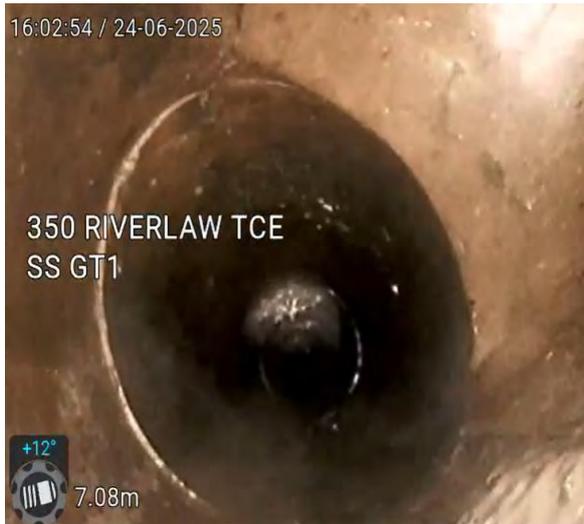
Cracking – Sewer

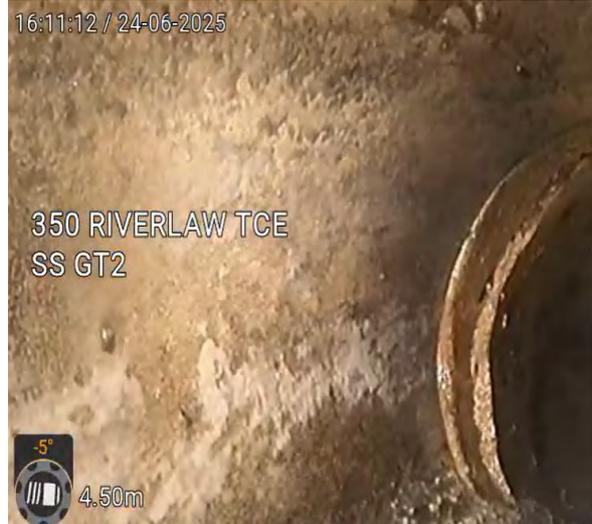
Cracking - Sewer

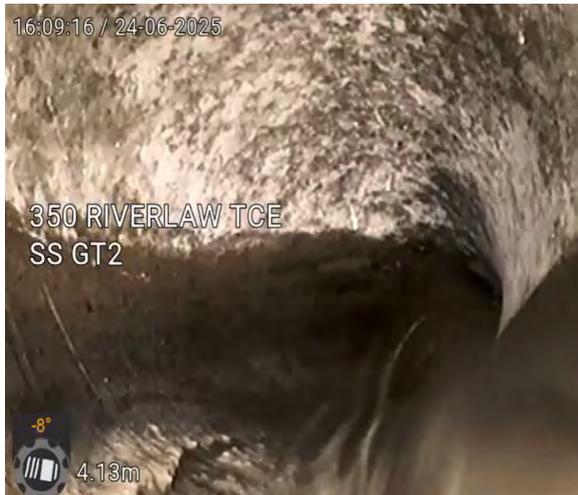
Cracking – Sewer

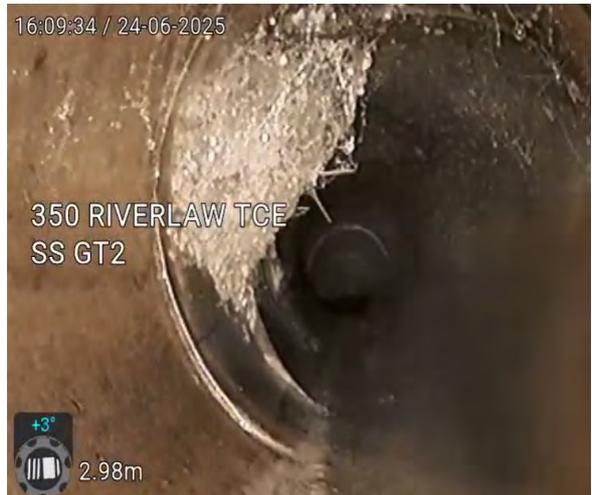
Cracking - Sewer

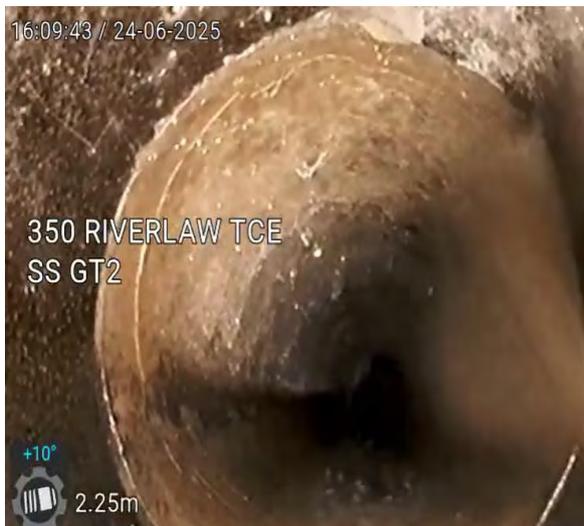
Cracking – Sewer

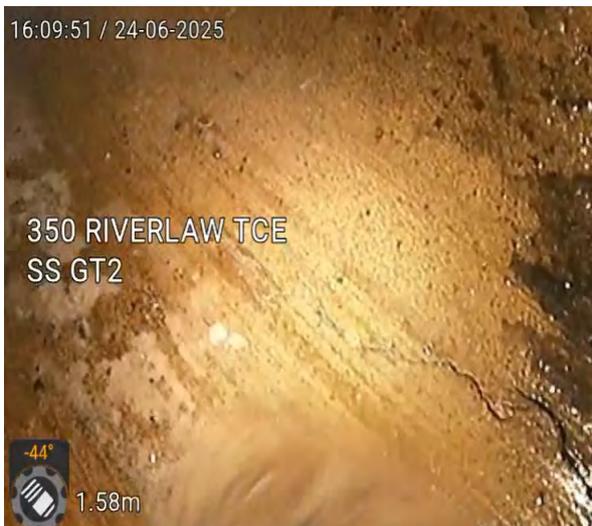
Cracking – Sewer

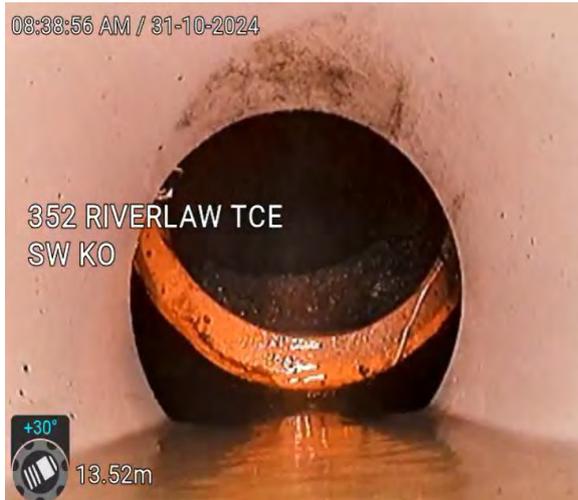
PVC repair – Stormwater

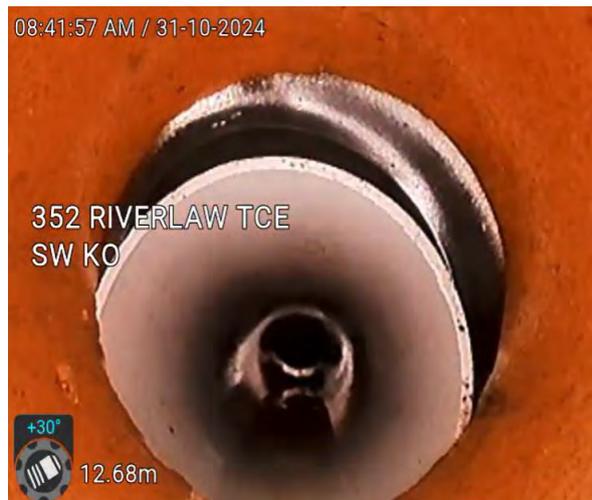
PVC repair - Stormwater

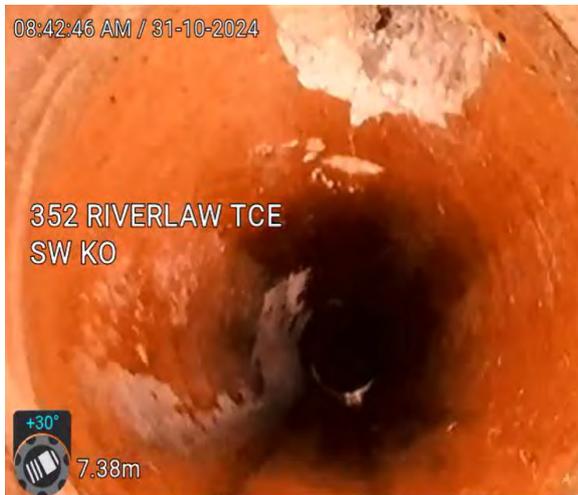
Impact damage – Stormwater

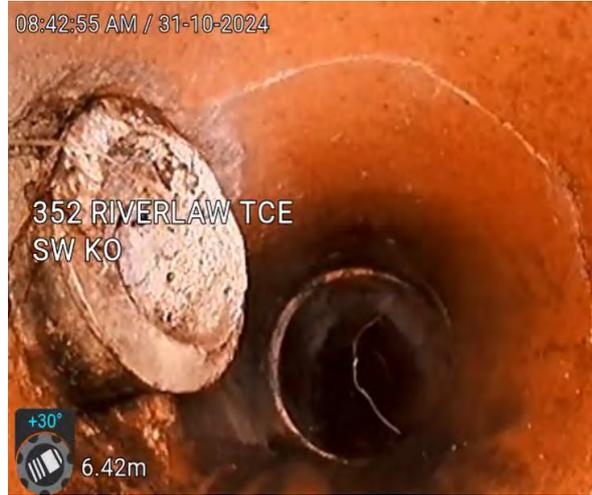
PVC pipe addition – Stormwater

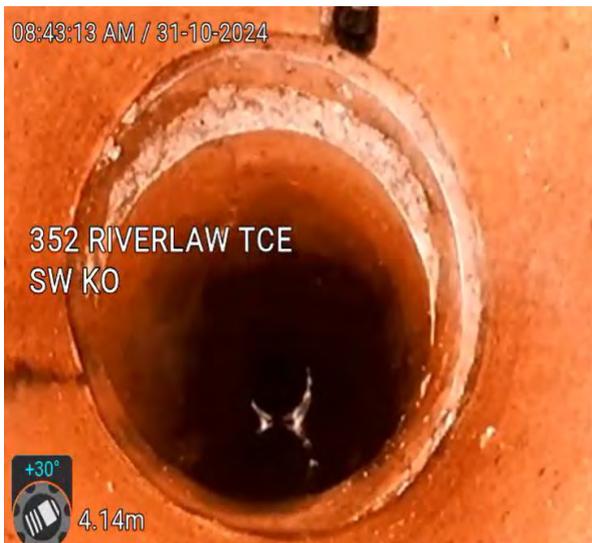
cracking - Stormwater

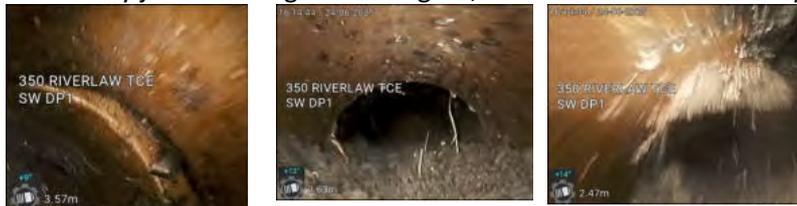
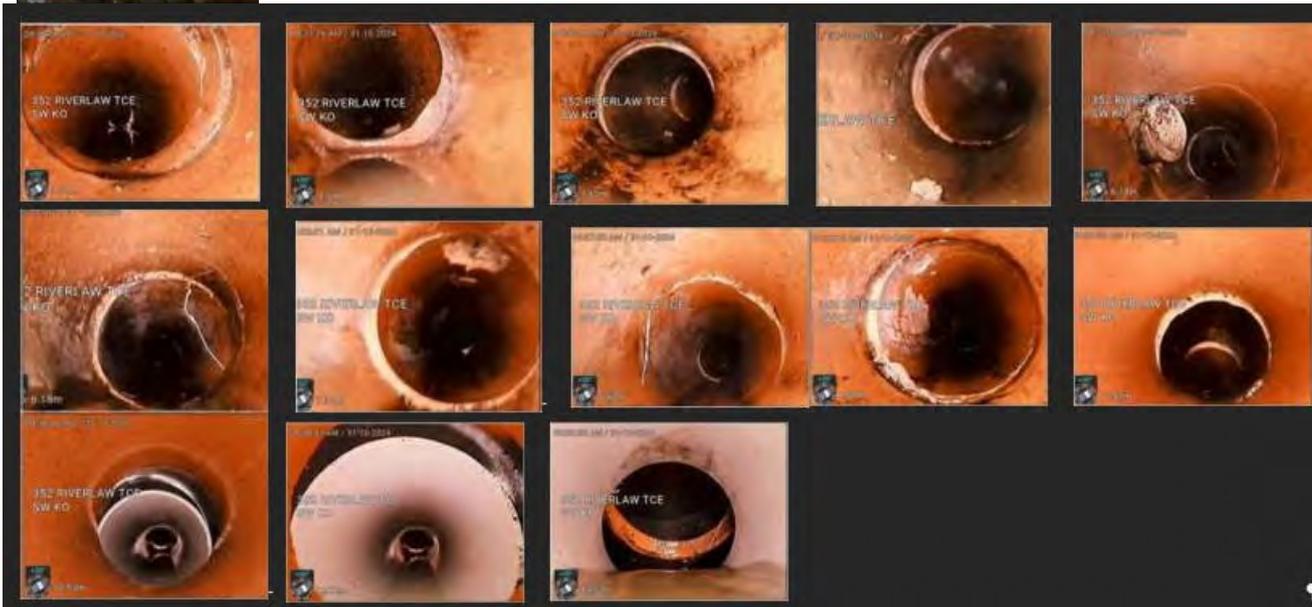
Nearly every joint is damaged in some way. There are multiple fractures in the line also. This is consistent with the damage that has been seen in the sewer. The displacements and fractures being caused by significant strain and movement of the pipes from ground movements.

Other than the pipe being holed with a pipe, the damage is consistent with damage from ground movements from the Canterbury earthquake sequence (CES). We are missing approx. 15m (not incl branch lines) of the SW. Given every joint is damaged to a degree, we recommend a full relay of the SW.

There are numerous obstacles in the path for the SW – retaining walls, steps and a recessed garage. We will reroute the SW, dig and lay to the garage then run the SW along the side of the garage and down to a new KO. This will be more cost effective and efficient than removing all of the trees around the garage or pipelining or removing and reinstating retaining walls.
