BUILDING INSPECTION REPORT

RED LBP PRE-PURCHASE REPORT

Property Address	97B Opawa Road, Opawa, Christchurch 8023
Client	Craig Wattam
Date of Inspection	4th February 2026
Time	8:00 am
Inspector	Jamie Chapman National Certificate in Carpentry
LBP Number	BP137228
People Present	Inspector
House Occupied	Staged

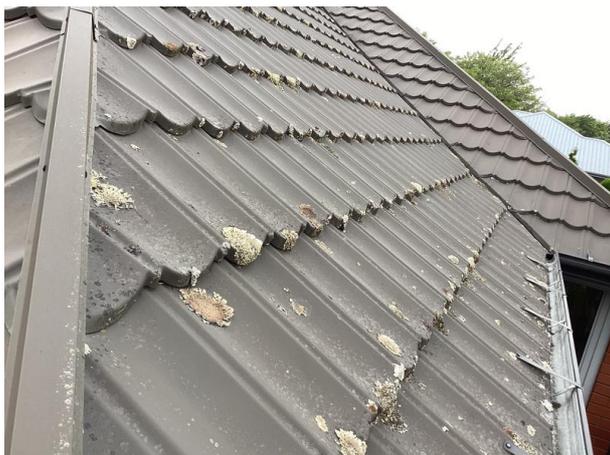
Photo 4

Moss, mould or lichen - Areas noted, refer to the photos below.

Moss/lichen was observed on the south side of the roof system.

To maintain the weathertightness of the building, it is important to follow the manufacturer's guidelines for regular maintenance of the roofing system. This may include periodic inspections to identify any signs of damage, such as dents or missing fixings, surface deterioration or leaks. Promptly addressing these issues can prevent further damage and protect the building from the elements.

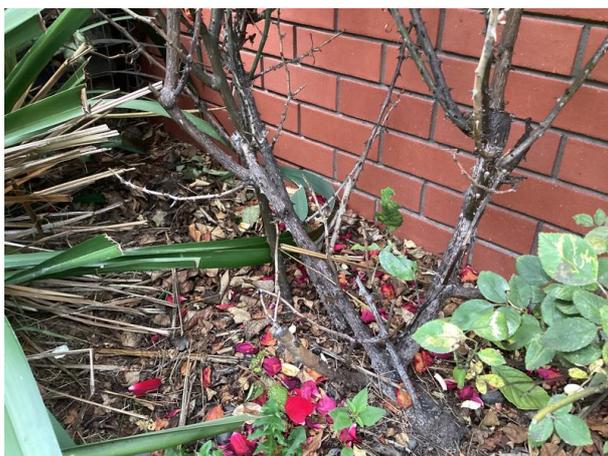
Photo 12

Bottom of masonry veneer cladding to unpaved ground - 150 mm. Areas requiring lowering.

Some garden beds around the dwelling were covering or close to the bottom of the brick veneer and brick weep holes. See the next photo.

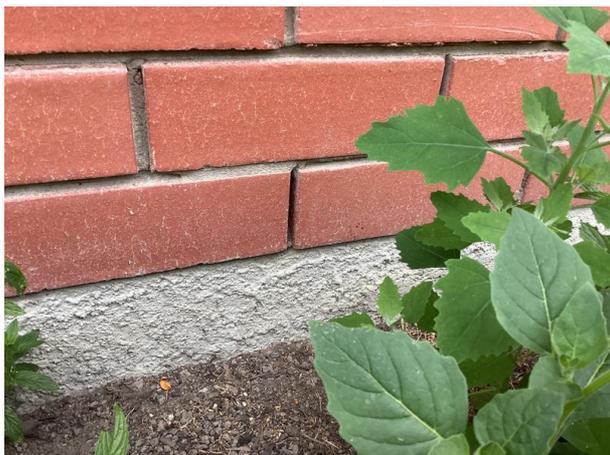
Photo 13

Example of a brick weep hole with the ground level below it. It is recommended to achieve this around the dwelling.

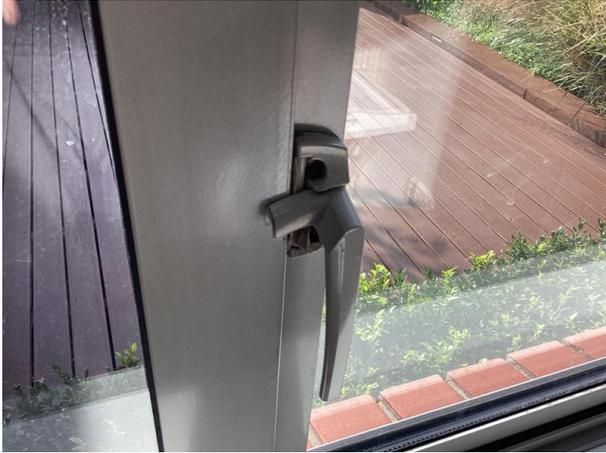
Photo 19

Hardware - Repairs or maintenance required (refer to the photos below).

A couple of the window hardware around the dwelling had broken/missing plastic tags. See the next photo.

This type of window hardware has a small plastic tag that closes the window tightly. These commonly break off through normal use. Repairing or replacing the damaged hardware will help to prevent minor draughts.

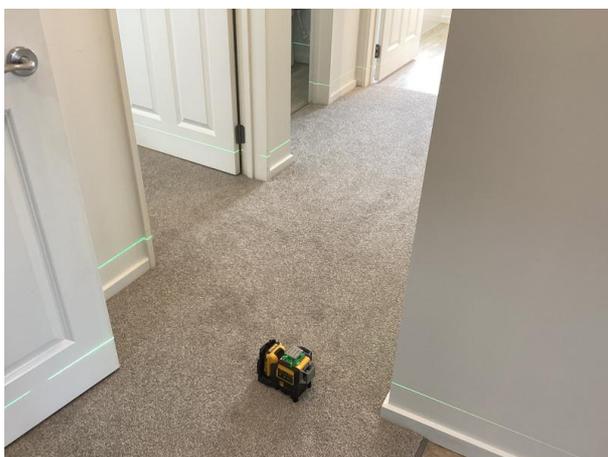
Photo 22

The tolerance ranges noted are provided as general guidance only and are commonly referenced for new concrete slabs within the early period after construction. In the sampled areas inspected, no significant faults or defects were identified at the time of inspection. The overall level difference measured was approximately 10mm.

No significant deviations were identified during the inspection. The approximate overall floor level difference was 10 mm.

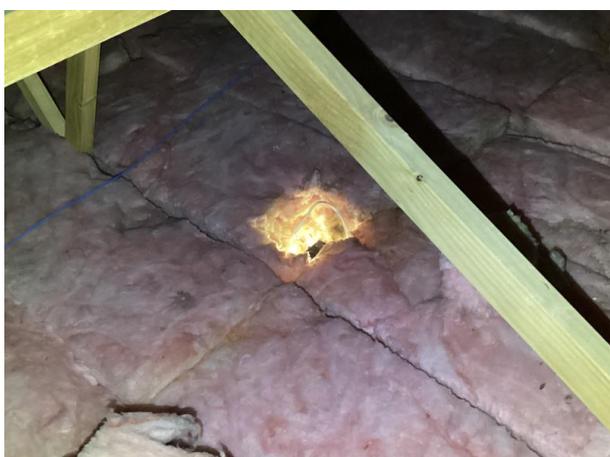
Photo 26
It is recommended to check the manufacturers specifications regarding clearance around the light fittings.

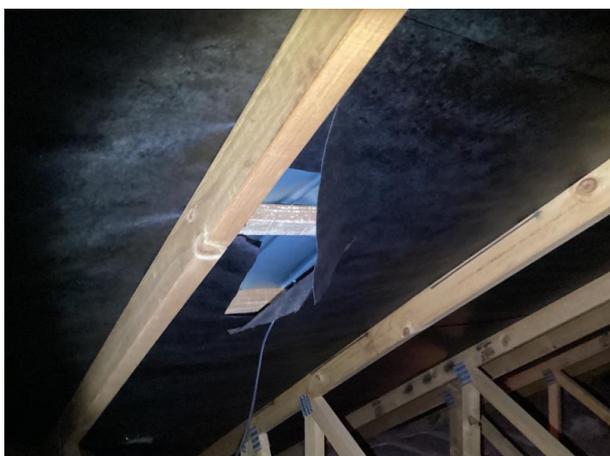
Roofing underlay - Bituminous self-supporting paper. Condition - Torn.

Photo 27
A couple areas of torn roofing underlay were observed in the roof space. Repairing these in the future is recommended.

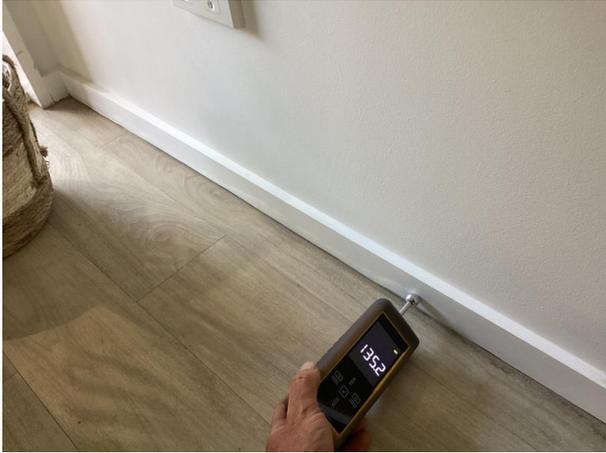
Photo 34

Elevated moisture readings were detected on the skirting board in the entrance area. This is detailed and explained further in the entrance section of this report.

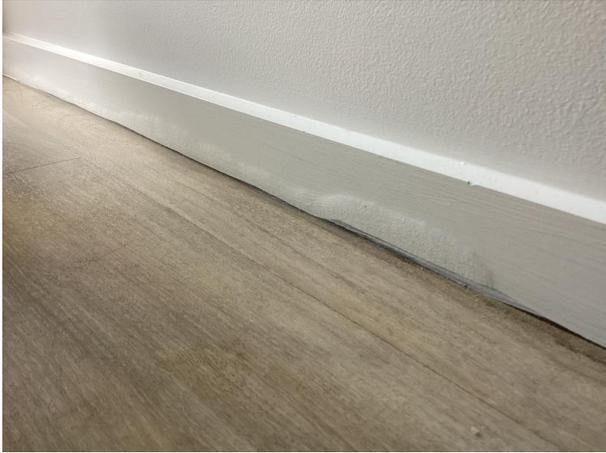
Swelling was observed on the skirting board near the entrance, with elevated moisture readings detected in this localised area. Further moisture testing was conducted to surrounding areas and on the opposite side of the wall within the kitchen, with no additional elevated readings identified.

Photo 36
Swollen MDF skirting boards were observed by the entrance.

The moisture presence is likely attributable to general cleaning activities or a localised spill. Replacement of the affected skirting board is recommended, as MDF readily absorbs moisture, and the swelling is unlikely to subside once affected.

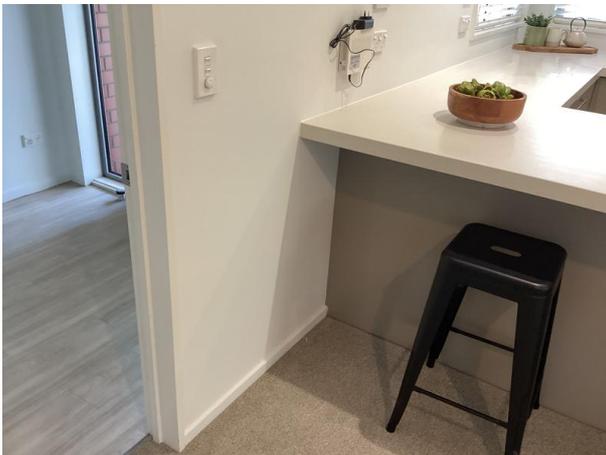
Photo 37
Likely due to cleaning or water spill due to their being a no visible issues around this area or on the other side of the wall during the inspection.

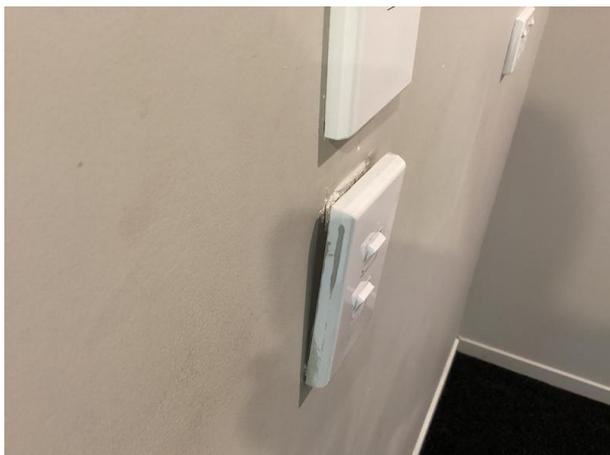
Photo 47

A light switch in the laundry was loose and would benefit from being reattached.

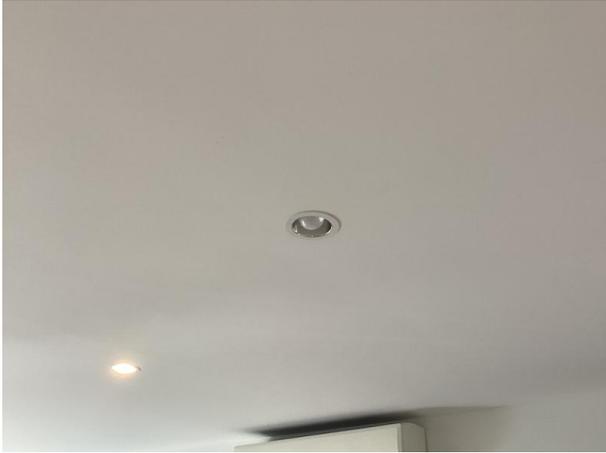
Photo 56

A couple light bulbs in the living area, bathroom and bedroom 1 weren't working during the inspection.
