Independent Builders Report

Total Home Inspection Services Porirua City Ltd

Thu 29 Jan 2026

76 Kotare St, Waikanae, Kāpiti, 5036, New Zealand

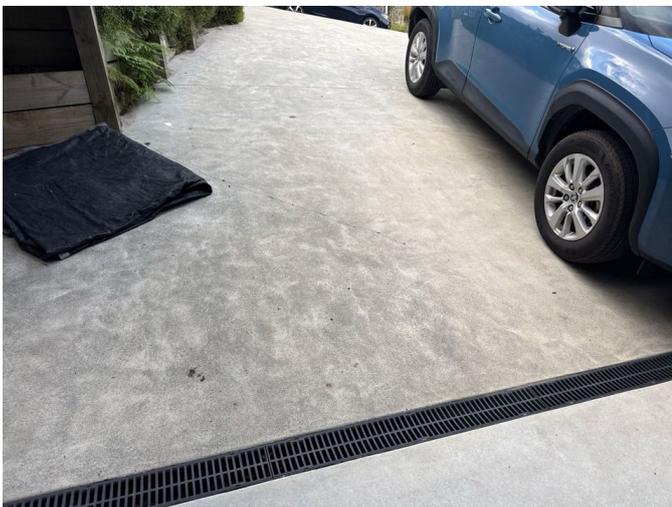
The driveway slopes towards the garage and channel drain which should remove excess water from the area. The surface condition of the driveway is generally good. Common shrinkage cracking only.

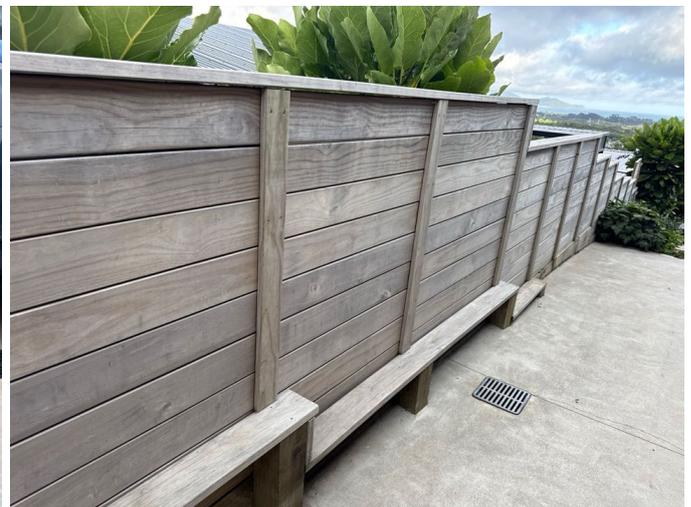
The perimeter fencing is solid and intact.

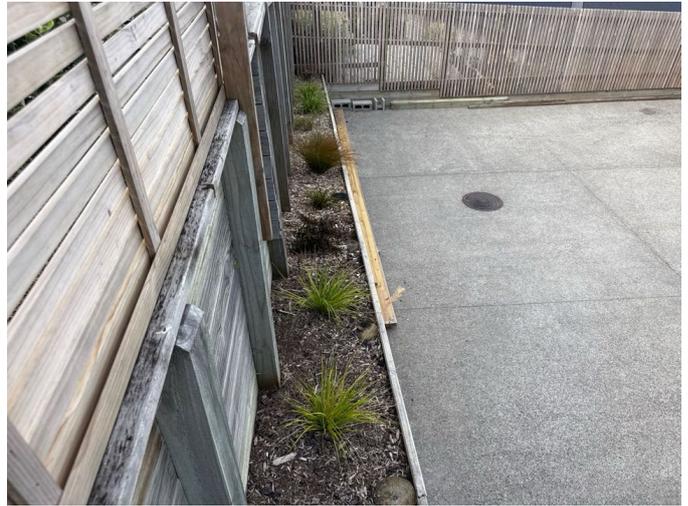
The condition of the retaining walls is consistent with the age of the property. The retaining walls will require ongoing monitoring. No signs of significant damage or movement at the time of inspection.

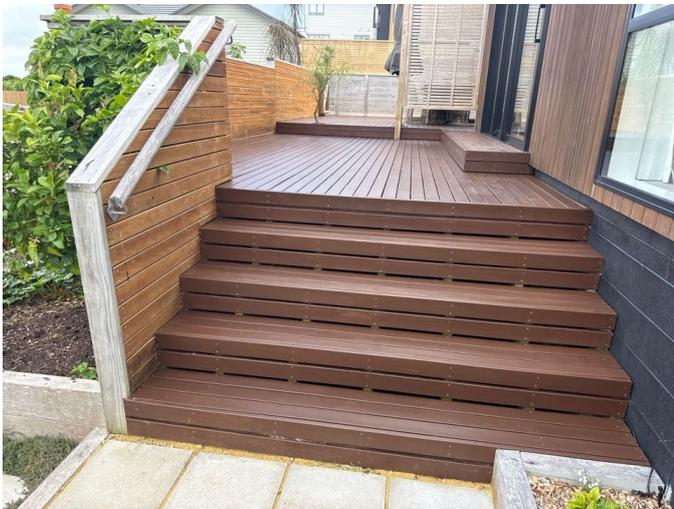
The timber stairs and handrail are solid and secure

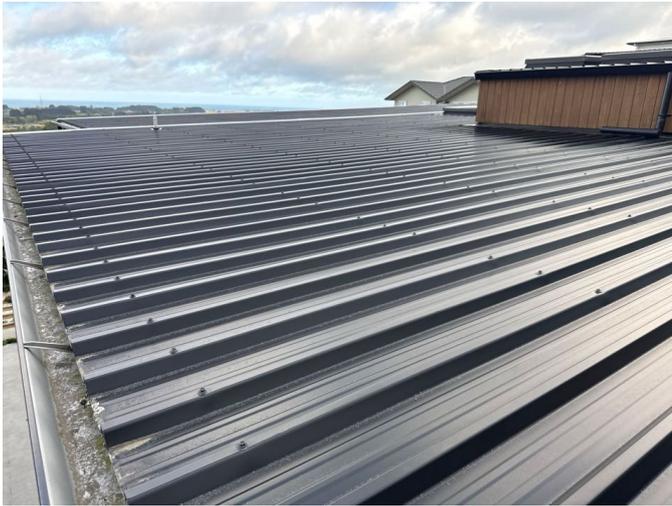
A once or twice yearly soft wash will help maintain the roofs surface condition and prevent premature deterioration

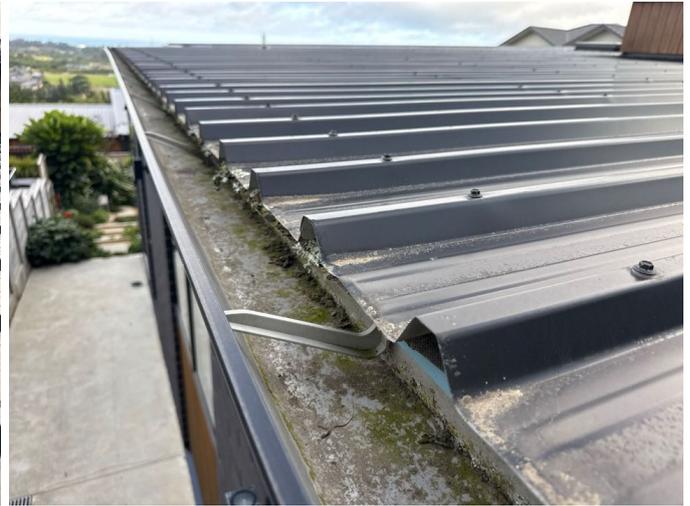
The spouting is in good condition and was clear on the day of the inspection. The effectiveness of the spouting will need to be checked during rainy periods. Due to the dry conditions that were evident on the day of our inspection we cannot comment on any leaks that maybe evident to the spouting or down pipes.

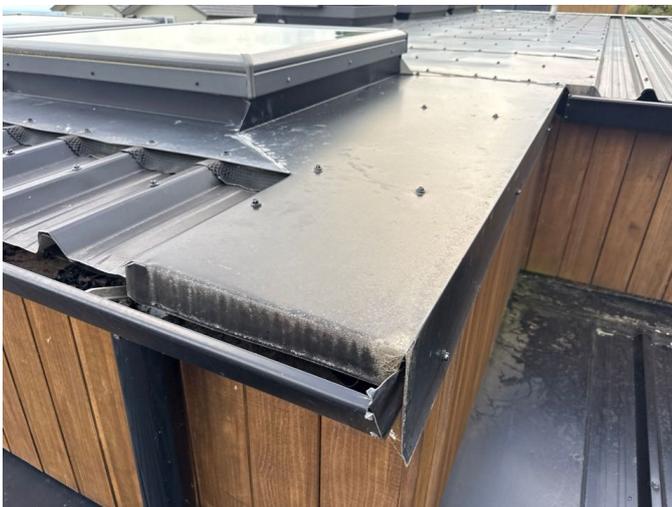
The roof flashings appear to be secure, intact and are effective. No sign of failure could be found beneath where accessible to view.

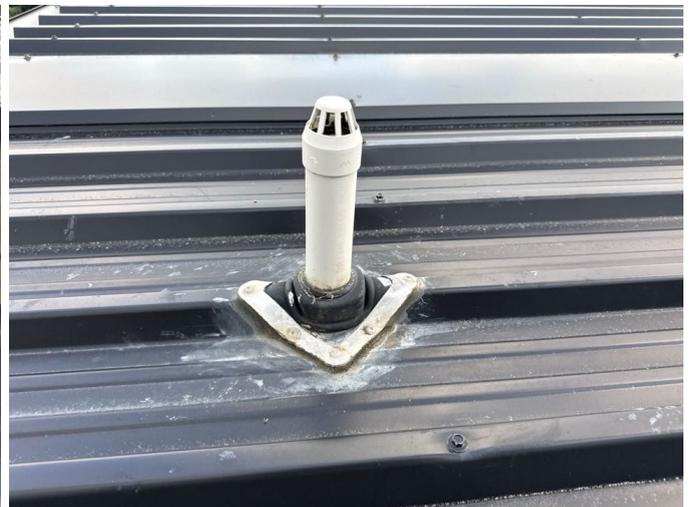
The roof penetrations are effectively sealed. The perimeter of the boot flashing at the base is finished with silicone which has a limited lifespan. The condition of the silicone seals should ideally be checked periodically and some replacement should be expected over time.

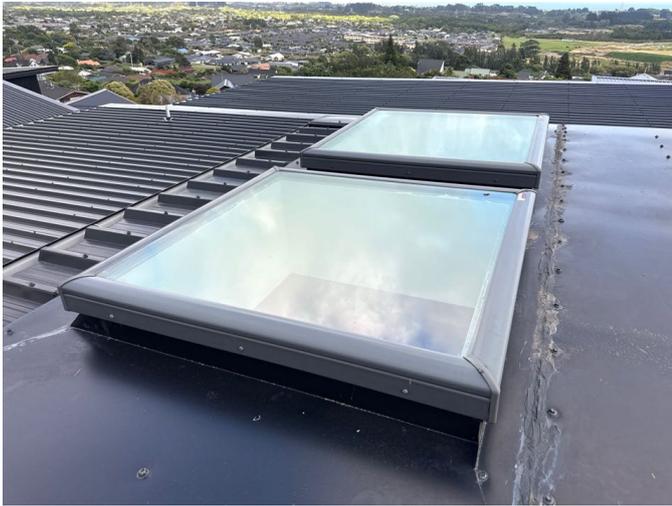
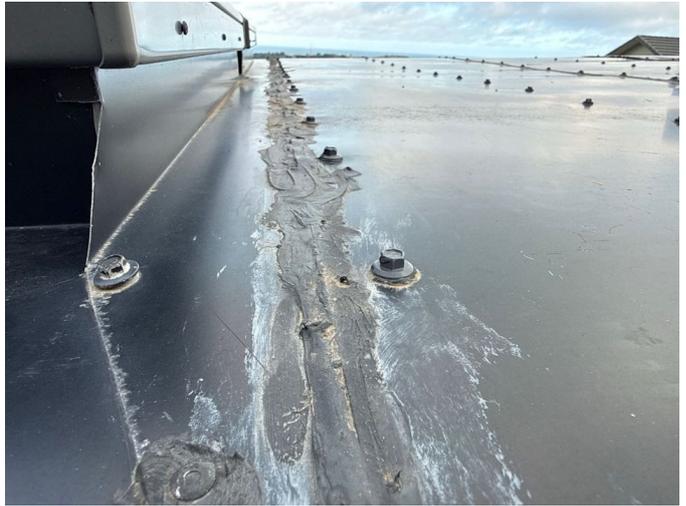
The owners disclosed a previous leak around the hallway skylight which was 'repaired' in July 2025. The leak didn't cause any damage and was completed by roofer. There was a bucket beneath this area nearly full of water and water pooling on the roof underlay. Further investigation is required.

Sealant used on a roof is a temporary solution only and should be monitored and maintained accordingly

Roof - The roof requires further professional assessment to determine if there is an on going leak at the previous location. The bucket should be emptied and the water removed from the roof underlay inside the ceiling cavity.

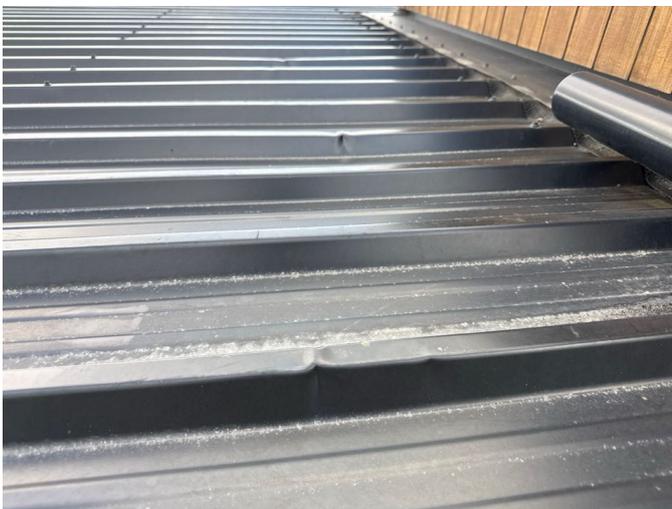
Dented tiles to the southwest side beneath the skylights. The dents are not currently affecting the performance of the roof however they are prone to splitting and should not be walked on.

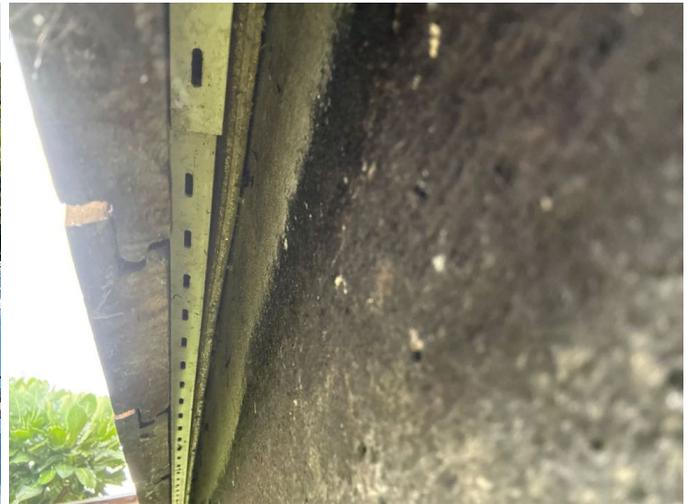
Cavity system detail behind the timber cladding. The cavity system is a modern detail that allows moisture to escape and ventilation to the back of the cladding.

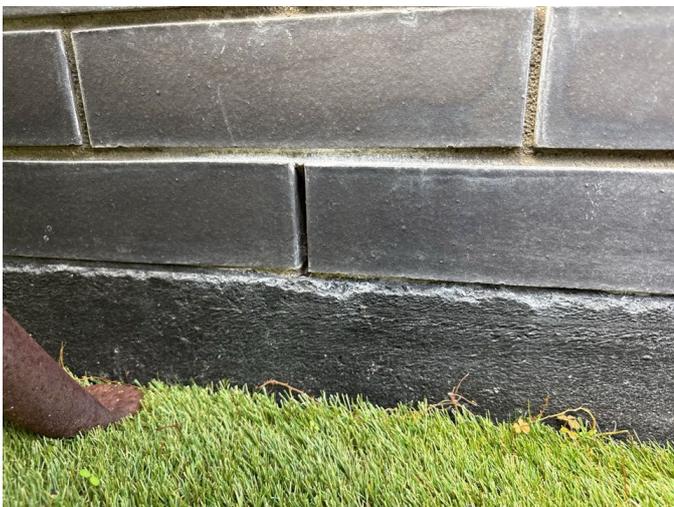
The brick facade has a cavity and weep hole detail which allows ventilation and drainage to and from the cavity behind the bricks. Weep holes and ventilation gaps must be kept clear for this to be effective.

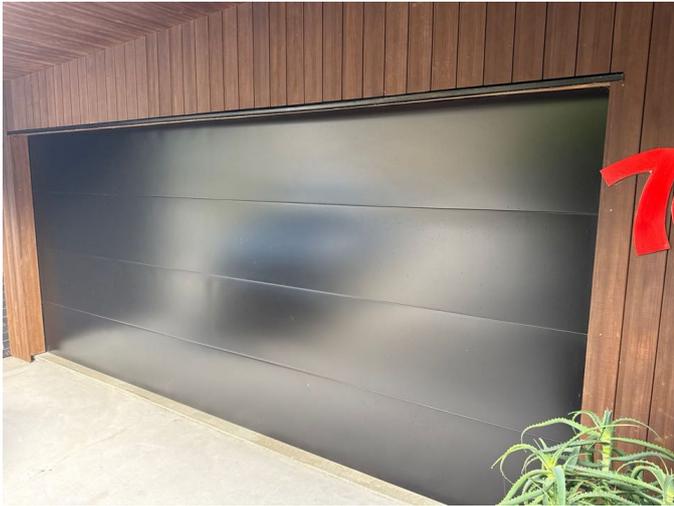
The surface condition of the garage door is good

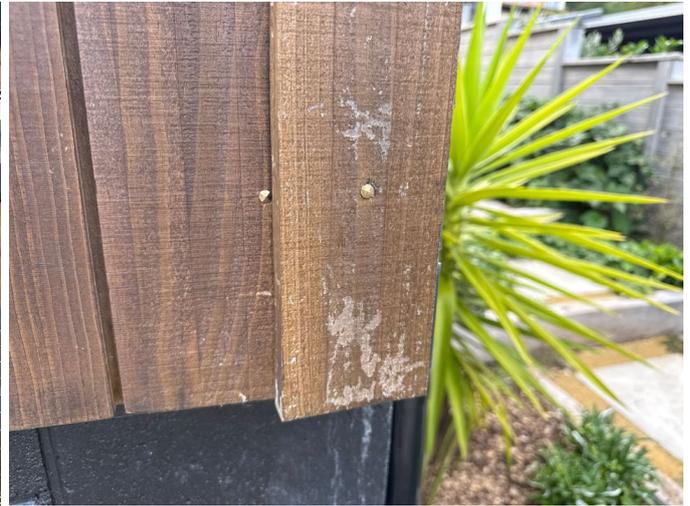
The timber shiplap weatherboards show early signs of surface deterioration in more exposed locations. While no significant failure was noted, the cladding will require ongoing maintenance to protect the timber. Particular care should be taken to ensure the end grain of the boards is well sealed, as unprotected end grain is more susceptible to moisture entry and deterioration. The timber cladding should be re-coated in the near future to maintain weather protection and extend the life of the cladding.

Early stage surface wear to the oil/stain coat

Timber claddings are durable when properly cared for, and regular maintenance is important to ensure their continued performance. To maintain protection against moisture and UV exposure, the weatherboards should be re-stained or oiled at intervals recommended by the coating manufacturer, or sooner if signs of surface breakdown, fading, or dryness are observed. Regular washing to remove dirt, mould, and lichen is also recommended, along with checking junctions, flashings, and sealant lines to help preserve weathertightness and extend the life of the cladding.

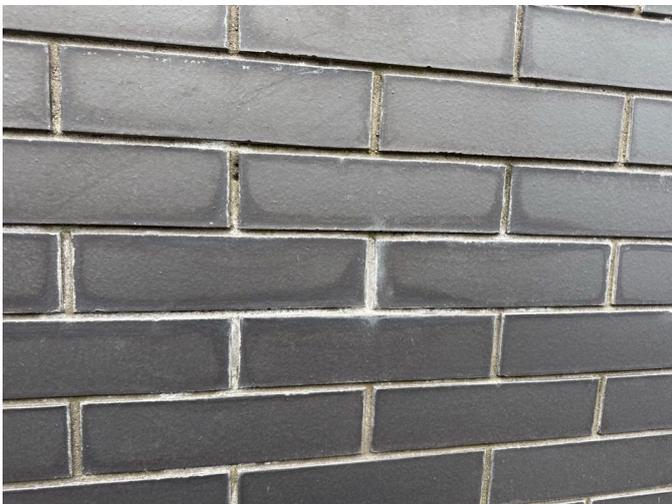
Salts migrating out of the mortar is staining the bricks. This is cosmetic only and may be able to be washed off.

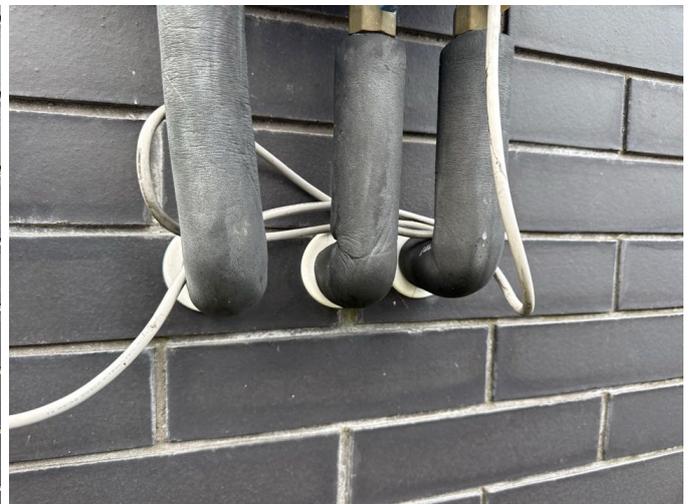
Cladding penetrations in general are a weather tightness risk area. Penetrations such as taps, screw fixings, gas or water pipes etc. A good seal must be maintained around all cladding penetrations over time to prevent issues. No evidence of failure could be found.

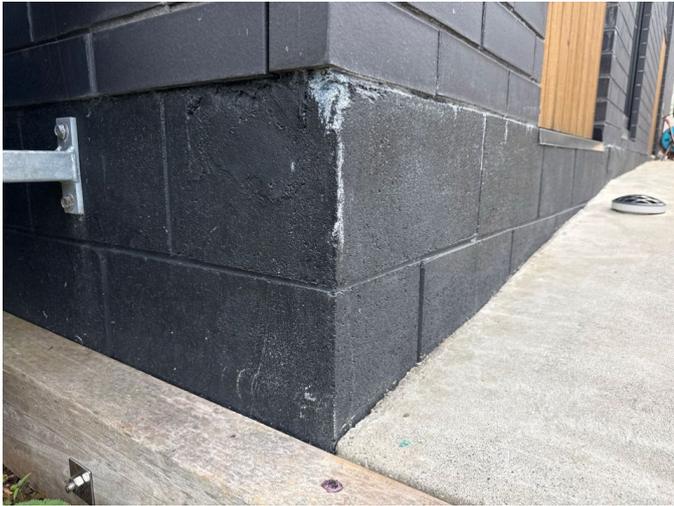
The concrete block ring foundation is in a typical condition for the age. There was no evidence of cracking or significant stress.

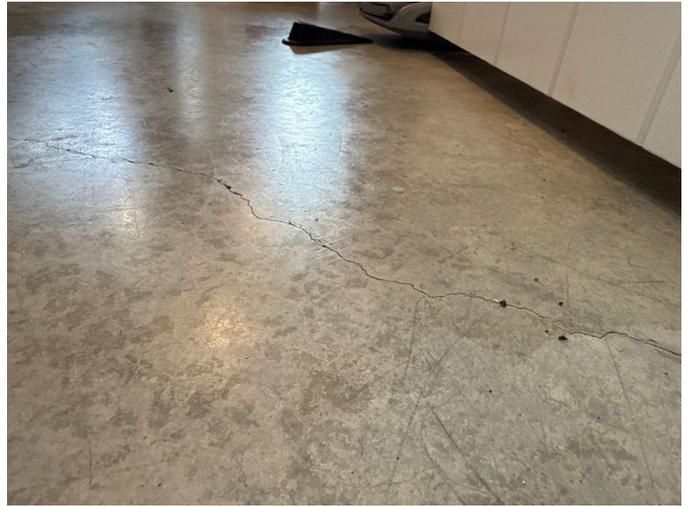
Common shrinkage cracking to the garage slab. This is not a structural concern and is commonly caused during the curing stage of the concrete hardening process.

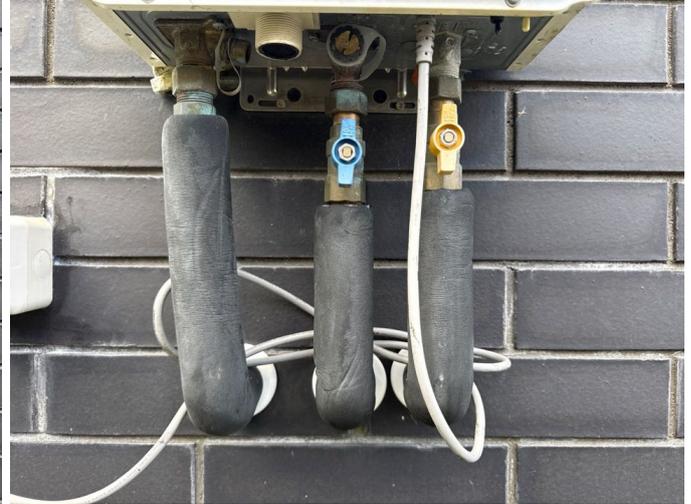
The presence of the insulation over the pipes will help prevent UV damage

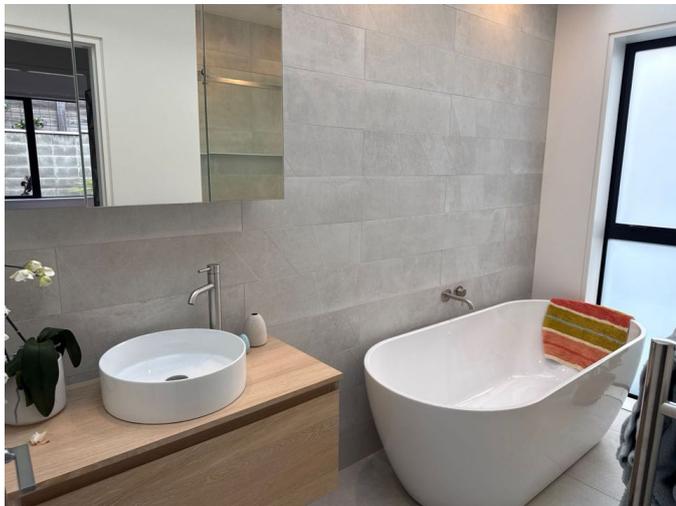
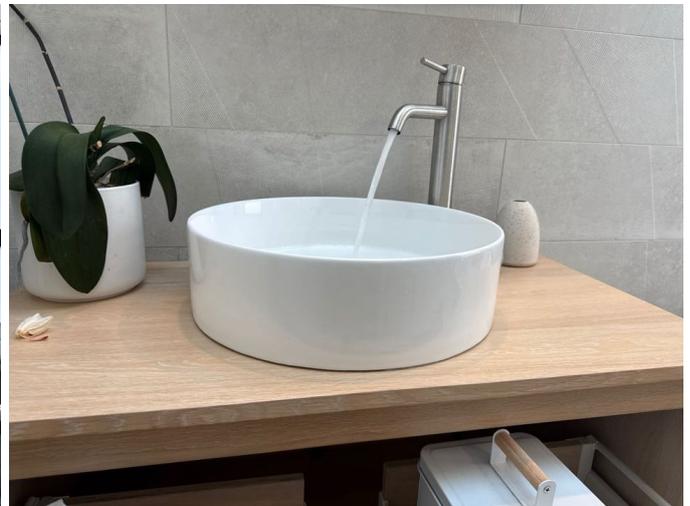
The rear edge of the vanity is well sealed. The tap is functioning well. No concerns with the water feeds or waste under the vanity

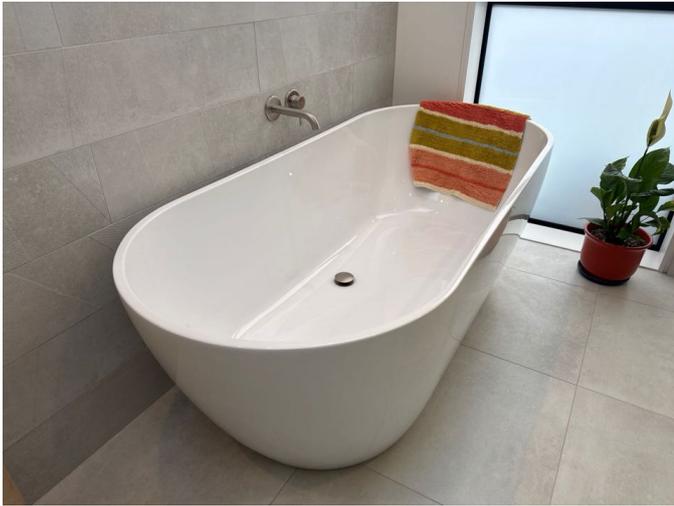
The bath is visibly in good condition and is functional

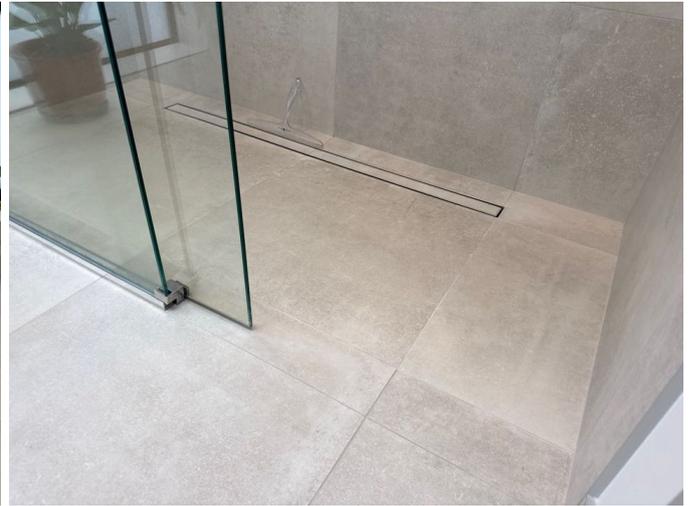
The tiled shower is showing no evidence of deterioration or failure at the time of the inspection. If there are any concerns with the condition of the tiles, sealant or grout in the future, a professional Tiler should be engaged for further assessment.

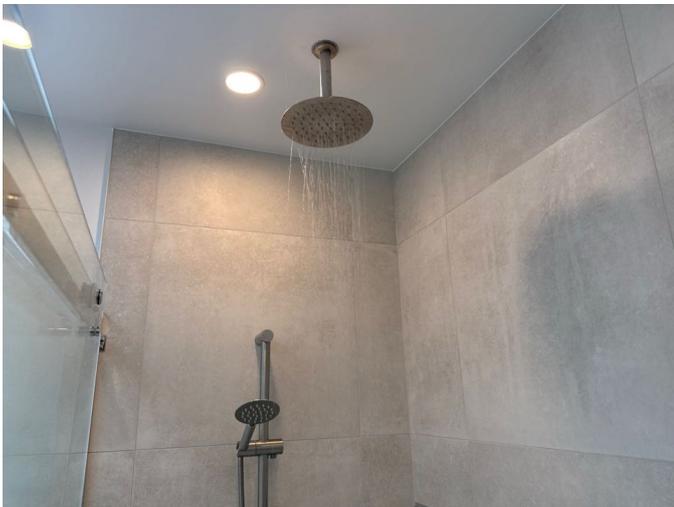
Good water pressure noted. No sign of current leaks from the shower frame during water testing.

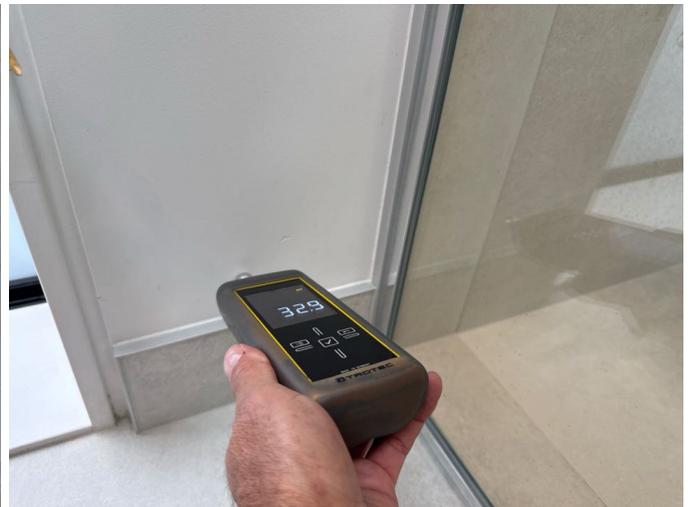
The common fail areas of the shower and plumbed areas were checked for elevated moisture. Moisture levels were within the normal range.

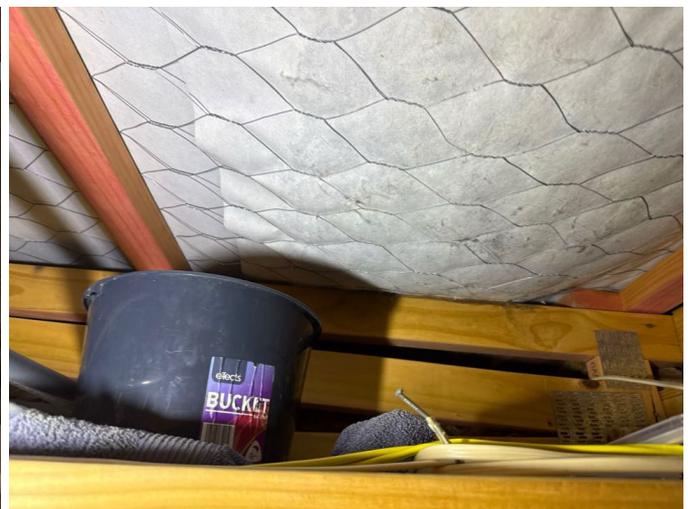
There was a bucket and towel placed on top of the wall frame where the previous leak was found. The roof underlay had a large bulge and was full of water. The bucket was also nearly full which indicates that there may be an ongoing leak. Further assessment and remediation should be completed by an experienced roofer.

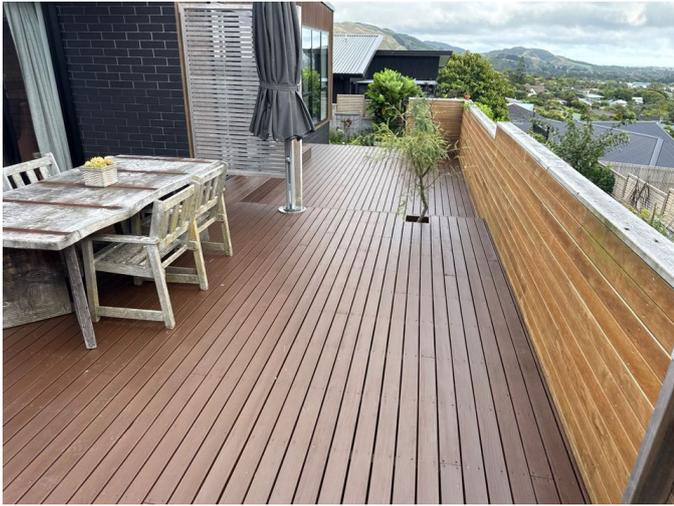
The decking is in good condition

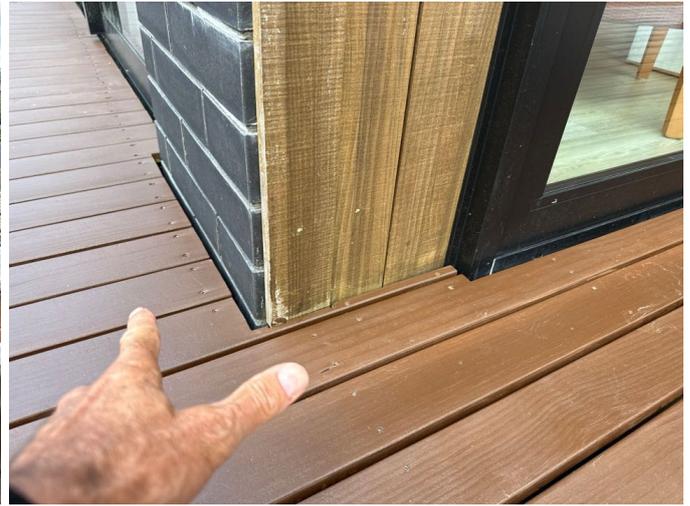
Good clearance gap between the deck and cladding. This will allow water to escape and will prevent premature deterioration.

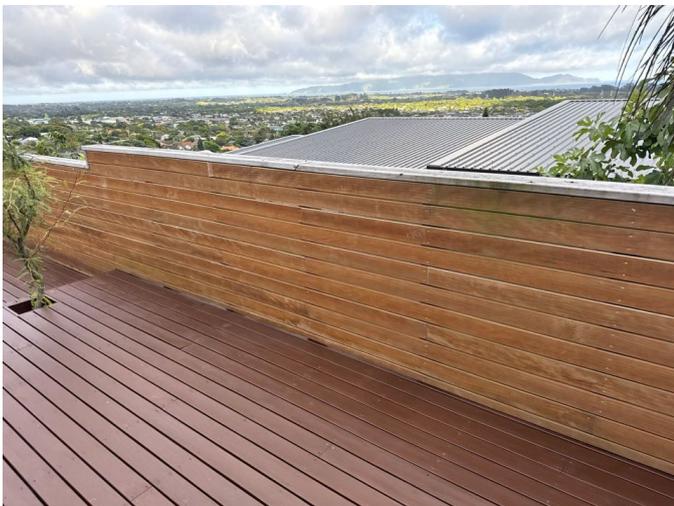
The balustrade is solid and connected sufficiently at the base

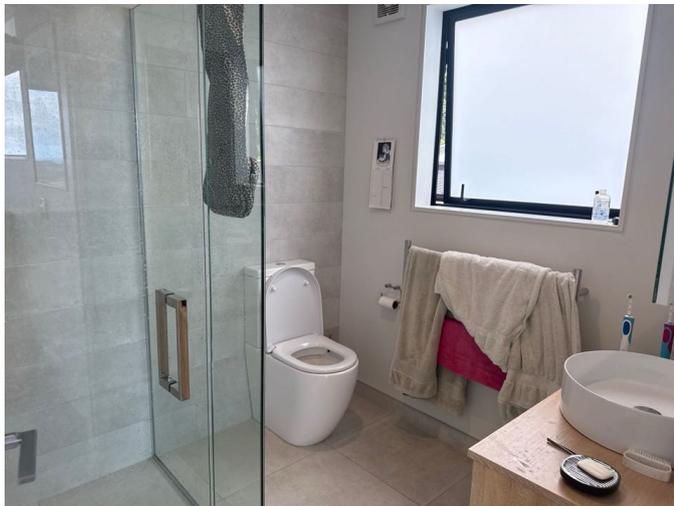
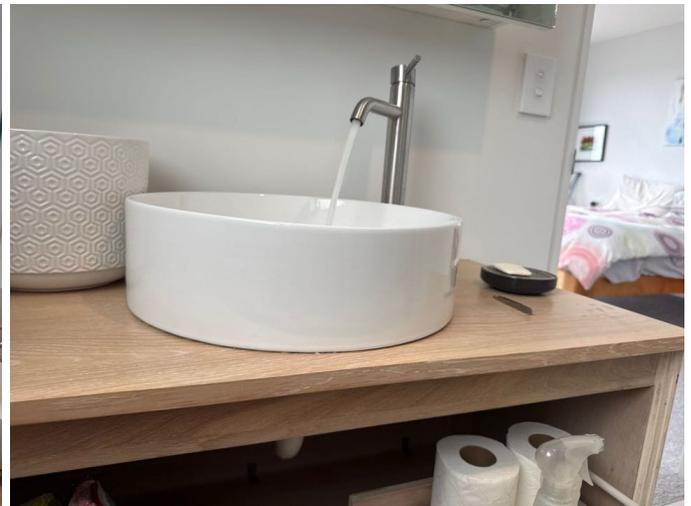
The rear edge of the vanity is well sealed. The tap is functioning well. No concerns with the water feeds or waste under the vanity

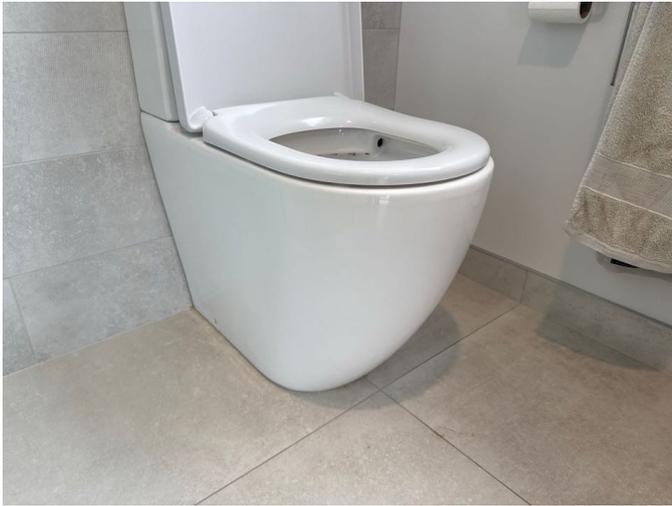
The base of the toilet is well sealed and secure. The toilet is in a functioning condition.

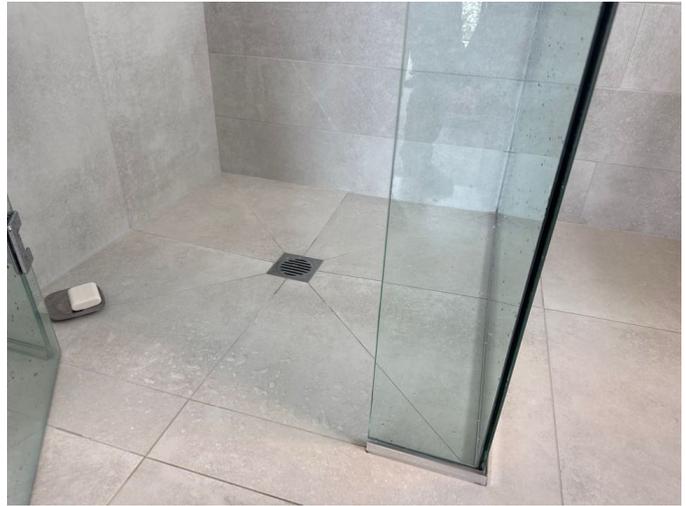
The base of the shower is well sealed. There was no evidence of damage to the shower base at the time of the inspection.

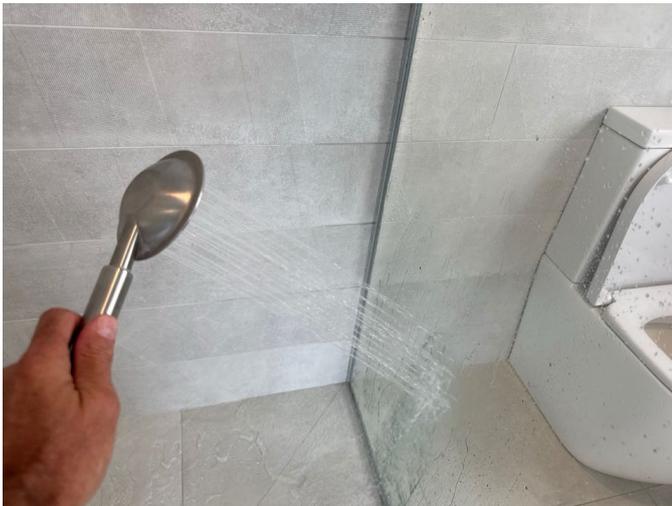
Good water pressure noted. No sign of current leaks from the shower frame during water testing.

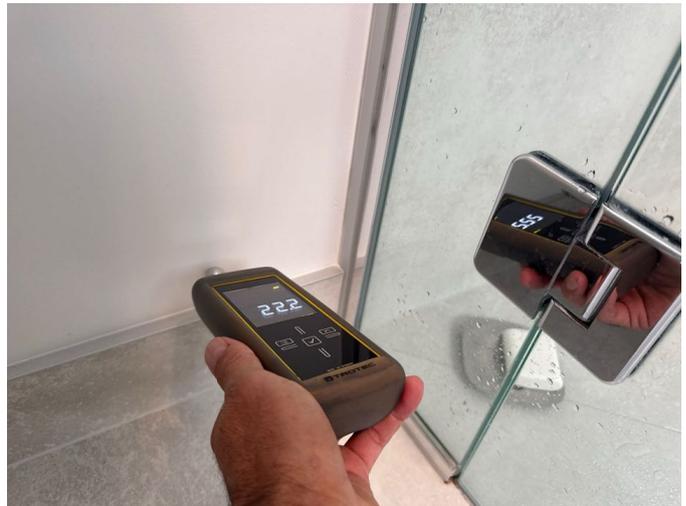
The tiled shower was showing no evidence of deterioration or failure at the time of the inspection. If there are any concerns with the condition of the tiles, sealant or grout in the future, a professional Tiler should be engaged for further assessment.

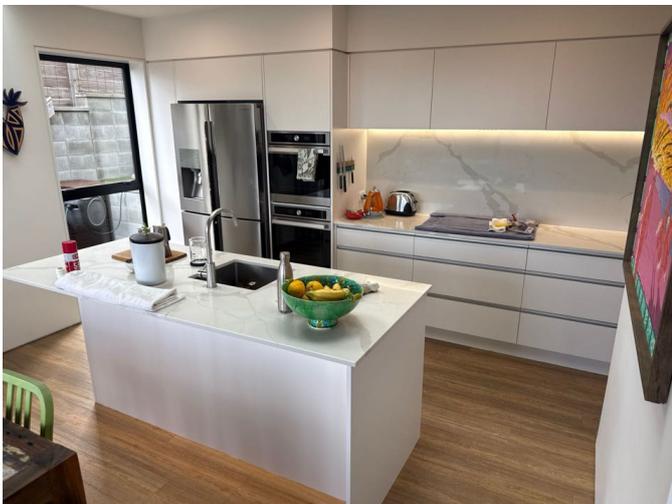
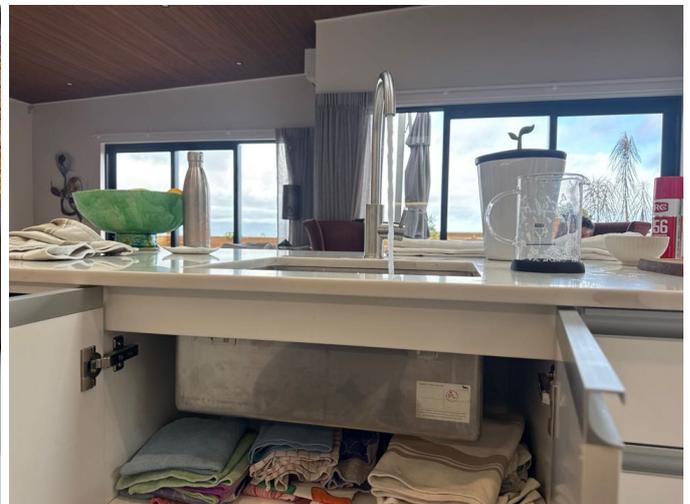
The bench and sink areas have been well maintained and are in good condition. The tap is functioning well.

No concerns with the water feeds or waste under the sink.

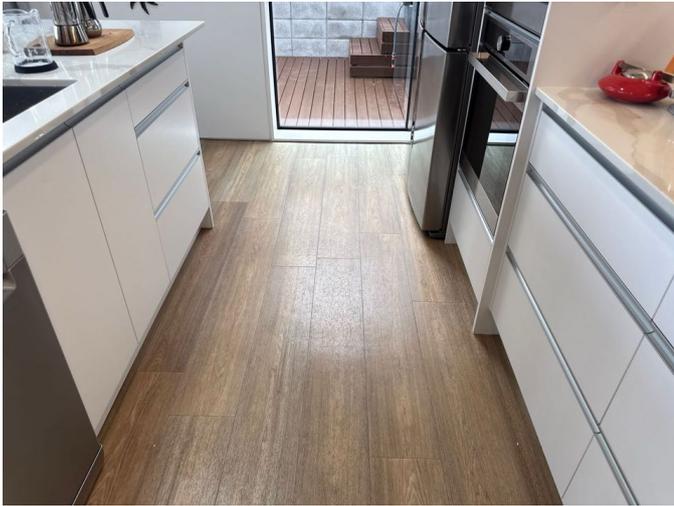
The kitchen cabinetry and vinyl floor are in good condition

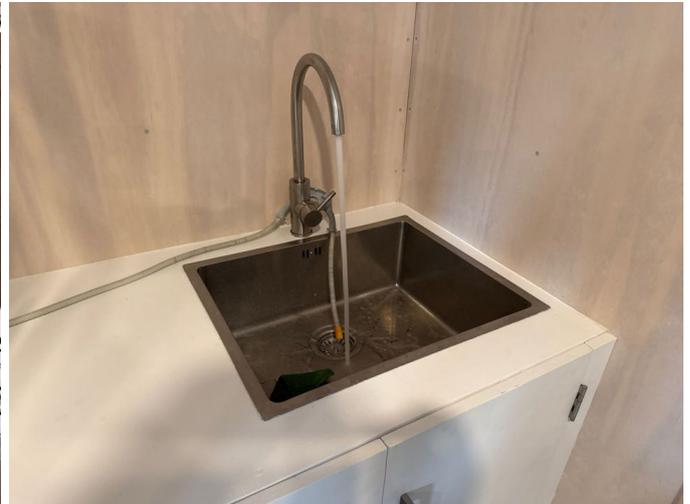
The tub is well sealed. The tap is functioning well.

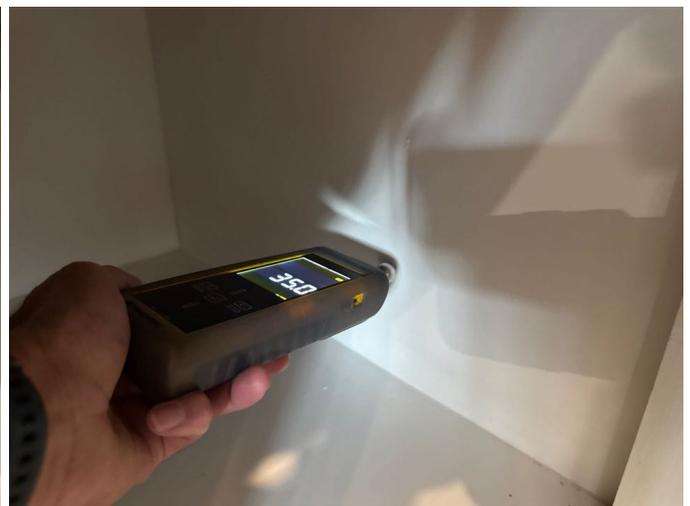
Moisture levels in the laundry were within the normal range at the time of inspection.

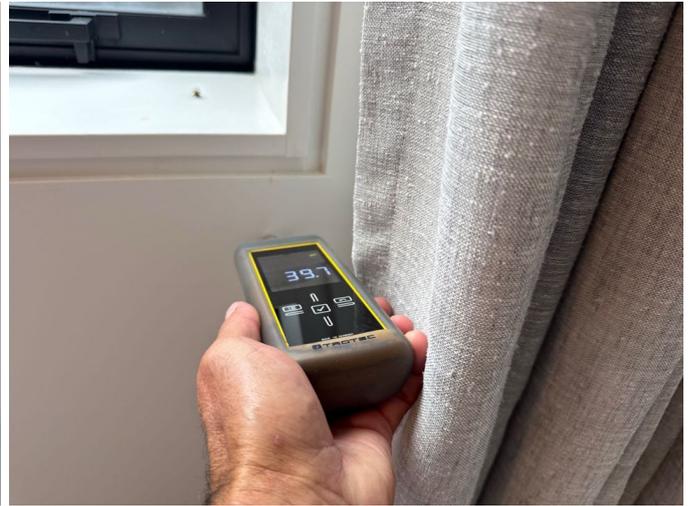
Moisture levels to the external walls were within the normal range at the time of inspection

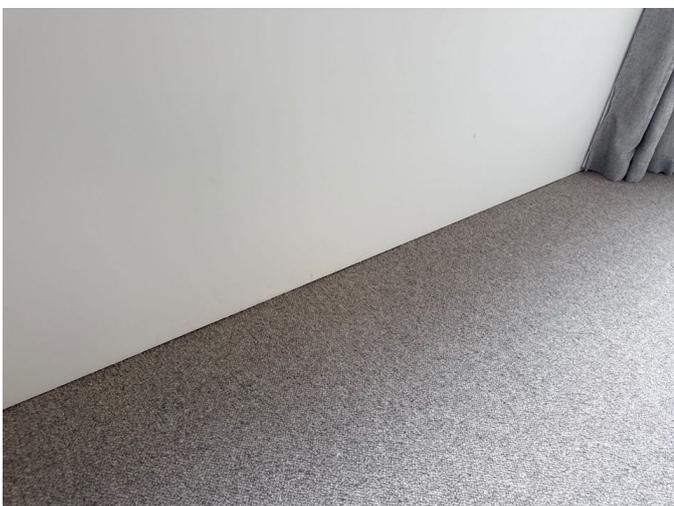
The wall and ceiling linings and carpet are in good condition

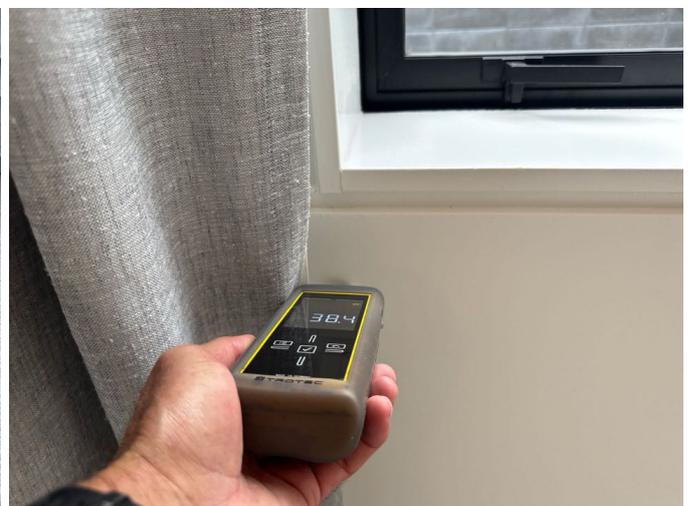
Moisture levels to the external walls were within the normal range at the time of inspection

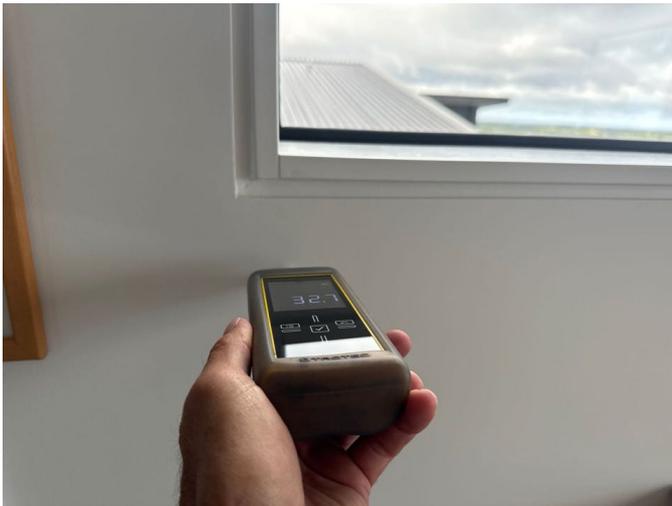
Moisture levels to the external walls were within the normal range at the time of inspection

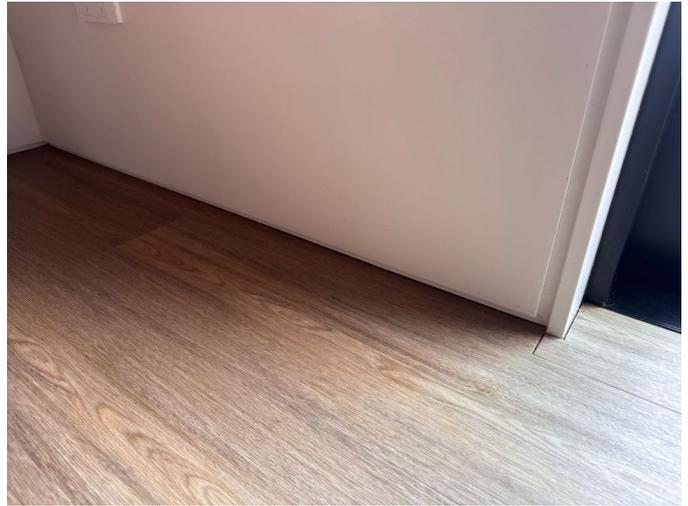
The wall, ceiling linings and vinyl flooring are in good condition

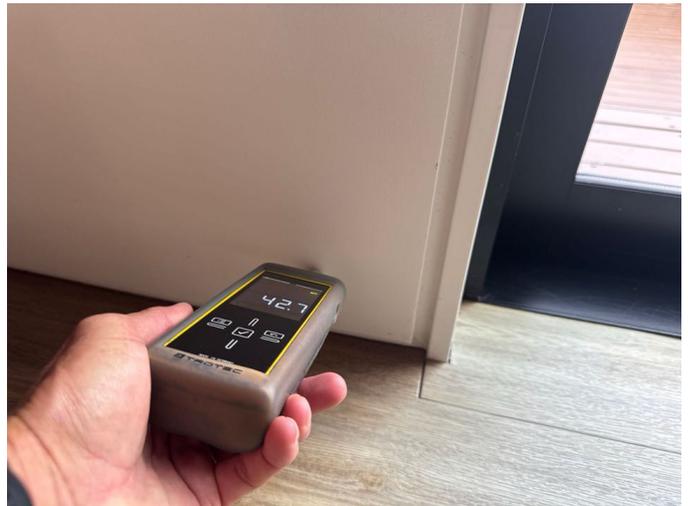
Moisture levels to the external walls were within the normal range at the time of inspection

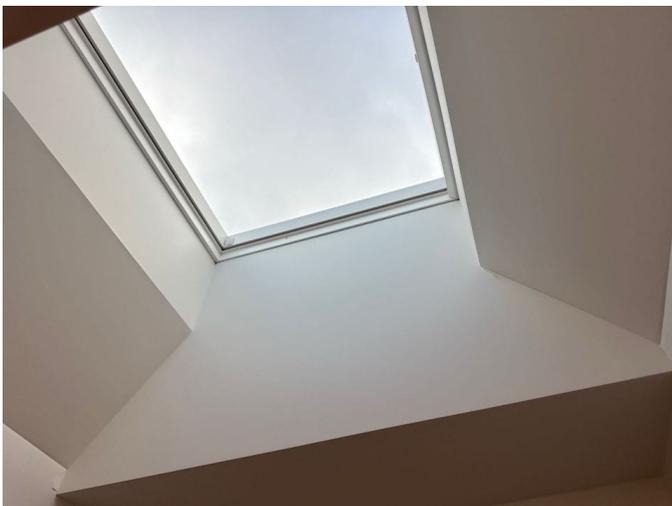
There was no visible evidence of failure beneath the skylight.

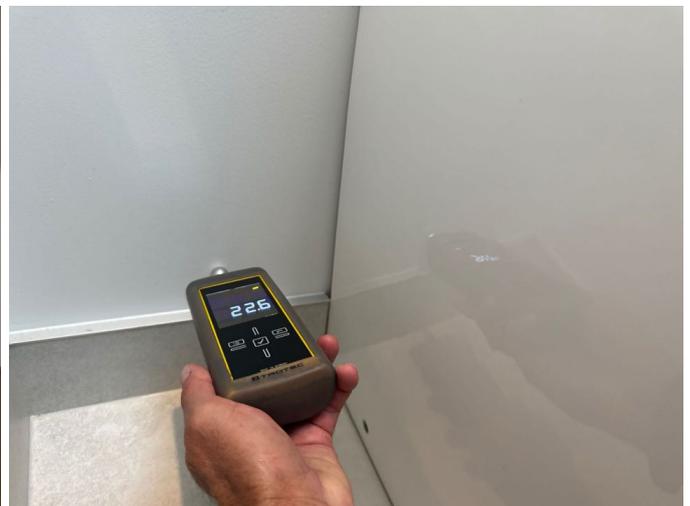
Moisture levels behind the toilet were within the normal range at the time of inspection
