BUILDING INSPECTION REPORT

RED LBP PRE-PURCHASE REPORT

PRE-PURCHASE BUILDING REPORT

Property Address	7/24 Whitmore Street, Edgeware, Christchurch 8013
Client	Jonathan Booth & Aurora Lin
Date of Inspection	7th February 2026
Time	8:00 am
Inspector	Jamie Chapman National Certificate in Carpentry
LBP Number	BP137228
People Present	Inspector
House Occupied	No

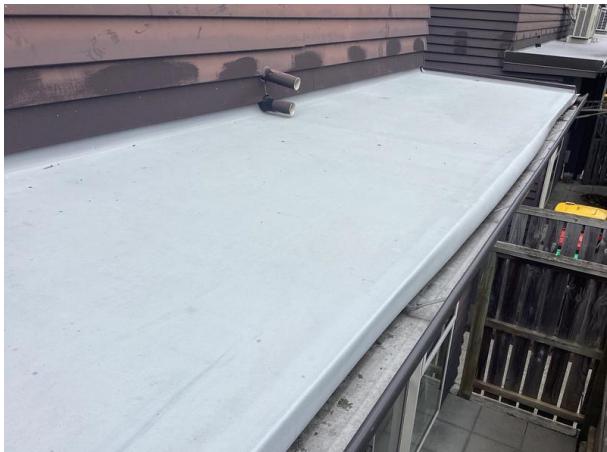
Photo 5

Membrane roof located on the north side of the dwelling. The membrane in the gutter was loose and would benefit from re-glueing/securing down.

No current significant issues, recommend re-glueing/securing the loose membrane noticed in the gutter.

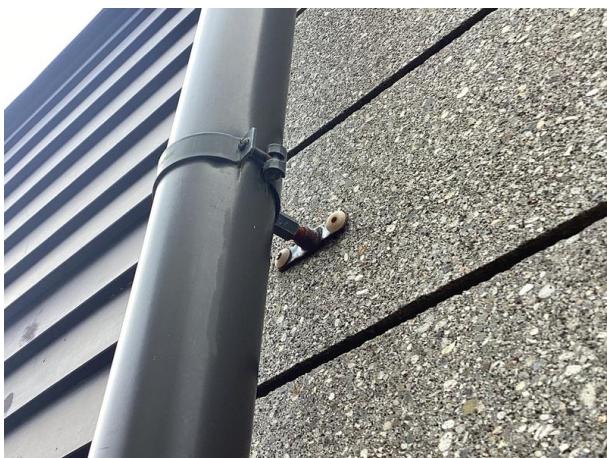
Photo 10

The metal downpipes were securely attached to the dwelling at the time of the inspection. Some corrosion was noticed. No current significant issue.

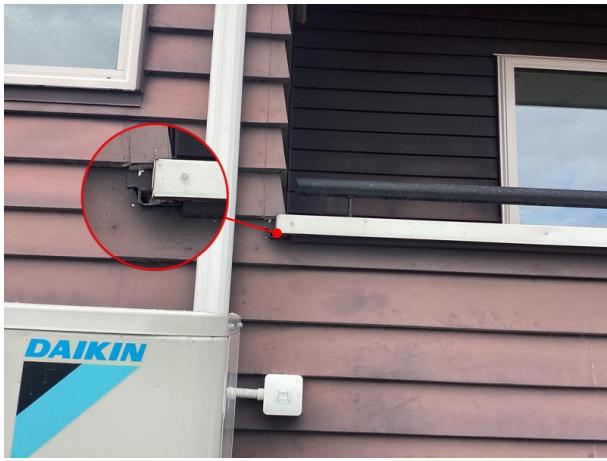
Photo 12

A gap was visible in the weatherboards located at the balcony junction on the north side. Recommend sealing.

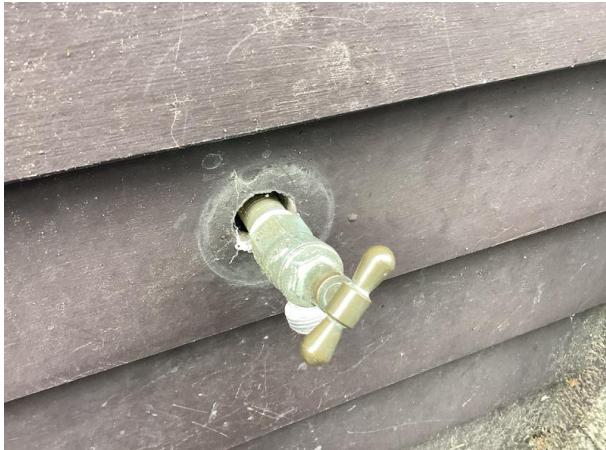
Photo 13

A couple other cladding penetration holes would benefit from being sealed. Photo of the west side tap.

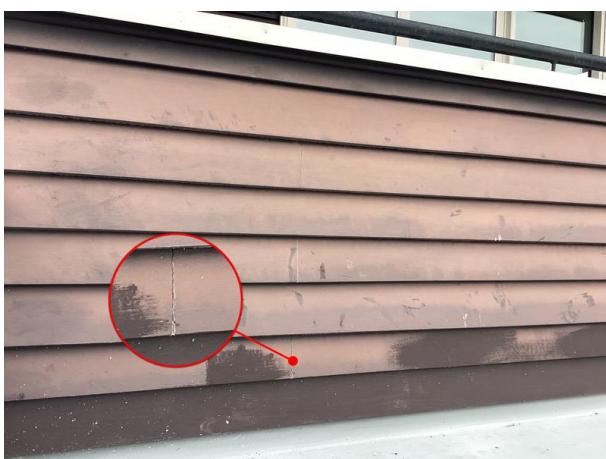
Photo 14

Near future maintenance would include repainting the fibre cement weatherboards as surface fading was noted and gaps at the weatherboard joins were starting to open.

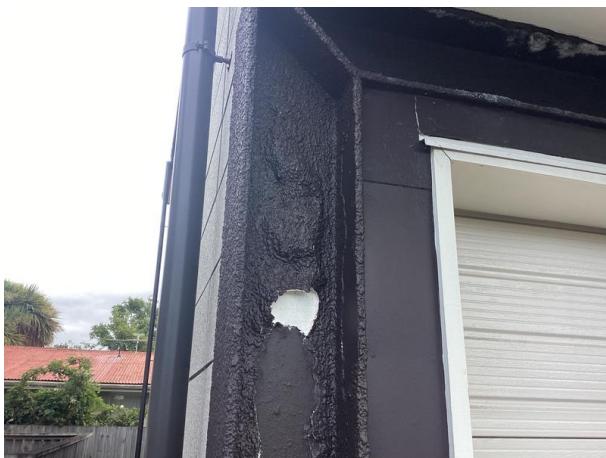
Photo 15

Paint flaking and detaching was visible on the steel portal located around the garage door.

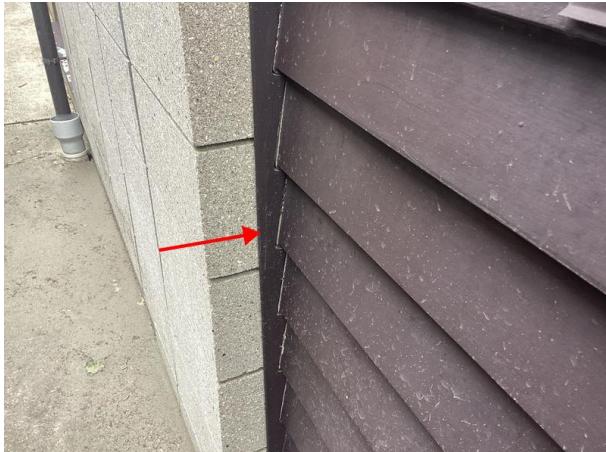
Photo 16

The Westside weatherboard subscriber was loose. Recommend resecuring into place.

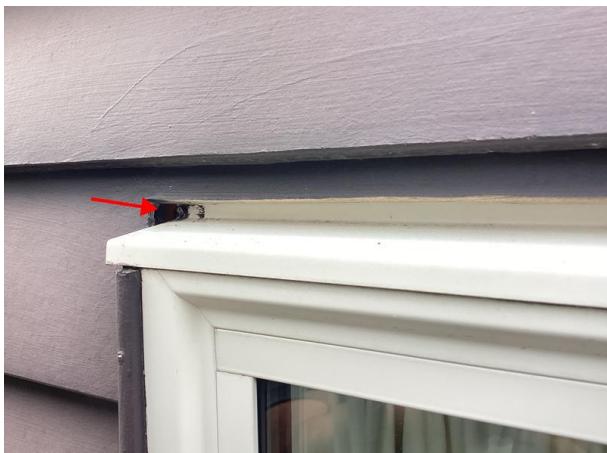
Photo 19

Gaps were visible at the head flashing into weatherboard junctions. It is recommended to seal these areas.

Keep up regular maintenance. It is recommended to seal the ends of the head flashing to weatherboard junctions.

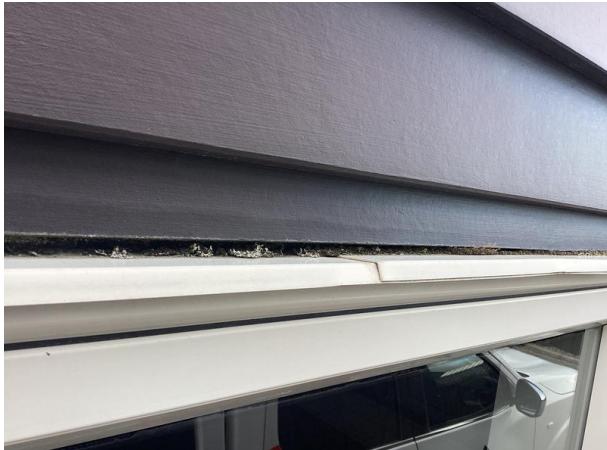
Photo 20

Moss buildup was visible between the weatherboard and head flashing.

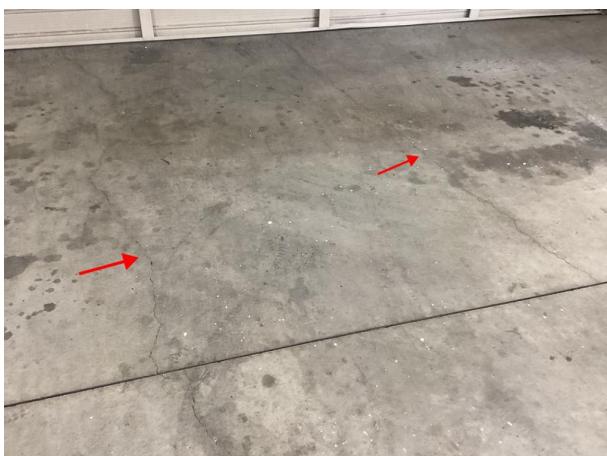
Photo 22

A couple of concrete cracks were noticed on the floor in the garage. No significant separation was noticed.

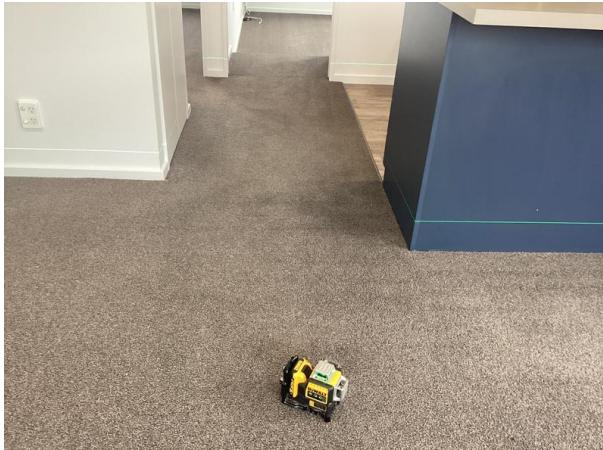
Photo 24

The property had an overall level difference of approximately 15mm (where measured) with a self-levelling laser. This is not a floor-level survey and only a spot-check.

No significant deviations were observed during the inspection. The approximate overall floor level difference was 15mm.

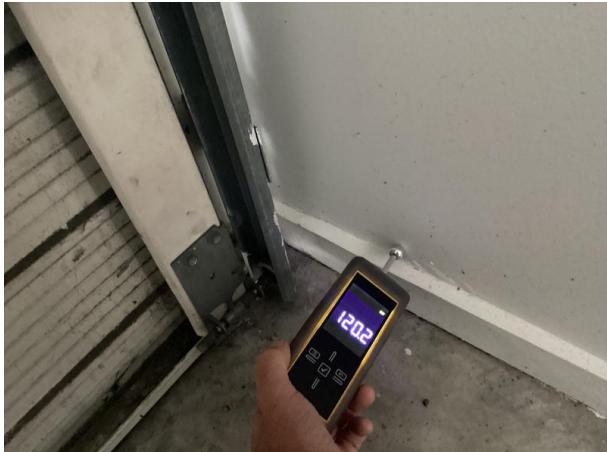
Photo 33

Indications of elevated moisture readings were detected in the garage and bedroom one. This are detailed further within this report.

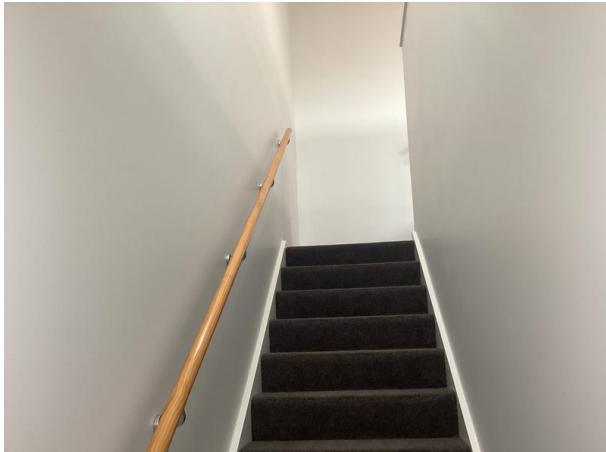
Photo 35

Stairwell, the flooring on the stairs were squeaking when walking on it.

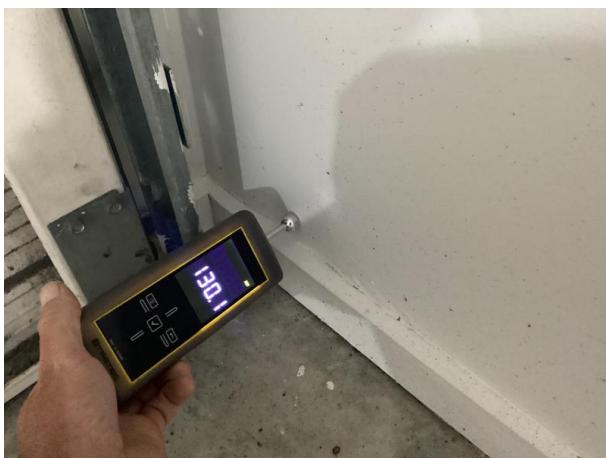
Photo 37
Paint defects and indications of elevated moisture readings were detected on the right hand side of the garage door.

As detailed in the photos below, paint defects and indications of elevated moisture readings were detected on the plasterboard wall beside the garage door. Moisture testing was then done below the plasterboard on the skirting boards, with no elevated moisture readings detected during the inspection. Moisture readings beside a garage door are not uncommon due to cold, damp weather and minor gaps common at the garage door opening junctions. Recommend having a licensed builder to double-check/ensure there are no significant unseen issues. Monitoring this area is recommended.

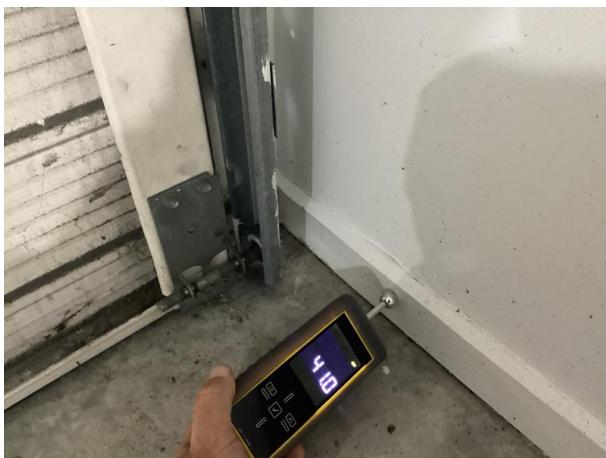
Photo 38
Normal moisture readings were detected below the previous photo on the skirting boards during the inspection.

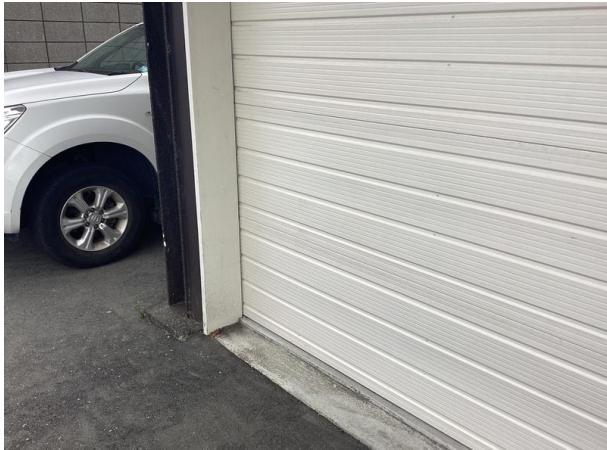
Photo 39

When viewing outside the dwelling around this area there were no obvious issues. Refer back to the recommendations for more information.

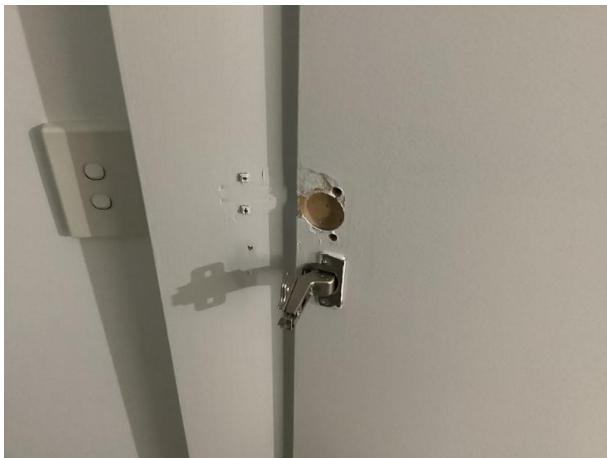
Photo 41

The laundry cupboard doors would benefit from maintenance and re-securing into place.

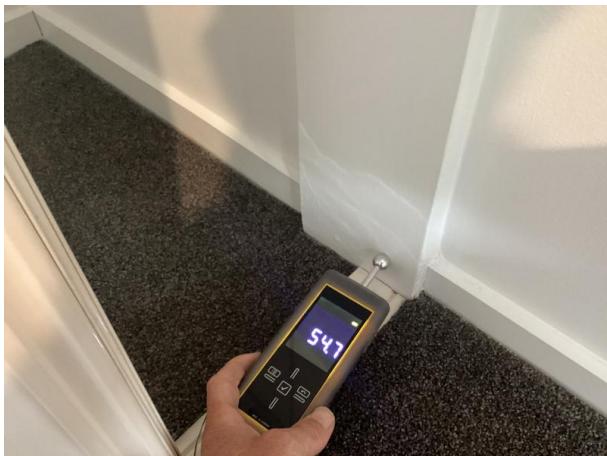
Photo 43
Swollen wardrobe reveals and slightly damp moisture readings were detected in bedroom one.

As detailed in the photos below, swollen wardrobes reveal, and slightly damp moisture readings were detected at the bottom of the bedroom wardrobe reveals. These reveals are MDF, which, if in contact with the cold, damp floor, can often absorb the cold, damp floor and cause the MDF reveals to swell. Recommend having a qualified builder trim the reveals off the concrete and seal the bottom. Then monitor this area to ensure that this was the cause.

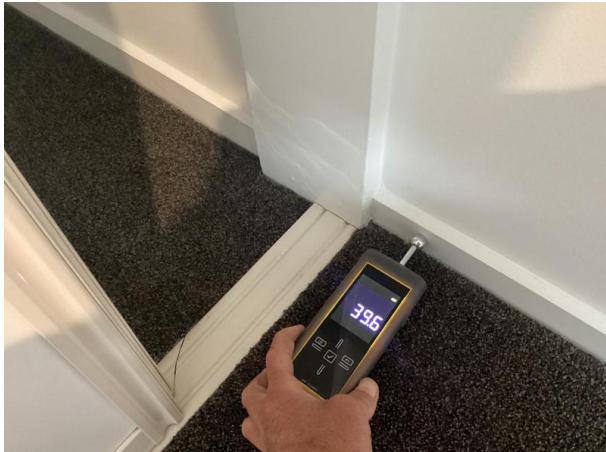
Photo 44

Normal moisture readings were detected on the skirting boards beside the previous photo during the inspection.

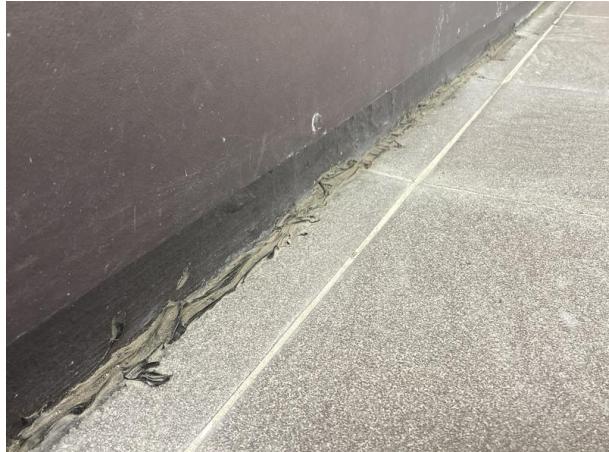
Photo 51

Silicone workmanship at the tile to wall junctions were in average condition.

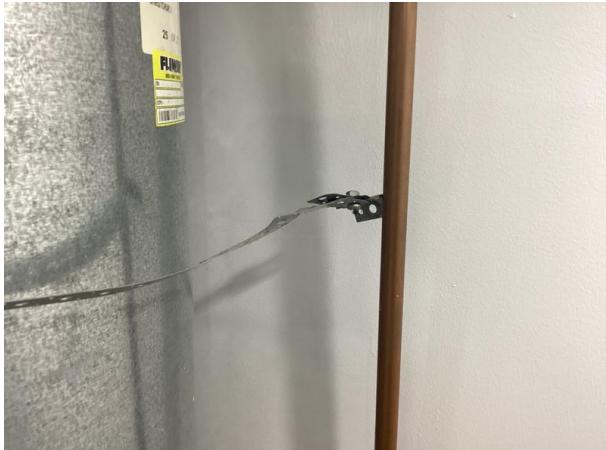
Photo 62

Any visible defects - Recommend re-installing seismic bracing.

Recommend reinstalling and securing these straps into place.

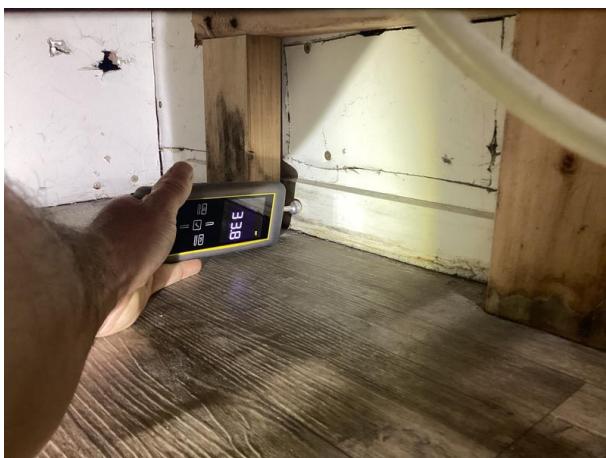
Photo 63

Discolouring and timber staining were noticed under the hot water cylinder. However, no elevated moisture readings were detected during the inspection.

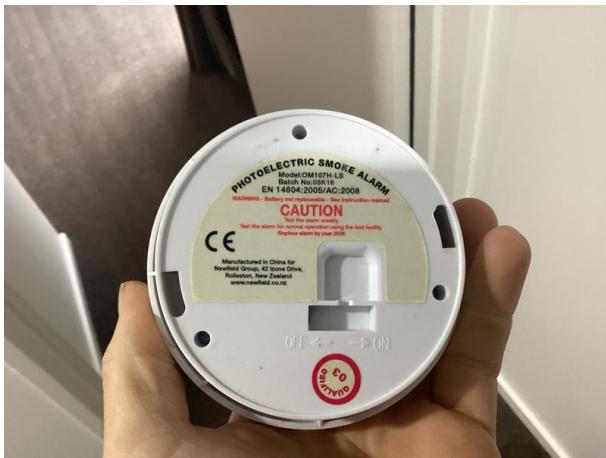
Photo 68

The smoke alarms were functional however have now expired. Recommend replacing.
