BUILDING INSPECTION REPORT

RED LBP PRE-PURCHASE REPORT

PRE-PURCHASE

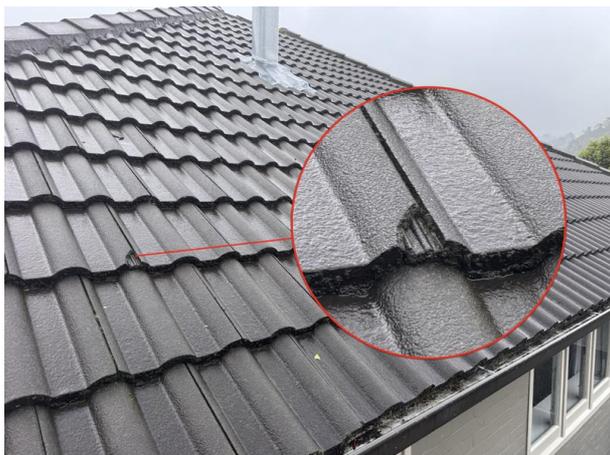
Tile condition - Tiles with chipped bottom corners.

Photo 7
Cracked bottom edges of the tiles.

Any masonry tiles with chipped or broken bottom corners should be replaced. Damaged tiles can compromise the roof's ability to shed water effectively and may lead to moisture ingress. Replacement of affected tiles should be undertaken by a suitably qualified roofing contractor to maintain the performance and integrity of the roof system.

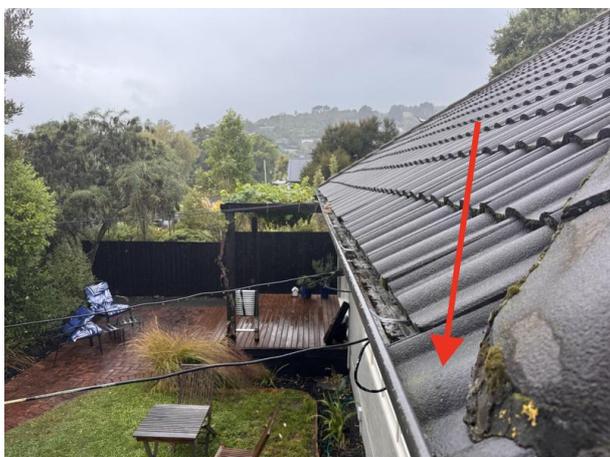
Tile alignment - Slipped tiles observed.

Photo 8
Slipped tile visible on the north east corner.

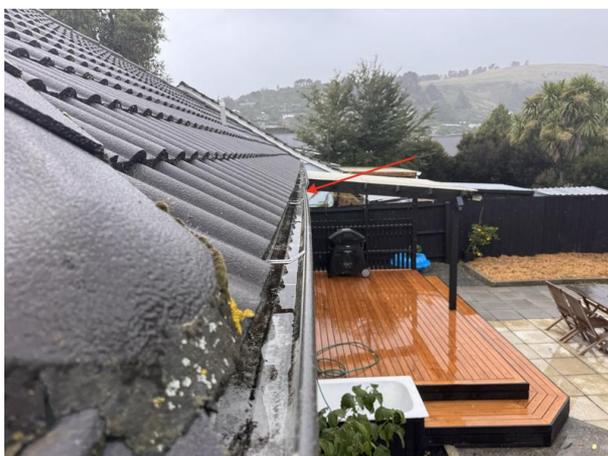
Photo 15
Profiled metal roof edge gutter on the south elevation, alignment defect visible.

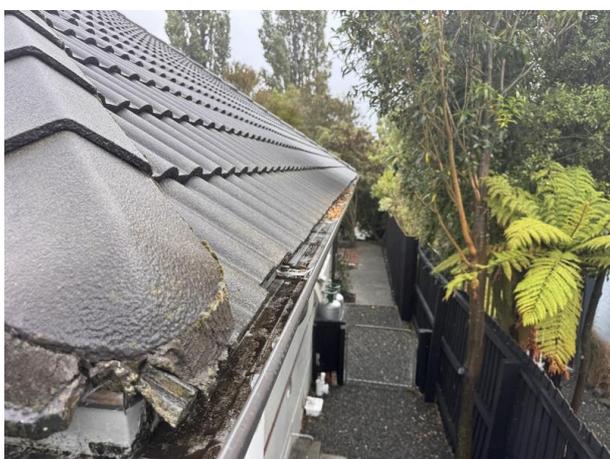
Photo 17
Profiled metal roof edge gutter on the east elevation. Some debris visible due to the recent windy conditions.

It is recommended to clear the gutters regularly to ensure proper drainage and prevent potential issues.

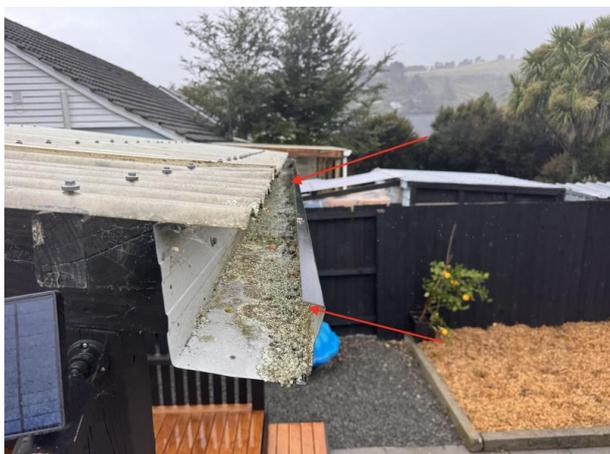
Photo 18
Profiled metal gutter installation on the back entrance pergola, lichen growth visible.

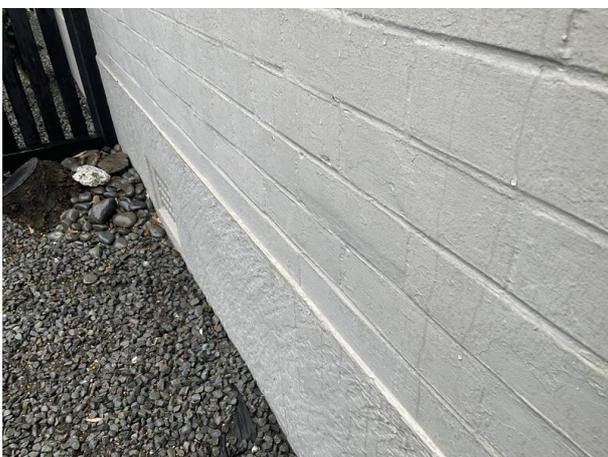
Photo 24

Brick to foundation alignment - Areas where brick does not overhang.

Small horizontal lip at the top of the foundation wall and the bottom brick course. Normally the brick would overhang the foundation wall.

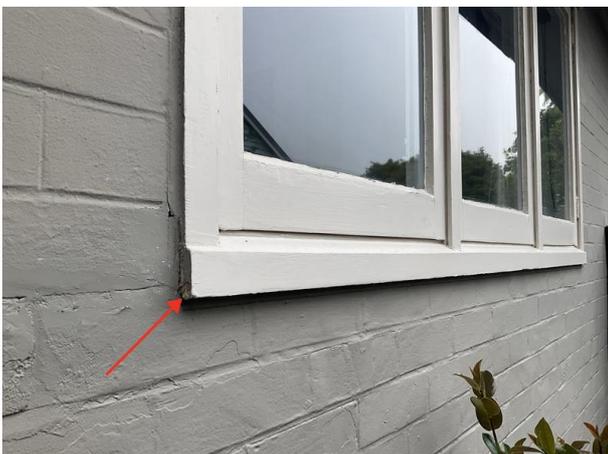
Photo 28
Side edge of the west elevation window sill requires sealing to prevent moisture ingress.

Any incomplete or damaged exterior side seals at the cladding to the exterior joinery units need to be repaired to stop water ingress.

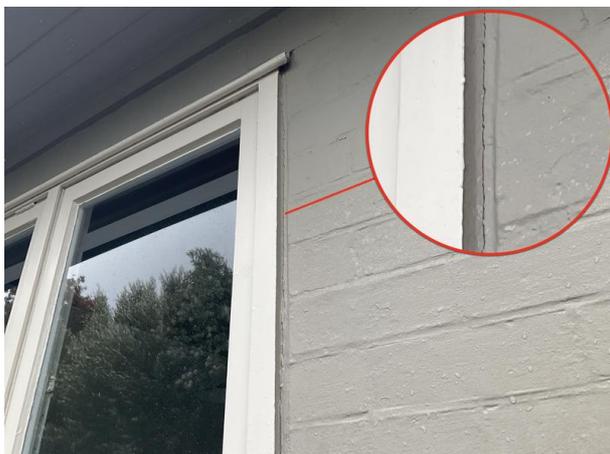
Photo 32
Visible gap in the joinery - cladding seal, recommend resealing.

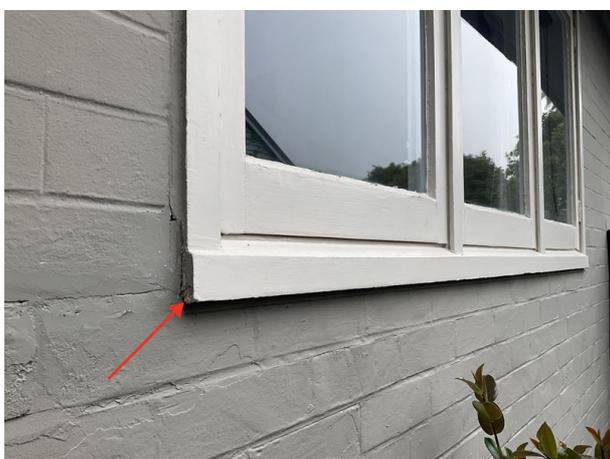
Photo 34
Timber window sill end, recommend sealing.

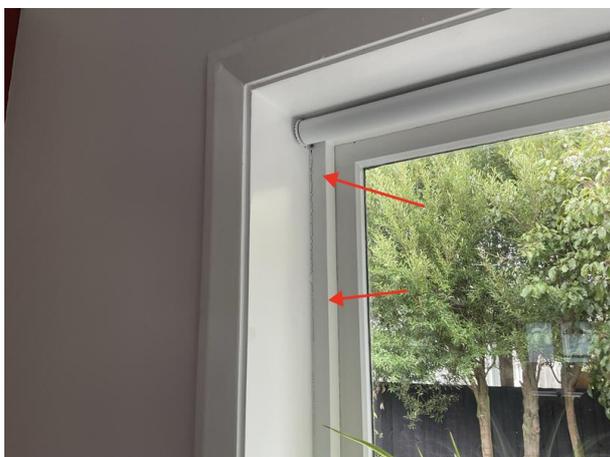
Photo 37
Defect visible on the side of the living room window.

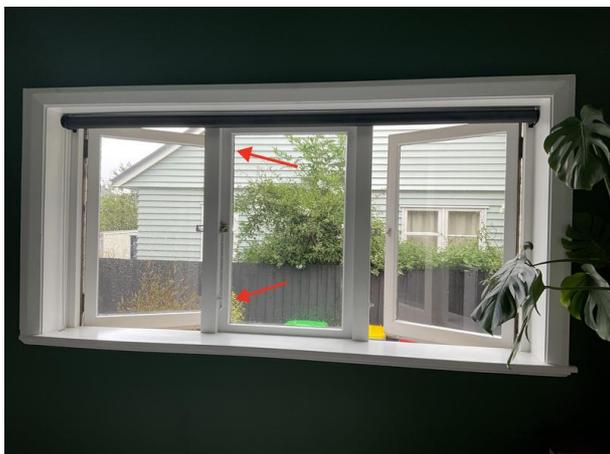
Photo 38
The middle window in bedroom one requires some adjustment to regain function.

Some repairs required to the opening sashes of the windows in order to restore functionality and to reduce draughts.

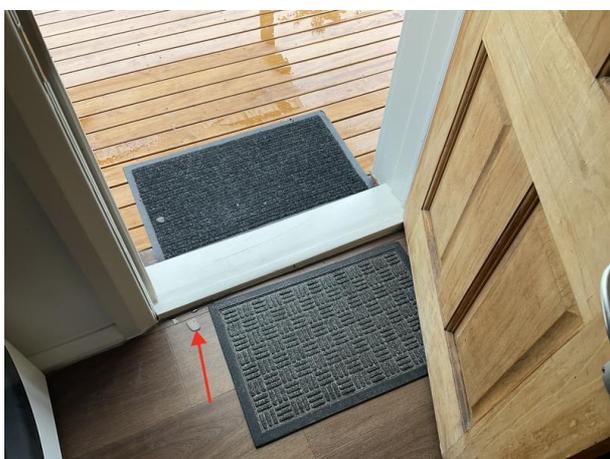
Photo 40
Some moisture visible on the inside of the back entrance, strong wind driven rain at the time of inspection.

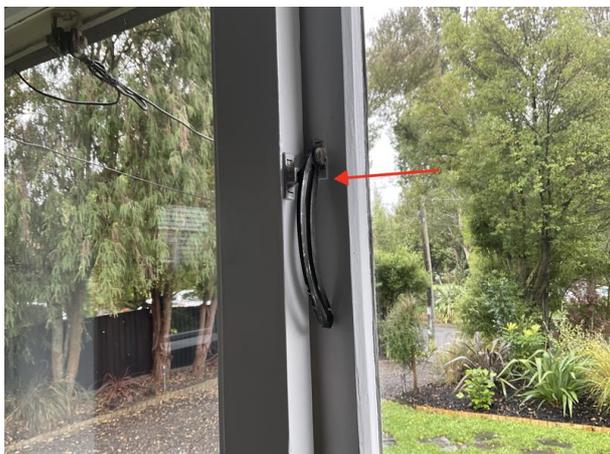
Photo 41
Missing stay screw handle in the living room north window.

There are some damaged or broken hardware, it is recommended that these are replaced or repaired to ensure full function of the joinery.

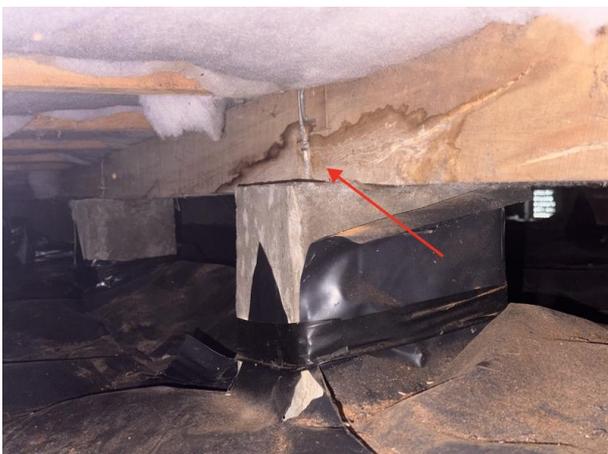
Subfloor timbers, type and condition - Suspended timber floor. Signs of moisture.

Because this property is in a High Flood Hazard Management Area (HFHMA) and near the river, the ground-water pressure (hydrostatic pressure) is likely higher than standard suburban sites. This makes the integrity of the DPC even more critical as the piles are often sitting in perennially damp soil.

Photo 44
Some moisture transfer visible through the concrete pile into the timber bearers due to the compromised DPC (damp proof coarse). Recommend replacing these to prevent further fungal decay (Rot).

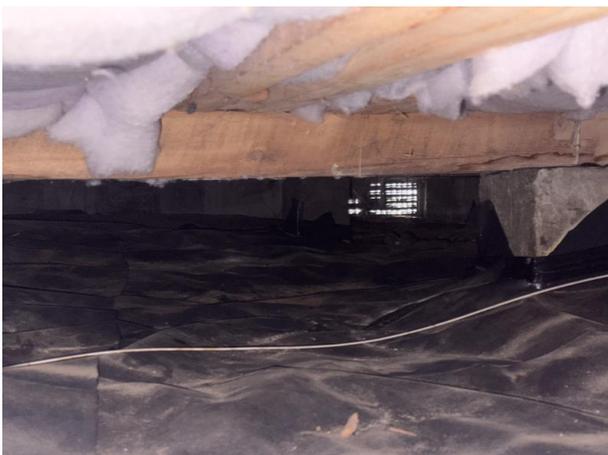
Photo 45
Foundation vents visible, only 250mm clearances under the bearers.

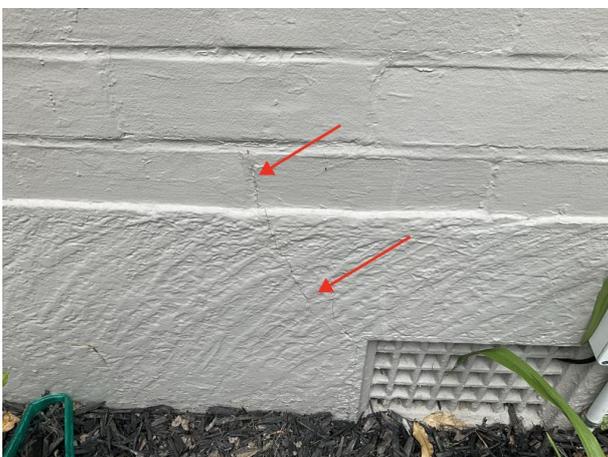
Photo 52
Cracking visible on the west elevation.

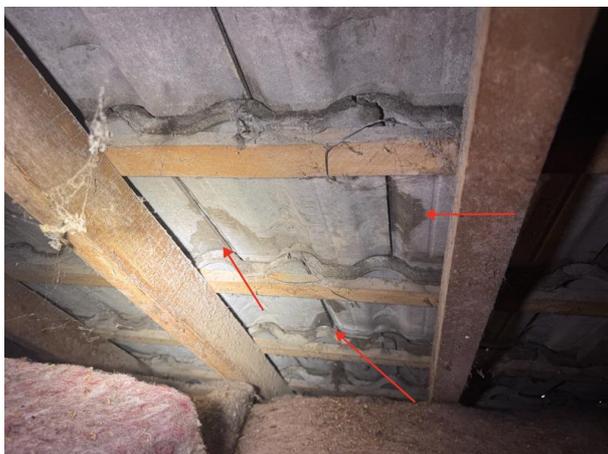
Photo 56
Moisture absorption visible as raining at the time of inspection.

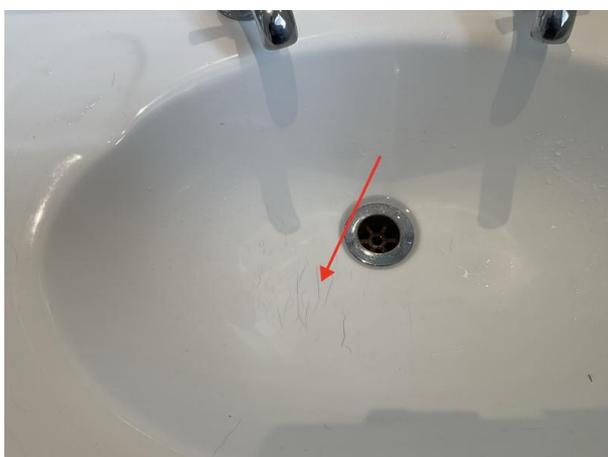
Photo 74
Surface cracking visible in the vanity basin.

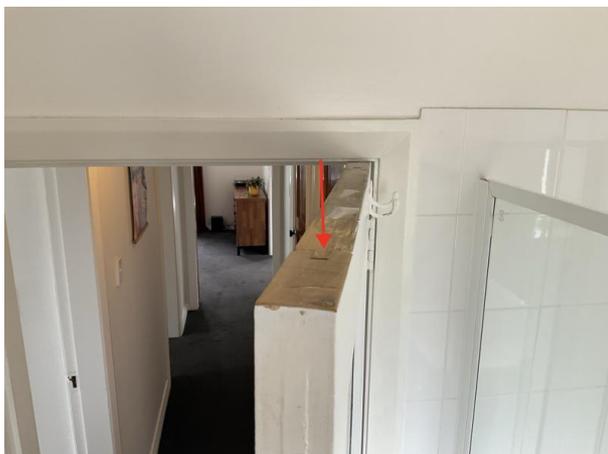
Photo 75
Unsealed door in the bathroom.

It's advisable to seal all six sides of every interior door. Neglecting to seal the tops and bottoms may result in moisture ingress, leading to surface damage on the door.

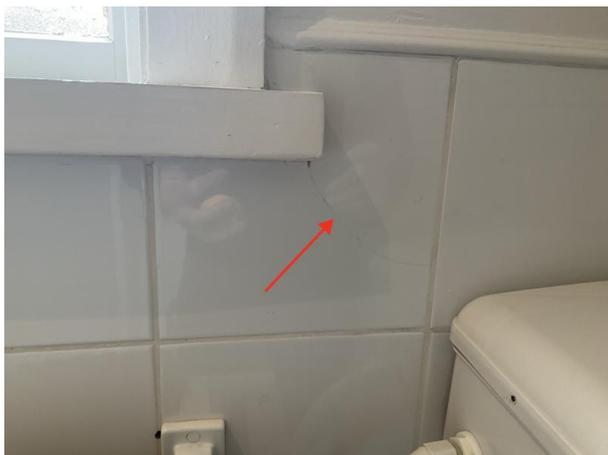
Photo 76

Wall tile cracking visible under both sides of the window.

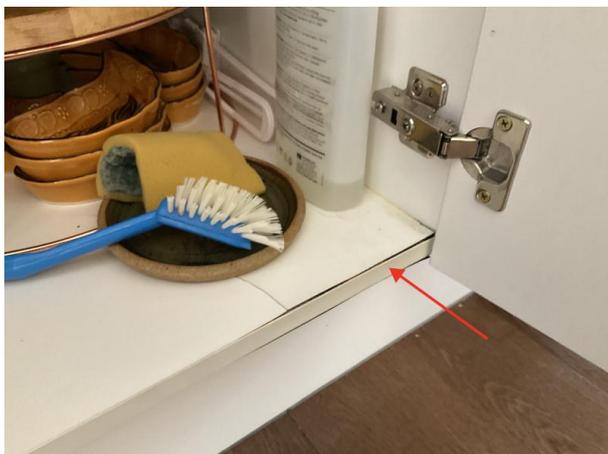
Photo 79
Moisture damage visible under the
kitchen sink.

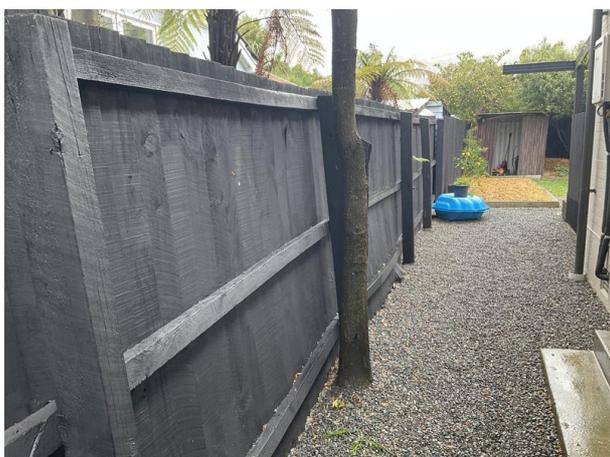
Photo 89
Stained timber peeling east boundary fence with some alignment issues visible.

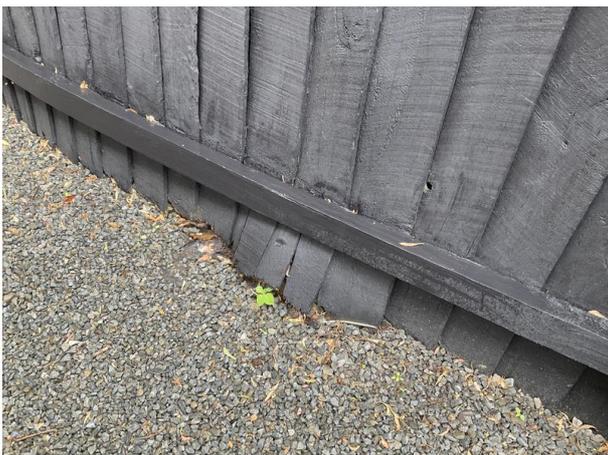
Photo 90
Damaged palings visible on the east boundary fence.

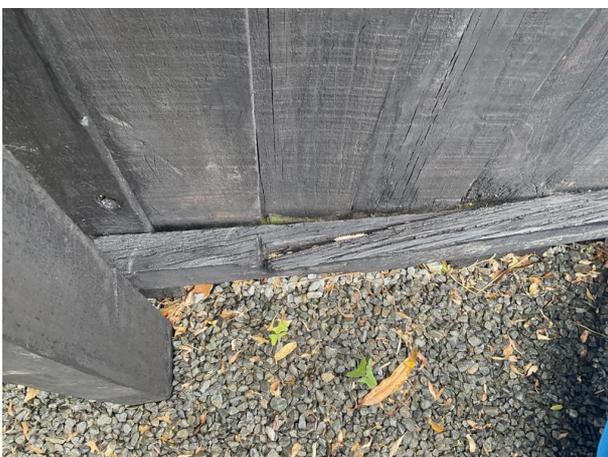
Photo 91
Some timber railing damage visible on these boundary fence.

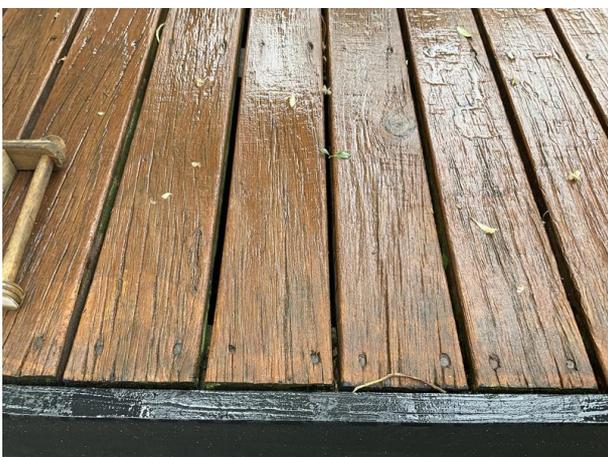
Photo 104
Surface deterioration visible, nail fixings used.
