# 5b Madeley Place, Mount Pleasant.

## **Structural Assessment & Building Report Property File Document Summary**

## **5b Madeley Road, Mount Pleasant, Christchurch**

RedFox Structural and Seismic Engineers have been engaged by Blackmilk Interiors NZ Ltd to provide a structural inspection report for the property at the above mentioned address.

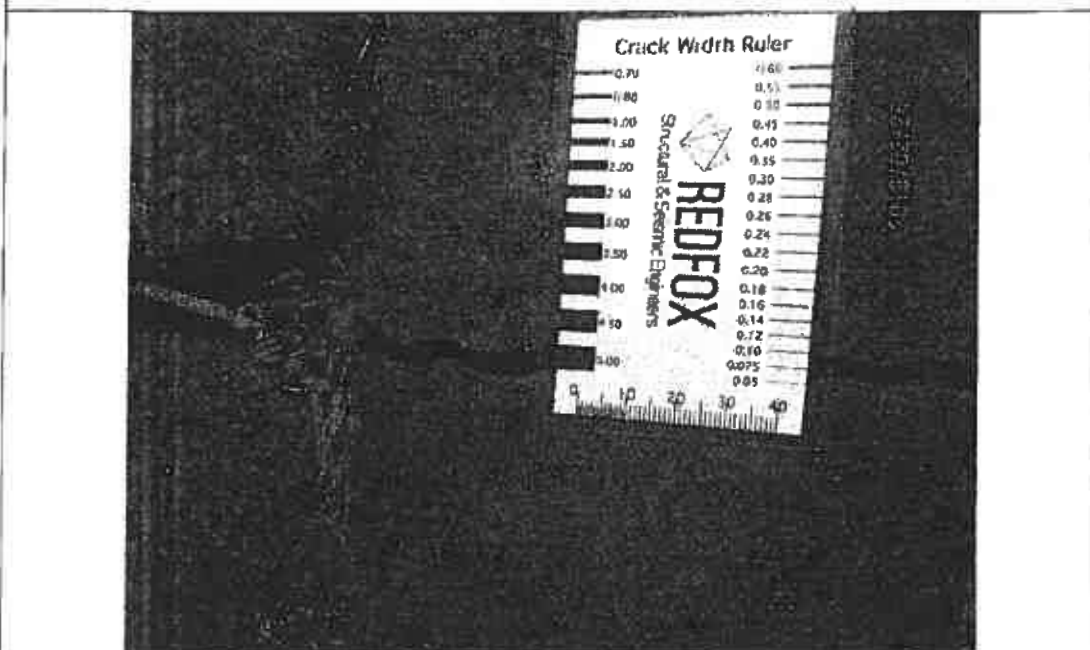
Crack in the driveway paving tiles

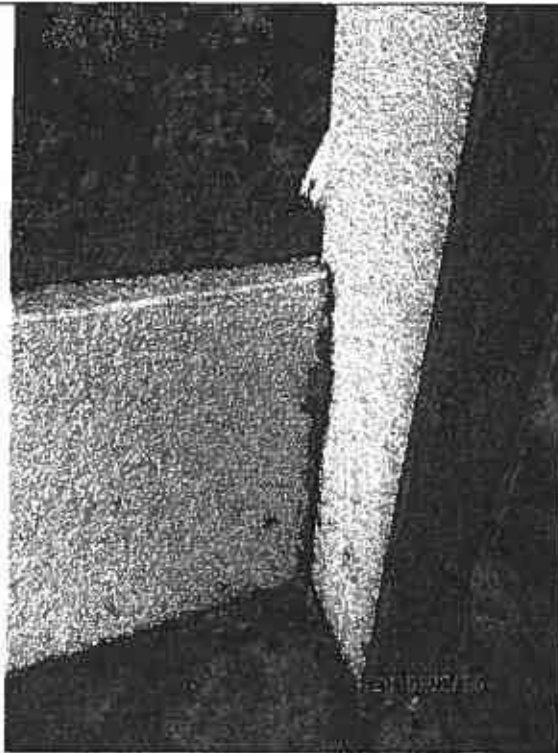
Foam infill in corner of retaining wall and garage

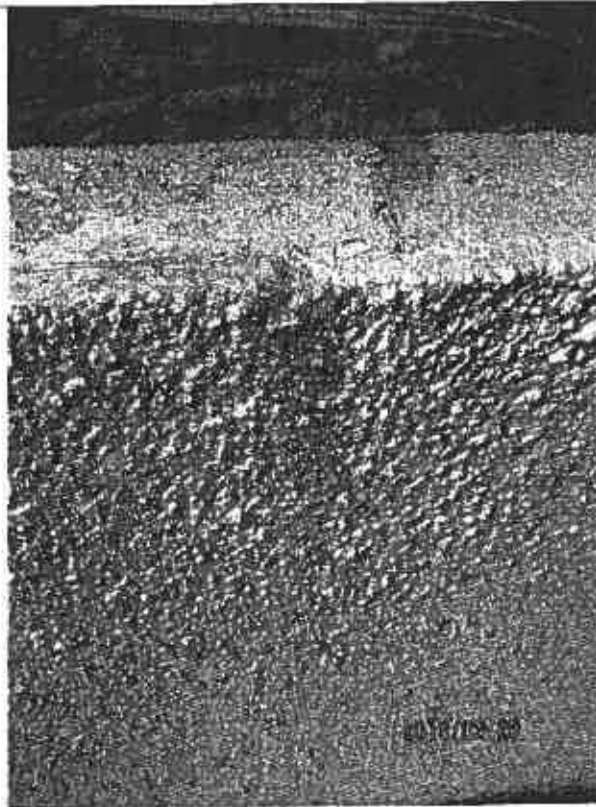
Typical repaired cracks in the front retaining wall

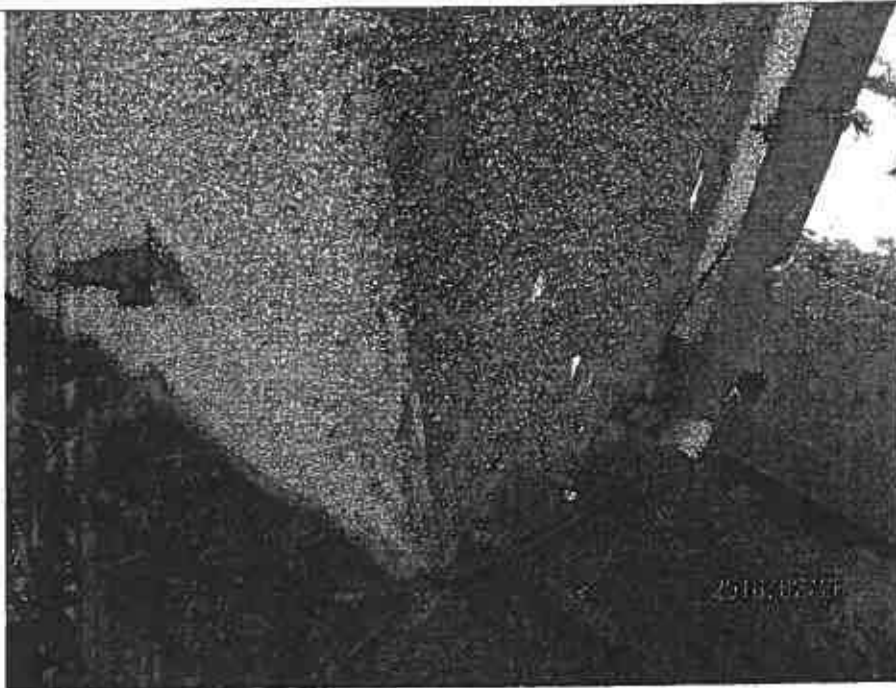
Spalling on plaster at SE corner of house

- The minor spalling of the plaster cladding on the south east corner of the house is to be repaired.
- The localised bowing of the plaster cladding on the north wall is to be removed and replastered.
- Cracking visible around the perimeter foundation plaster is to be replastered, if the cracks are found to penetrate into the foundation concrete then the foundation concrete is to be epoxy repaired.
- The internal doors that stick are to be eased.
- The minor cracks in the concrete floor slab are to be epoxy repaired.

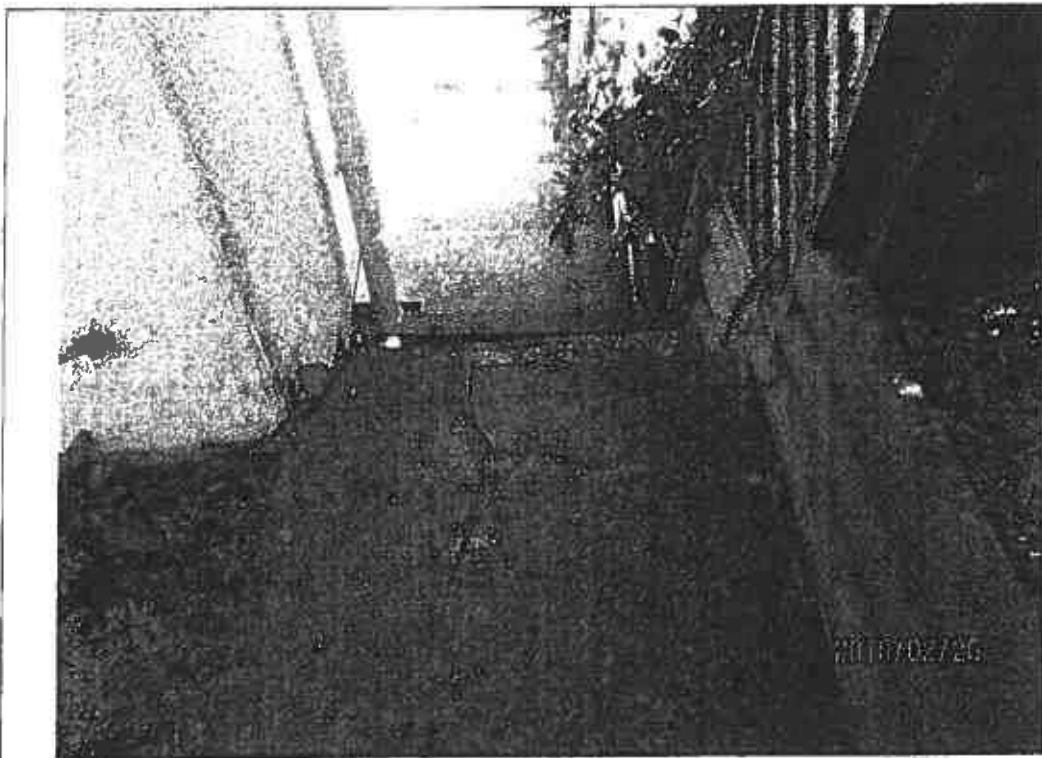
Cracks in the concrete paving

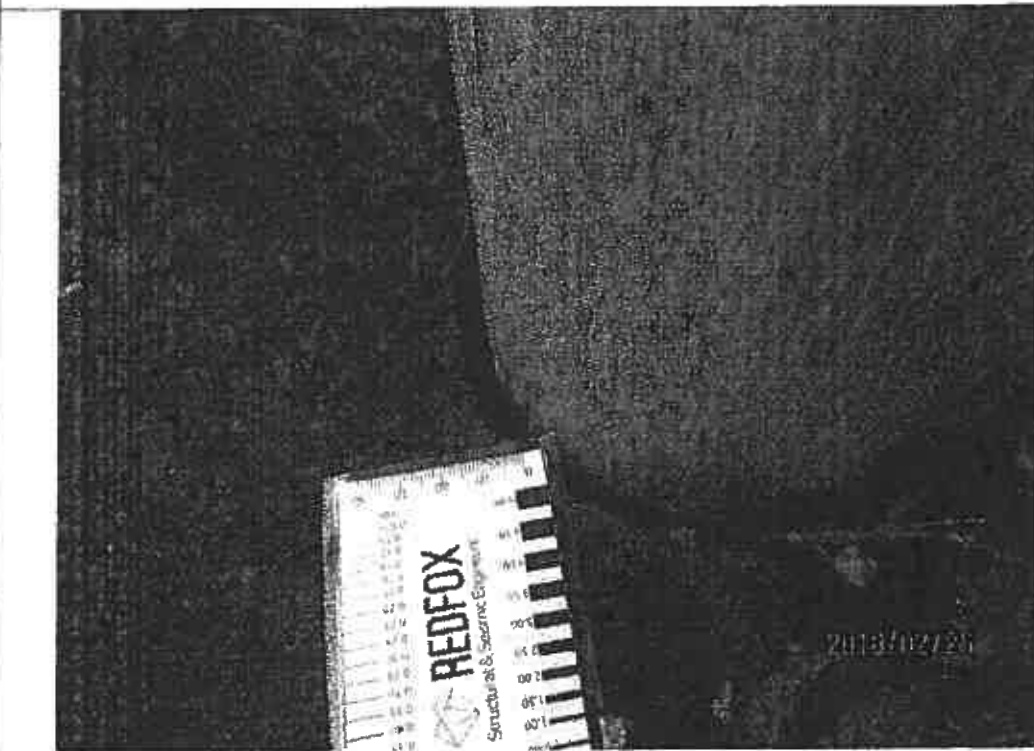
Separation between boundary timber post and concrete paving

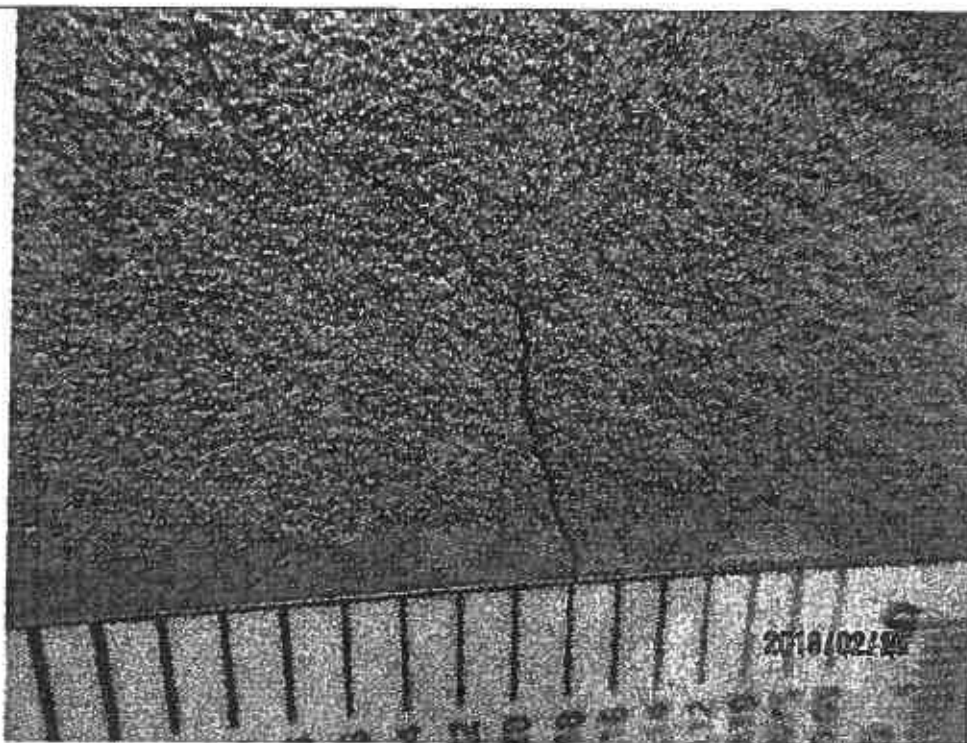
Minor crack in the foundation wall plaster on the east wall

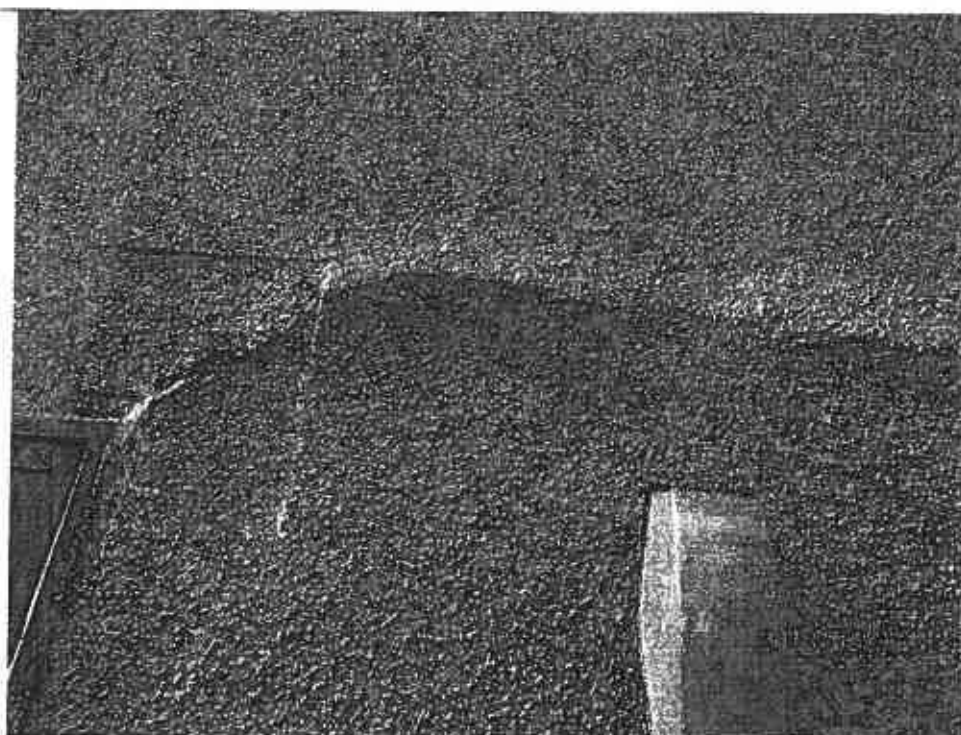
Localised bowing in plaster wall on north wall

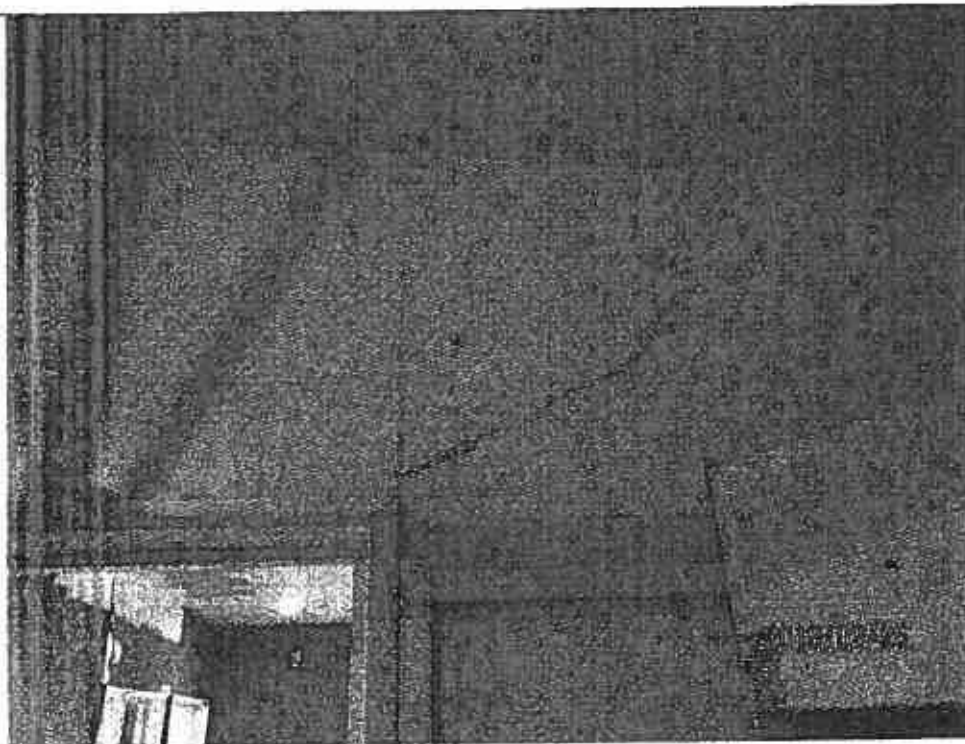
Typical Gib wall lining crack in garage above door

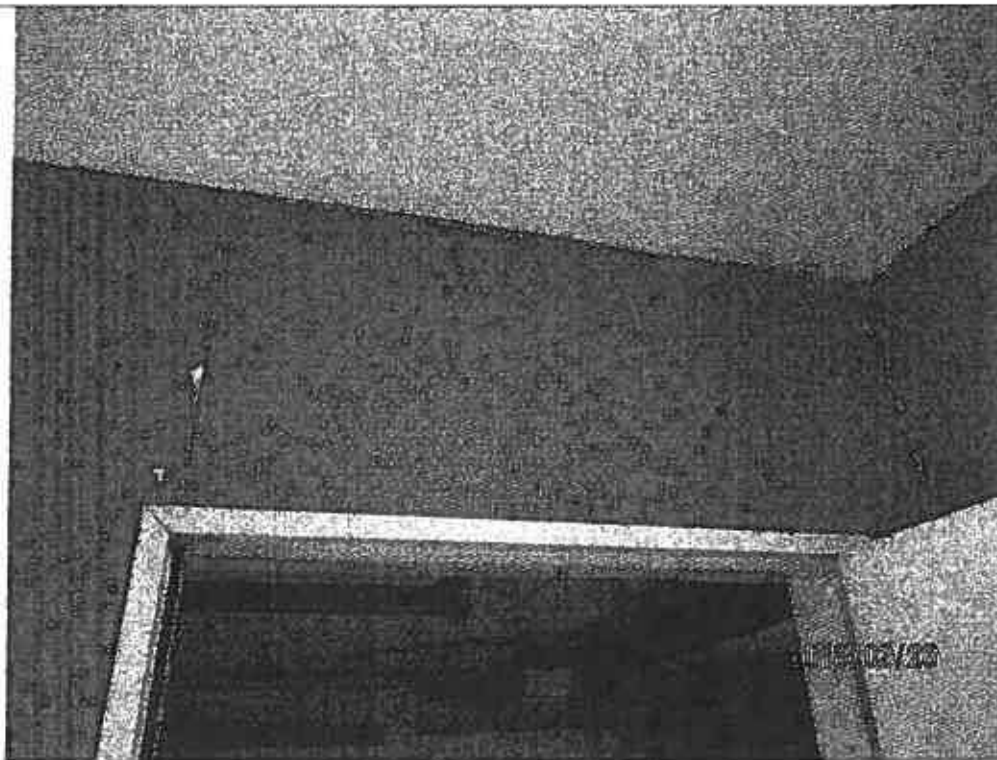
Typical Gib wall cracks in ground floor entry

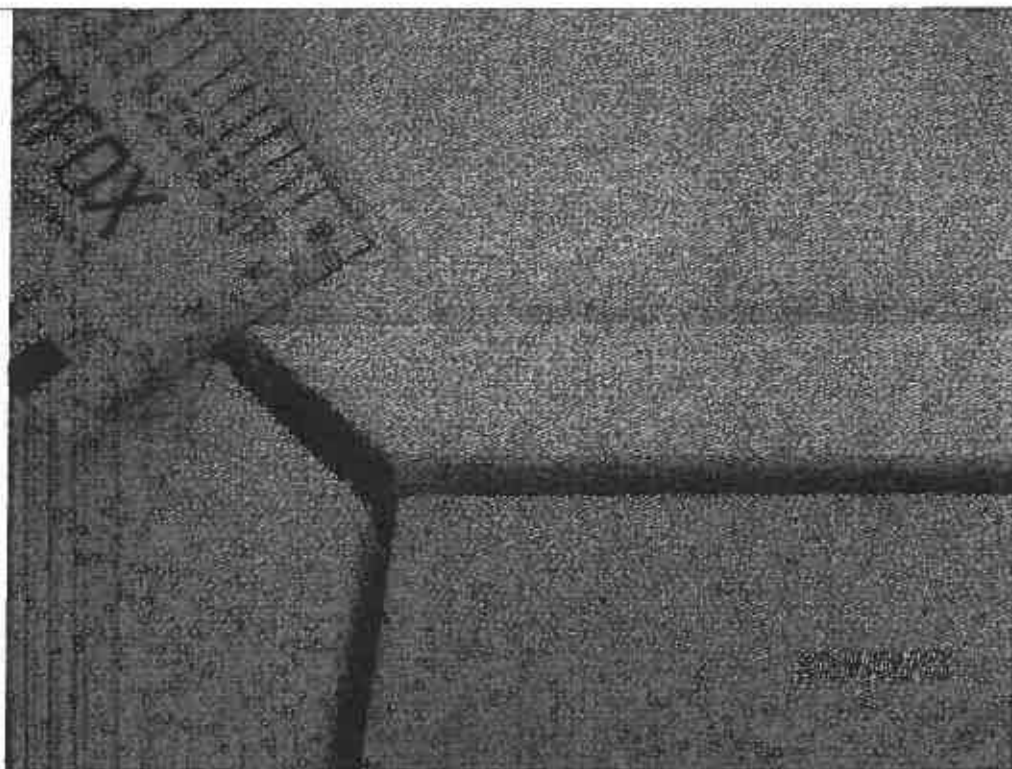
Major separation in timber door reveal in the entry

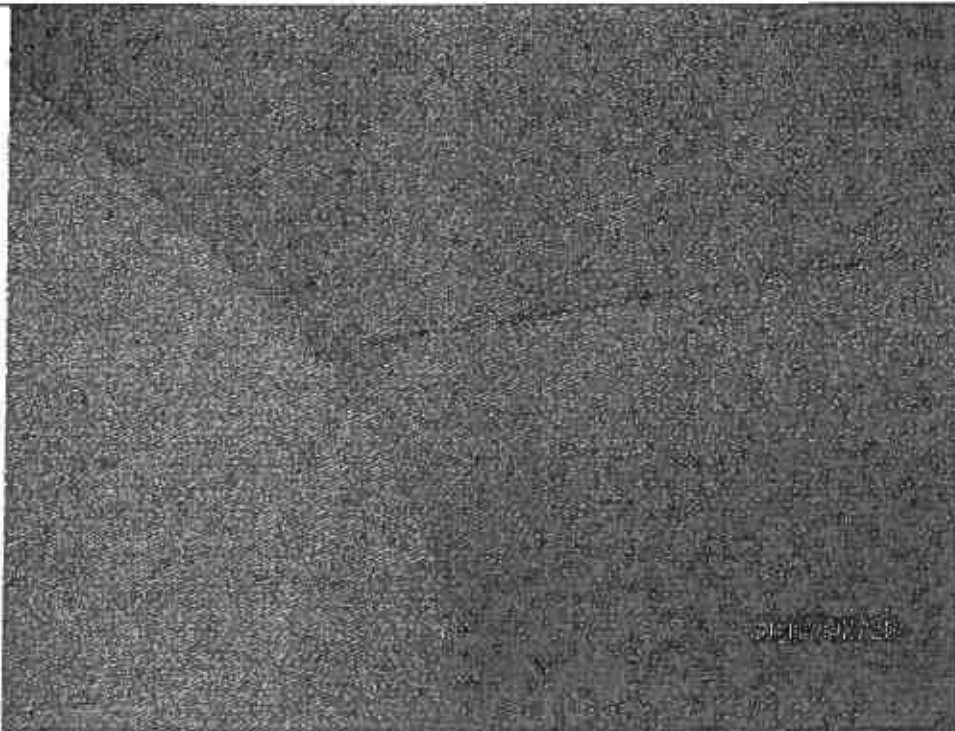
Minor Gib ceiling lining crack in lounge

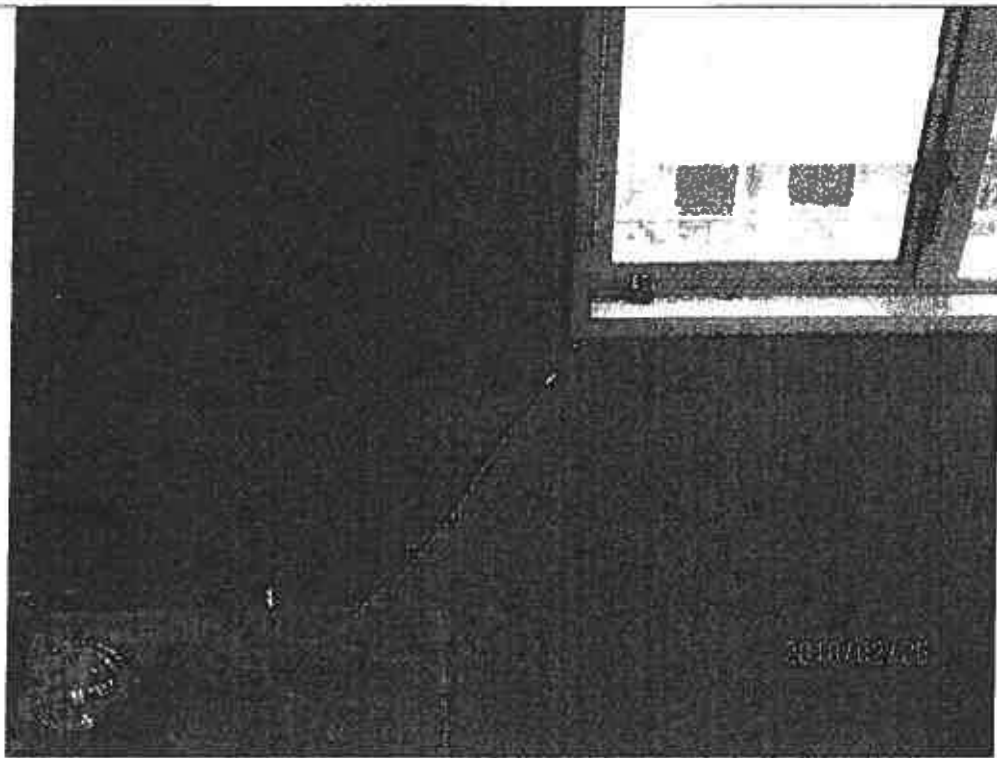
Significant Gib wall lining crack in lounge

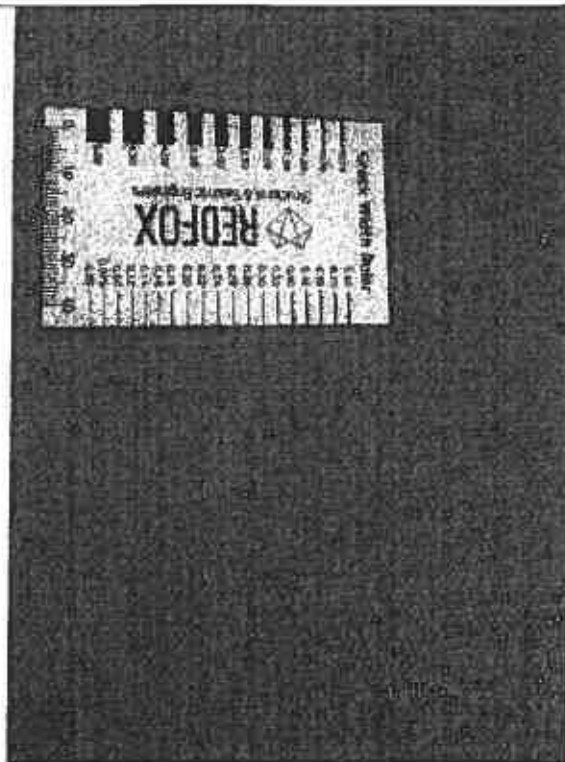
Minor concrete slab crack in garage floor

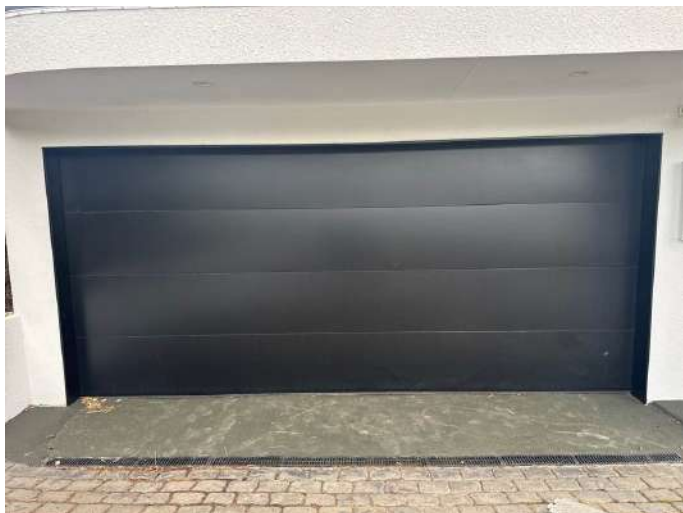
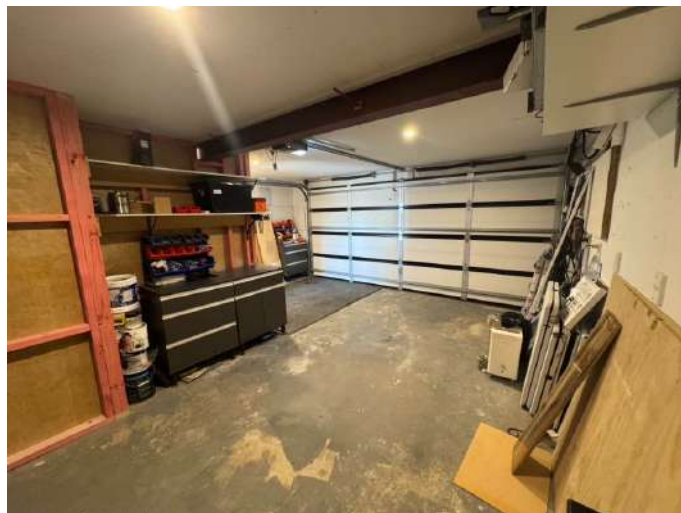
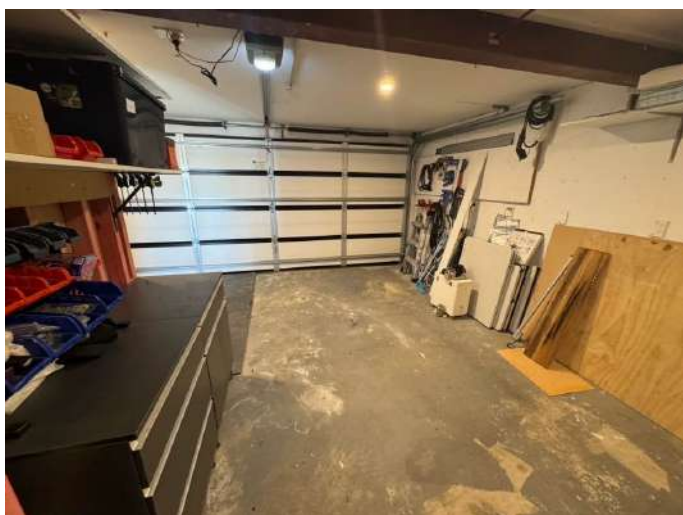
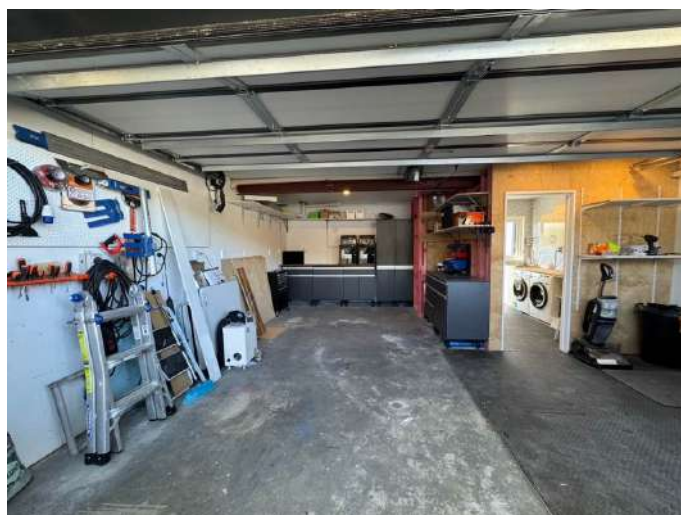
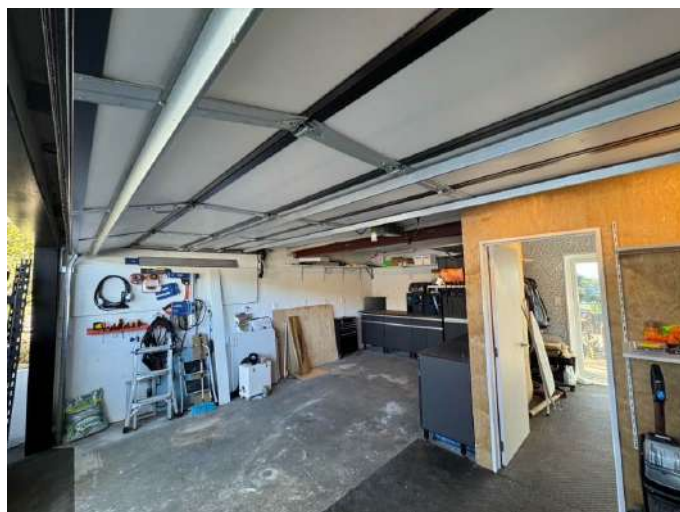
### Garage

| Comments | <p>The attached garage has internal access and is fitted with a two-car Colorsteel insulated sectional garage door. The door was operated at the time of inspection and is functioning smoothly. The concrete garage floor and exterior garage walls are in generally good condition, with no visible defects noted.</p> <p>No signs of moisture ingress, dampness, or structural issues were observed within the garage at the time of inspection.</p> <p>Risk: Low</p> |

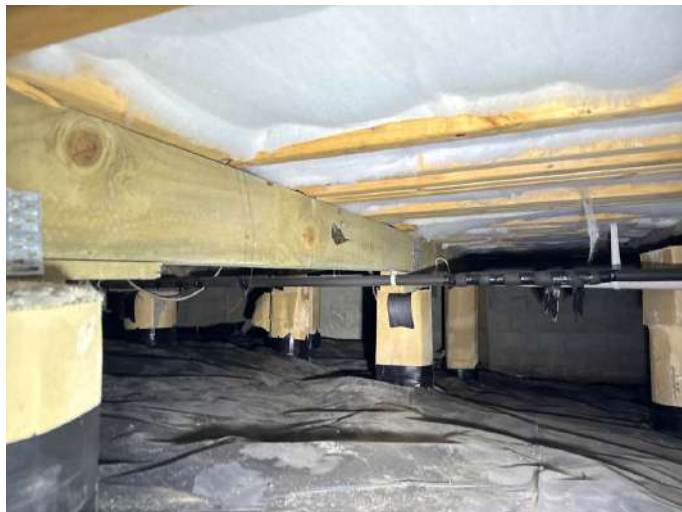
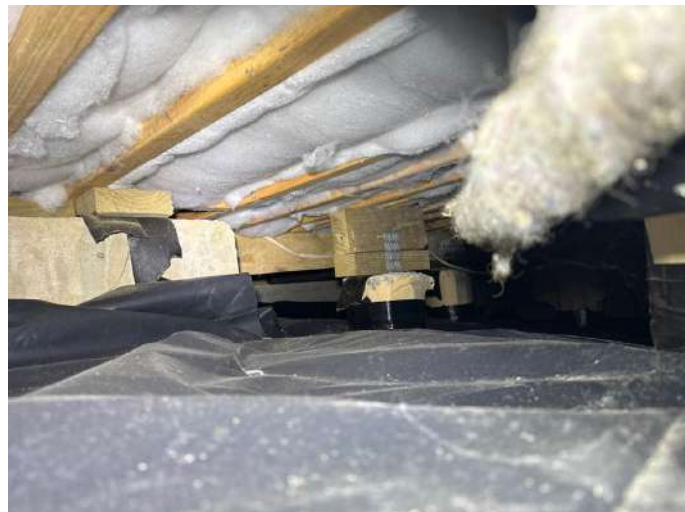
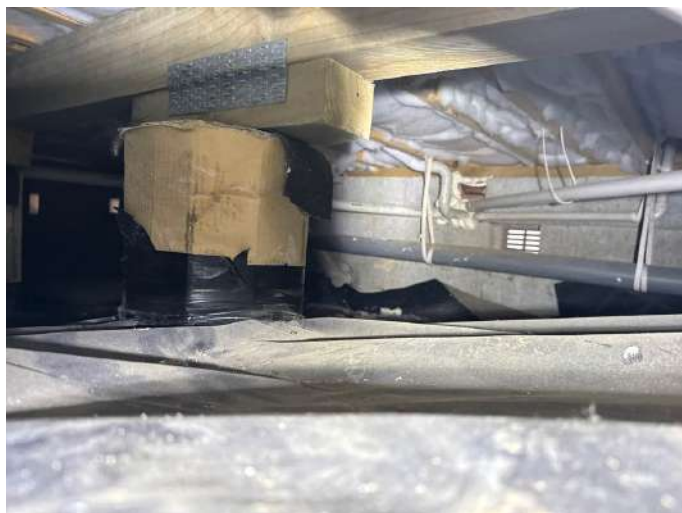
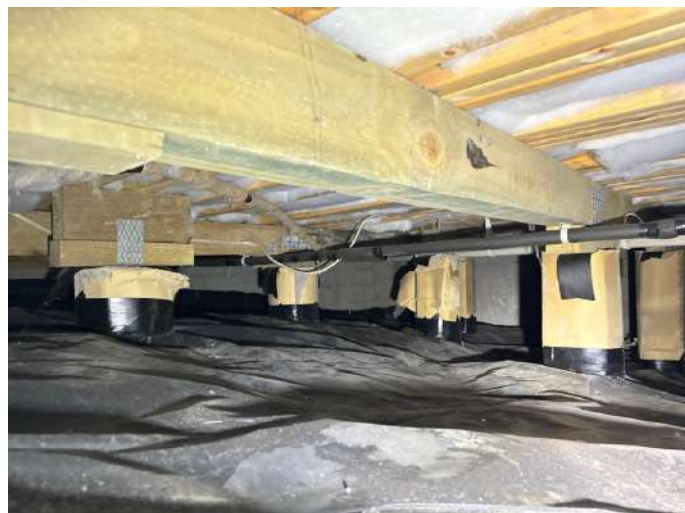
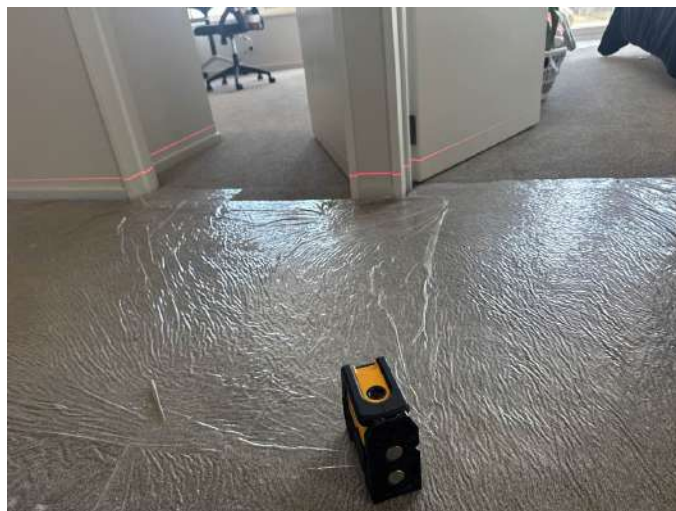
### Foundation

| Comments | <p>Foundation, Subfloor &amp; Floor Levels</p> <p>The dwelling is supported on concrete piles beneath a timber floor structure. The garage portion is constructed on a concrete foundation with a concrete slab floor. Underfloor observations indicate the area is in good, clean condition. All piles and associated timber floor framing appear stable, with no visible signs of deterioration, damage, or dampness noted at the time of inspection.</p> <p>All visible plumbing within the underfloor area appears secure and stable, with no leaks or defects observed. Floor levels were checked using a DeWalt cross-line laser level. Measurements indicate floor level variations are within 15 mm overall, with no slopes exceeding 10 mm over a 2 m span. These results fall within acceptable MBIE tolerance guidelines, and the foundation is considered stable.</p> <p>Risk: Low</p> |

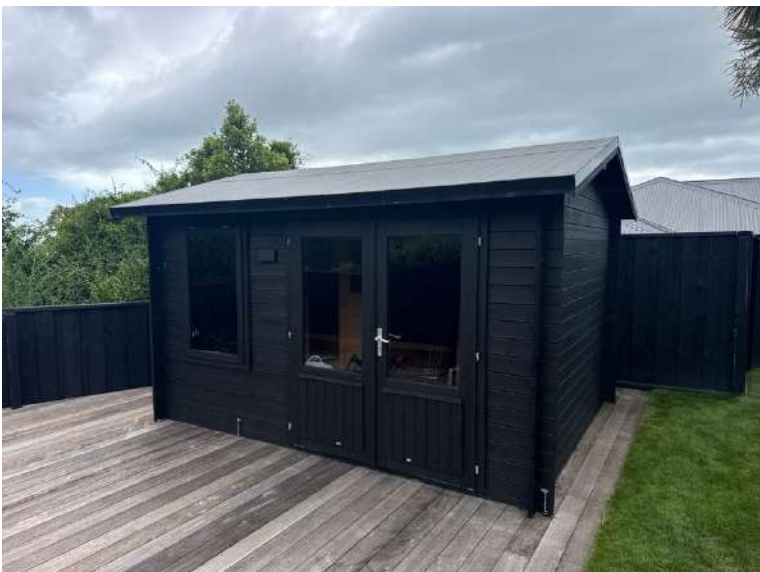
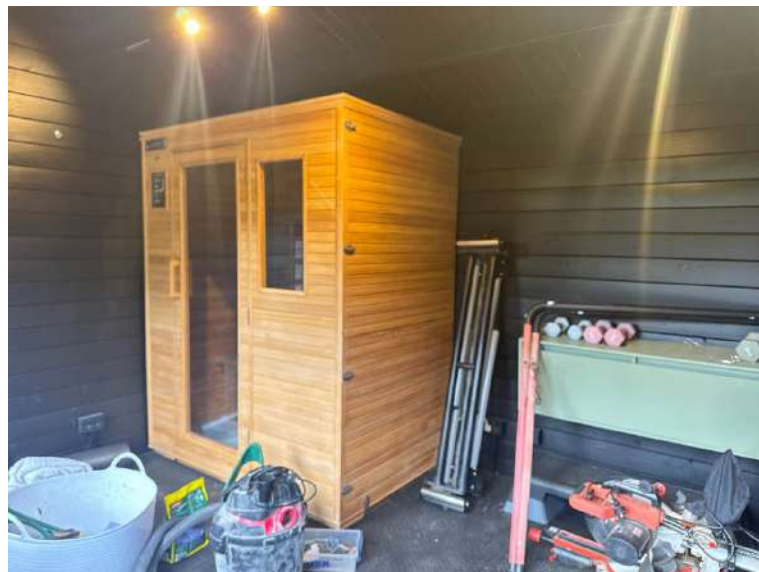
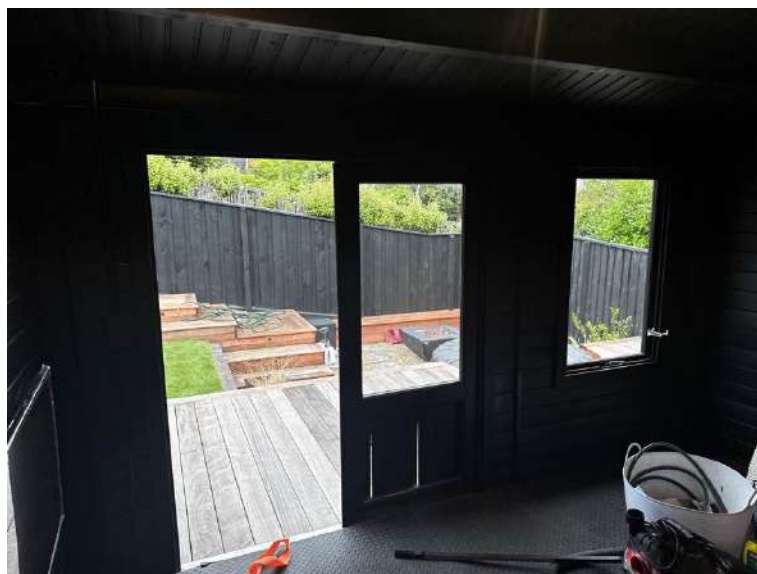
### Sheds/Sleepout

| Comments | <p>Outbuildings – Timber Shed</p> <p>The timber shed structure is in very tidy, well-maintained condition and is currently being used as a sauna/yoga room. The structure appears sound, with no visible defects or areas of concern noted at the time of inspection. The roof is finished with a butynol membrane surface, which appears to be in good condition, showing no signs of deterioration, splitting, or failure.</p> <p>No visible issues were observed with this structure, and it appears to be fully functional. Power is connected and in use.</p> <p>Risk: Low</p> |

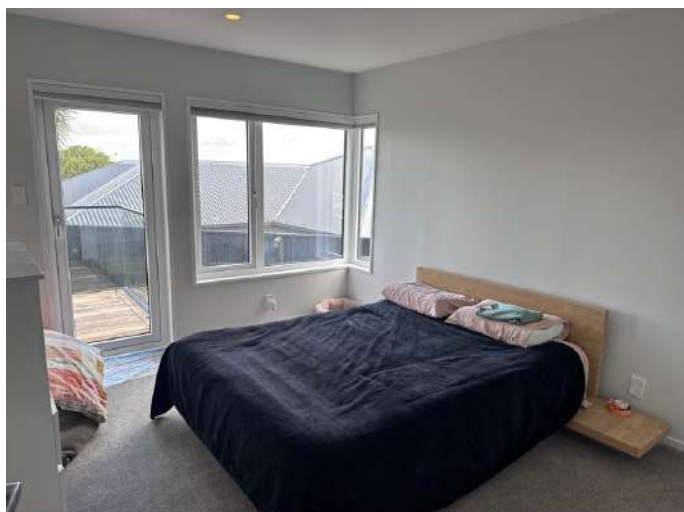
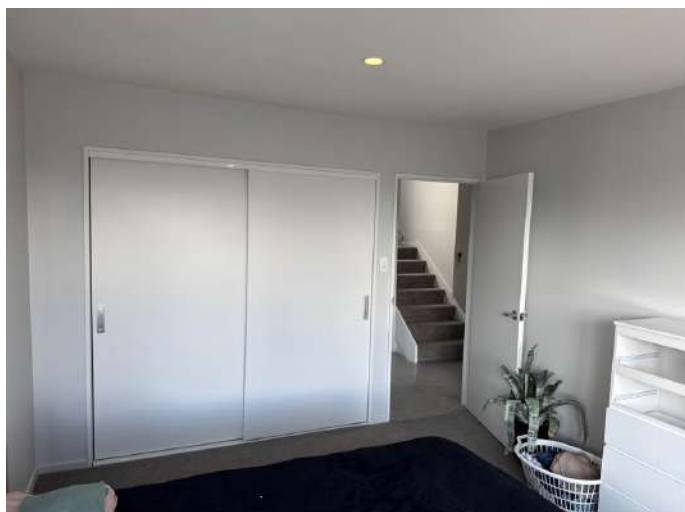
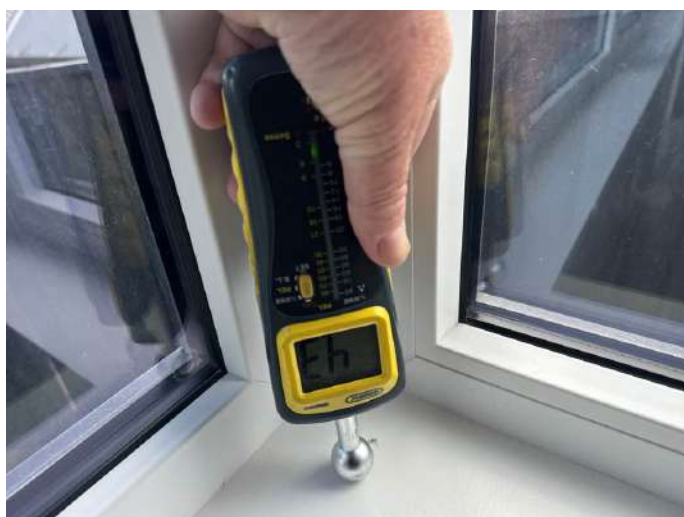
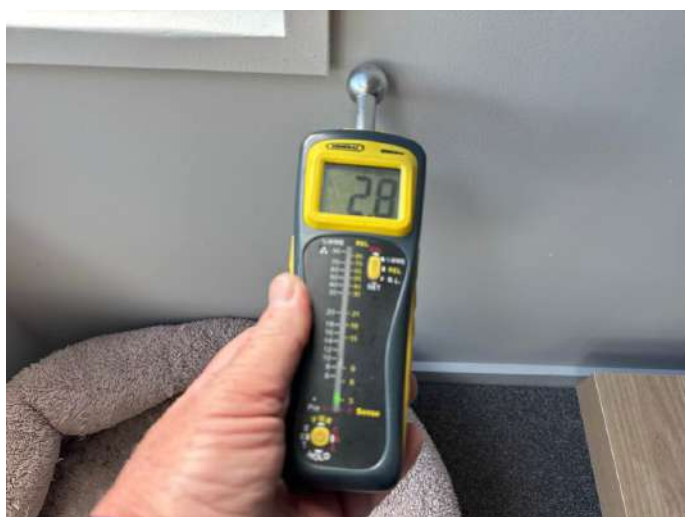
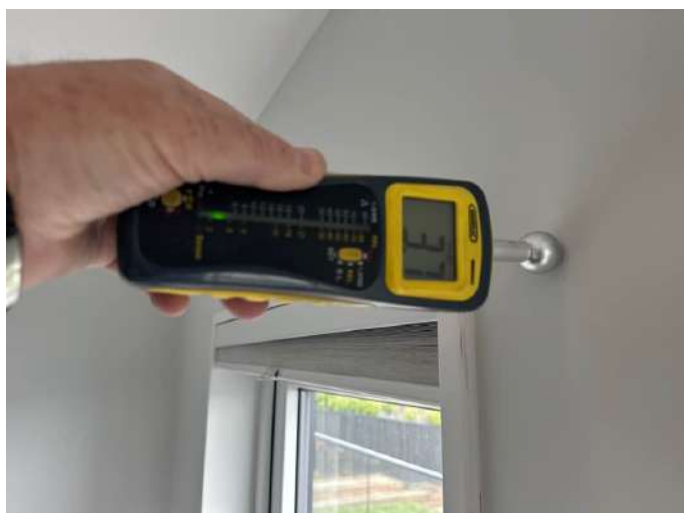
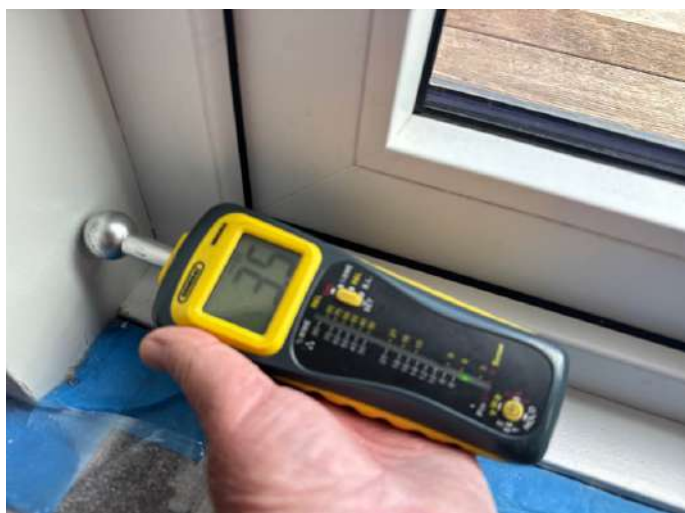
**Master Bedroom**

| Comments | <p>The master bedroom is in good condition overall. Walls, ceiling, and floor finishes present well, with no visible defects or areas of concern noted at the time of inspection. Windows and doors were checked and appear to open and close properly.</p> <p>Moisture testing was carried out in typical risk areas, with readings below 15; the green light indicates dry conditions. No moisture-related issues were detected.</p> <p>Risk: Low</p> |

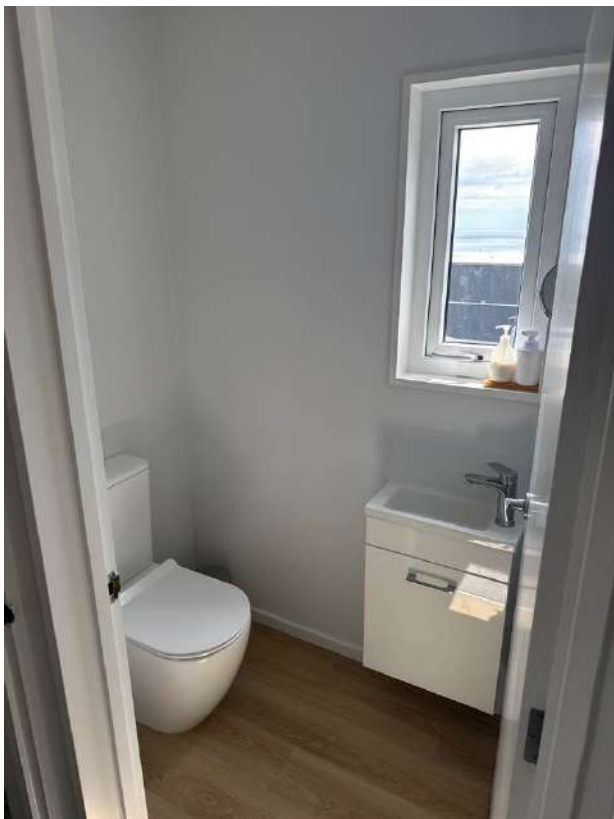
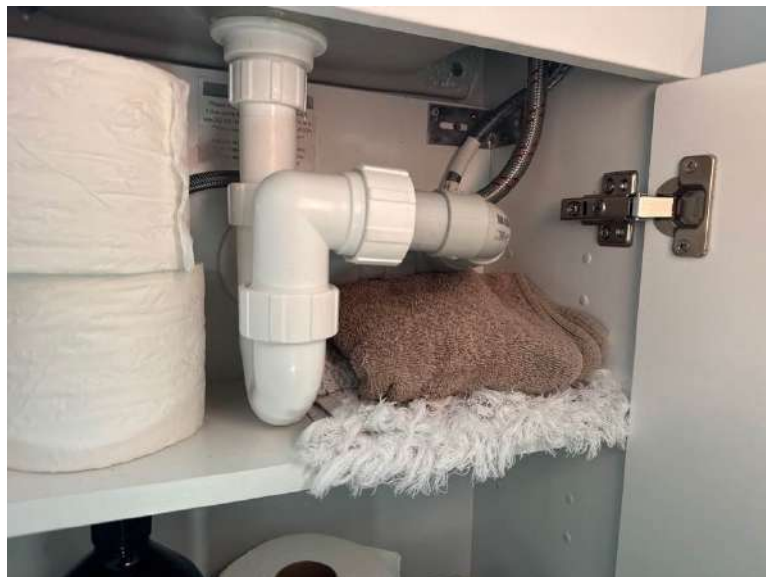
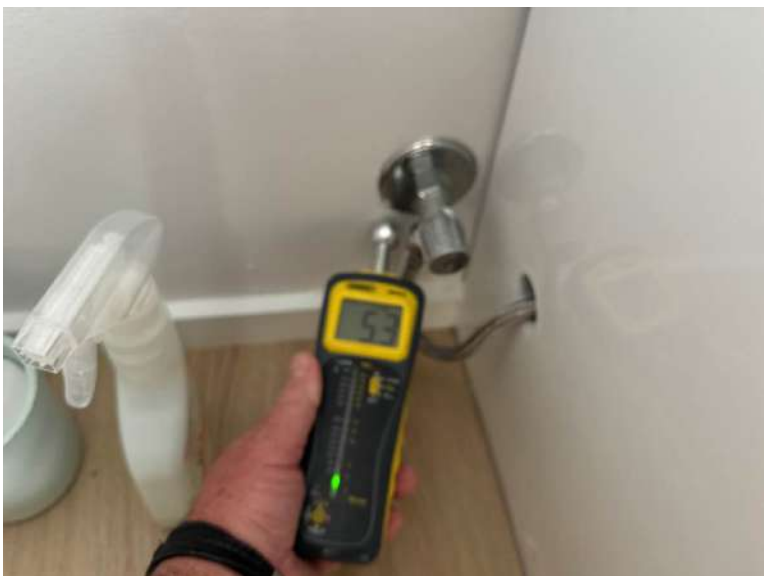
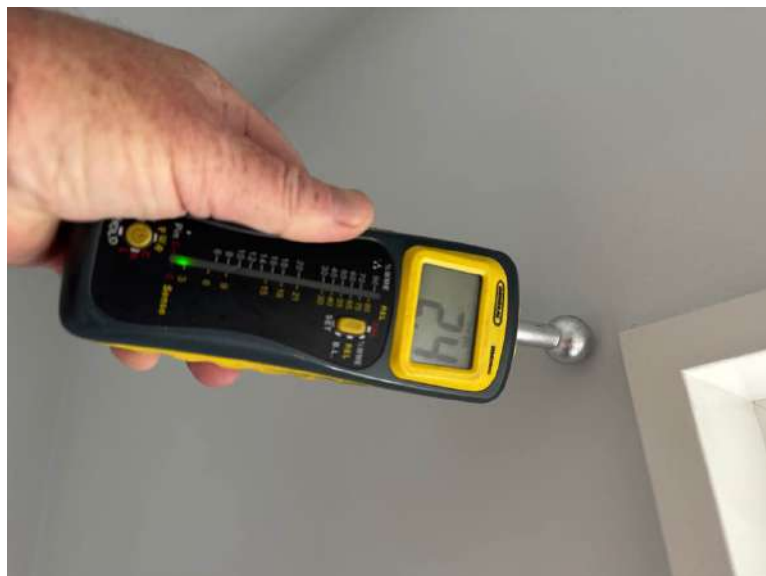
**Toilets**

| Comments | <p>The upstairs toilet, including the small hand basin, is in good condition. Tapware is in good working order and functioning as intended. No leaks were detected beneath the basin or associated plumbing at the time of inspection.</p> <p>Moisture testing was carried out in typical risk areas, with readings below 15; the green light indicates dry conditions. No moisture-related issues were detected.</p> |

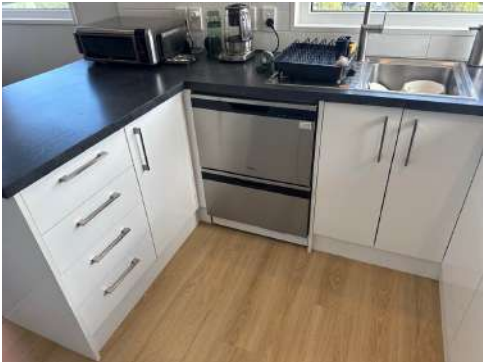
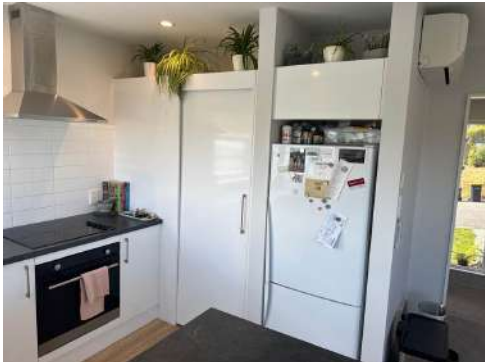
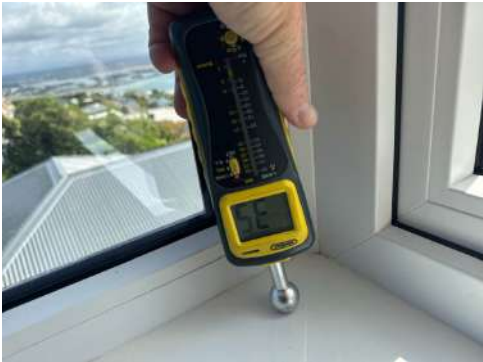
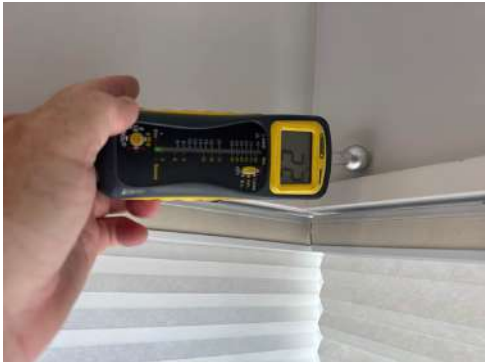
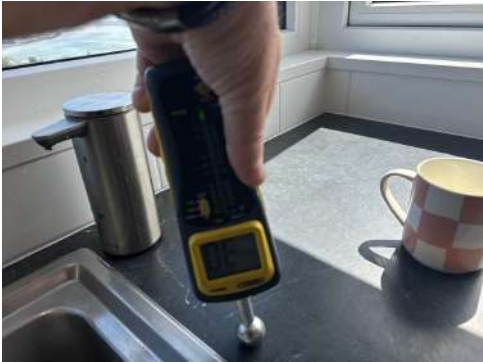
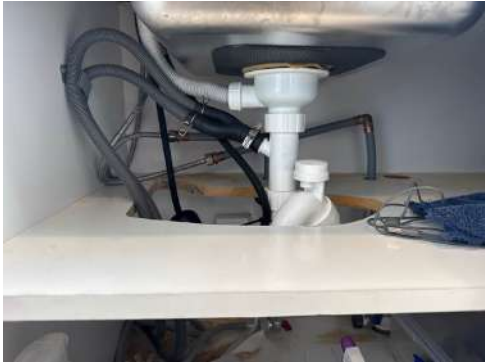
Kitchen

| Comments | <p>The kitchen is in excellent condition overall. Cabinetry, benchtops, and wall and ceiling surfaces present very well, with no visible defects noted at the time of inspection. All doors and drawers appear to be functioning as intended. Plumbing fixtures and tapware were checked and are in good working order, with no leaks observed beneath the sink.</p> <p>Moisture testing was carried out in typical risk areas, with readings below 15; the green light indicates dry conditions. No moisture-related issues were detected.</p> <p>Risk: Low</p> |

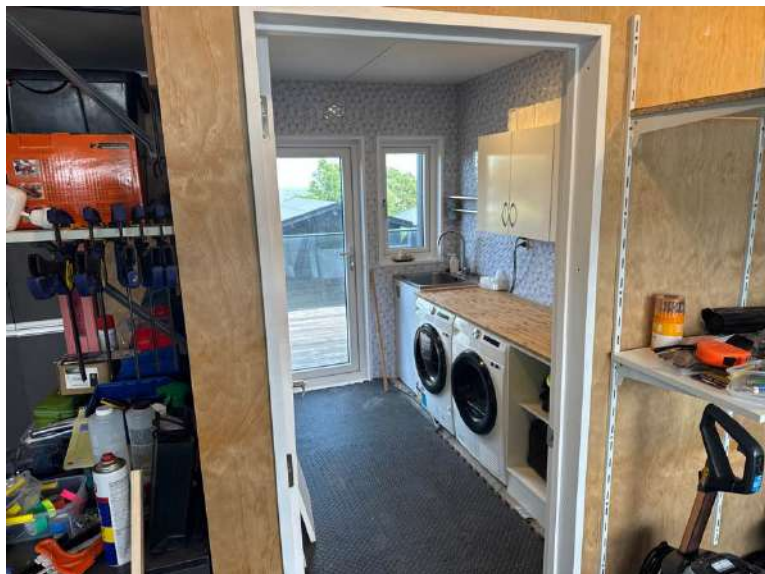
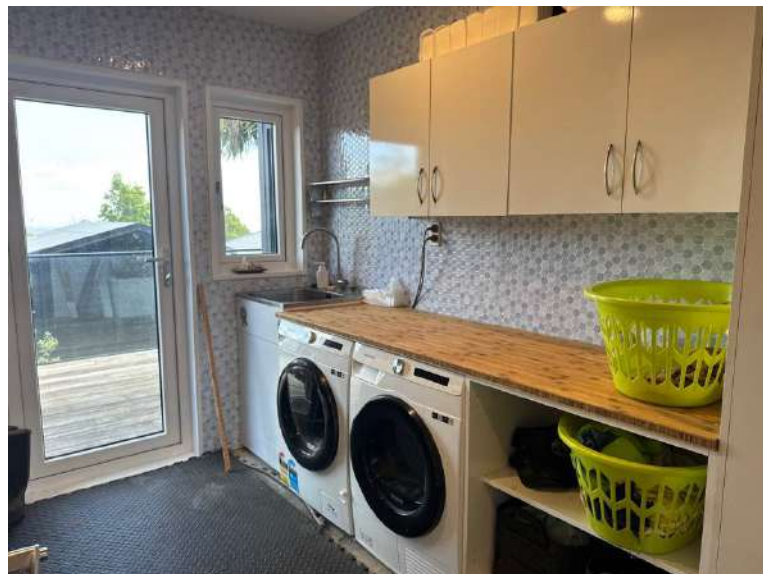
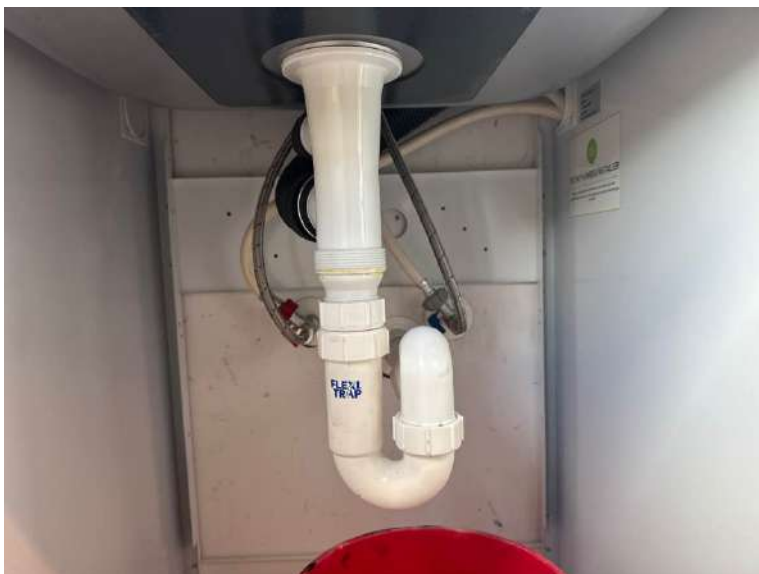
Laundry

| Comments | <p>The laundry is located off the garage and is in good condition overall. Cabinetry and benchtop surfaces are in good order and appear fully functional, with no visible defects noted at the time of inspection. A Colorsteel laundry tub is installed; tapware is functioning properly, and no leaks were observed at the sink or associated plumbing at the time of inspection. No visible water damage was noted in this area.</p> <p>The door providing access to the timber deck was operated and is functioning properly. Moisture testing was carried out in typical risk areas, with readings below 15; the green light indicates dry conditions. No moisture-related issues were detected.</p> <p>Risk: Low</p> |
