# 5b Madeley Place, Mount Pleasant.

## **Structural Assessment & Building Report Property File Document Summary**

## **5b Madeley Road, Mount Pleasant, Christchurch**

RedFox Structural and Seismic Engineers have been engaged by Blackmilk Interiors NZ Ltd to provide a structural inspection report for the property at the above mentioned address.

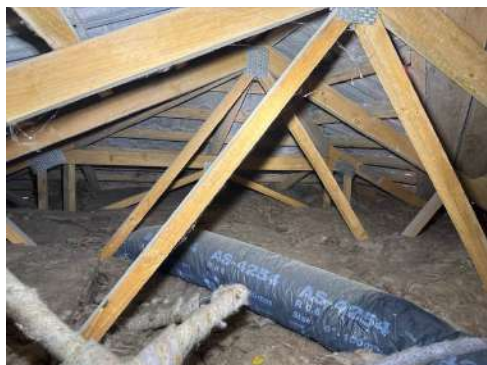
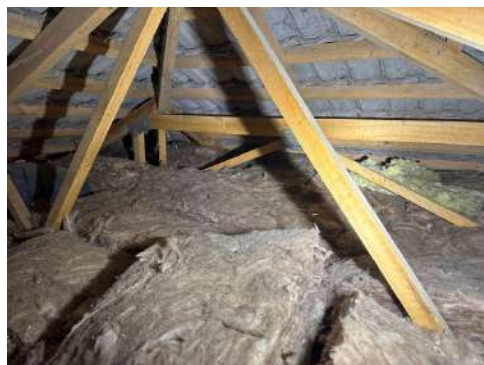
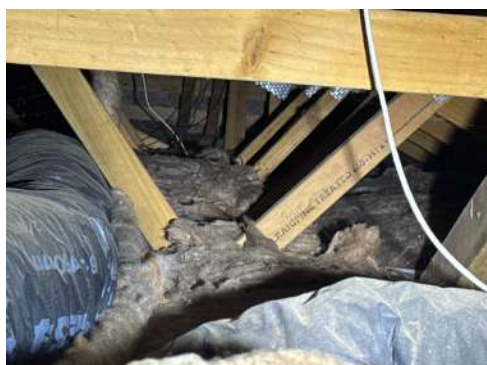
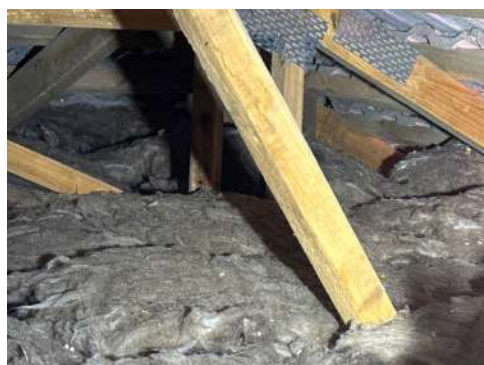
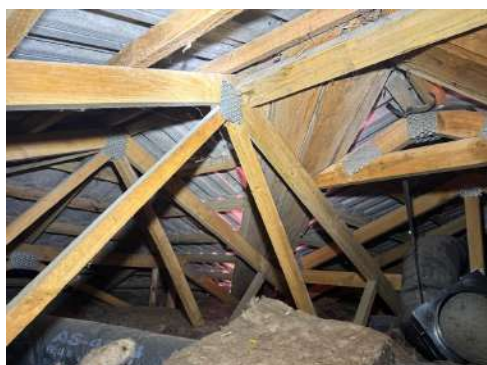
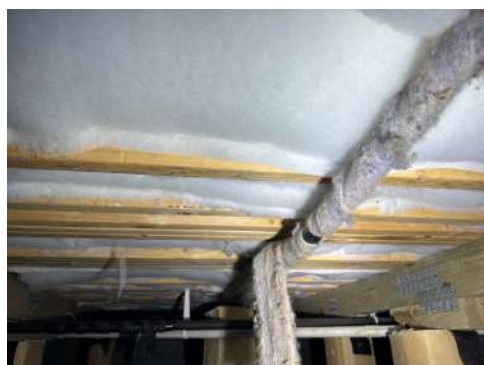
### Insulation

| Comments | <p>Earthwool ceiling insulation batts were observed installed within the roof space. The insulation is in good condition, providing good coverage and effective thermal protection at the time of inspection. No signs of displacement, damage, or deterioration were noted. The roof framing structure observed appears stable, with no issues identified. No other concerns were observed throughout the accessible roof space.</p> <p>Polyester underfloor insulation is installed beneath the timber floor and appears to be in good condition and correctly installed. A ground moisture barrier is also in place, correctly installed, and in good condition. The underfloor area appeared dry and clean at the time of inspection.</p> <p>Risk: Low</p> |
