BUILDING INSPECTION REPORT

RED LBP PRE-PURCHASE REPORT

Property Address	19 Tirangi Street, Hei Hei, Christchurch 8042
Client	[REDACTED]
Date of Inspection	2nd February 2026
Time	8:30 am
Inspector	Jamie Chapman National Certificate in Carpentry
LBP Number	BP137228
People Present	Owner
House Occupied	Yes

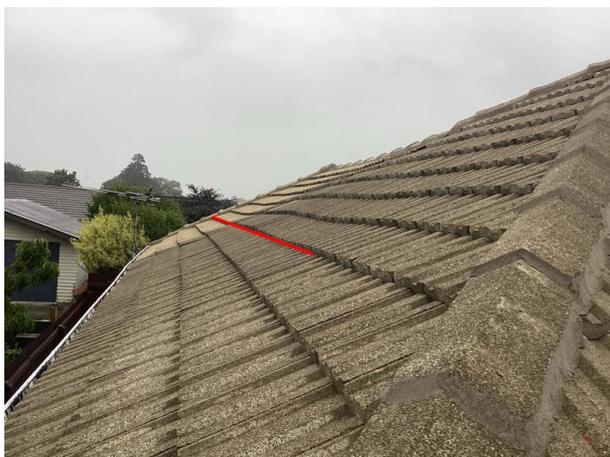
Photo 4

A couple areas of deflections were noticed along the roof. Mainly on the east side of the dwelling.

Deflections in a masonry tiled roof can be caused by various factors. Addressing deflections in a masonry tiled roof is essential to ensure its long-term stability and prevent potential damages. Regular inspections and proactive maintenance are key to identifying and addressing issues early, helping to extend the life of the roof system. The roof may benefit from extra timber bracing being installed to help straighten and support some areas. A licensed builder can advise further on this.

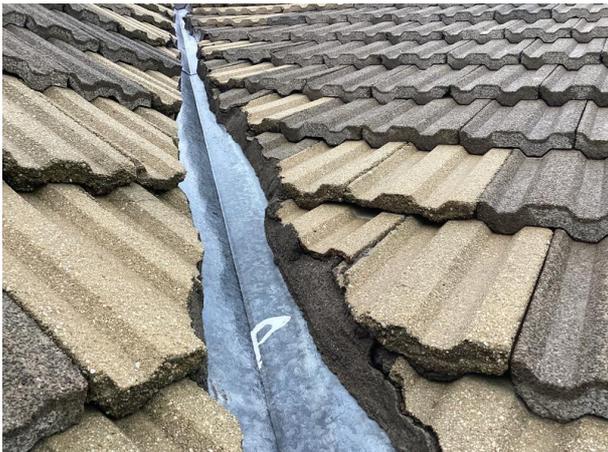
Photo 5

The valley tiles have been cut relatively short and mortar filled between the metal valley and tile system.

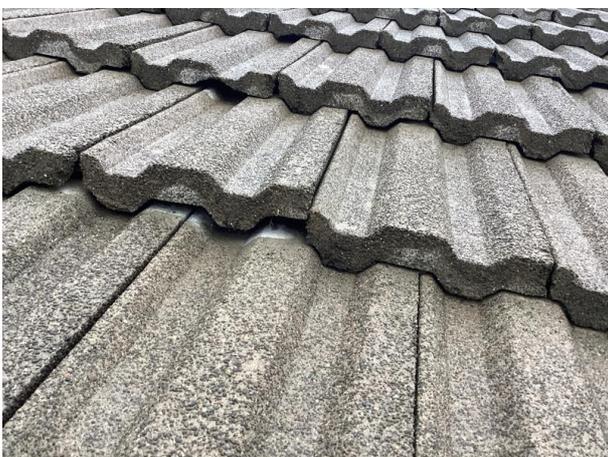
Photo 6

Tile alignment - Slipped tiles observed.

Some tiles on the east side were slightly out of alignment. Recommend adjusting these back into place.

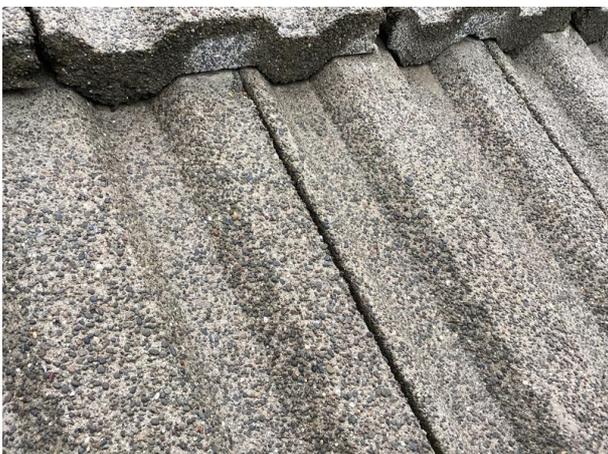
Photo 7

Condition of surface - Deterioration of the surface coating.

Close-up view on the condition of the masonry tiles. Note the rough surface. See the next photo.

The masonry tiled roof system is in a condition expected for age however, due to its age, surface deterioration has occurred over time on the masonry tiles. It is recommended to have a licensed roofer specialized in masonry tiles advised further on maintenance and repairs.

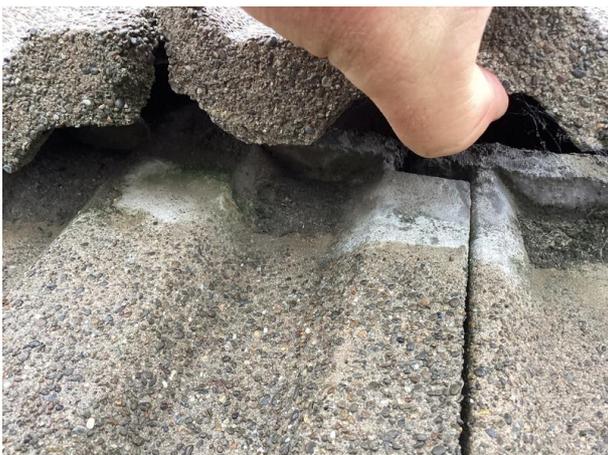
Photo 8

When lifting up the masonry tiled lap, that exposes a smooth surface underneath. This was the original condition of the tiles.

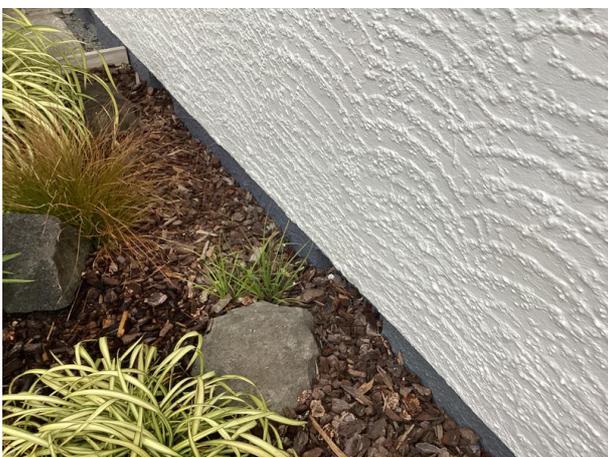
Photo 22
Some ventilation holes were partially blocked due to raised garden beds.

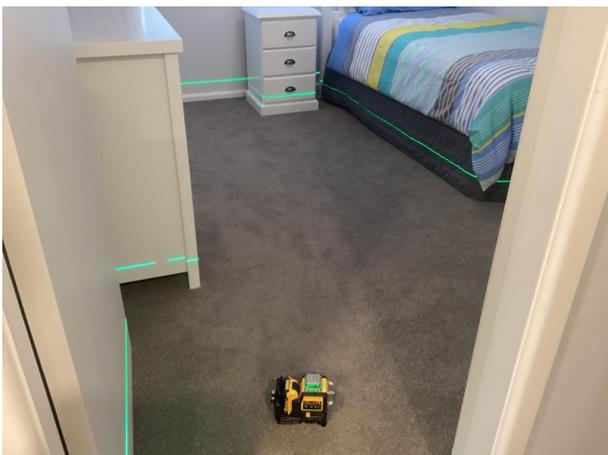
Photo 24

No significant deviations identified during the inspection. The approximate overall floor level difference was 25 mm.

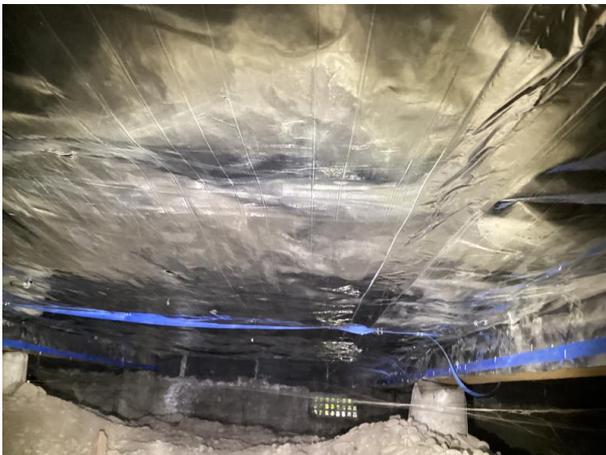
Photo 28
Silver foil insulation was visible in the subfloor. In a relatively tidy condition.

A ban has been declared on the installation and/or repair of foil insulation in residential buildings with existing electrical installations. This ban is due to safety concerns associated with the method of attaching the foil to the building. It relates to Building Code Clause G9 Electricity. This ban is declared from 1 July 2016.

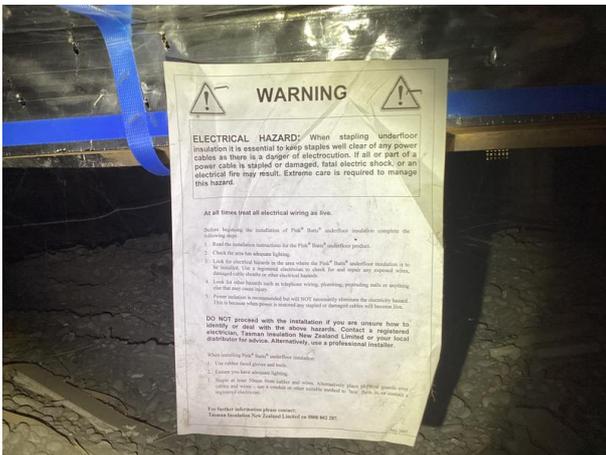
Photo 29
Due to the silver foil insulation being in the subfloor there is a warning electrical hazard sign.

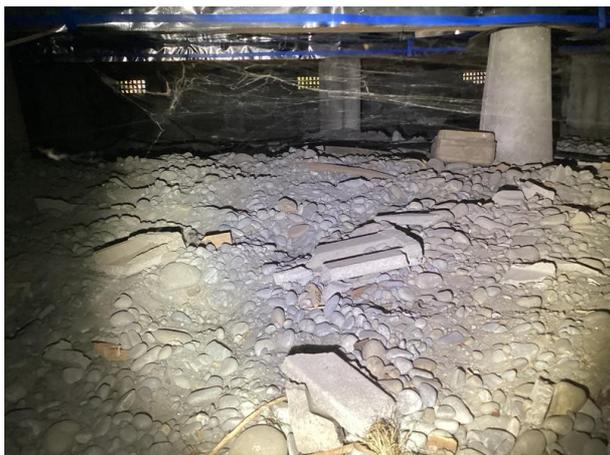
Photo 30
Future maintenance could include installing a ground moisture barrier in the subfloor.

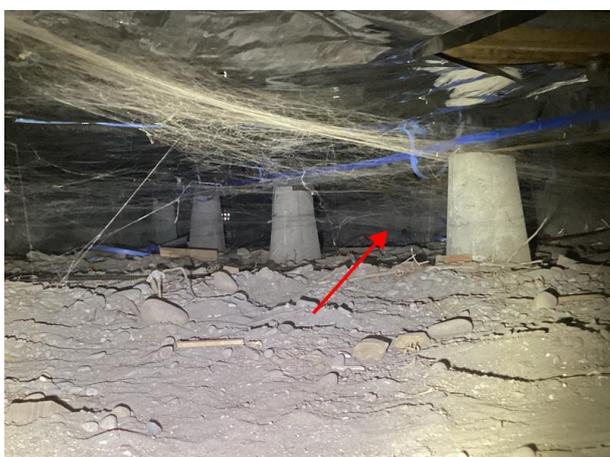
Photo 31
Under the extended section of the dwelling was not visible due to the original ringing foundation blocking access and visibility.

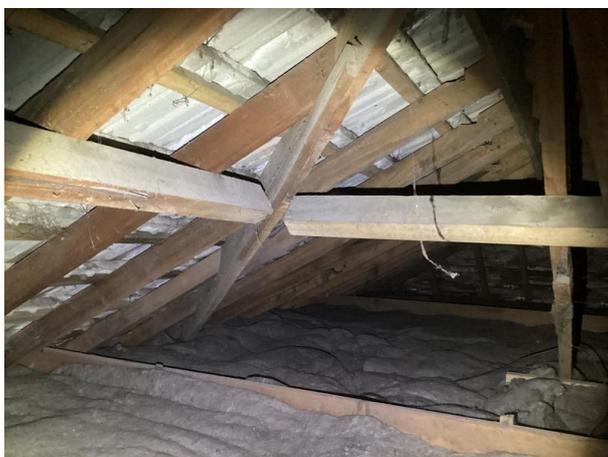
Photo 33
Photo of where the main deflection was noticed on the roof. This is where the extended section of the dwelling starts on the south side.

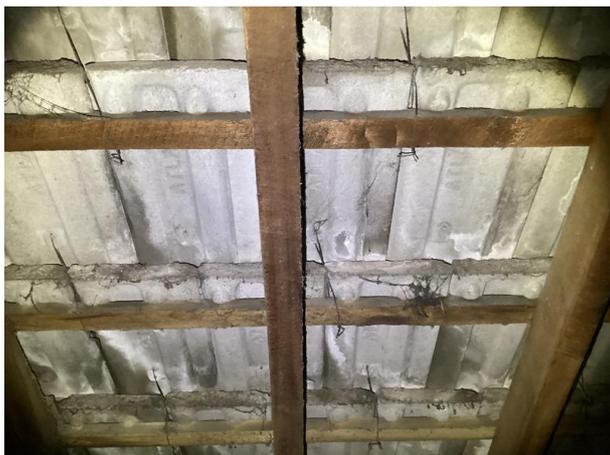
Photo 35

Efflorescence refers to the crusty white deposits of mineral salts that form on the surface of masonry materials such as concrete, render, brick, or mortar. This phenomenon occurs when moisture travels through the substrate, dissolving soluble salts within the material. As the moisture evaporates at the surface, it leaves behind these salt deposits. Efflorescence is a common issue and often serves as an indicator of moisture movement within the masonry.

Signs of efflorescence were noticed on the underside of the masonry tiles. Refer to the roof system section of this report to view the condition of the roof.

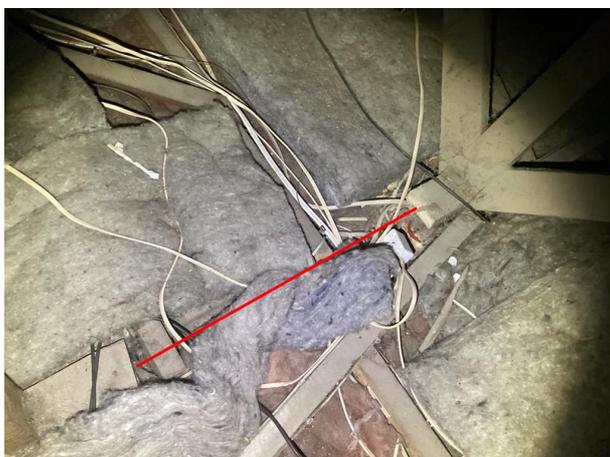
Photo 36

It appears a timber has been cut in the roof space possibly to allow for electrical wires. This cut timber is what the roof space bracing attaches to.

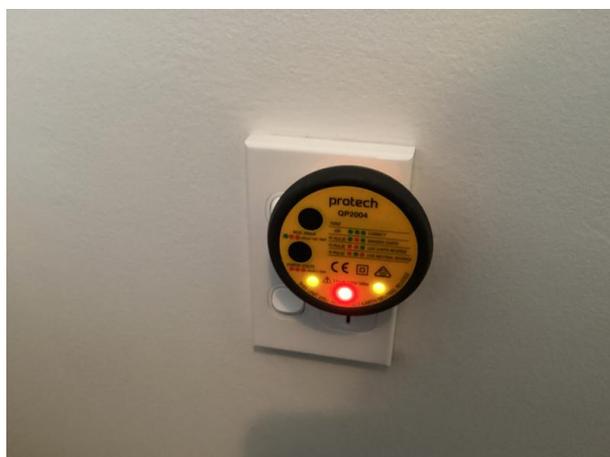
Photo 60

A plug in bedroom two indicated the Earth is missing. Recommend having a registered electrician to advise further.

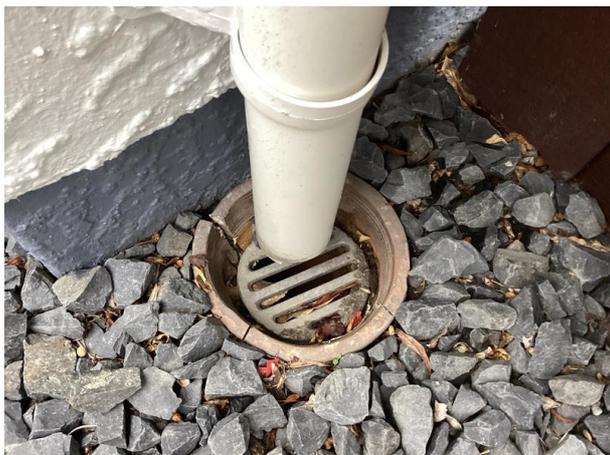
Photo 61

Cracking in the south/West stormwater riser was visible.

Earthenware drains were noted at the property. These are prone to tree root blockage. It is recommend that these drains be CCTV inspected and cleared if required.
