# Independent Builders Report

Total Home Inspection Services Porirua City Ltd

Tue 24 Feb 2026

**87 The Esplanade, Raumati South, Paraparaumu, 5032,  
New Zealand**

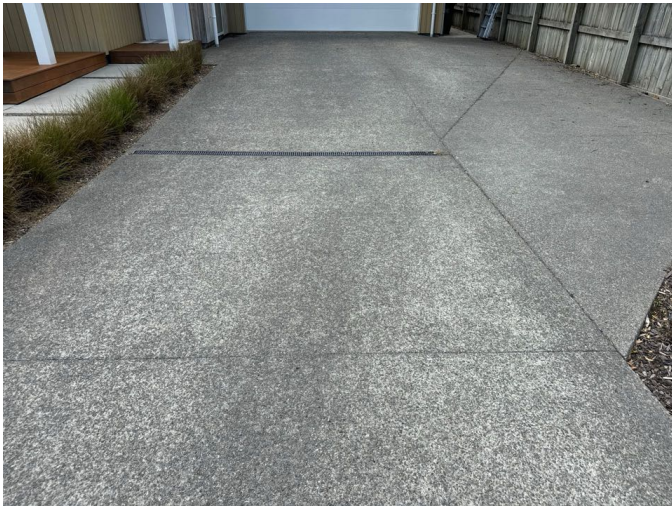
The driveway is well formed and in good condition

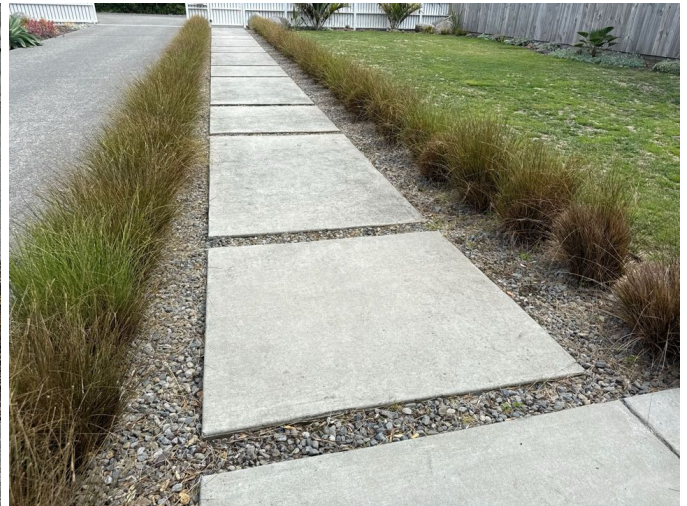
The paths are in good condition

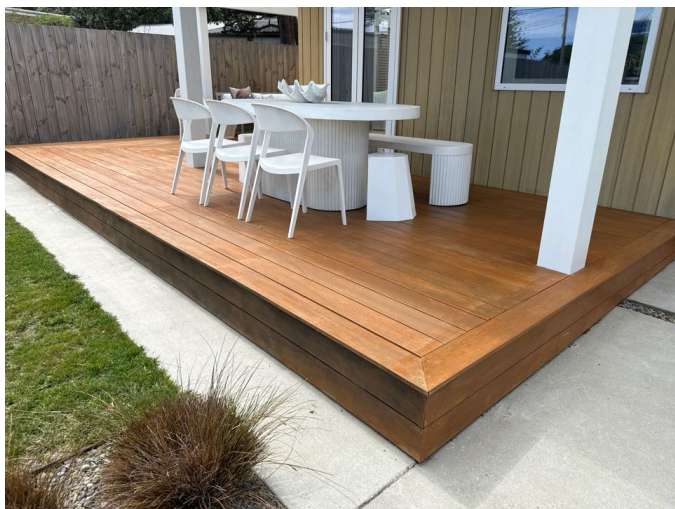
The low height timber deck has been finished to a good standard. No concerns found.

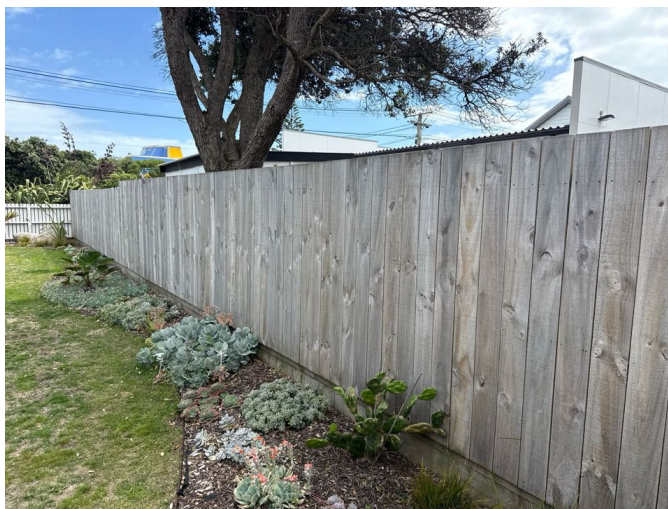
The perimeter fencing is solid and intact.

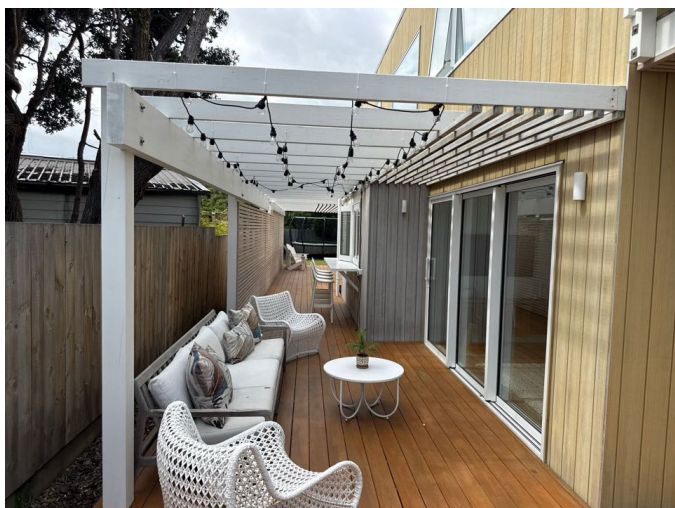
The timber pergola is structurally solid and secure. Rust affected fixings should be treated with rust converter.

Rust affected external fixings - Rust affected fixings should be treated with rust converter and painted to slow the deterioration.

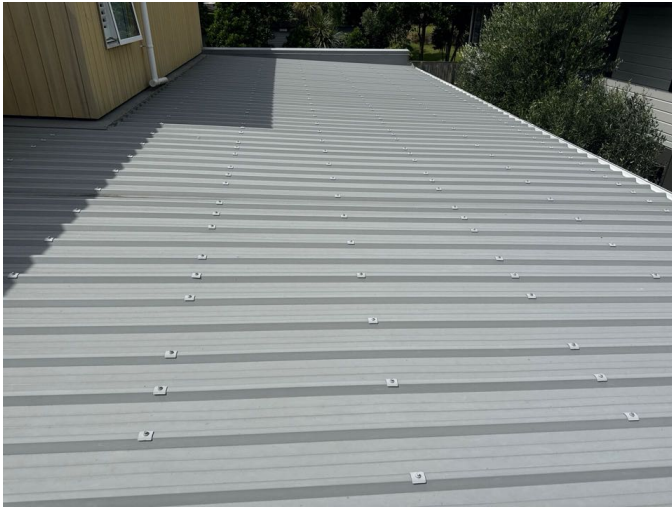
A once or twice yearly soft wash will help maintain the roofs surface condition and prevent premature deterioration

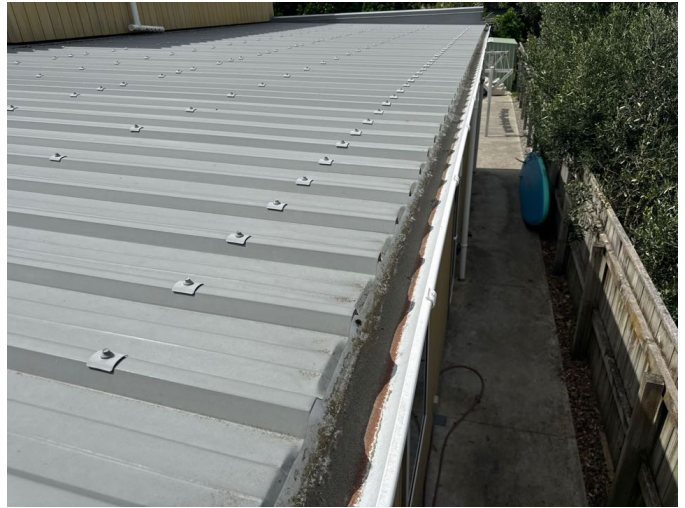
The spouting is in good condition and is clear. The effectiveness of the spouting will need to be checked during rainy periods. Due to the dry conditions that were evident on the day of our inspection we cannot comment on any leaks that maybe evident to the spouting or down pipes.

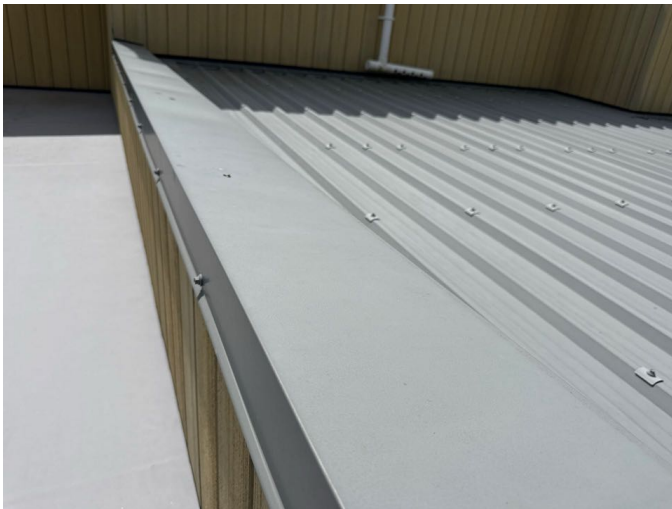
The roof flashings are secure, intact and are effective. No sign of failure could be found beneath where accessible to view.

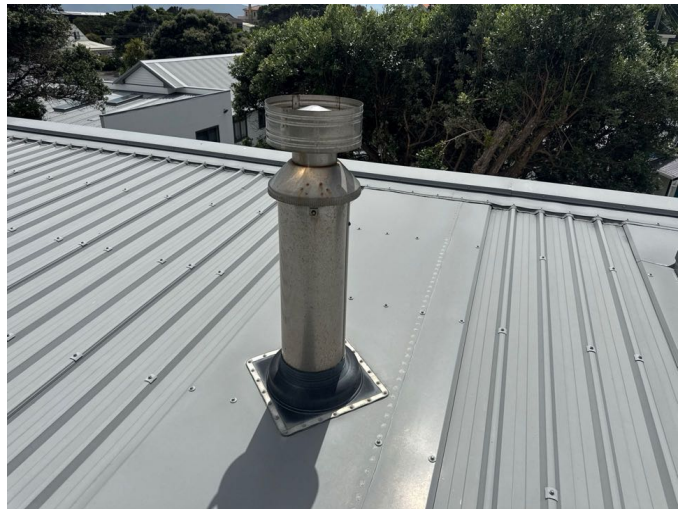
The steel flue is in good condition and is effectively flashed

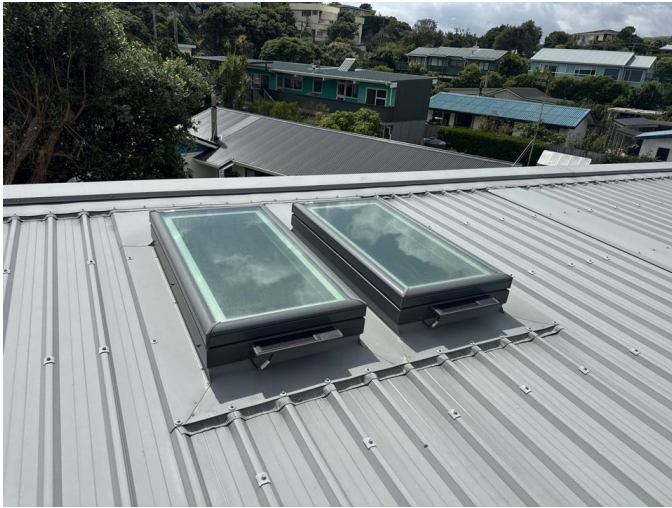
The skylights are effectively flashed and sealed

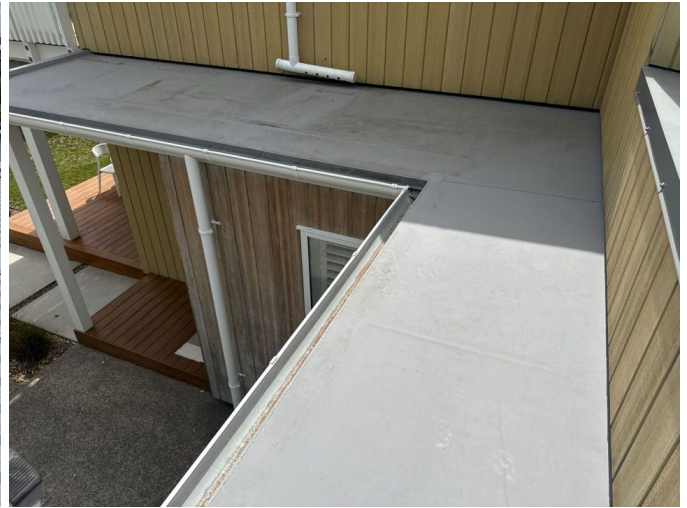
The waterproof membrane sections are intact and in good condition

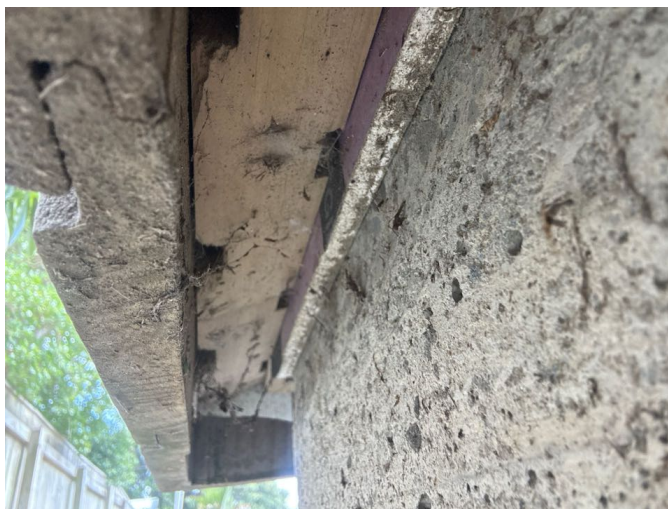
Cavity system detail noted. The cavity system is a modern detail that allows moisture to escape and ventilation to the back of the cladding.

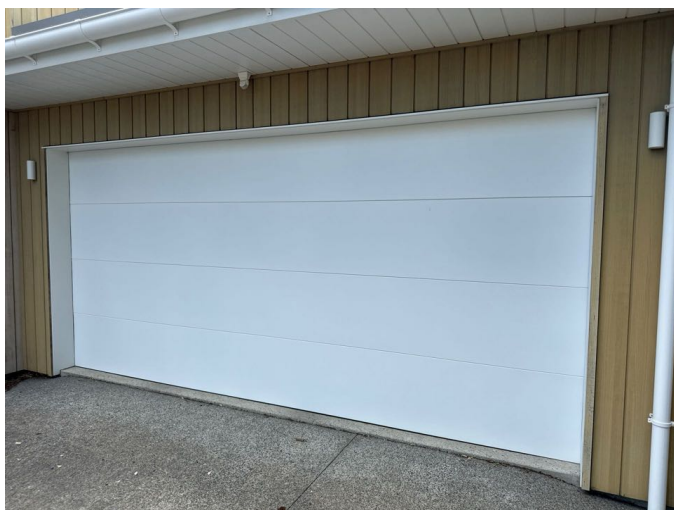
The surface condition of the garage door is good

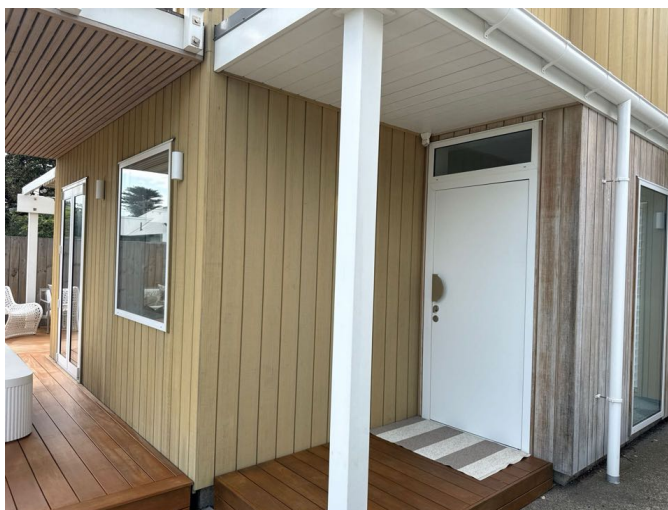
The timber roof support is solid and secure

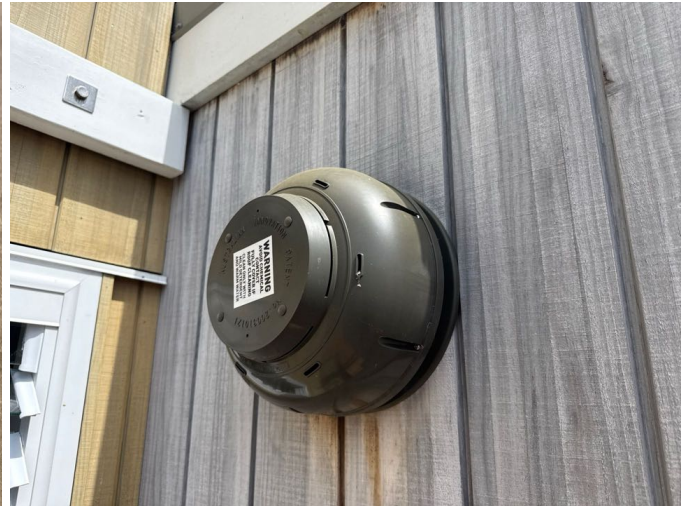
Extraction vents exit through the wall and rear soffit

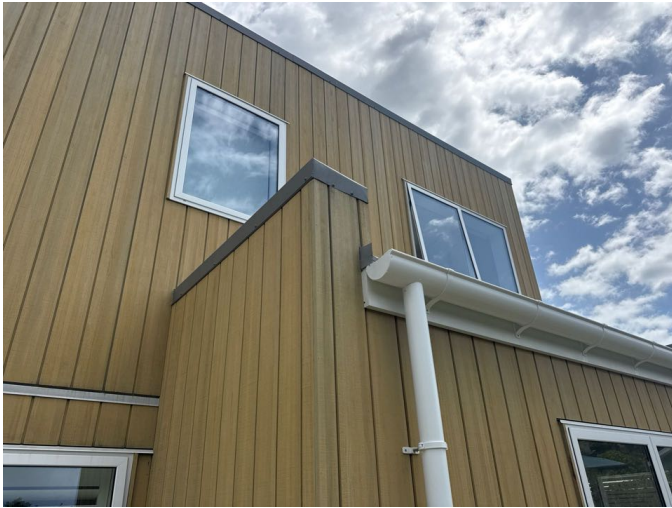
The parapet wall has been flashed, which is a necessary detail to prevent water ingress at the roof-wall interface. Properly installed flashing helps divert water away from vulnerable joints and prevents moisture penetration into the wall assembly and roofing structure.

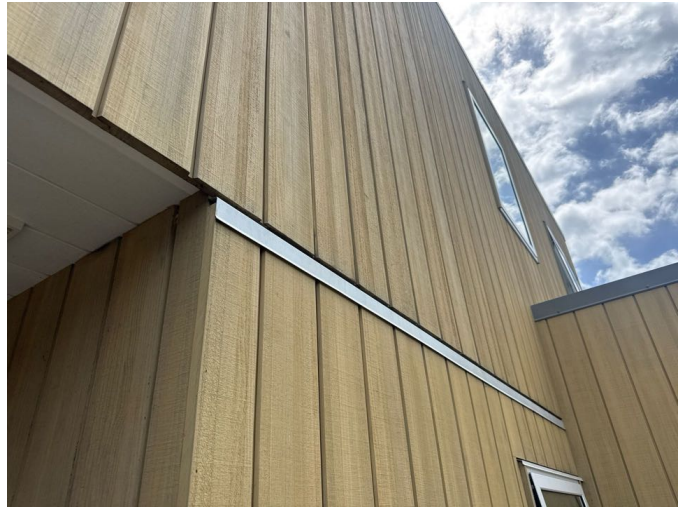
Cladding junction flashings installed where required. Flashings deflect water away from the junction.

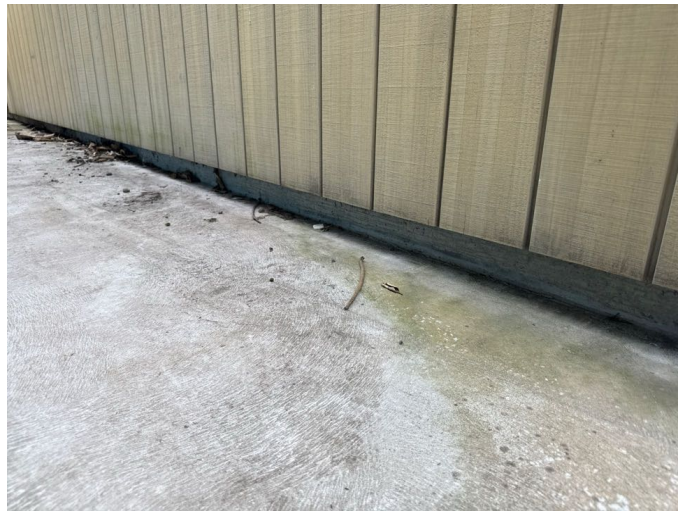
Good ground clearance around the perimeter. The current building code requires a 150mm clearance between the internal floor height and the sealed ground and 225mm to unsealed ground.

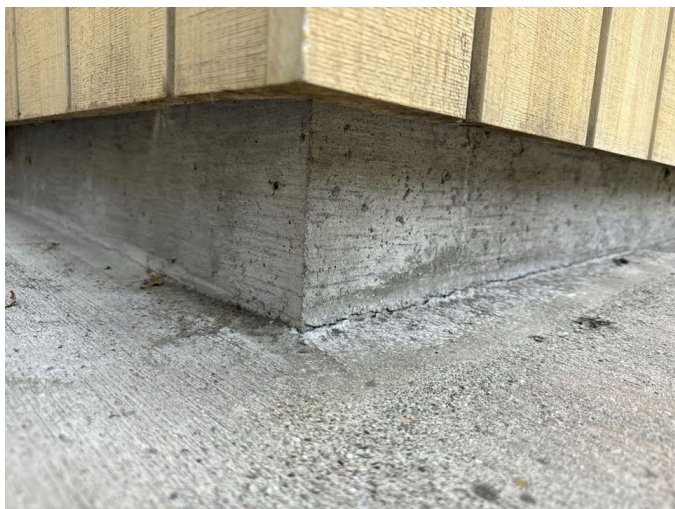
There is limited space to sight the concrete foundation but where visible it appears to be solid. No damage or deterioration could be found at the time of inspection.

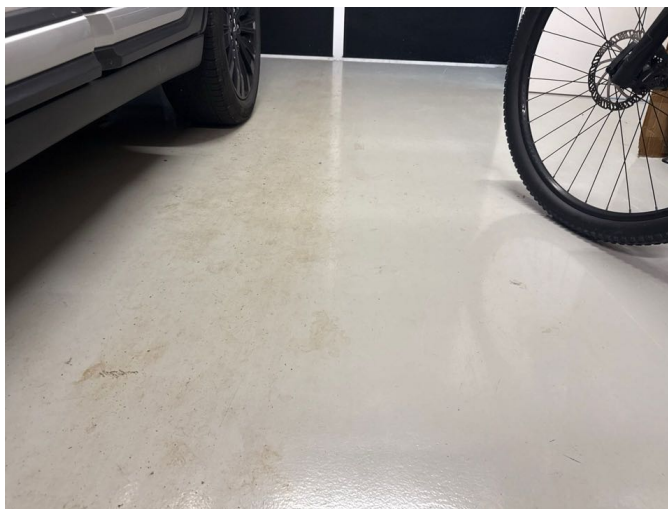
The painted garage floor is in good condition

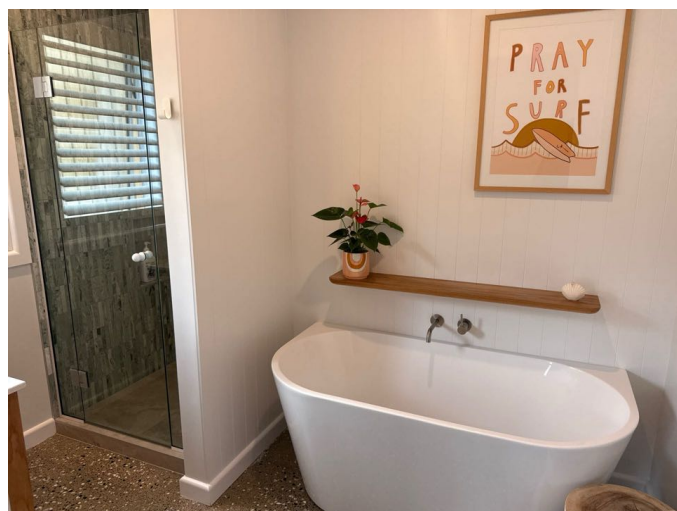
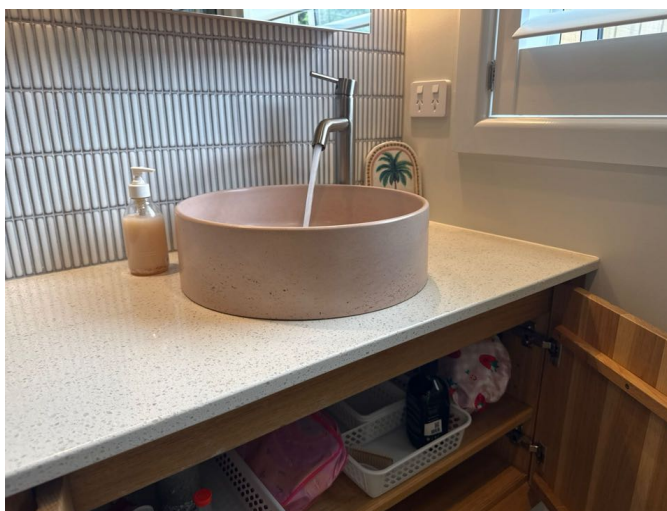
The rear edge of the vanity is well sealed. The tap is functioning well. No concerns with the water feeds or waste under the vanity

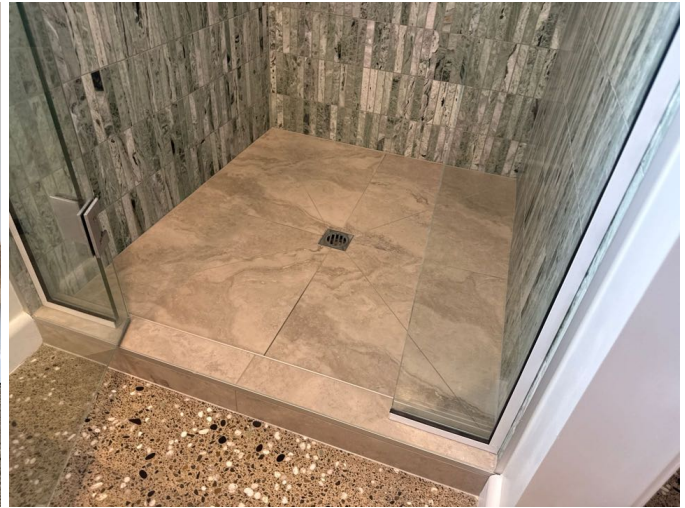
The tiled shower is showing no evidence of deterioration or failure at the time of the inspection. If there are any concerns with the condition of the tiles, sealant or grout in the future, a professional Tiler should be engaged for further assessment.

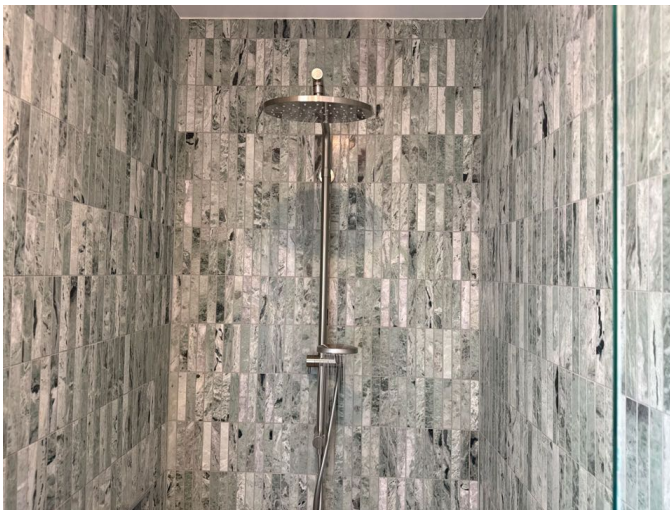
Good water pressure noted. No sign of current leaks from the shower frame during water testing.

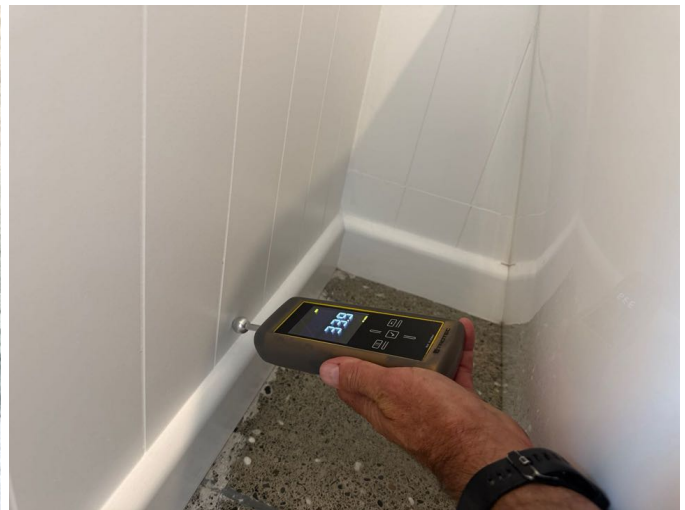
The common fail areas of the shower and plumbed areas were checked for elevated moisture. Moisture levels were within the normal range.

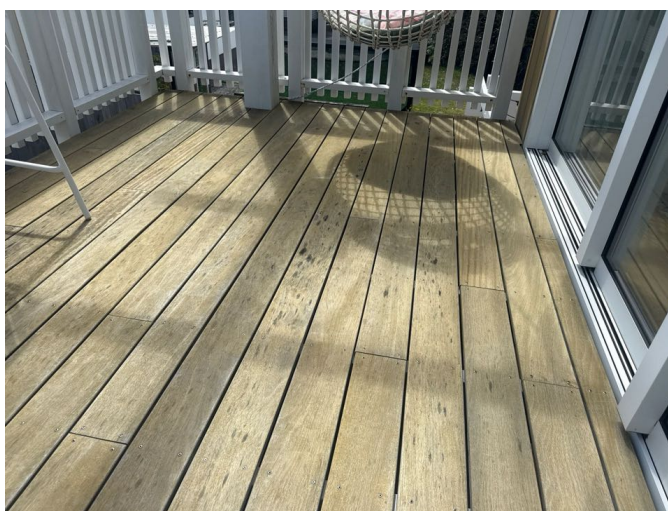
The hardwood decking is in good condition

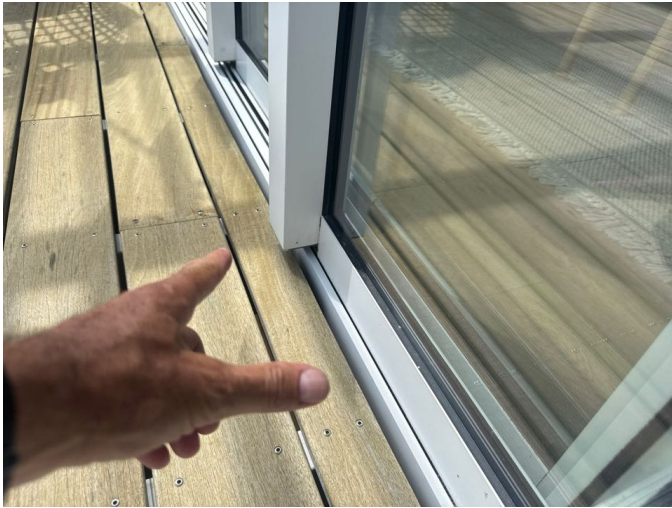
Good clearance gap between the deck and cladding. This will allow water to escape and will prevent premature deterioration.

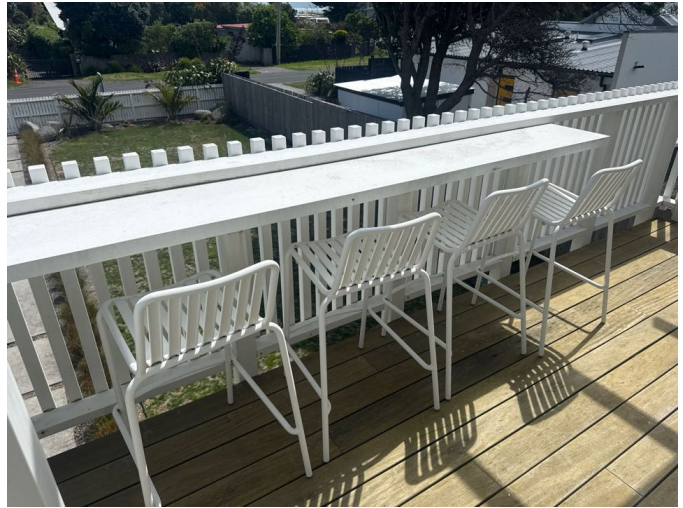
The bench is secure. Rust affected fixings should be treated with rust converter and painted to slow the deterioration.

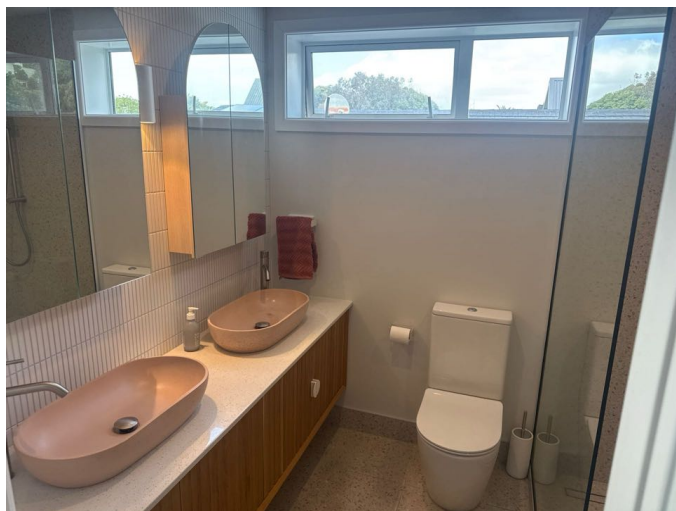
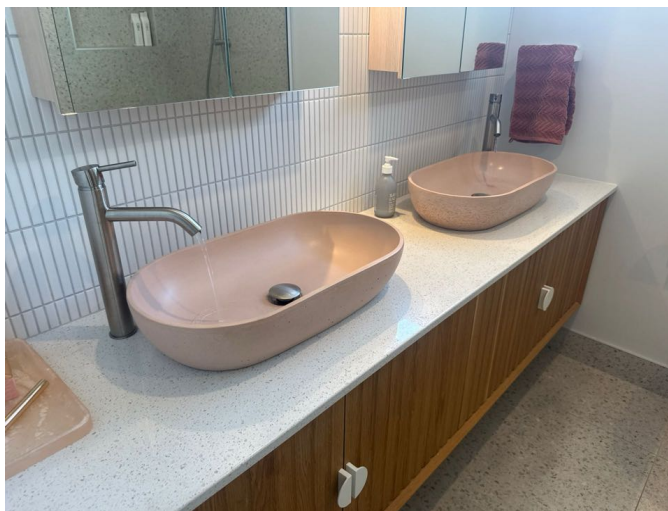
The rear edge of the vanity is well sealed. The taps are functioning well. No concerns with the water feeds or waste under the vanity

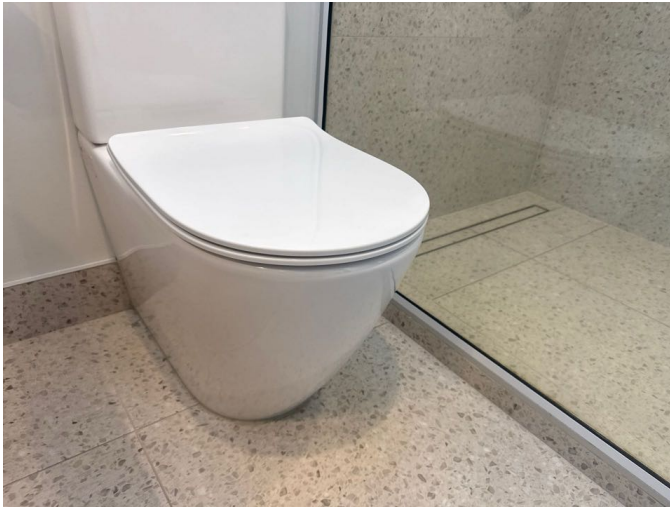
The base of the toilet is well sealed and secure. The toilet is in a functioning condition.

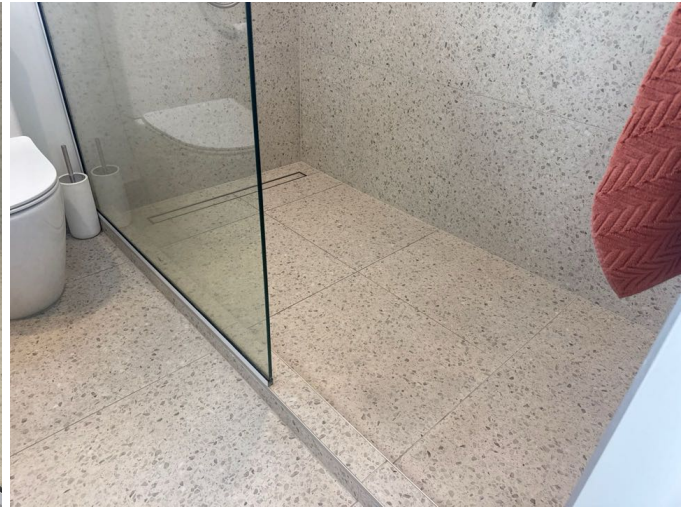
The tiled shower is showing no evidence of deterioration or failure at the time of the inspection.

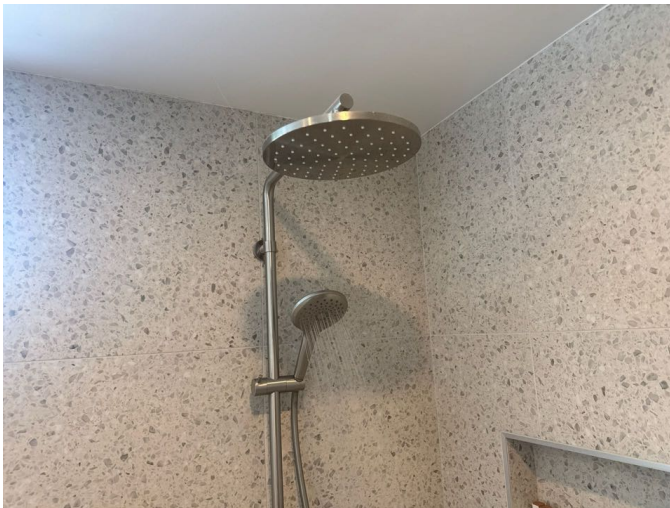
Good water pressure noted. No sign of current leaks from the shower frame during water testing.

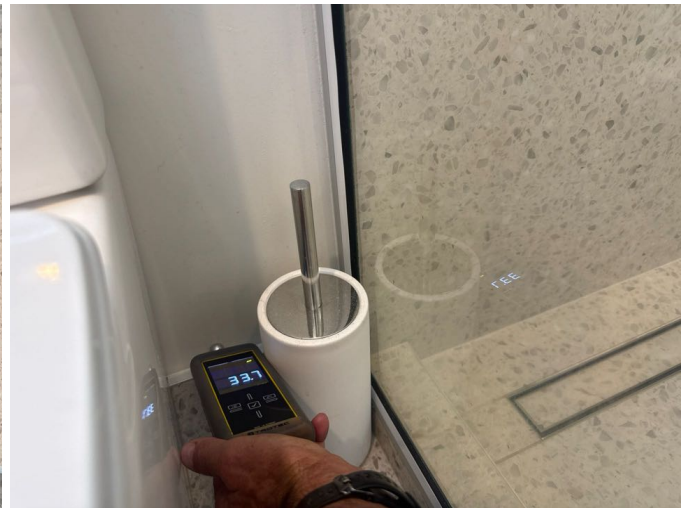
The common fail areas of the shower and plumbed areas were checked for elevated moisture. Moisture levels were within the normal range.

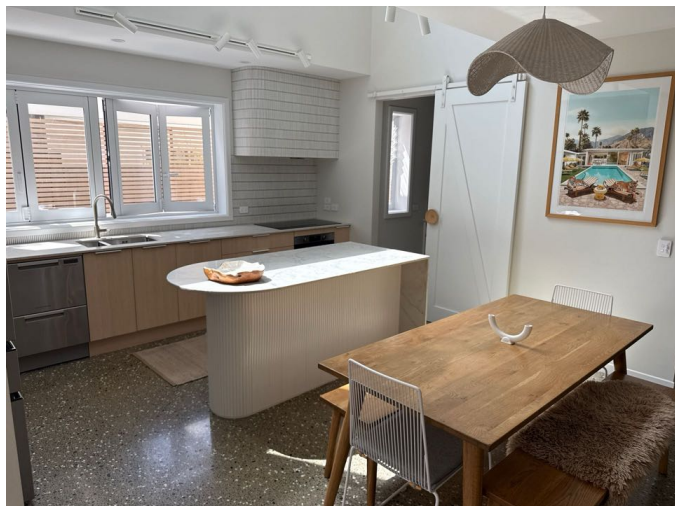
The rear edge of the bench top is well sealed. The tap is functioning well. No concerns with the water feeds or waste pipes under the sink.

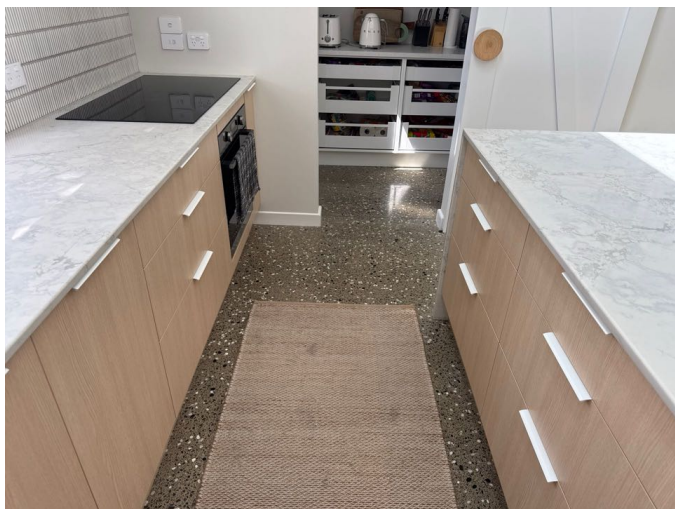
The kitchen cabinetry and concrete floor are in good condition

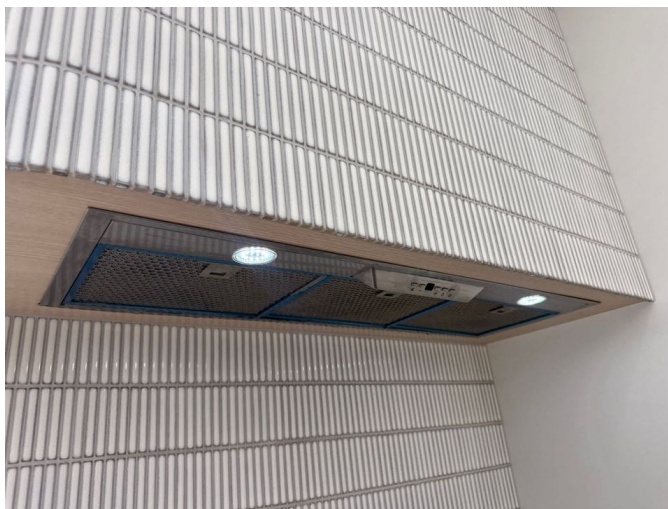
The range hood extraction unit is functioning

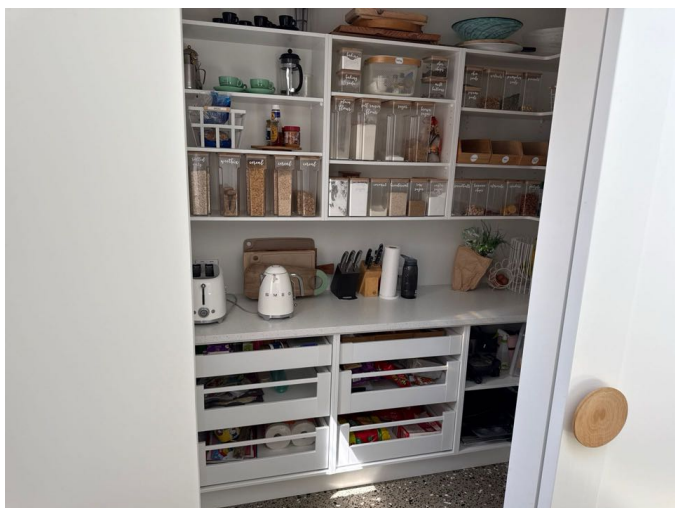
The walk in pantry is in a similar condition to the main kitchen area. Very tidy condition.

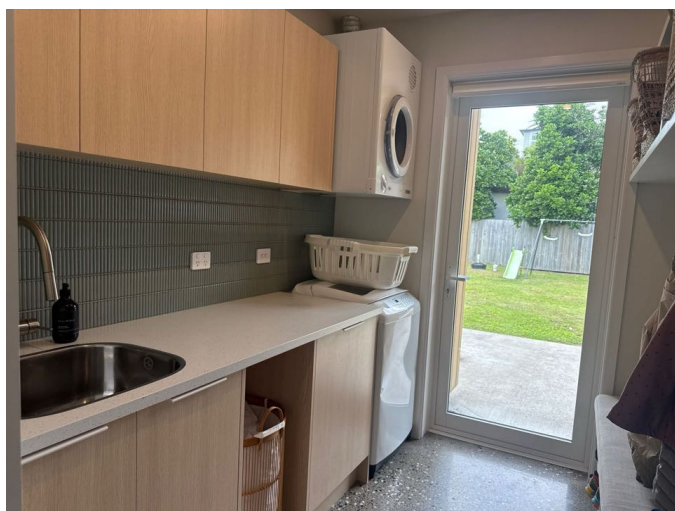
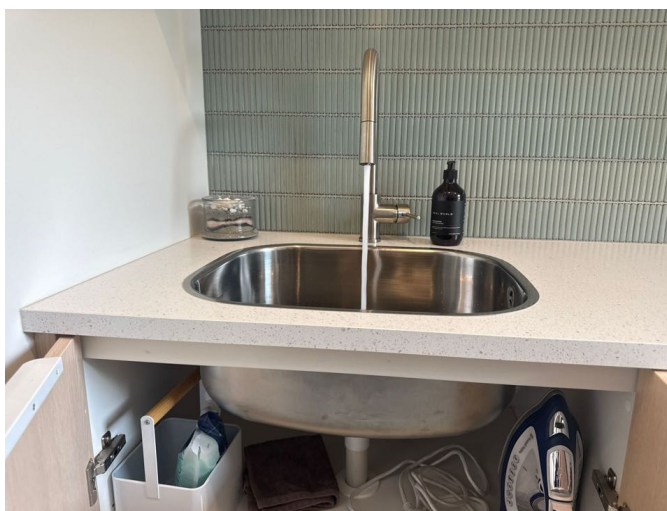
The bench is well sealed. The tap is functioning well. There were no visible concerns with the water feeds or waste under the tub.

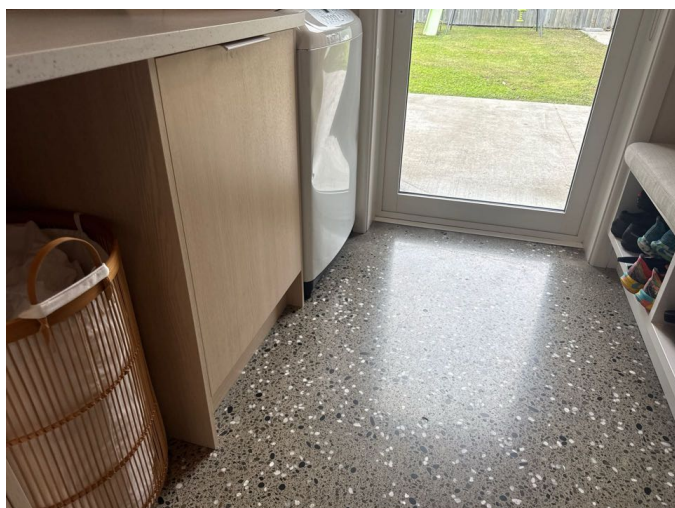
The cabinetry and concrete floor are in good condition

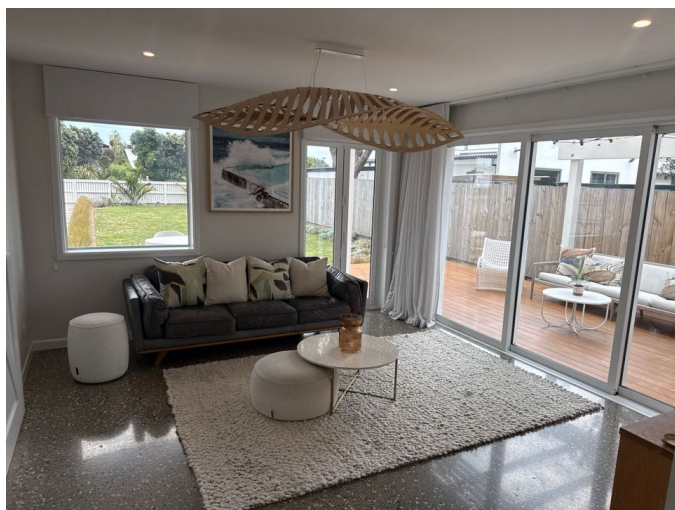
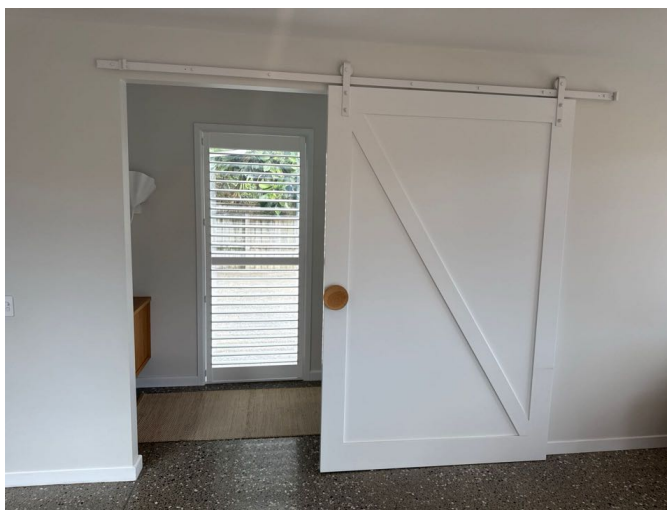
The barn style sliding door is functioning well

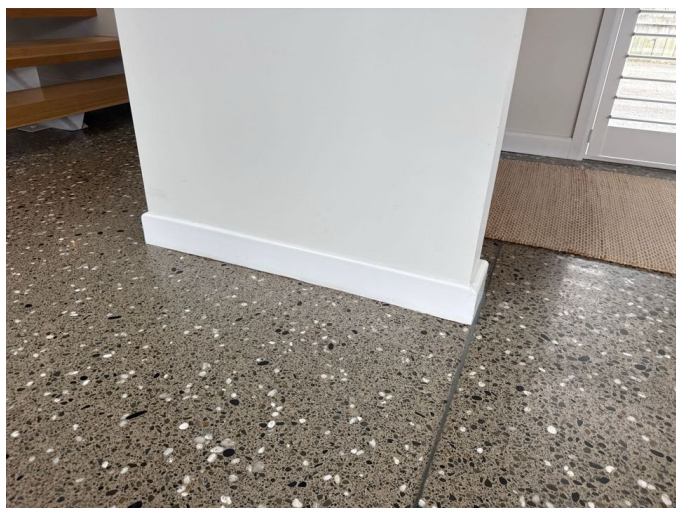
The concrete floor and wall linings are in good condition

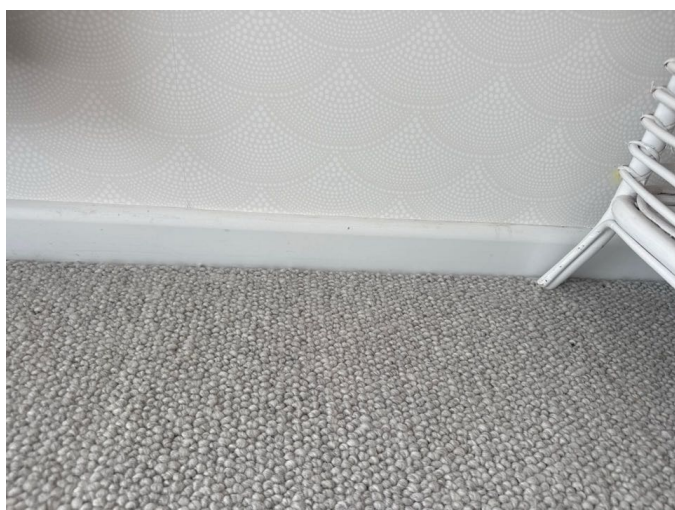
The wall and ceiling linings and carpet are in good condition

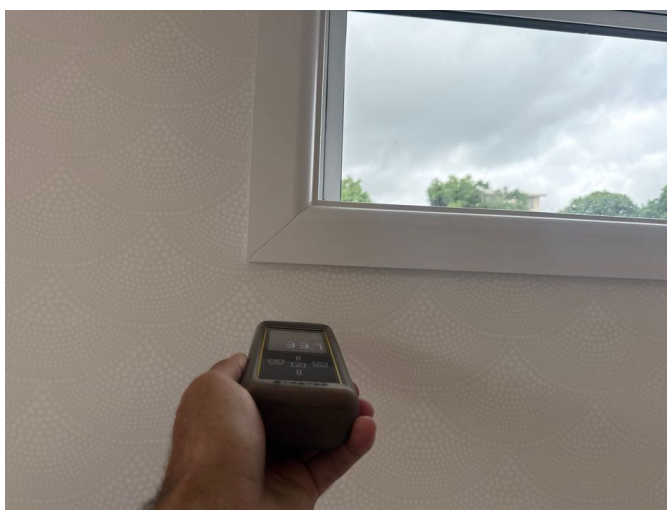
Moisture levels to the external walls were within the normal range at the time of inspection

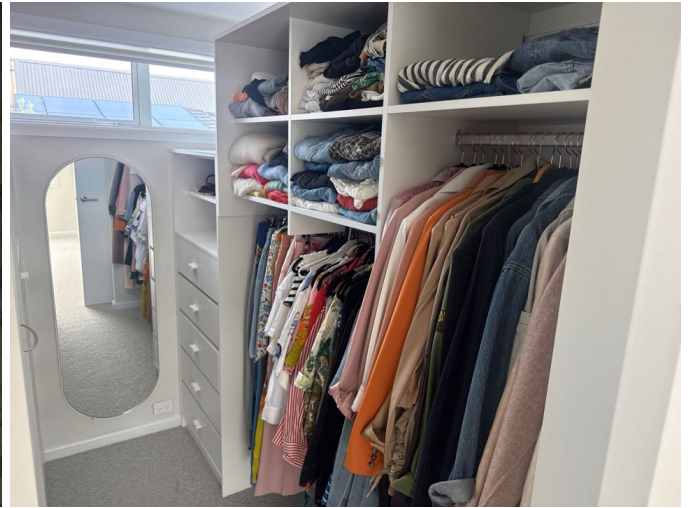
The walk in wardrobe has a storage system in place which is secure and in good condition

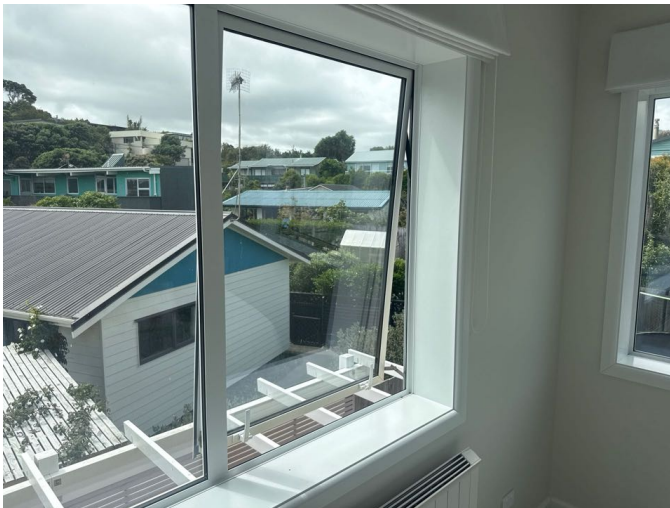
The windows are functioning throughout

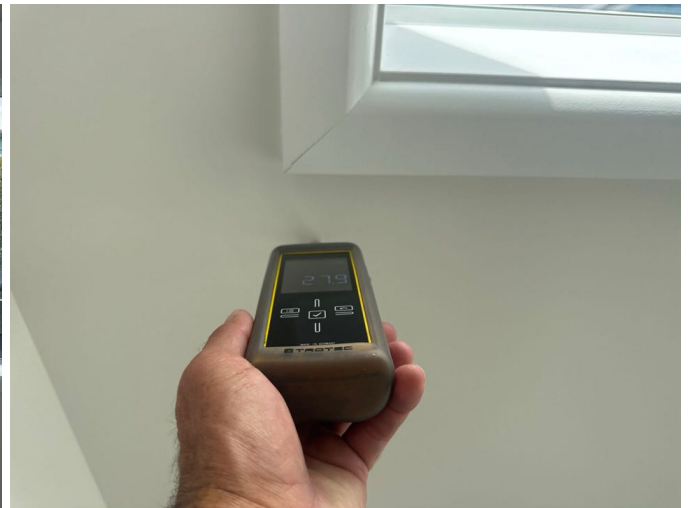
Moisture levels to the external walls were within the normal range at the time of inspection

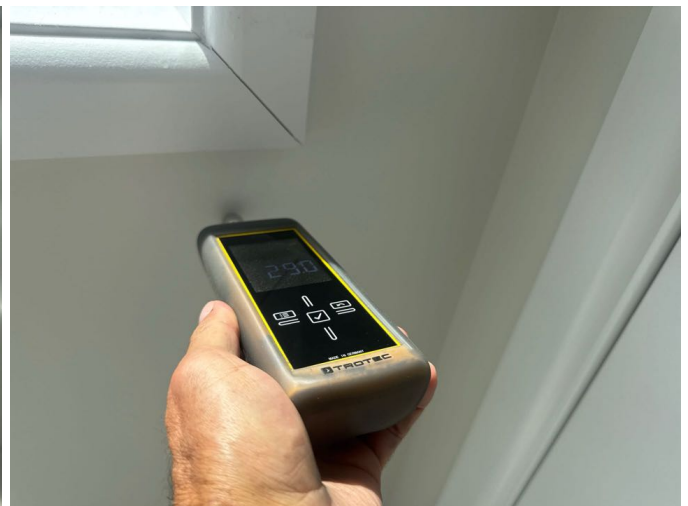
Moisture levels to the external walls were within the normal range at the time of inspection

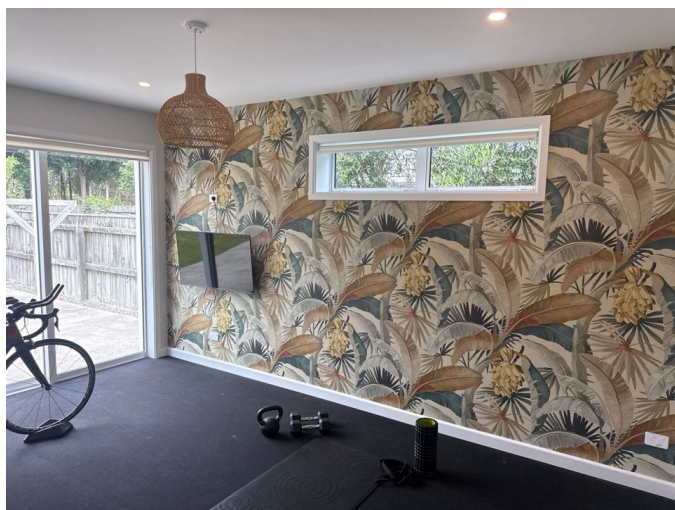
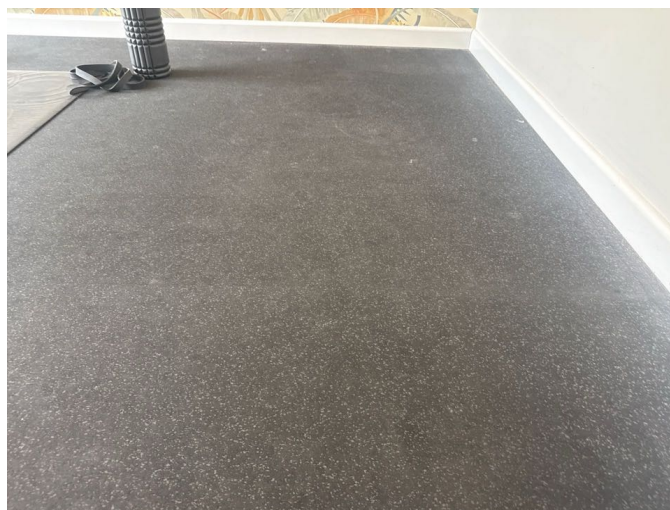
The rubber flooring is in good condition

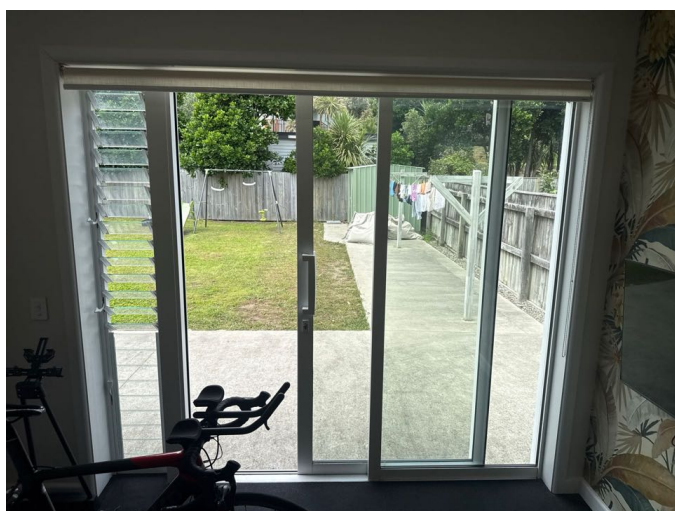
The sliding door and windows are functioning well

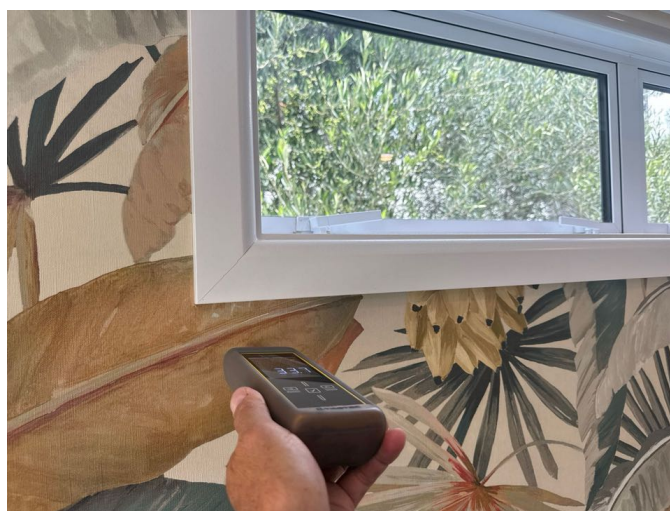
Moisture levels to the external walls were within the normal range at the time of inspection

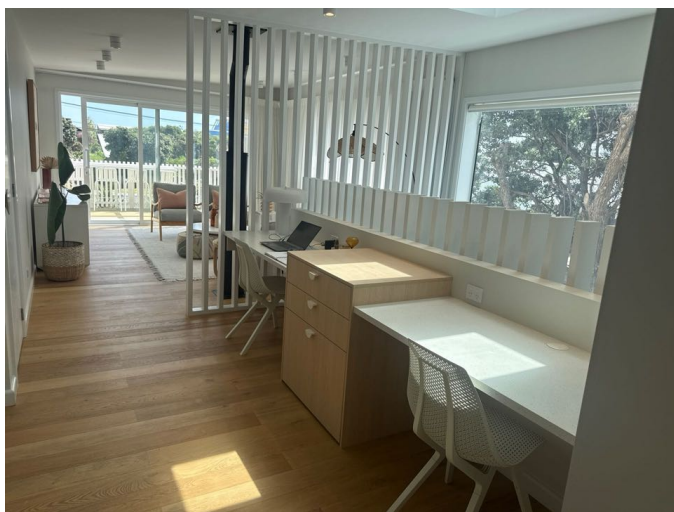
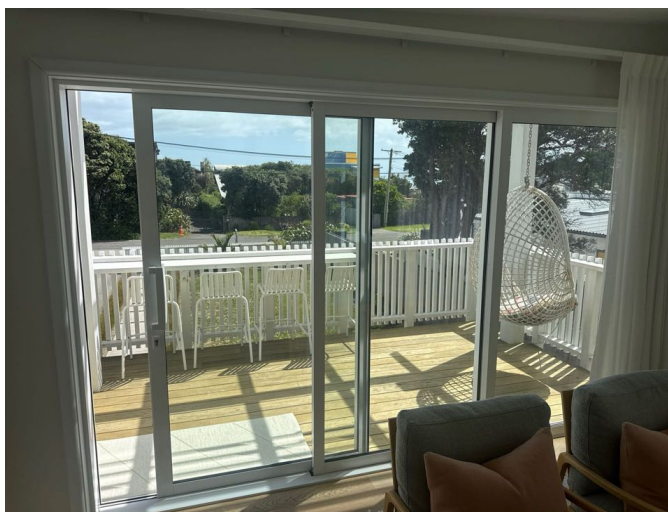
The sliding door and windows are functional

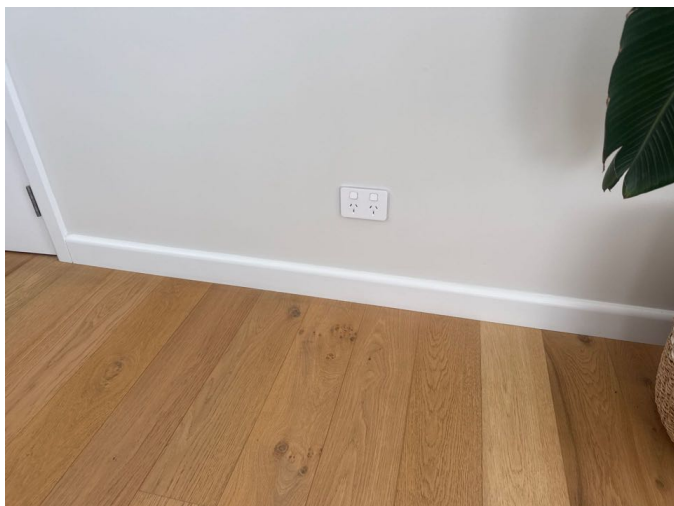
The wall and ceiling linings and timber flooring are in good condition

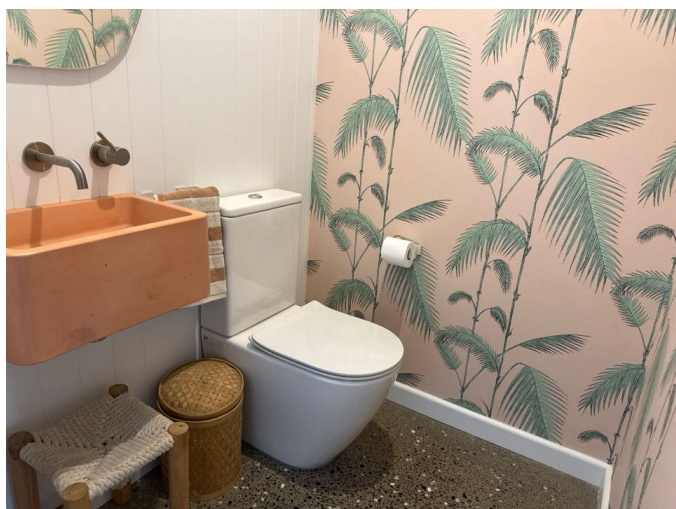
The sink is well sealed to the wall. The tap is functioning well. No visible concerns with the water feeds or waste beneath the sink.

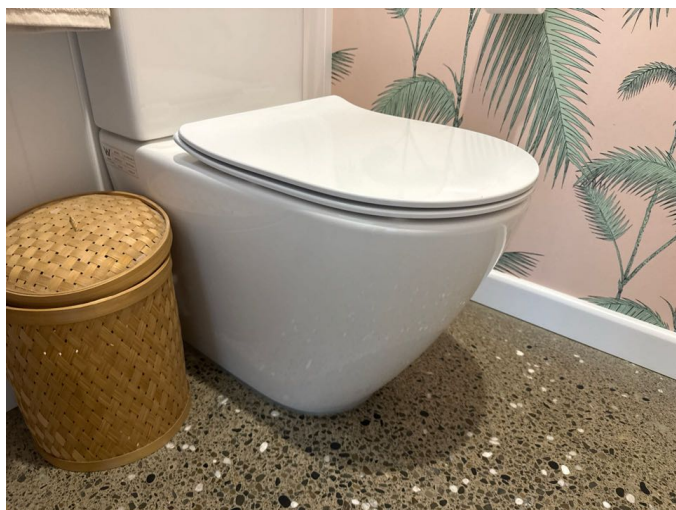
The base of the toilet is well sealed and is secure. The toilet is in a functioning condition.

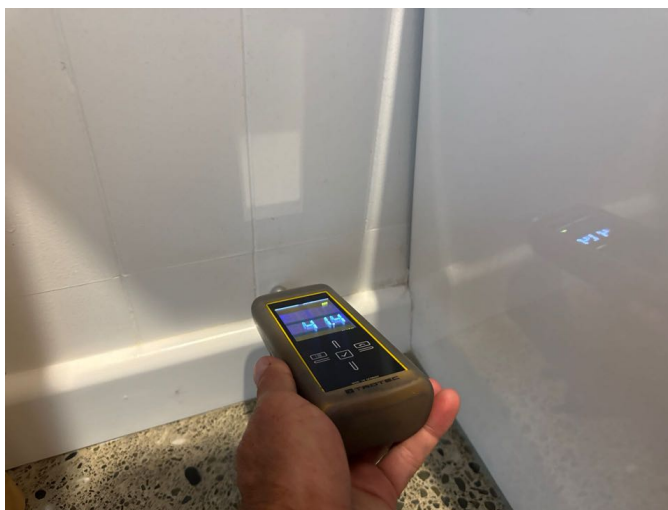
Moisture levels behind the toilet were within the normal range at the time of inspection

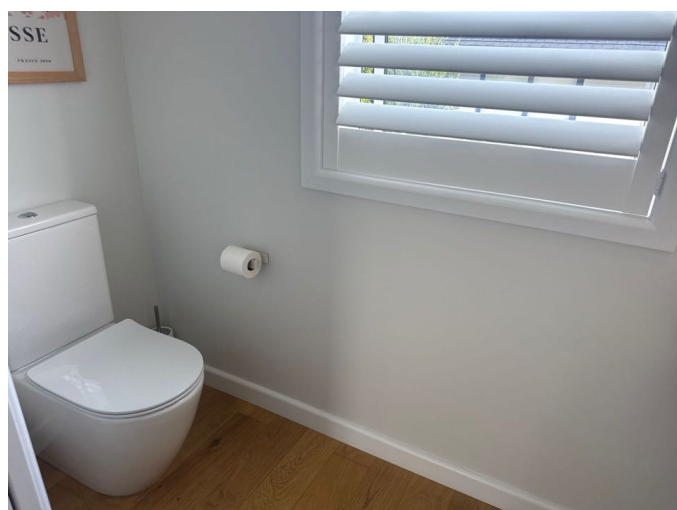
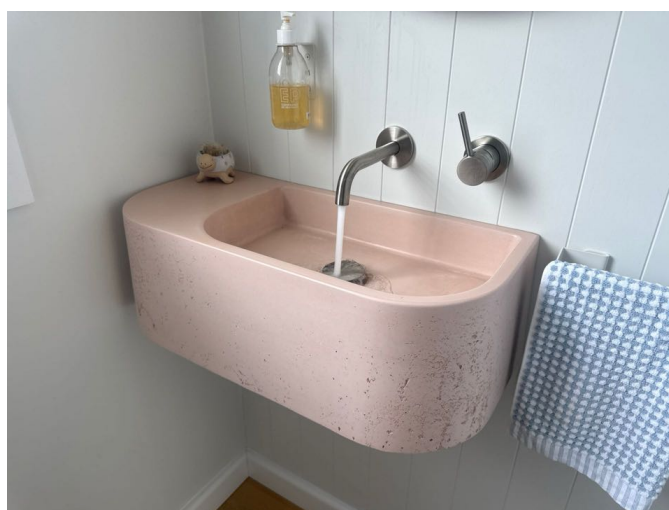
The sink is well sealed to the wall. The tap is functioning well. No visible concerns with the water feeds or waste beneath the sink.

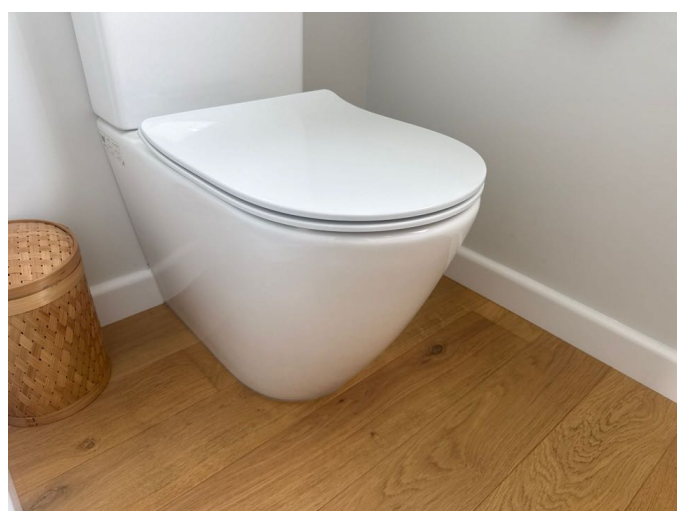
The base of the toilet is well sealed and is secure. The toilet is in a functioning condition.
