# Independent Builders Report

Total Home Inspection Services Porirua City Ltd

Tue 24 Feb 2026

**87 The Esplanade, Raumati South, Paraparaumu, 5032,  
New Zealand**

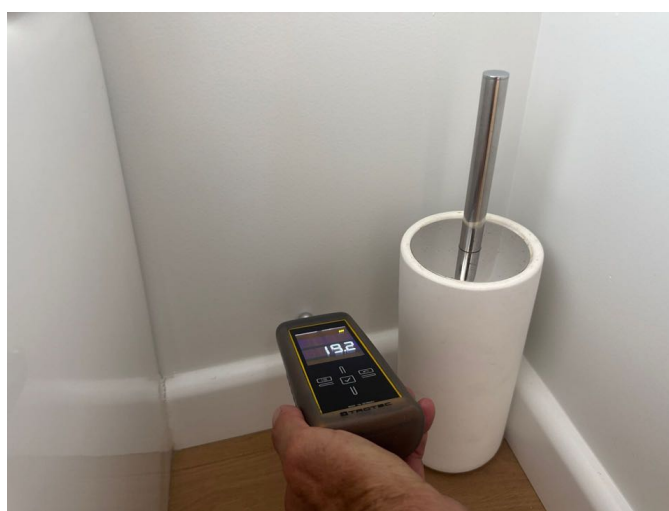
Moisture levels behind the toilet were within the normal range at the time of inspection

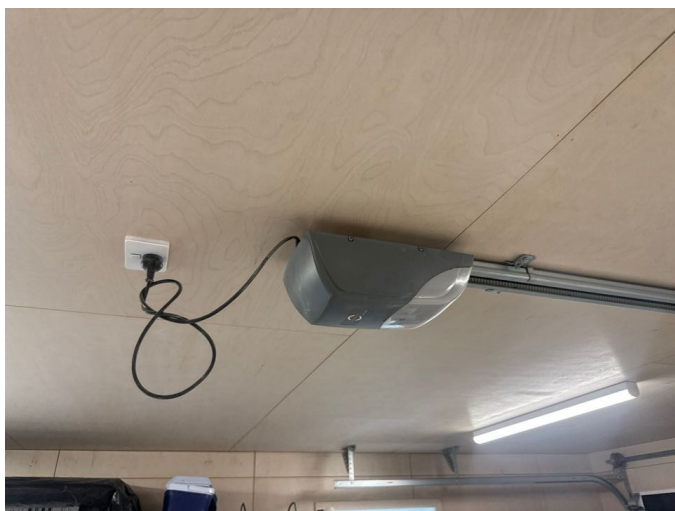
The electric garage door is functioning

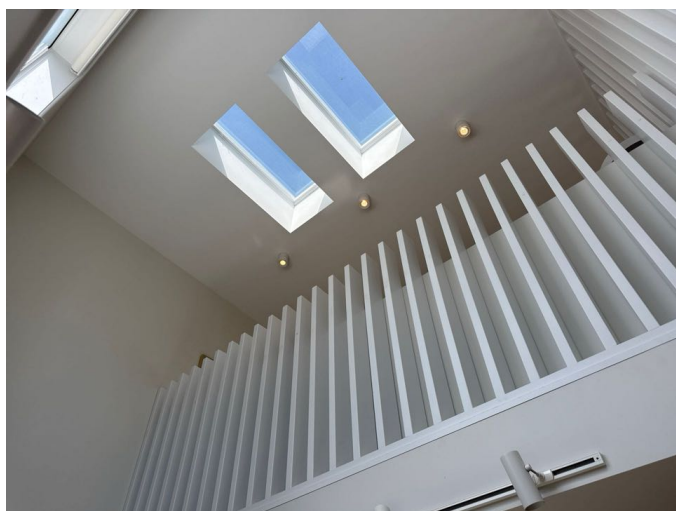
No visible evidence of failure could be found beneath the skylights
