## EQC CLAIM DOCUMENTATION

# EARTHQUAKE RECOVERY (EQR) DOCUMENTATION

Released Under the Official Information Act 1982  
**EQR Property Overview Report**

EQC Property ID	Property Address	Vulnerable?	Property F Status	Property Finalisation Indicator		
2010074181	237A MAIDSTONE ROAD, AVONHEAD		F3 - Complete & Finalised	Some Finalisation has taken place		
Main Contractor:	CLOSED OUT-JFS Construction Limited ***** (S092)		Property F2'd By:	System Generated Finalisation	F2 Completed Date:	03-03-2015
Cont Managing Hub:	Riccarton	Not Vulnerable	Property F3'd By:	System Generated Finalisation	F3 Completed Date:	03-03-2015

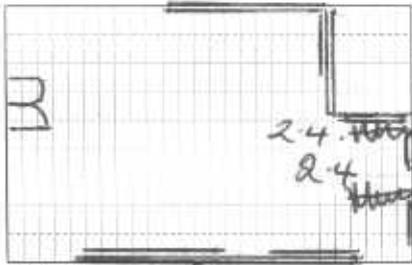
Lounge 6.4

Room	Earthquake Damage	Walls	Ceiling	Floor	Repair Strategy
	Y/N	✓	✓	✓	
Lounge	Y	✓	—	—	Take out crack. Tape, stop. Paint 4x walls
Dining Room	N	—	—	—	
Kitchen	N	—	—	—	
Family Room	N/A	—	—	—	
Bedroom 1	N	—	—	—	
Ensuite	N	—	—	—	Leaking / drip coming from waste pipe. Claimant to get plumber to investigate further
Bedroom 2	N	—	—	—	
Bedroom 3	N	—	—	—	Existing crack to wall

Room	Repair Strategy	Units	Length	Breadth	Depth	Quantity	Rate	Cost
Lounge	Rake out, stop cracks.	hr				1	45	45
	Materials	qa				1	5	5
	Paint wall	m <sup>2</sup>	23.6	2.4		52.64	24	1359.36
Dining Room								
Kitchen								
Family Room								
Bedroom 1								
Ensuite								
Bedroom 2								
Bedroom 3

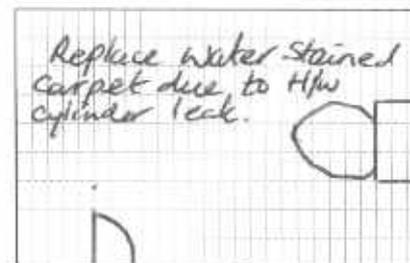
Toilet 1 1.5

Room	Earthquake Damage	Walls	Ceiling	Floor	Repair Strategy
	Y/N	✓	✓	✓	
Bedroom 4	N/A	—			
Bathroom	N	—			
Toilet 1	Y	—		✓	replace carpet - stained from leak coming from hot water cylinder adjacent.
Toilet 2	N/A	—			
Office / Study	N/A	—			
Rumpus	N/A	—			
Entry / Hall(s)	N	—			
Stairwell	N	—			
Laundry	N	—			
Garage	N	—			
Other	N	—

Room	Repair Strategy	Units	Length	Breadth	Depth	Quantity	Rate	Cost
Bedroom 4								
Bathroom								
Toilet 1	UPLIFT & RELAY NEW CARPET MINIMUM CHARGE INCLUDES : NEW CARPET REPAIR LEAK (REF INVOICE APPLIED)	1				1	300	300.00
Toilet 2								
Office / Study								
Rumpus								
Entry / Hall(s)								
Stairwell								
Laundry								
Garage								
Sub total (Page 2)								300.00
