Under floor Inspections

Report prepared for: Claire Holmes

Property address: 41 Mackenzie Avenue, Woolston

Date: 14 February 2023

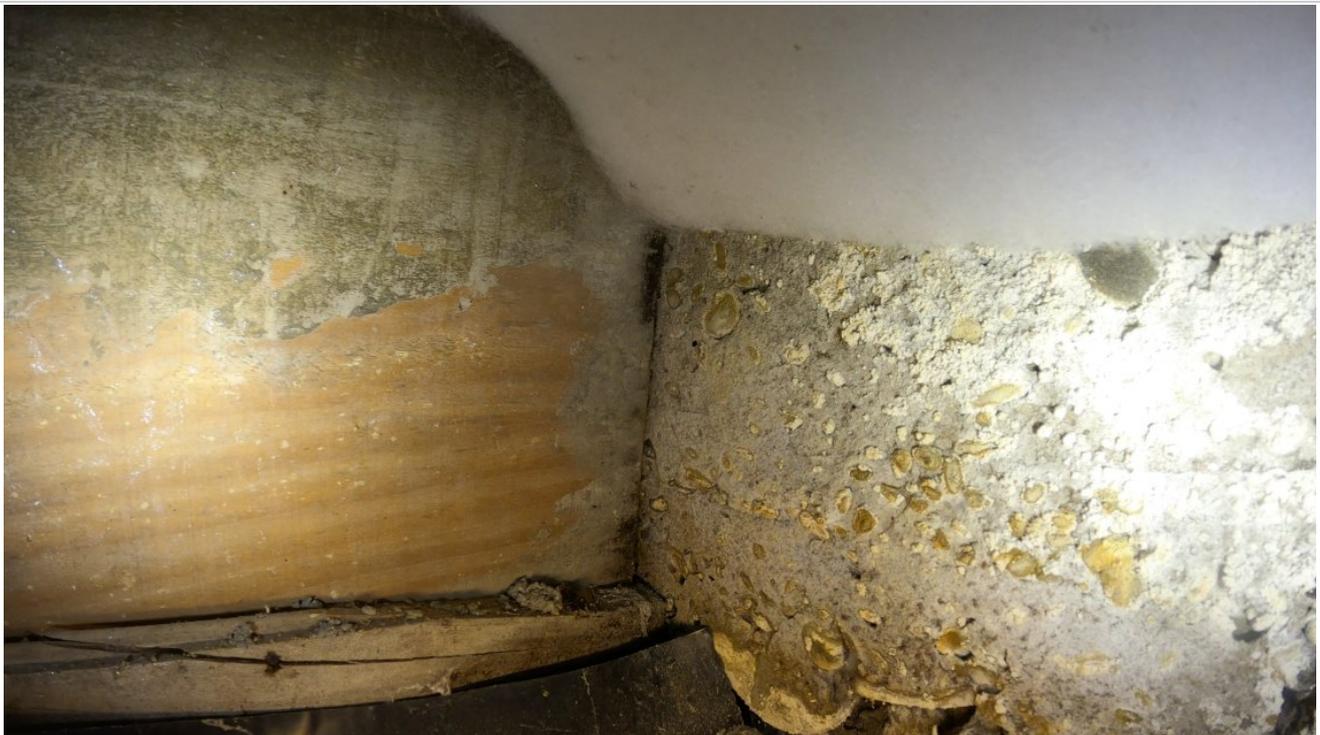
2: The home has had the side foundations replaced and here we are looking at the original to the right and the new to the left. However, the untreated boxing has been left on which is not good practice as it rots and this will spread to the joists and indeed the rot is already happening.

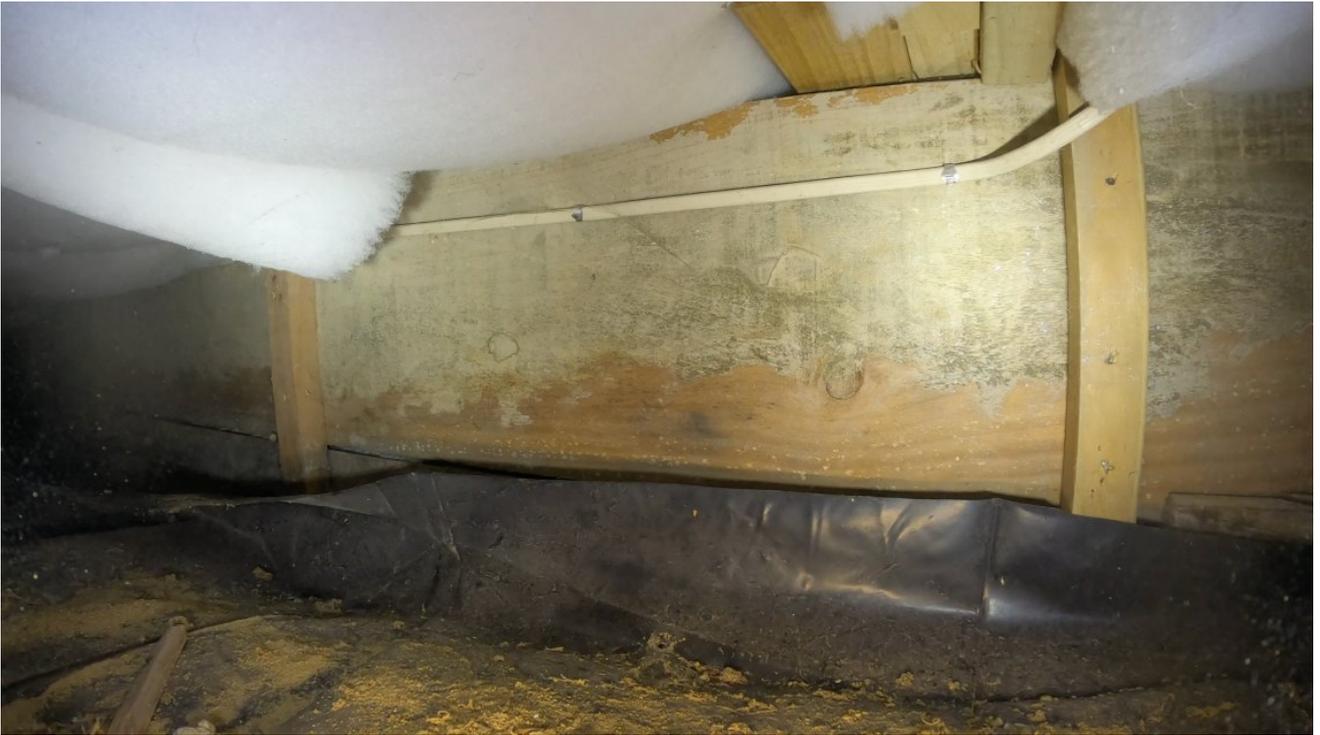
3: Wires have been fixed to the boxing. Note that we do see new H3.2 treated timber joists in this area.

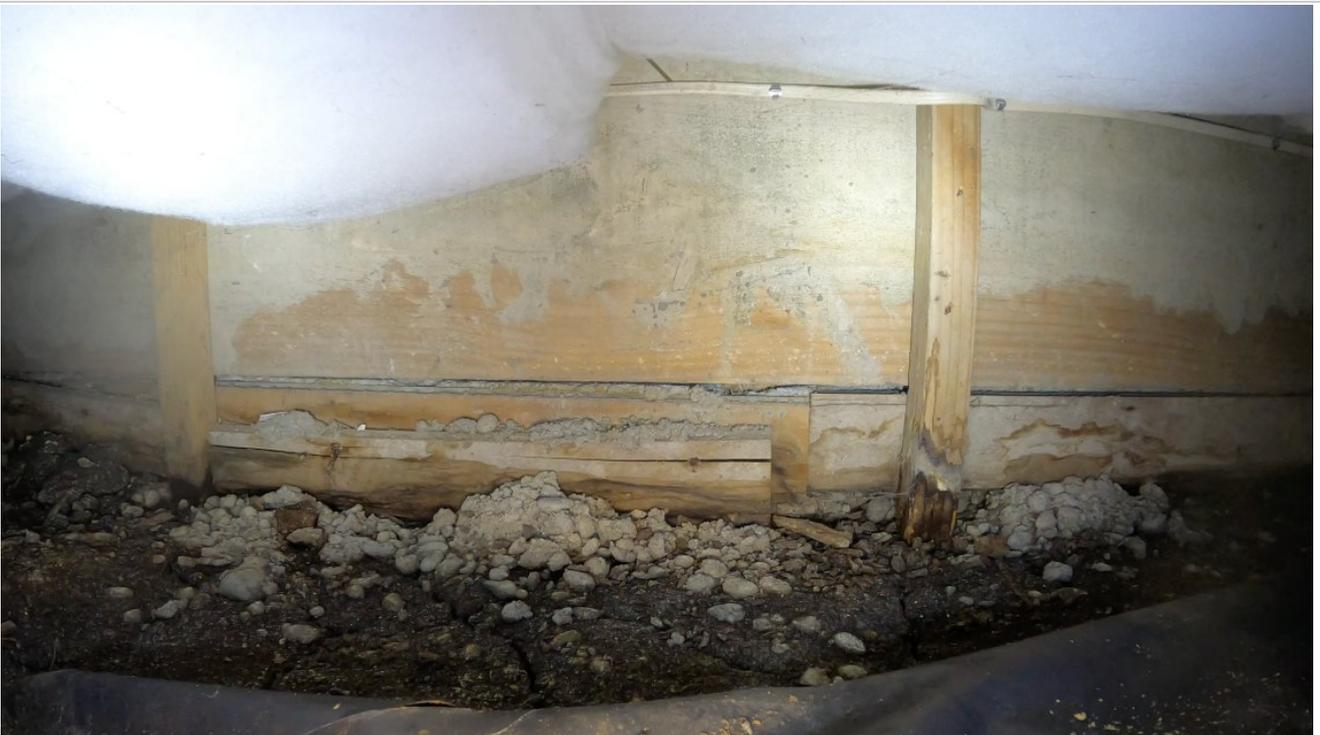
4: Here we see the rot taking hold on the boxing and damp ground conditions. It is very important to note that by leaving the boxing on every vent has been blocked, if indeed there are any on the sides of the home. These are exceptionally important and a legal requirement.

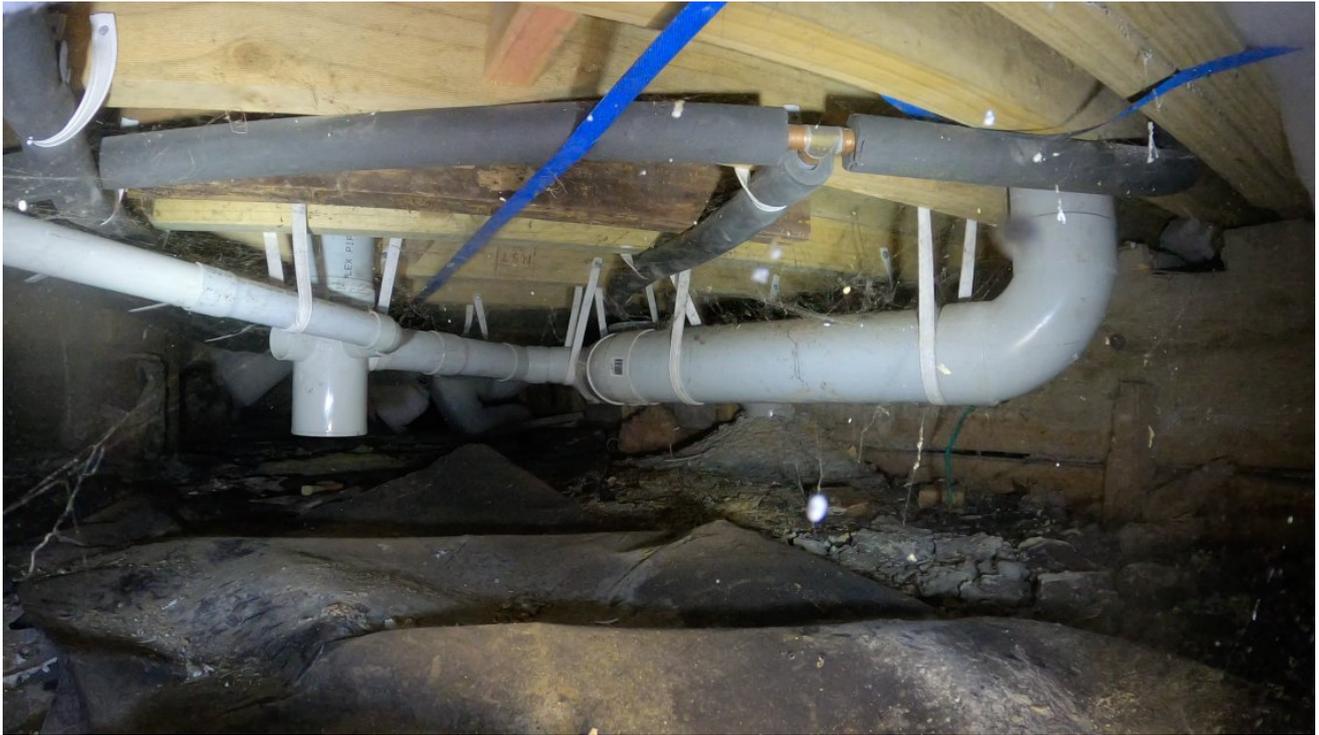
5: The new services are well supported and reasonably well lagged although the join has been left uncovered.

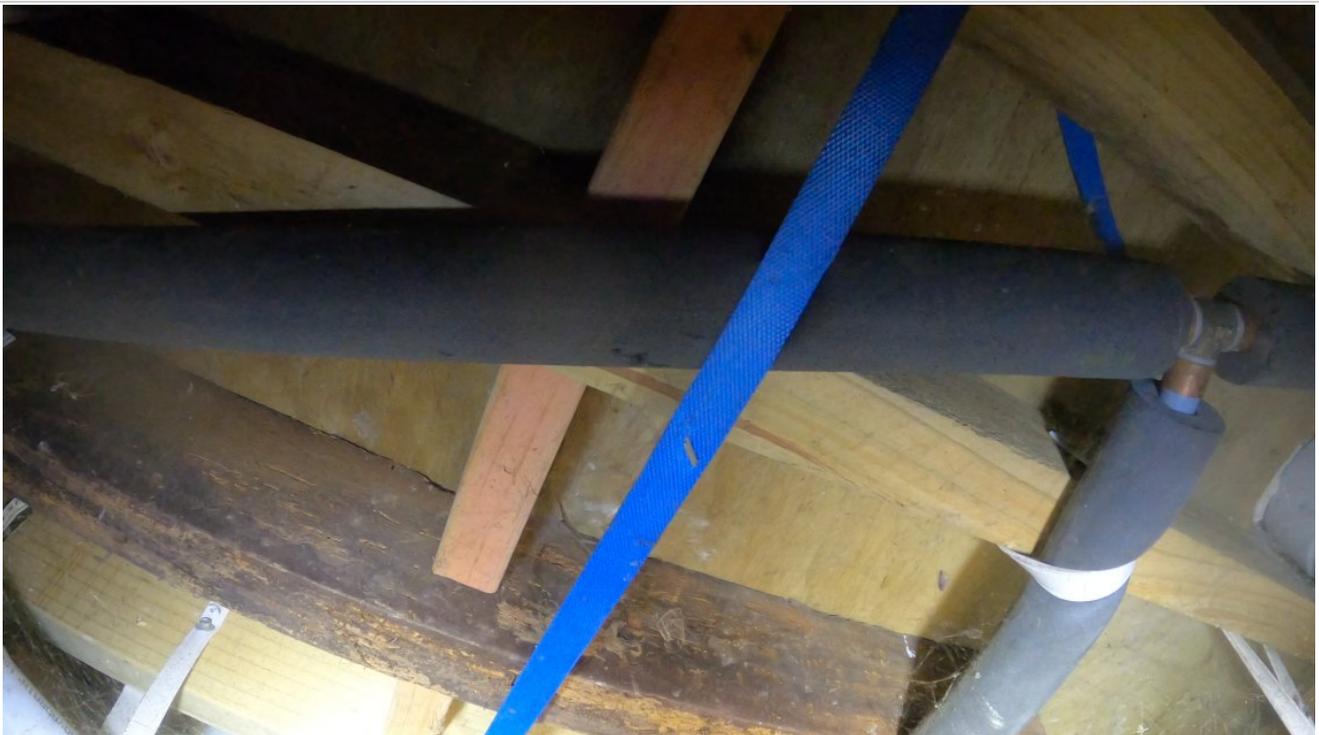
6: Here we see that a section of original timber has been left in place and this has terminal borer and rot. This is important to note because any original timber we see is generally in this poor state and is often still supporting walls.

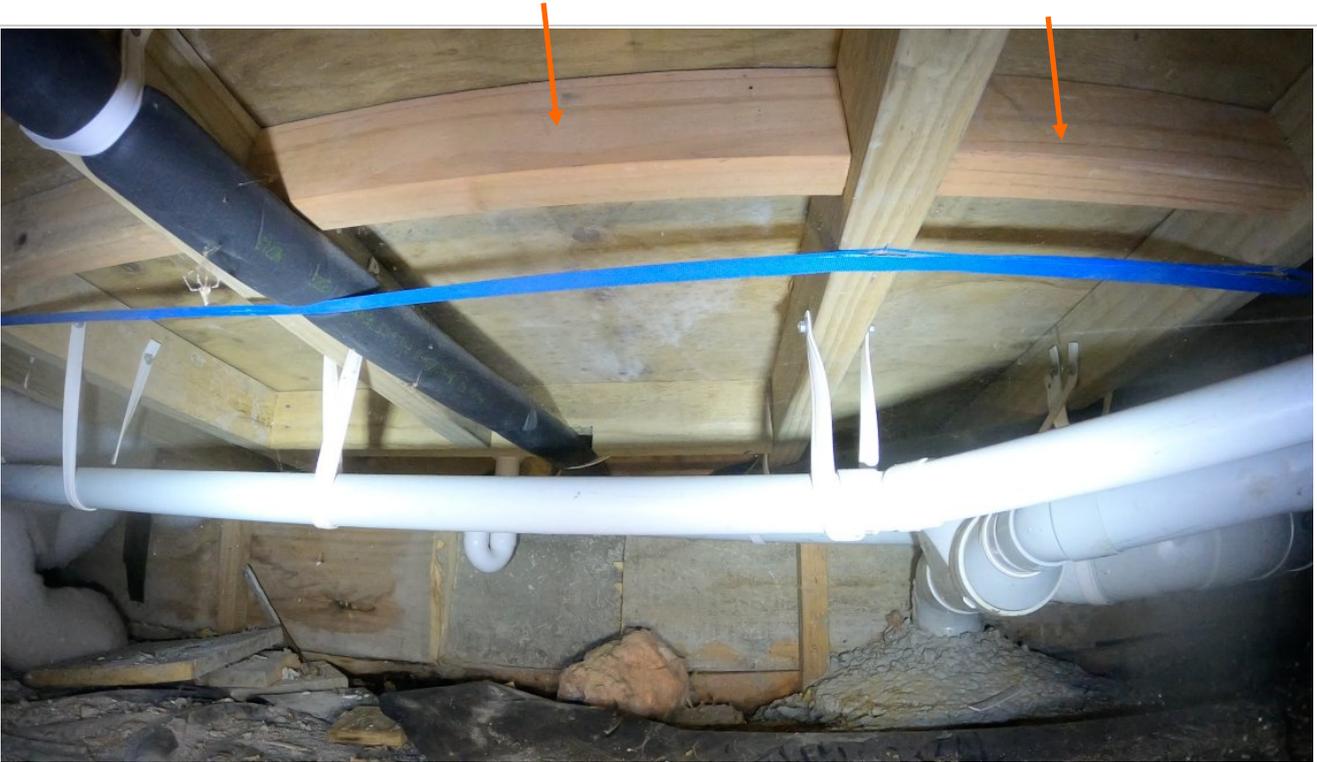
7: Most of the new timber used in the subfloor is the correctly treated H3.2 timber, however here we do see the use of some H1.2 which is not rated for use in this environment.

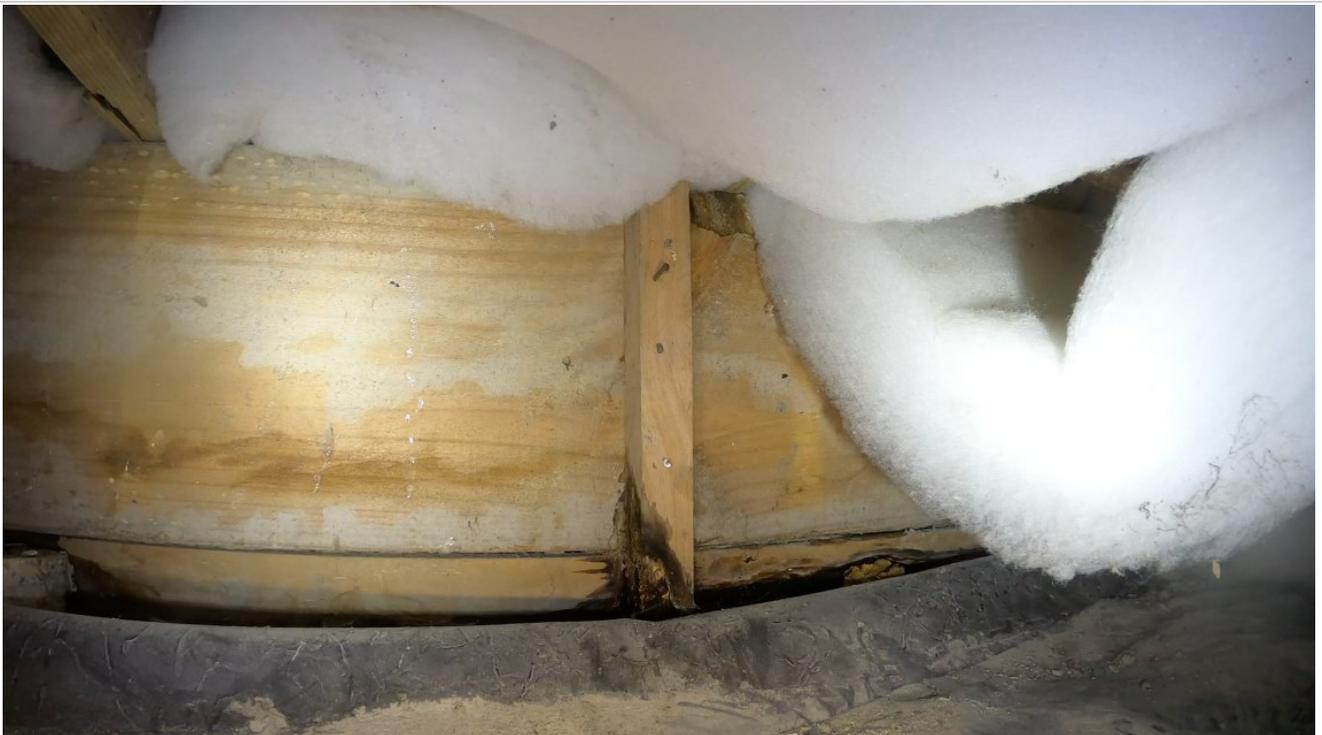
10: View of rotting boxing.

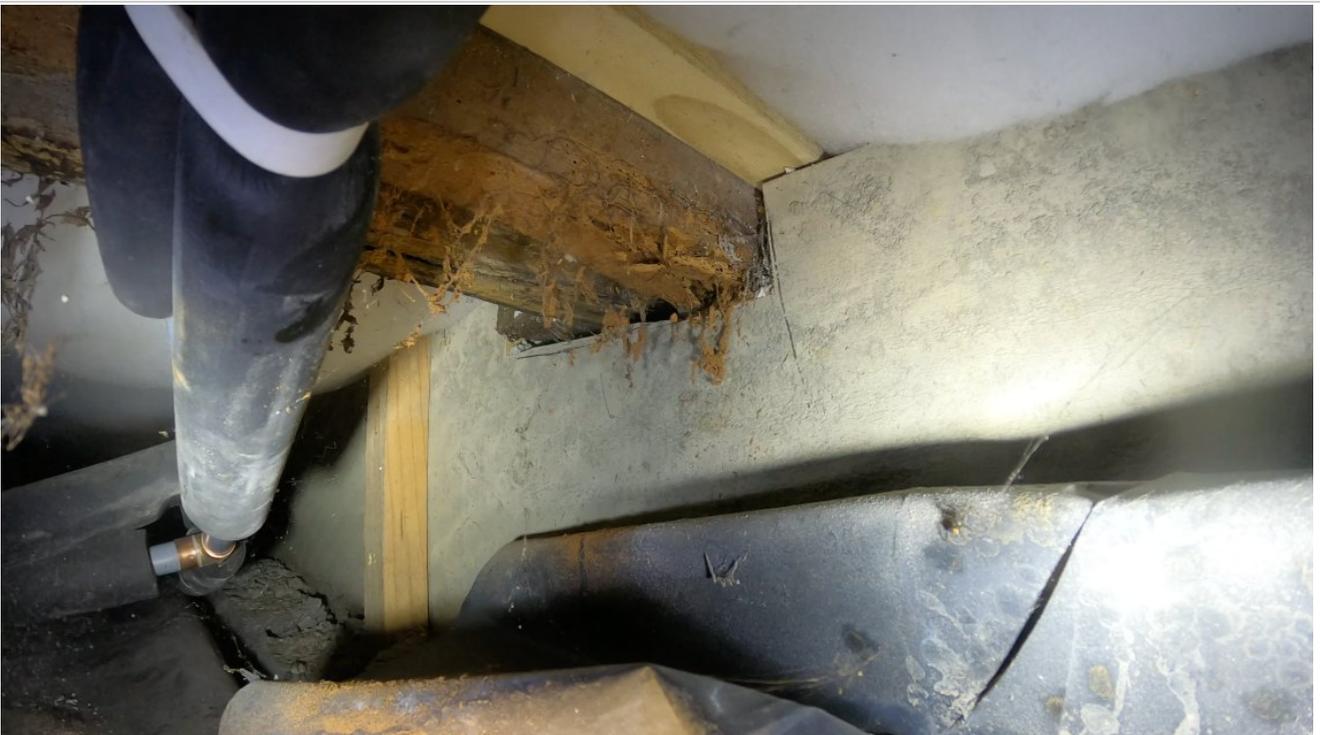
12: Here we see some original timber left in place but in poor condition.

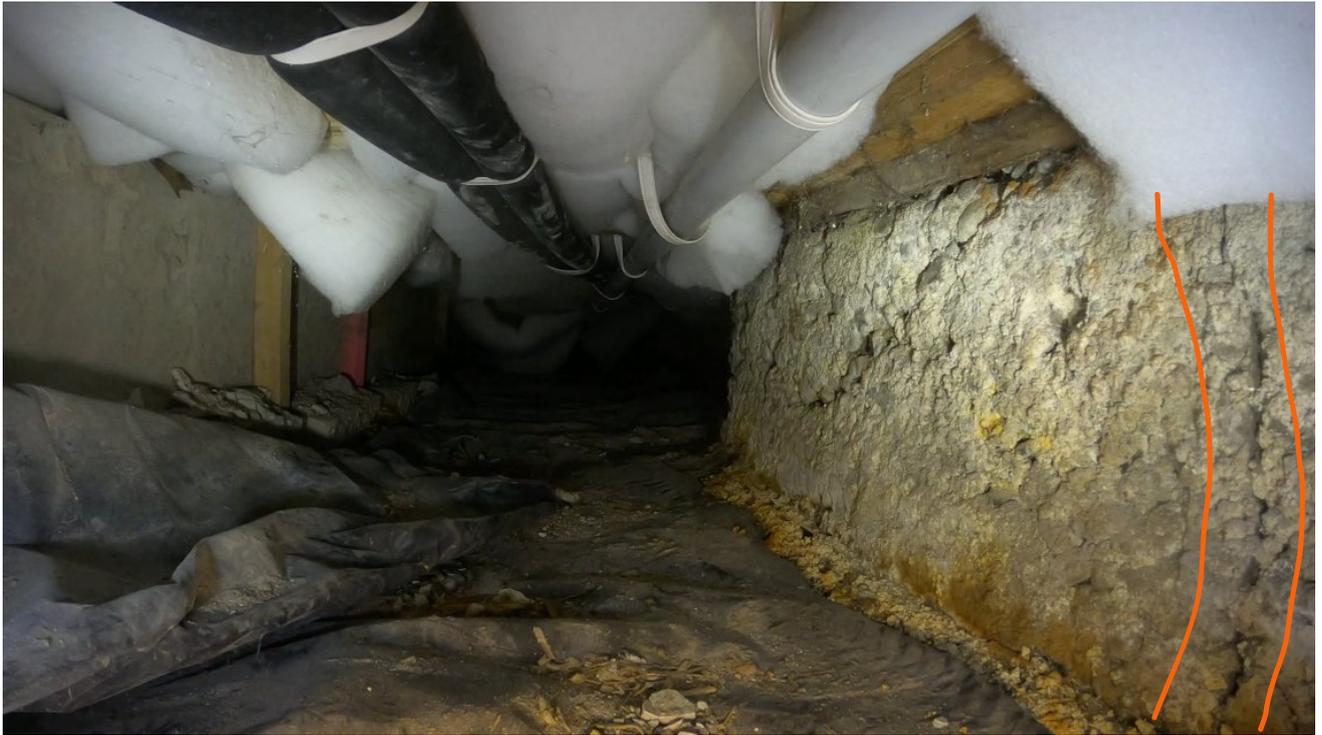
13: View along chimney breast with crack. These cracks are important as the concrete chimney breasts are still holding the load of the flooring and walls.

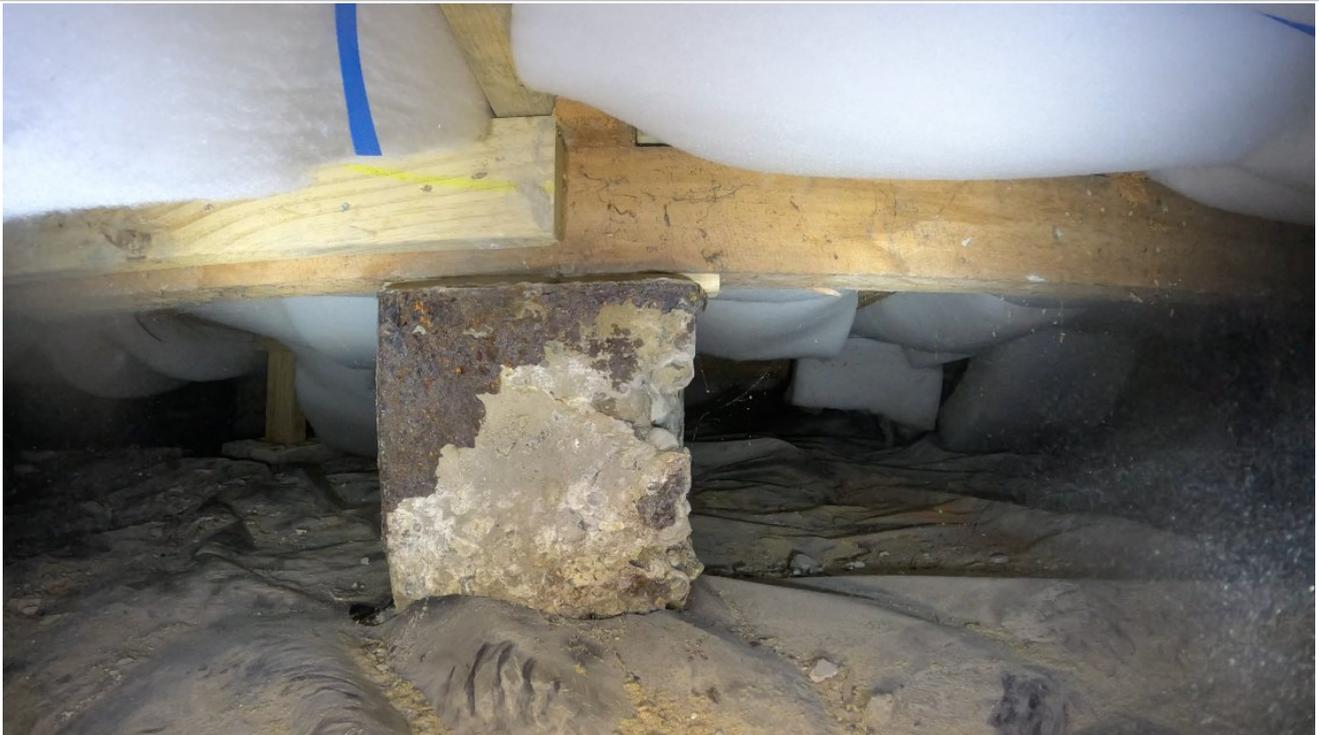
15: The home has concrete piles cast in jerry cans that have rusted away. The concrete used in these is very poor quality and they are not suitable to pack off, but this has been done. On top of this the packers are not compliant, and no effort has been made to connect the piles to the bearers, as is required.

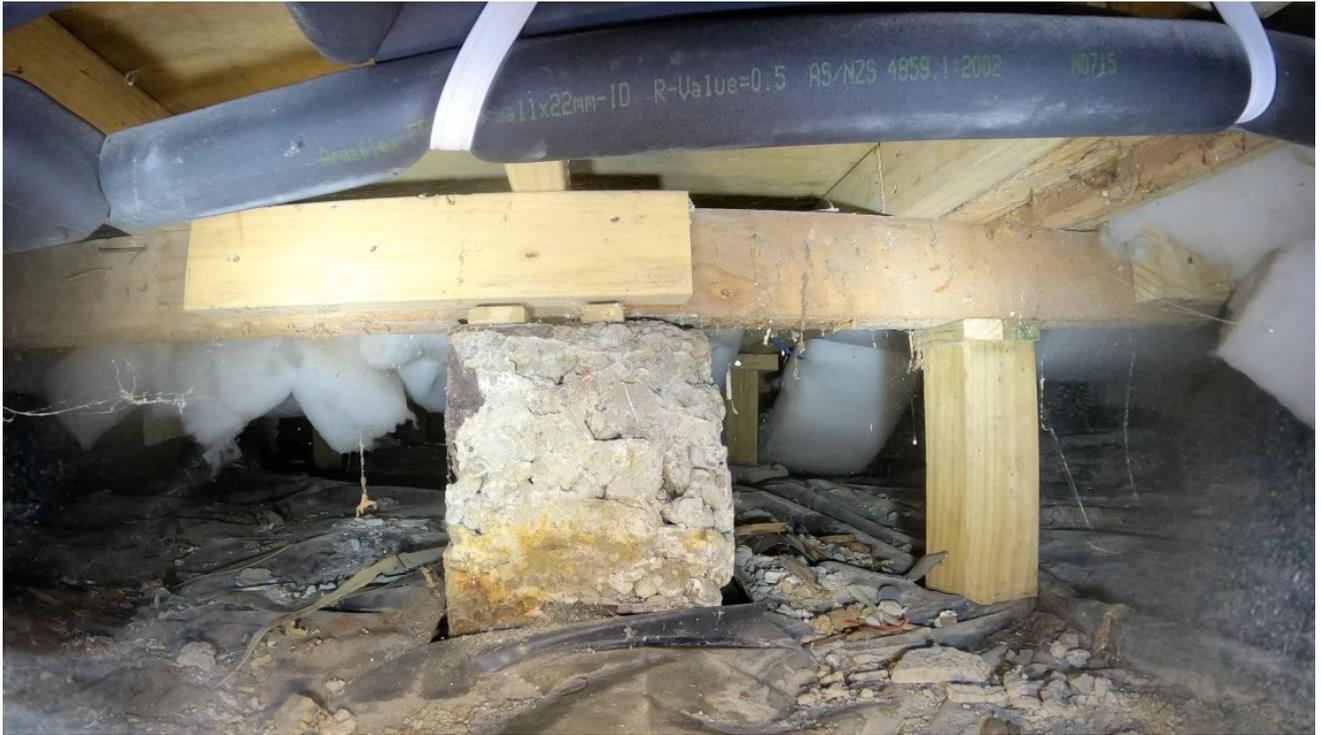
17: Jerry can pile with packing and no connection.

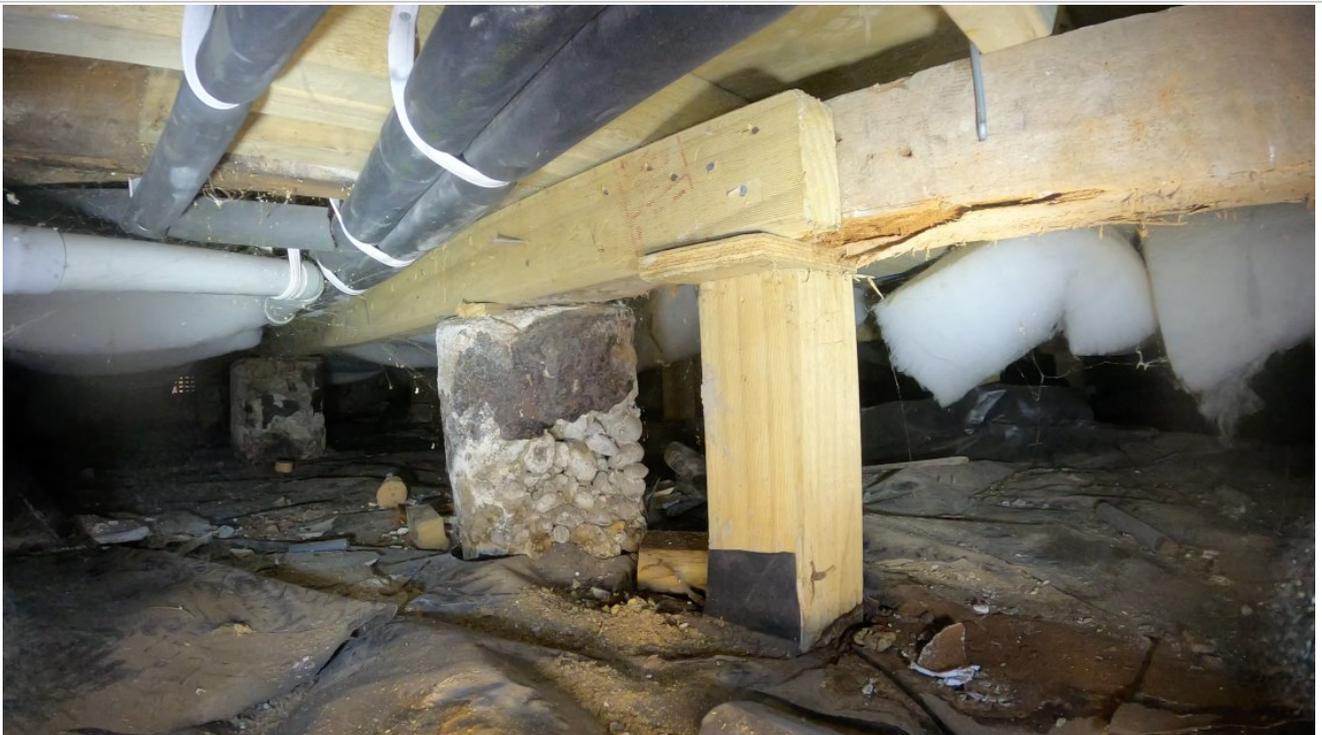
18: Here we see that the bearer is in poor condition but has been left in place with new timber being fixed to it.

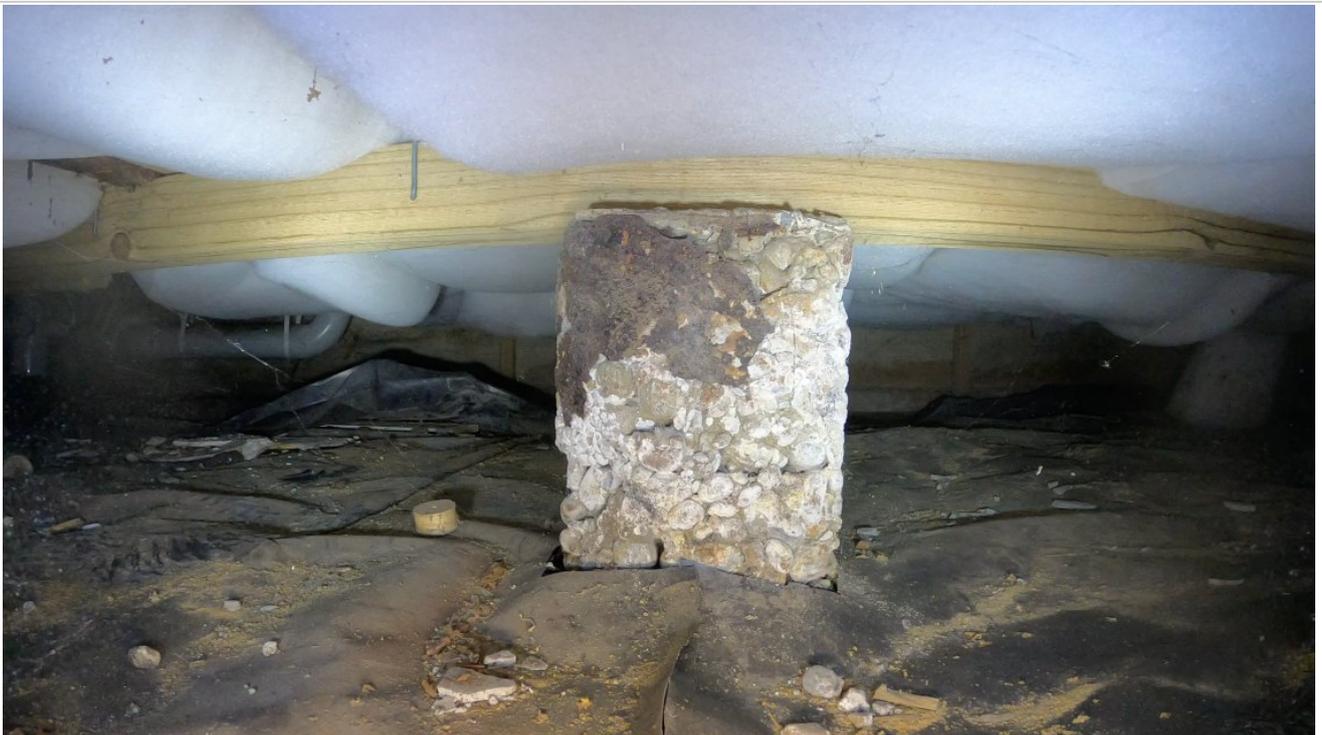
20: Jerry can pile with no connection.

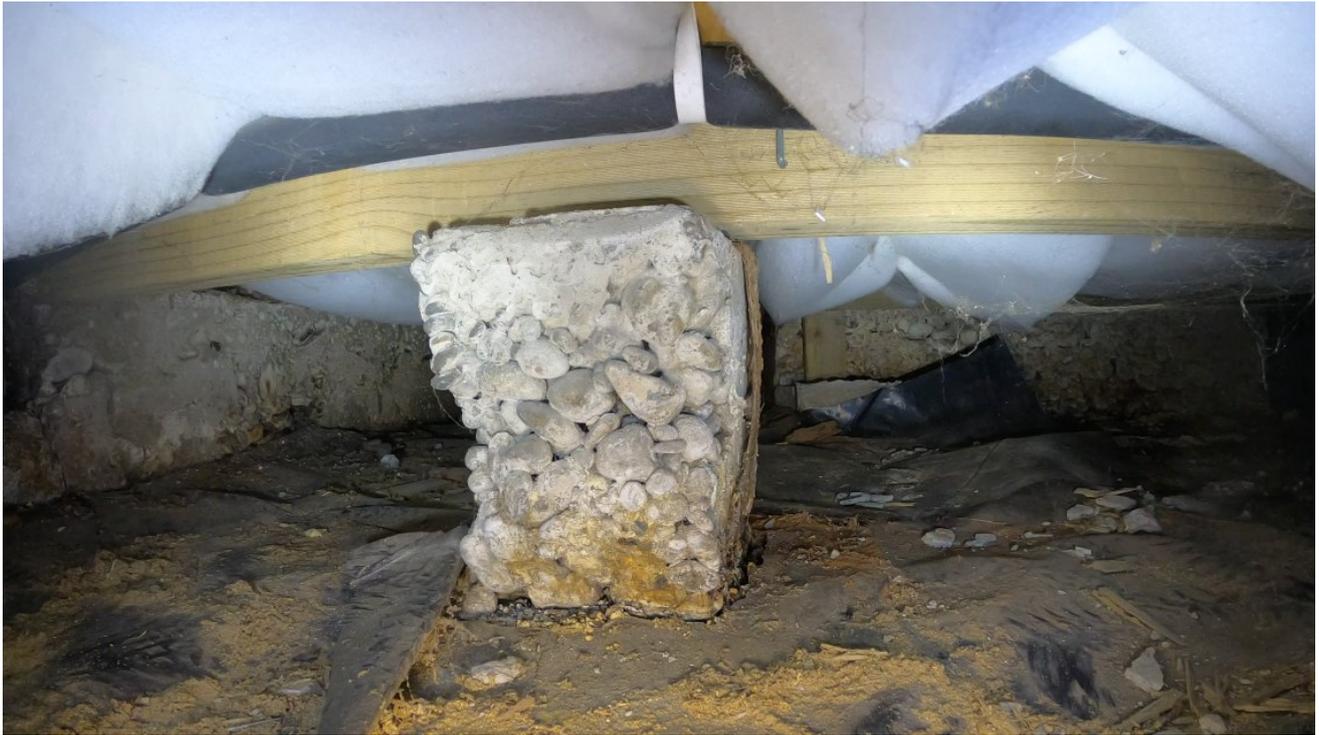
21: Jerry can pile with no connection.

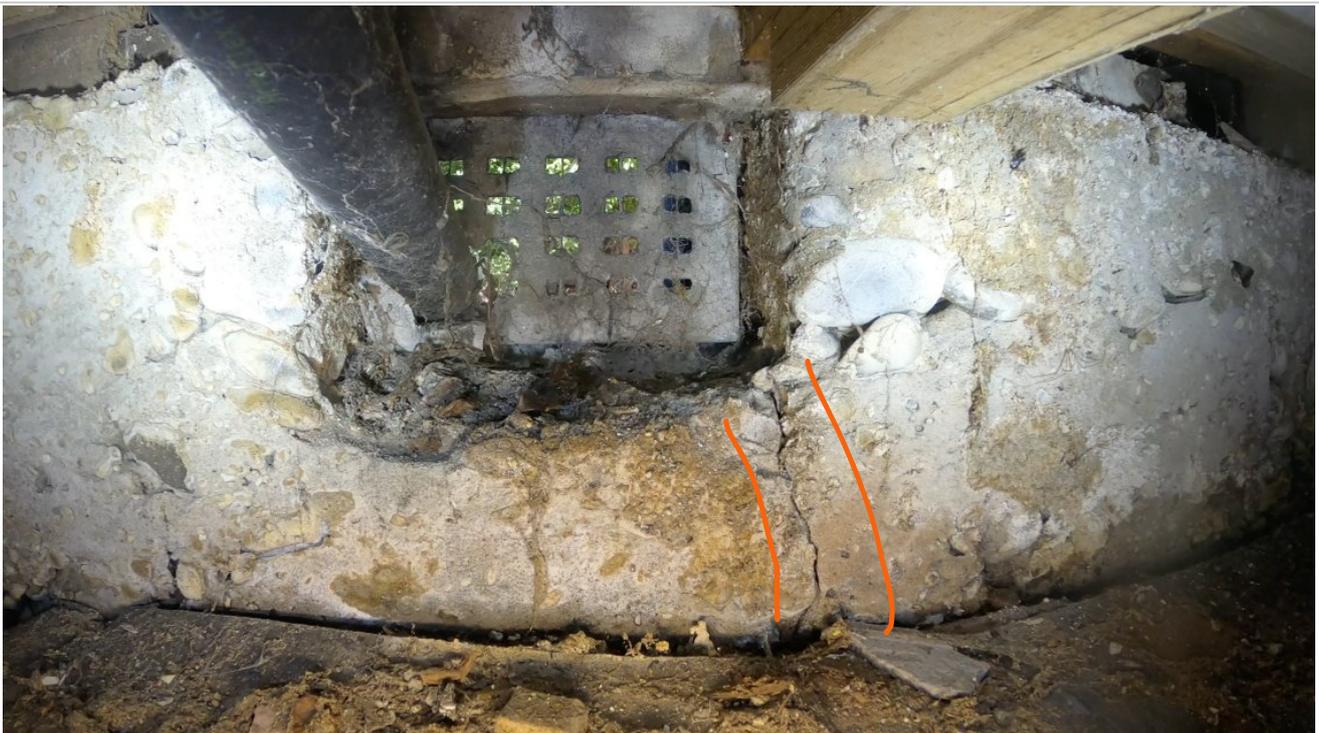
22: View of bearer meeting ring foundation with cracking. The foundations are average to poor quality type "B" rubble foundations. There has been extensive use of large stones in the aggregate. These can weaken the concrete and often create voids which affect epoxy repairs. It is not unusual to see fine cracking at the corner of vents and these existed pre-earthquakes however, the cracks we see are not just at the vents and are larger than would be expected. None show any sign of being repaired, so if the EQC scope of repairs says otherwise this would be important.

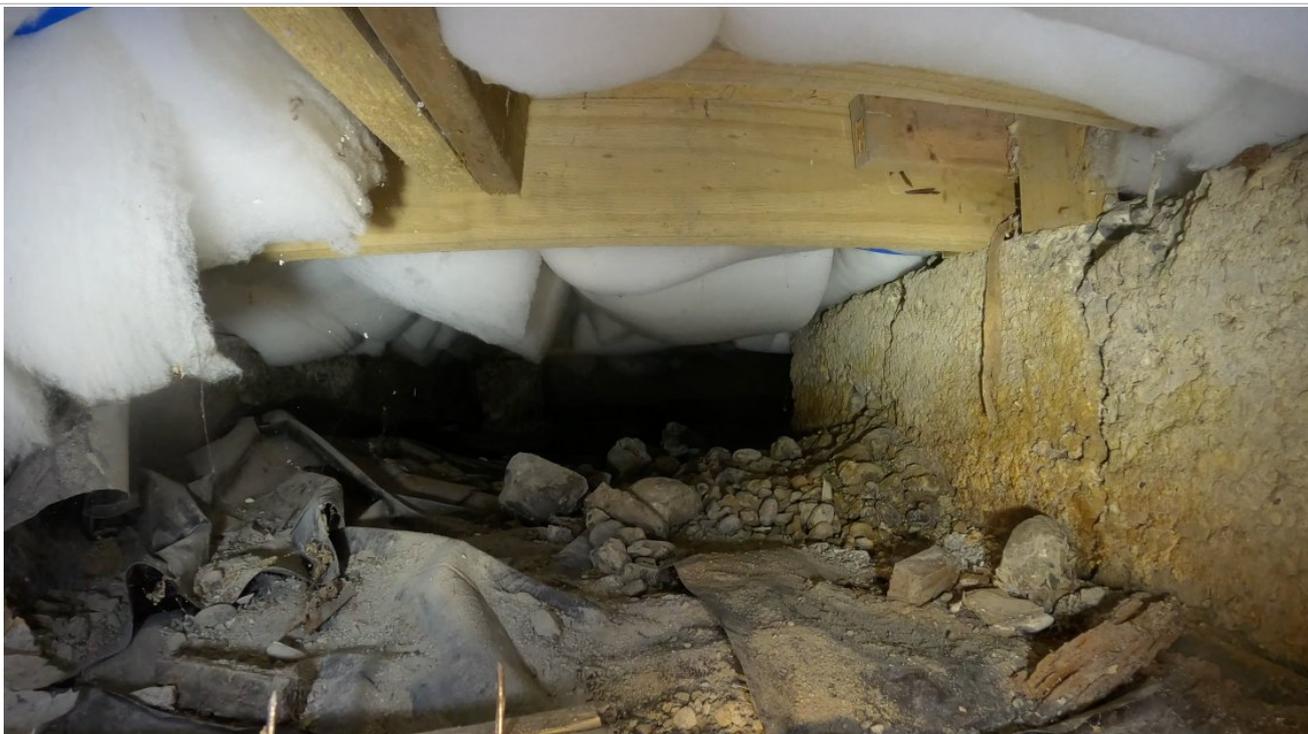
26: This is a replacement bearer, and it is not fixed to the chimney breast, nor is there any dampcourse evident.

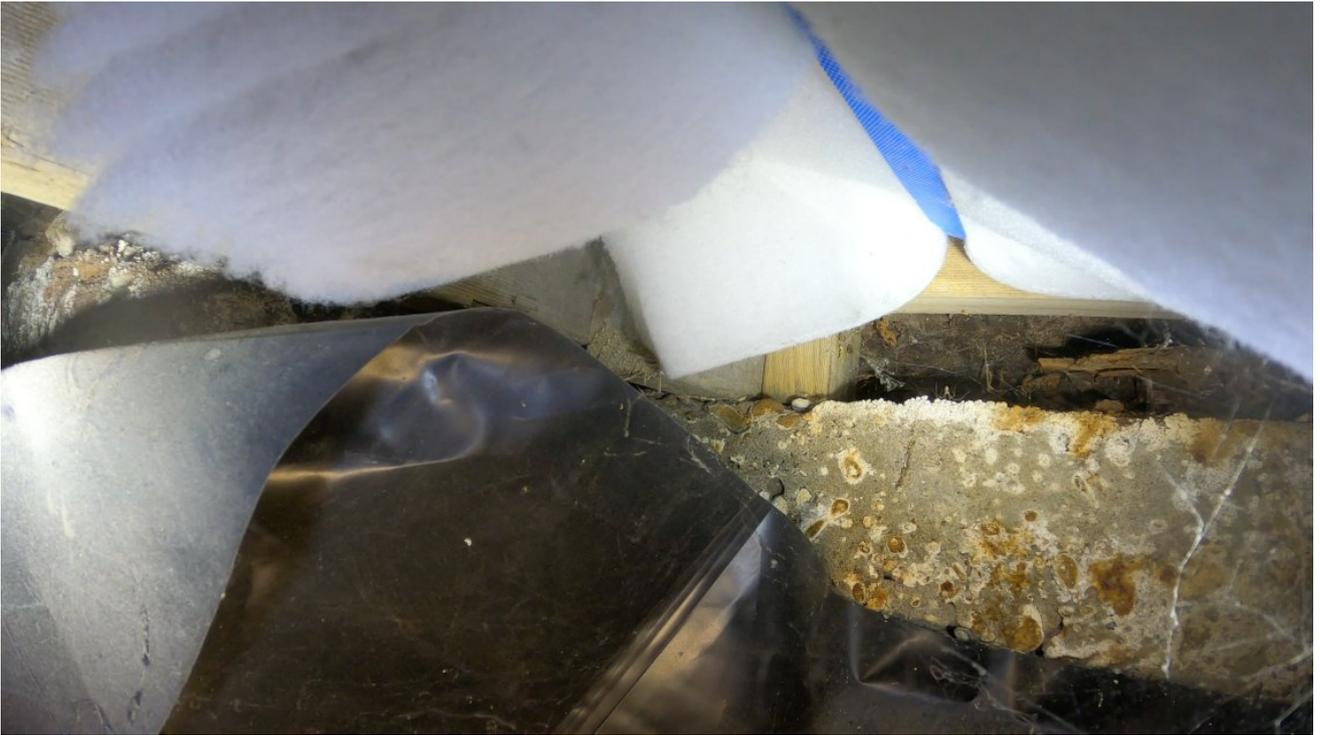
29: View of ring foundation with rotten timber.

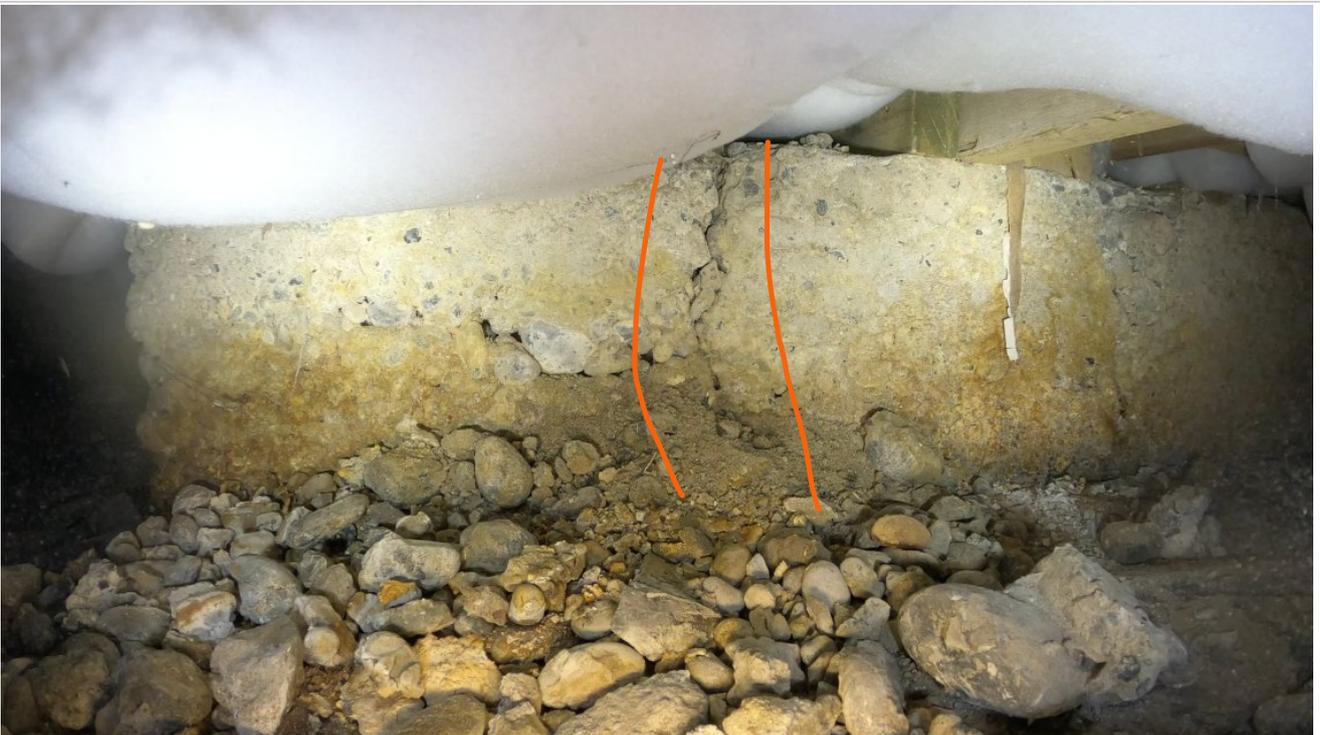
30: View of the chimney breast with cracking.

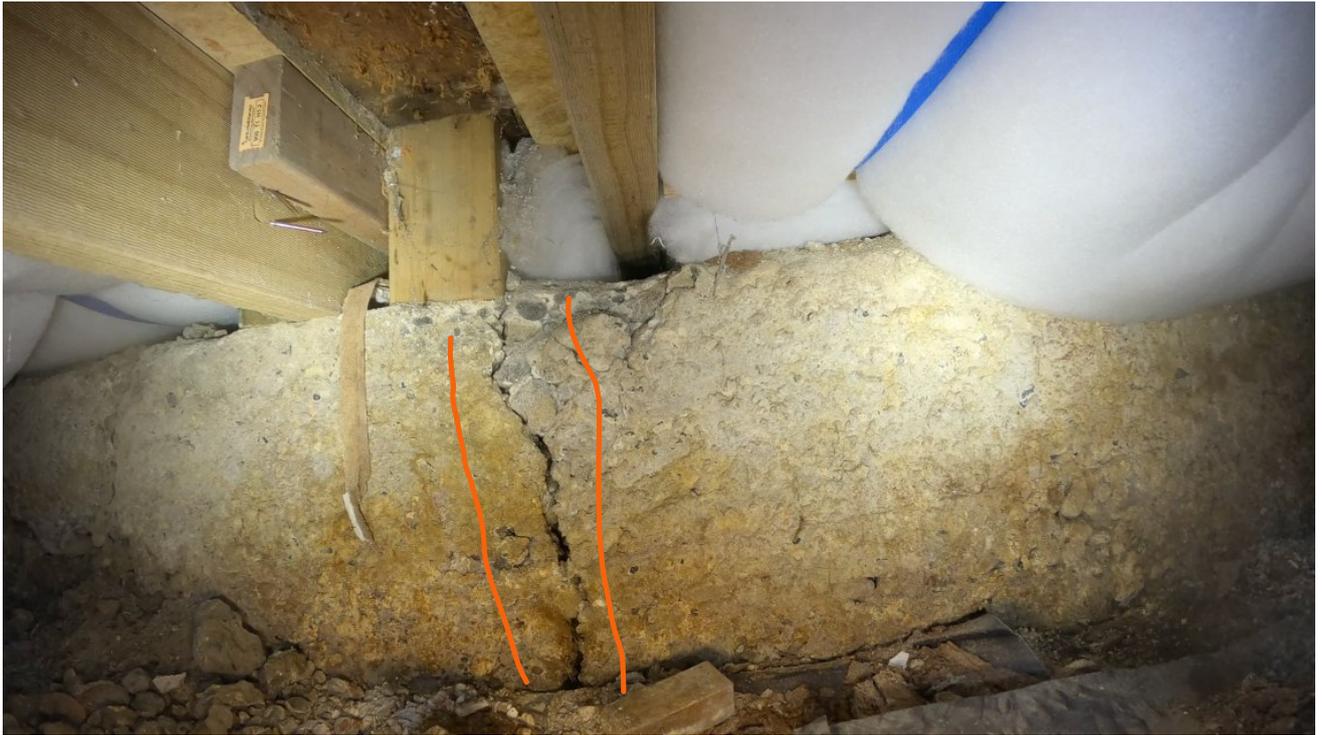
31: View of the chimney breast with cracking. Note the rotten wall plate supported on a block of timber.

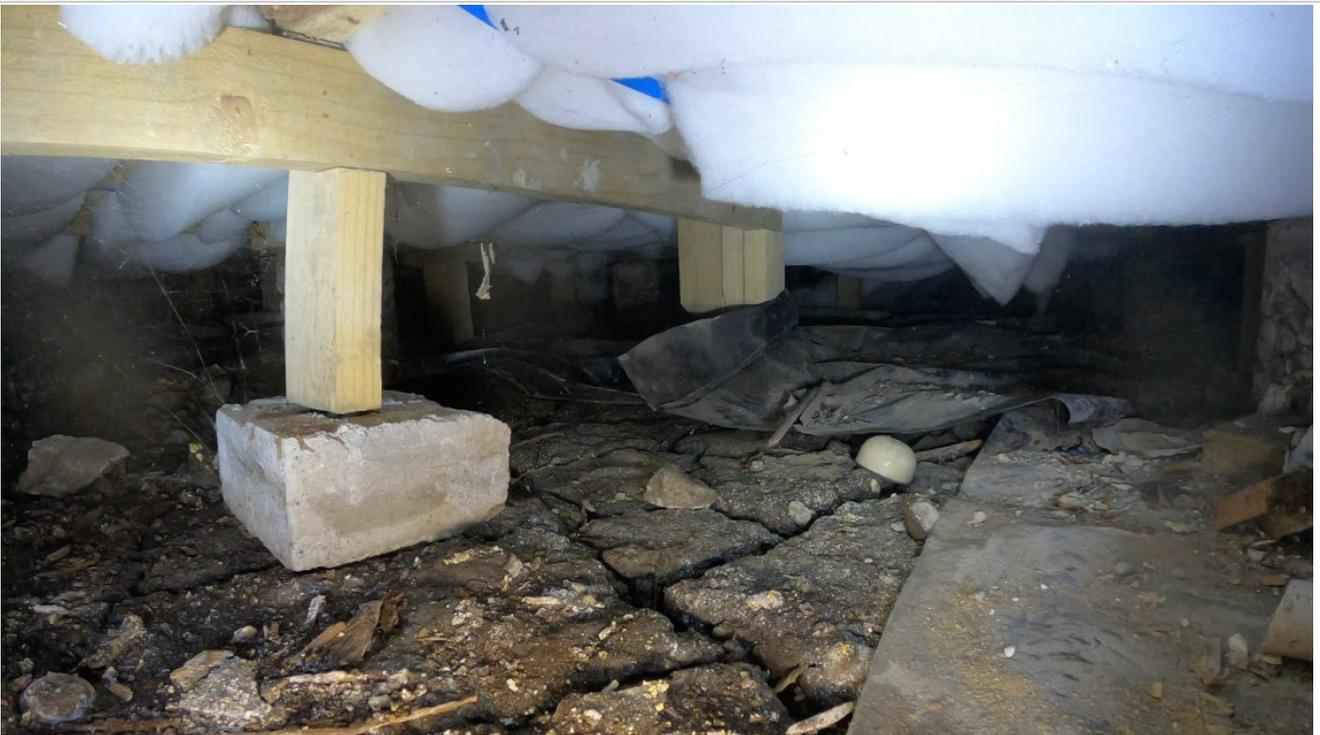
34: View of propping. In this view we can see significant ground cracking. This is typical of a subfloor that has suffered flooding and the upper layer has dried allowing it to shrink. This can have a negative effect on the grounds ability to hold the piles.

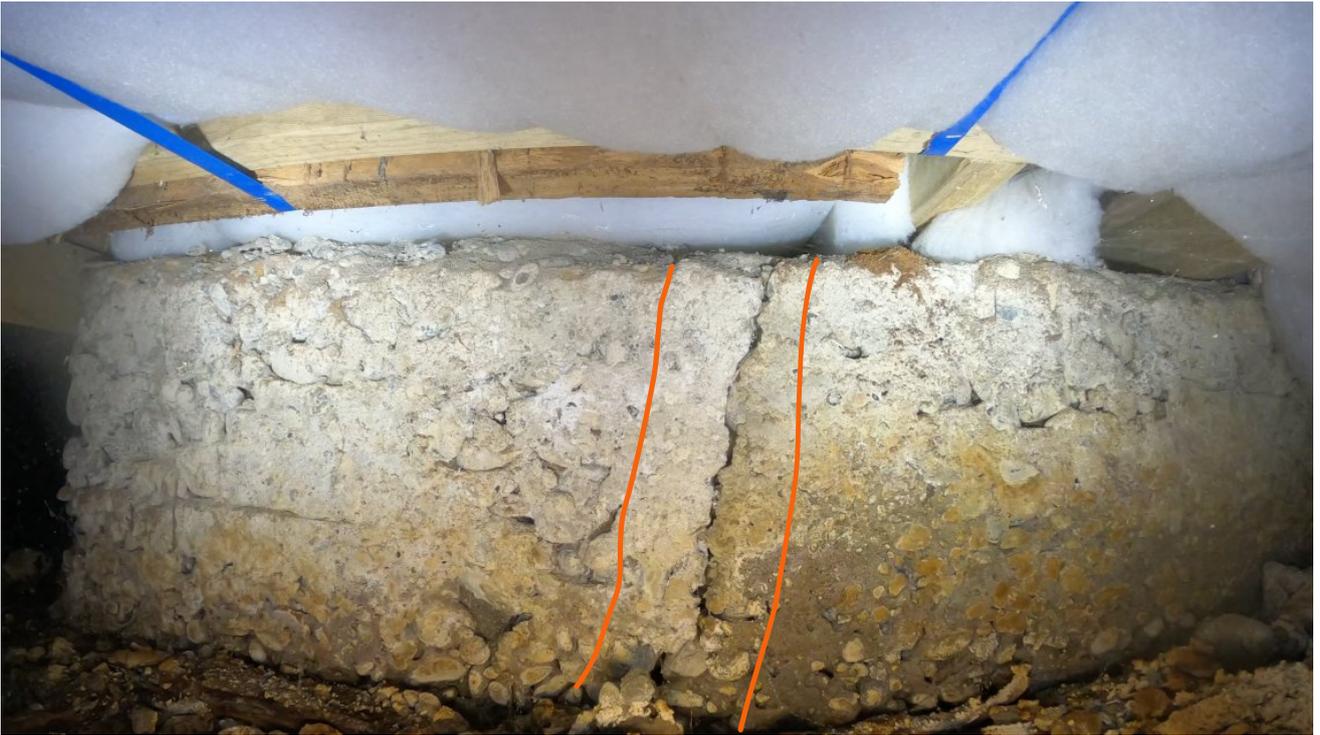
35: View of the chimney breast with cracking.

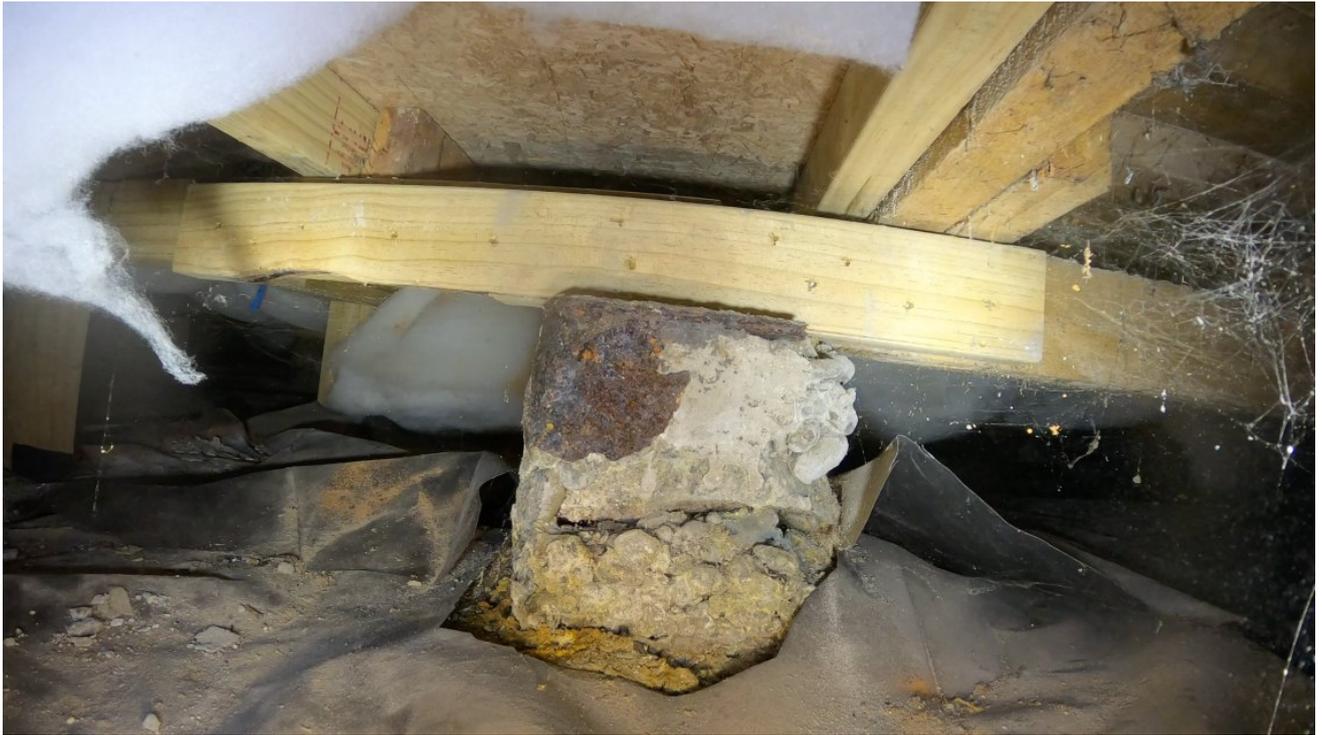
41: Jerry can pile with no connection. Note the use of particle board. It is not rated for use this close to the ground and we often see it with mould growing on it when used in this manner.

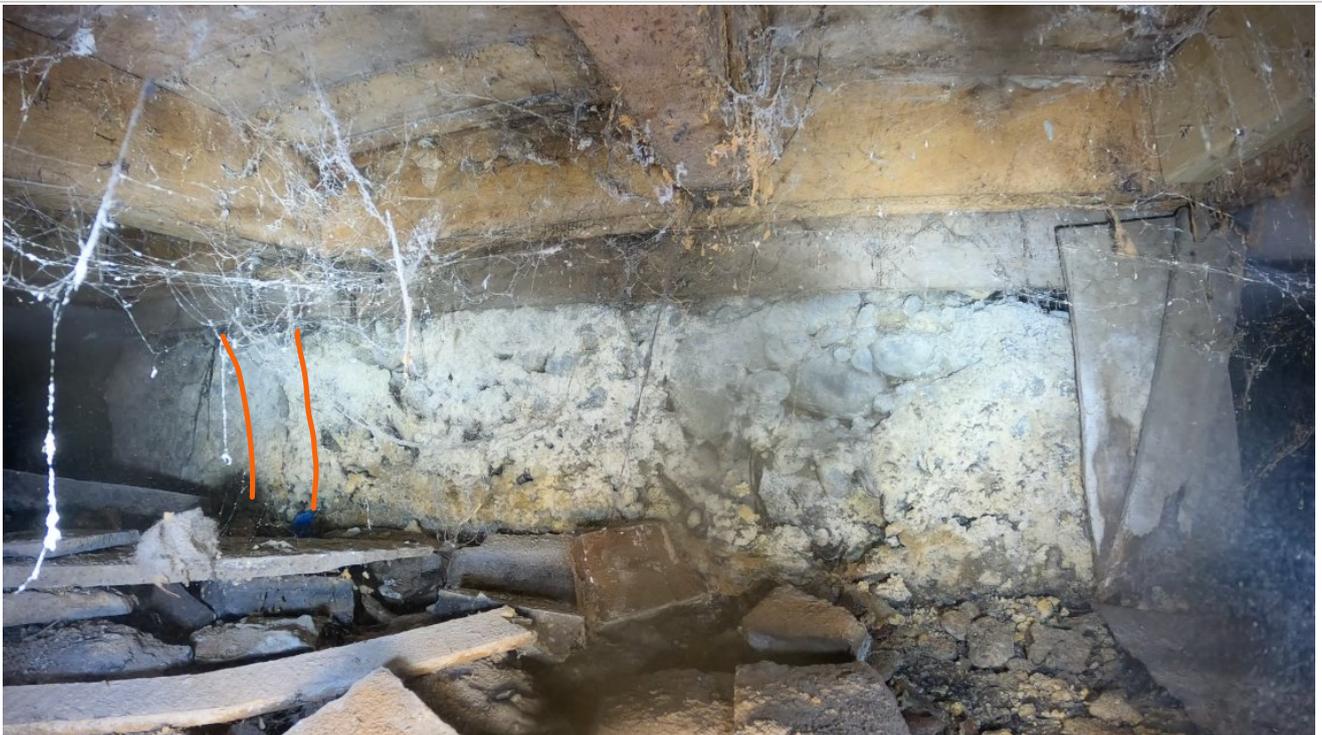
42: View of the chimney breast with cracking.
