Under floor Inspections

Report prepared for: Claire Holmes

Property address: 41 Mackenzie Avenue, Woolston

Date: 14 February 2023

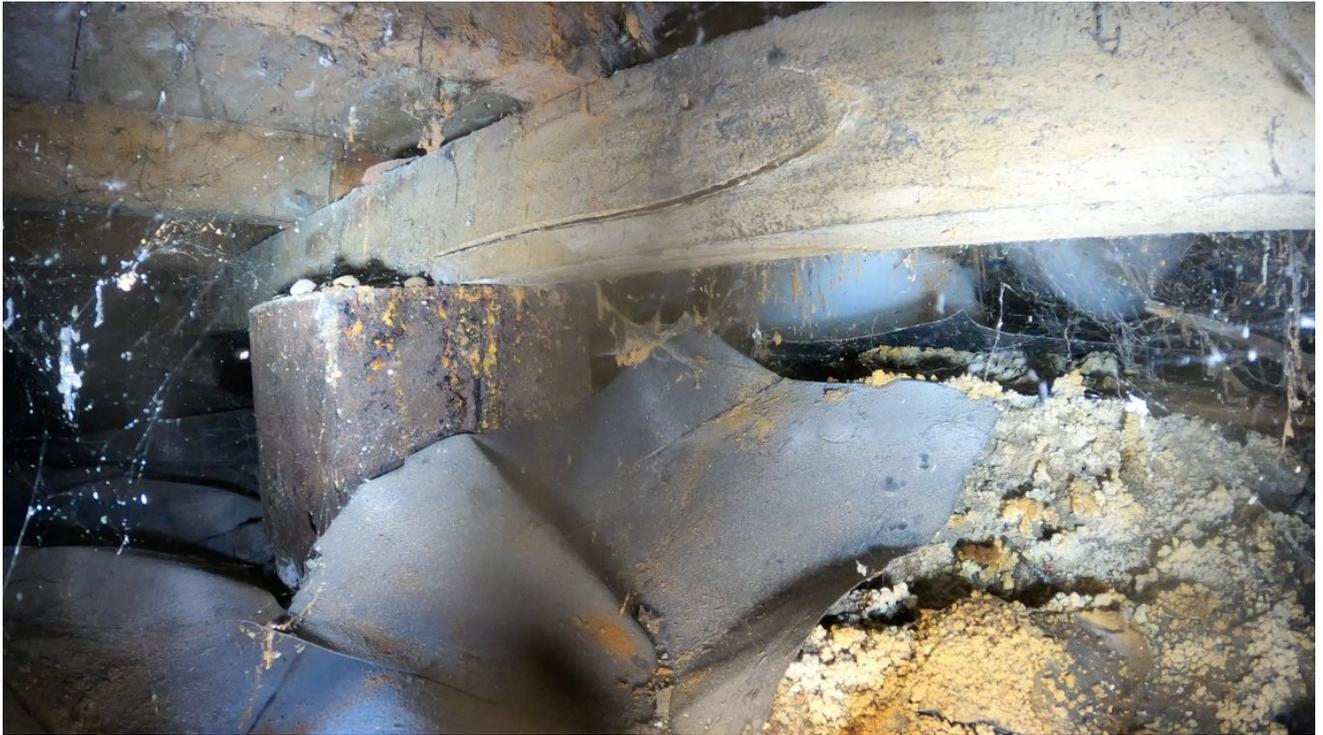
43: Jerry can pile with no connection.

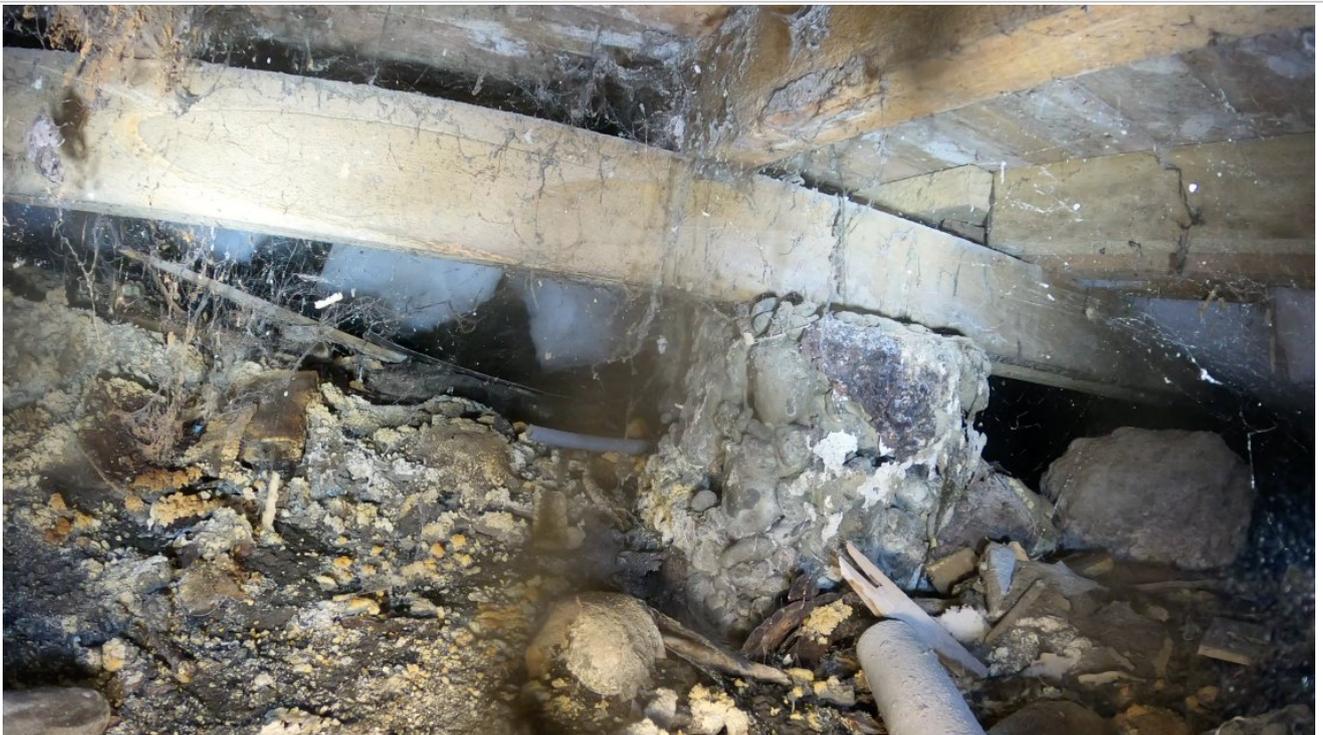
44: Jerry can pile with no connection.

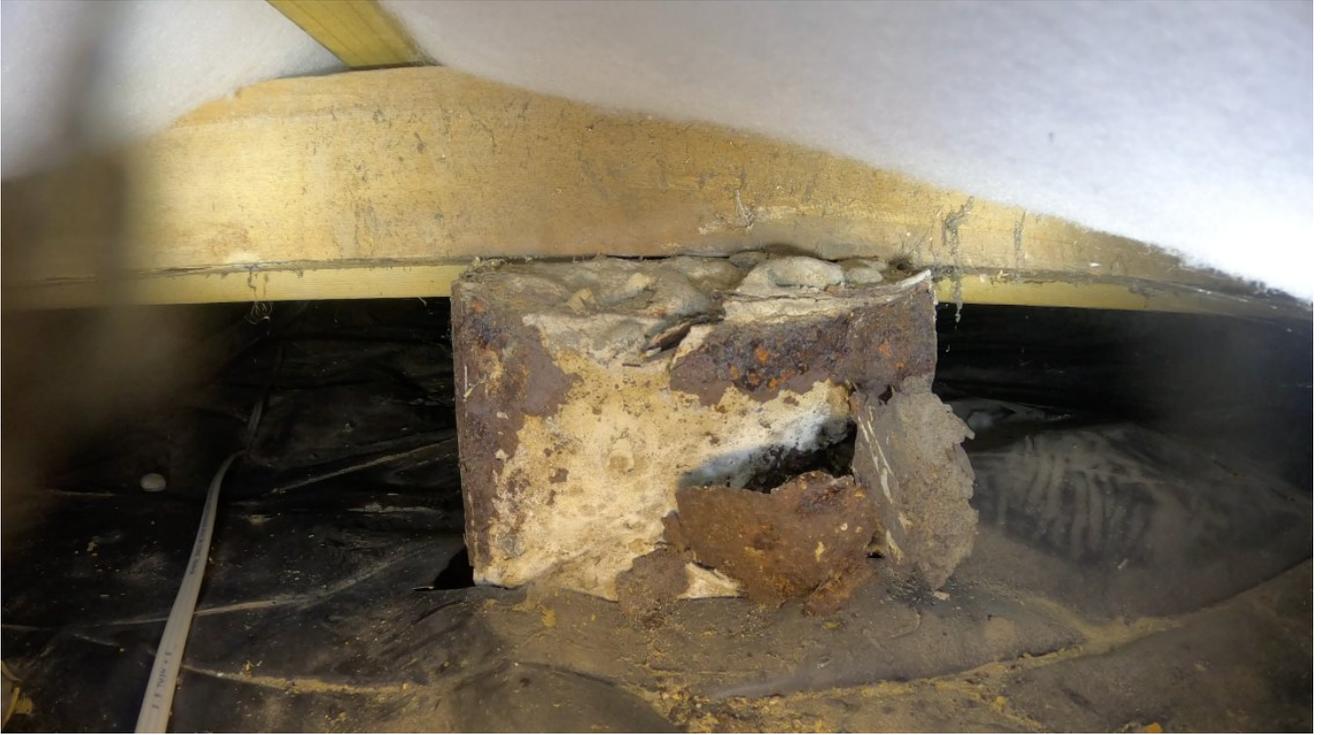
45: Jerry can pile with no connection.

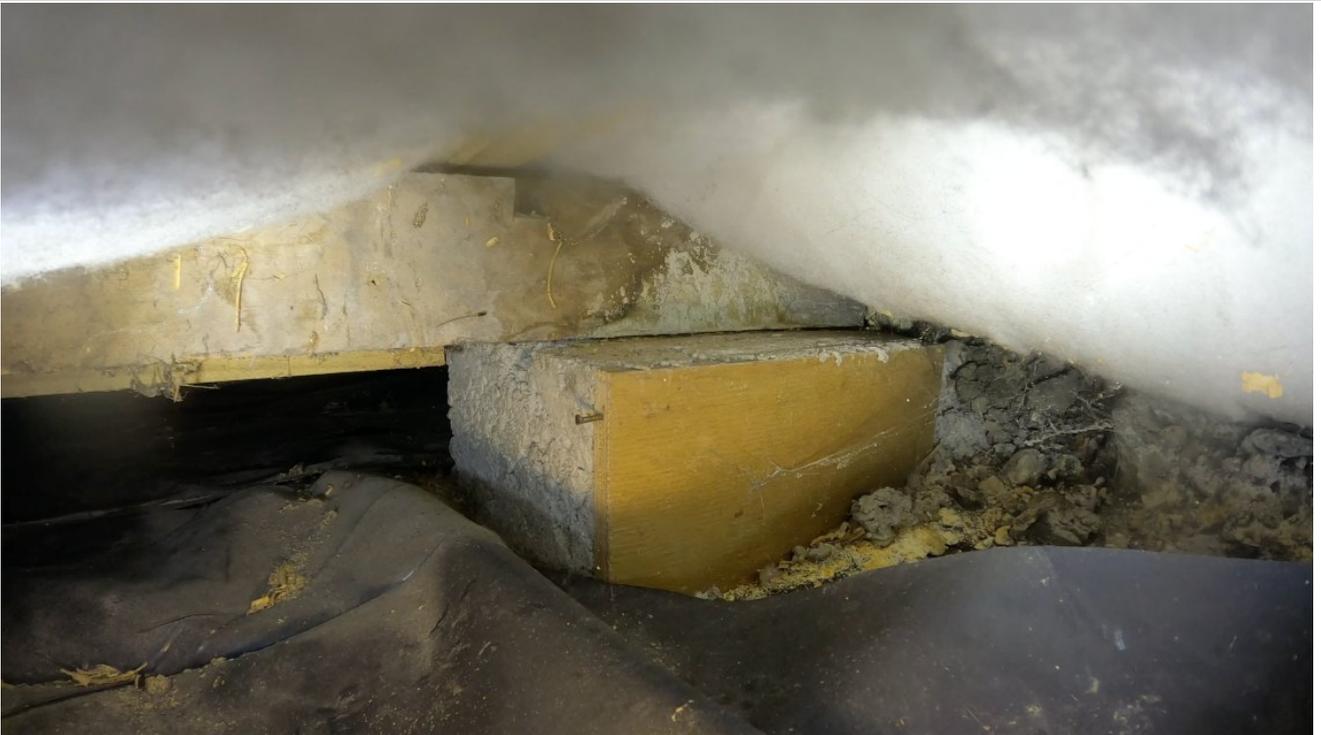
46: New concrete piles have been cast down this end of the home to support the bearers. No dampcourse has been used and no fixings are evident.

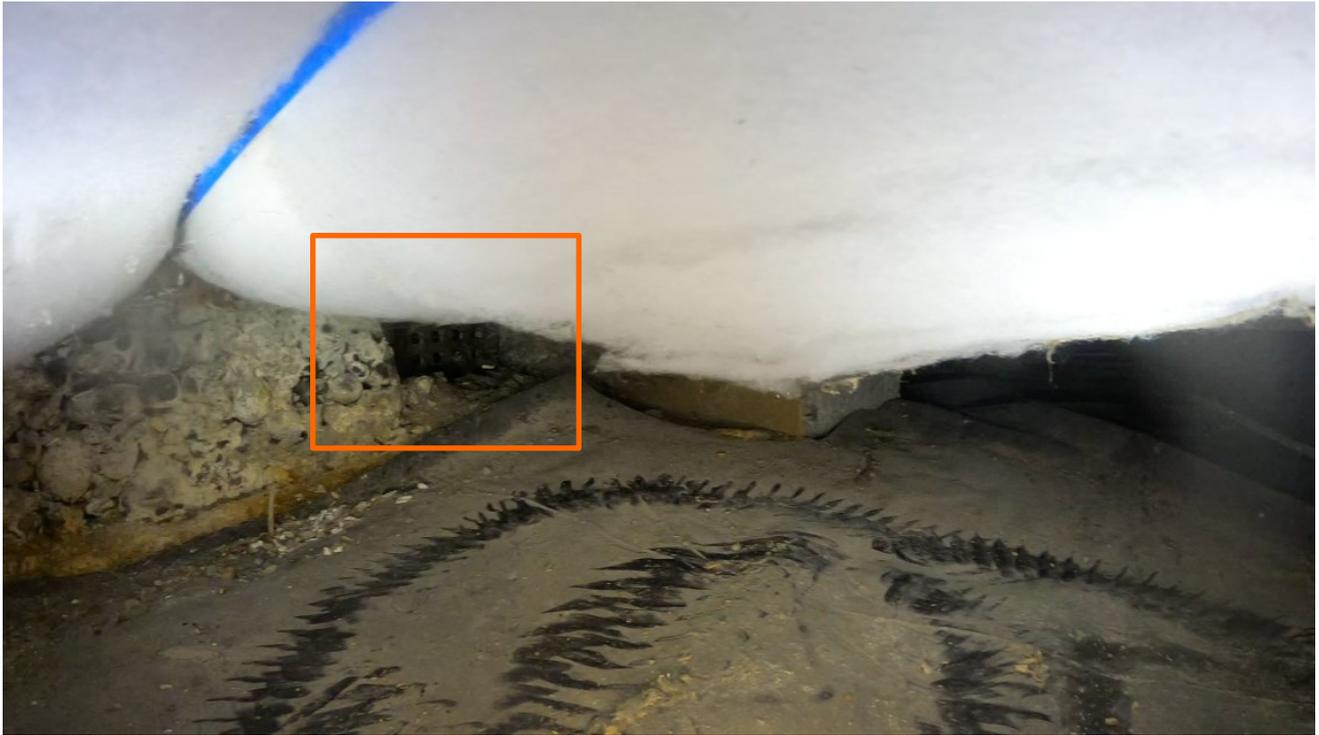
47: View of ring foundation. Note there is no evident daylight visible in one of the few vents we do see. Also, some of the insulation is falling down in areas, as seen here.

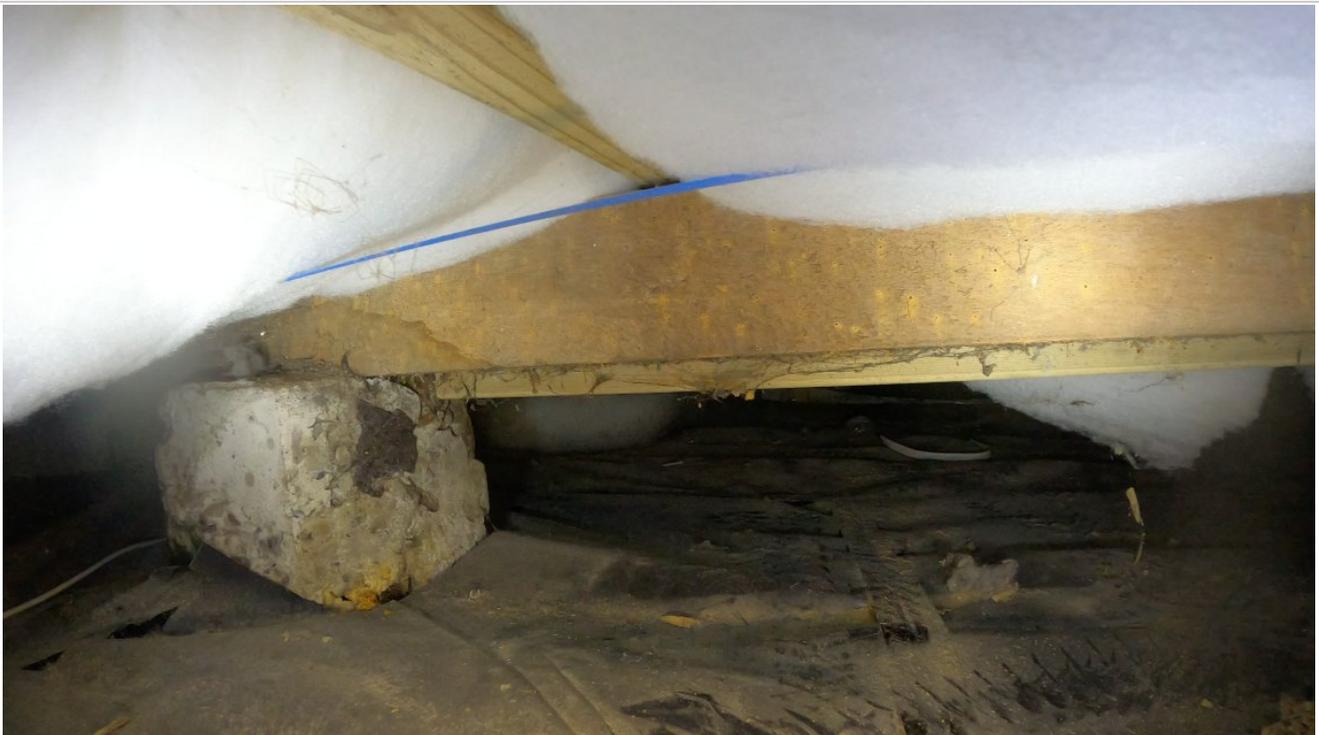
48: Jerry can pile with no connection. This bearer has extensive borer.

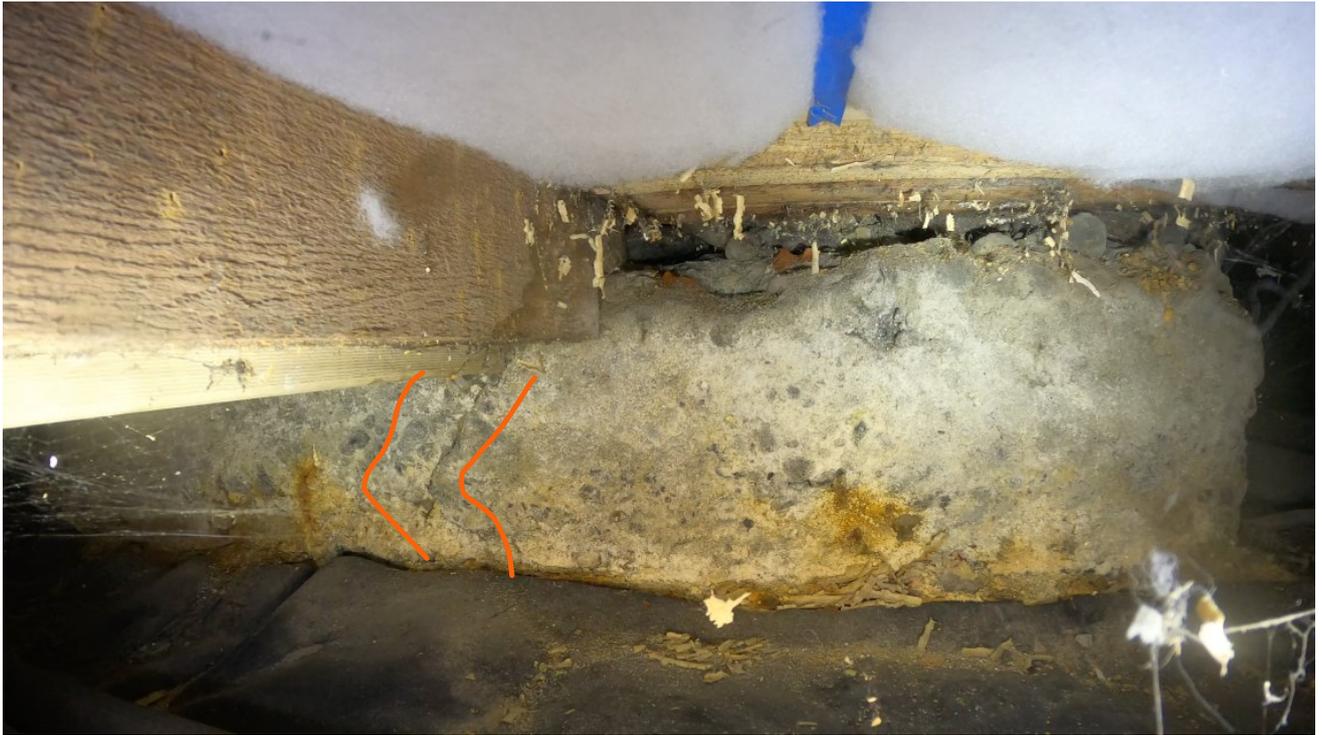
49: View of bearer meeting chimney breast with cracking.

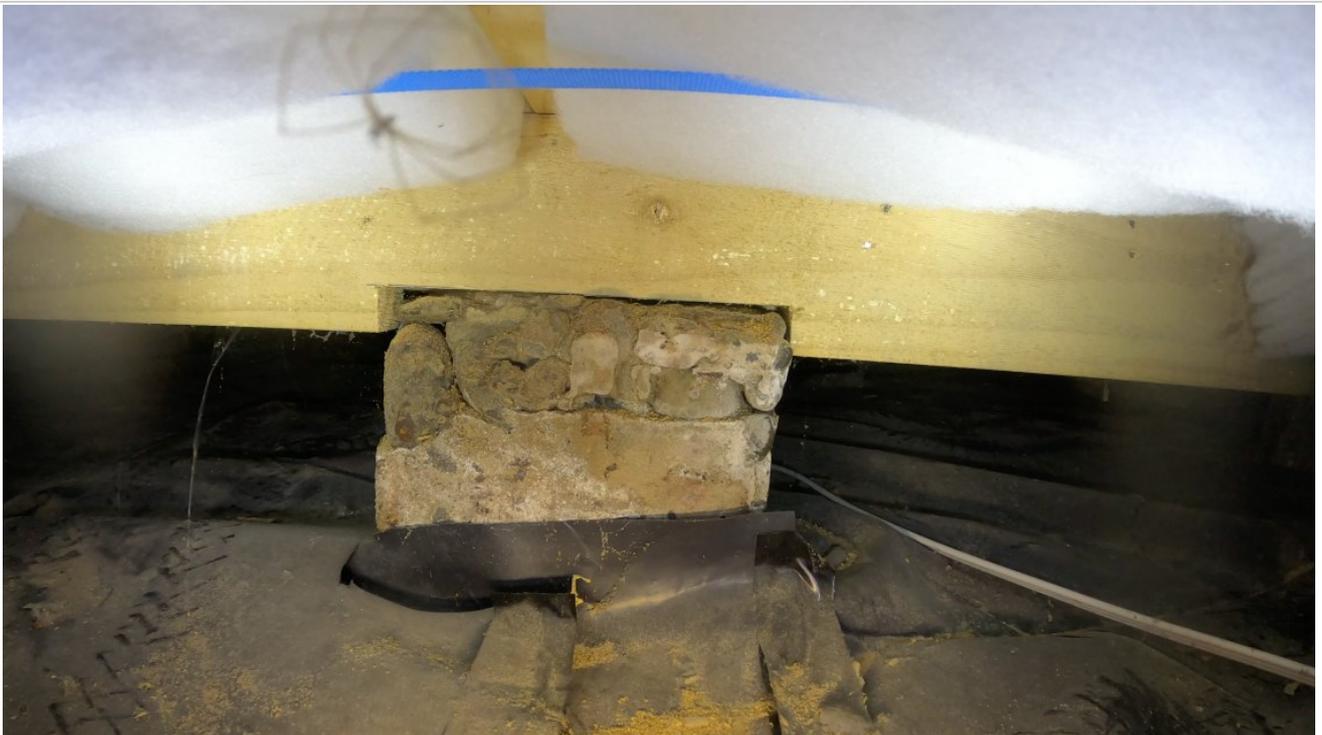
50: The bearer has been clashed on one side. The old bearer should have been removed.

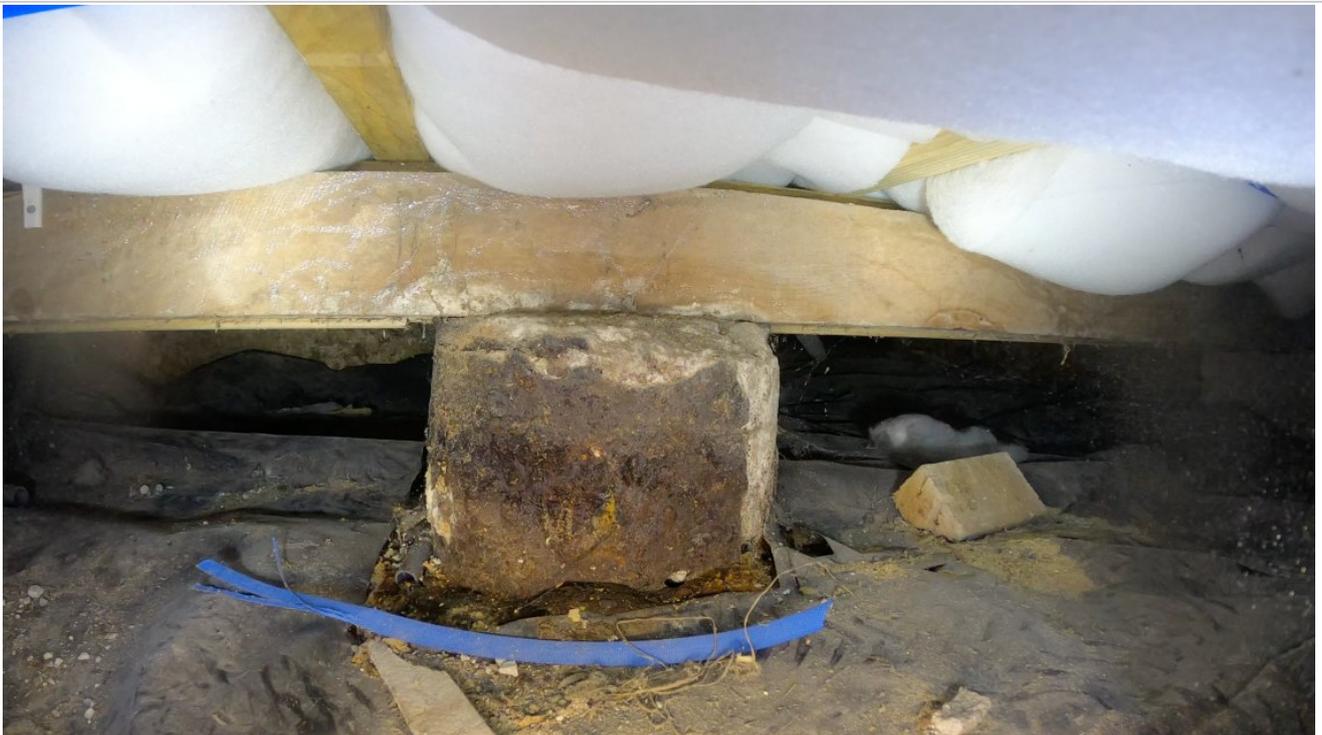
54: Jerry can pile with no connection.

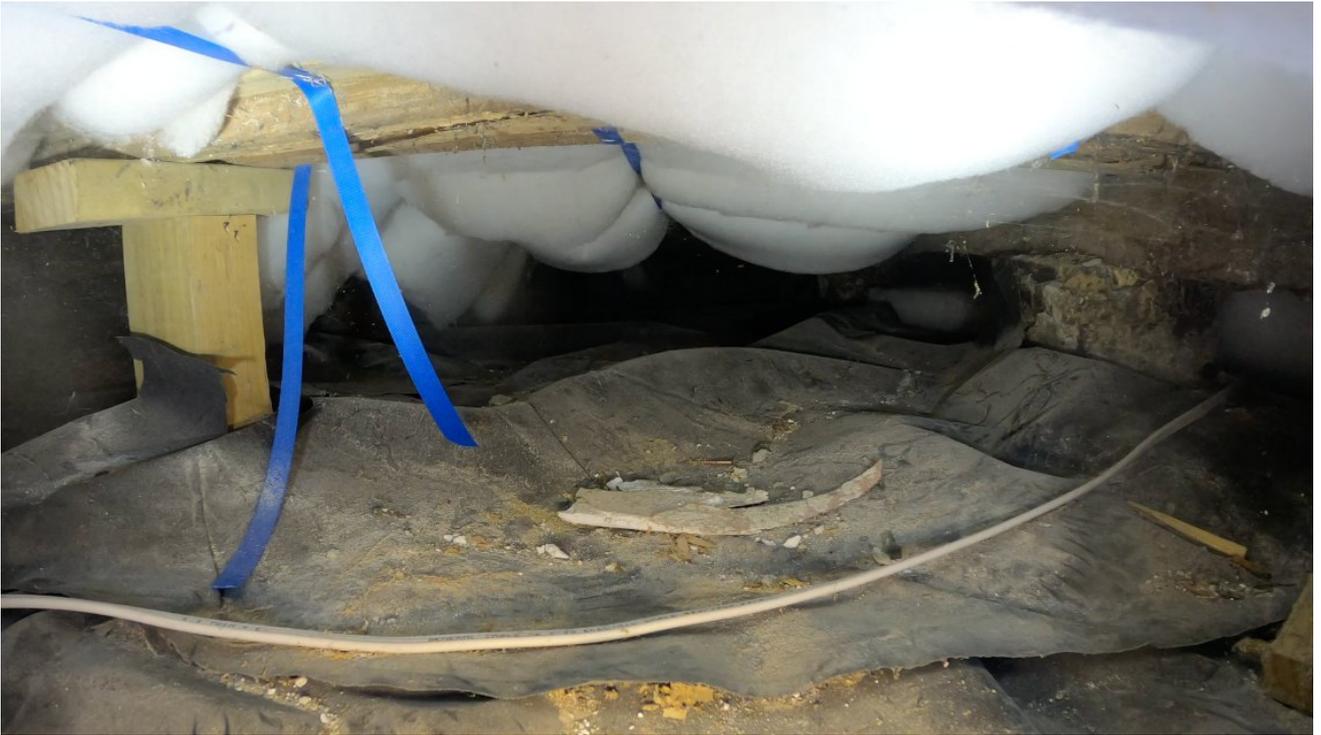
55: View of propping and the joist is cracked.

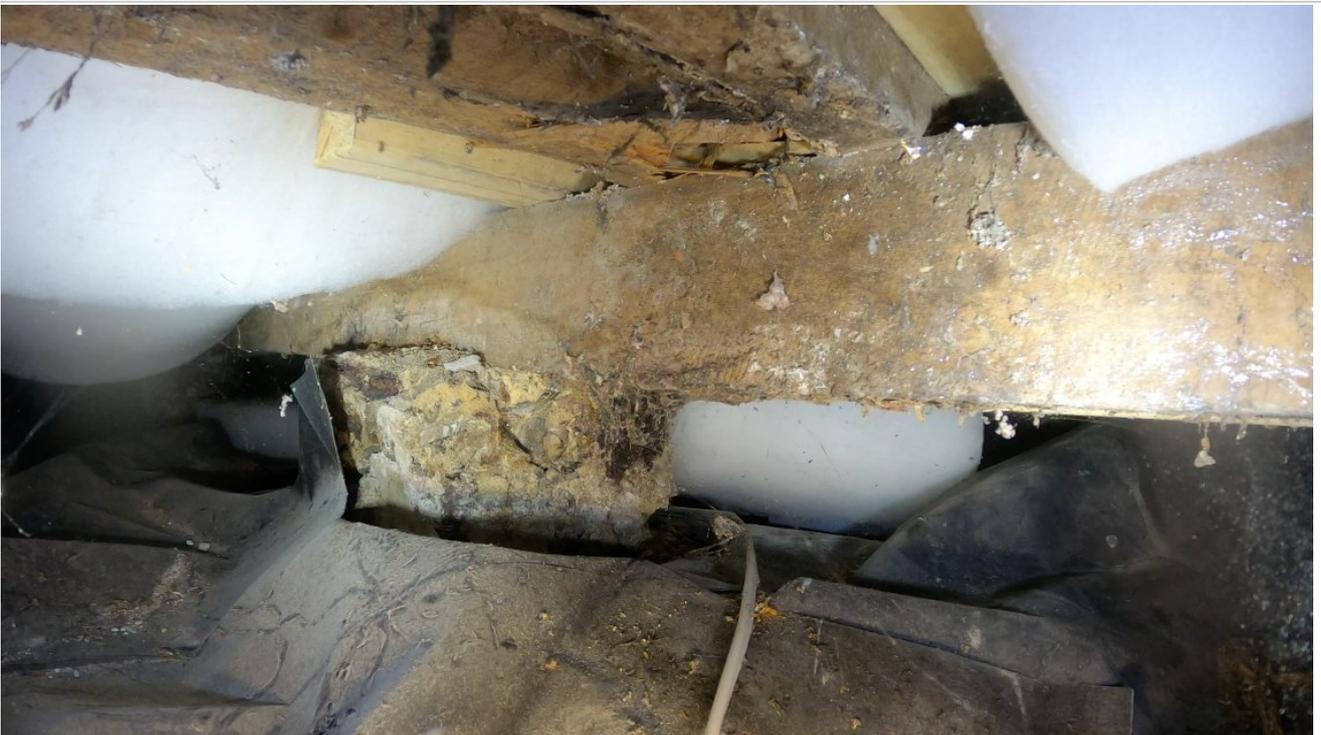
56: Jerry can pile with no connection.

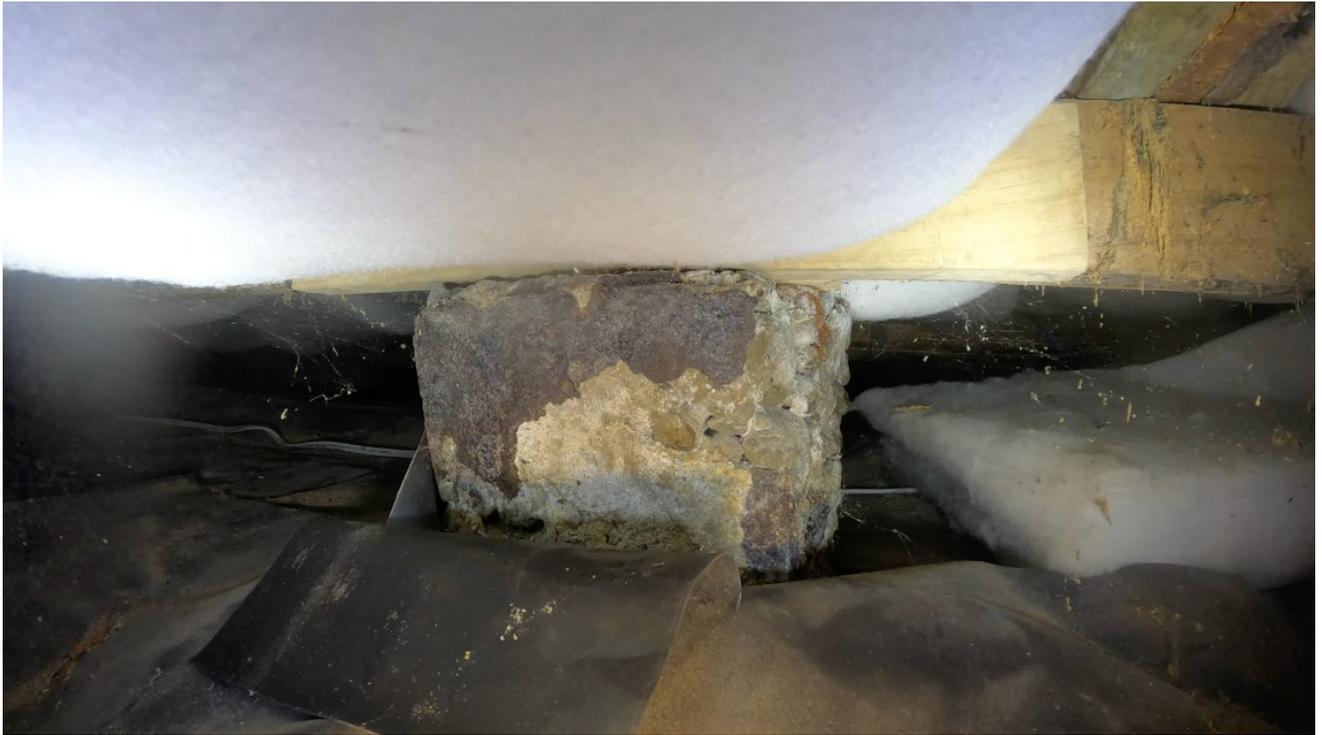
57: Jerry can pile with no connection.

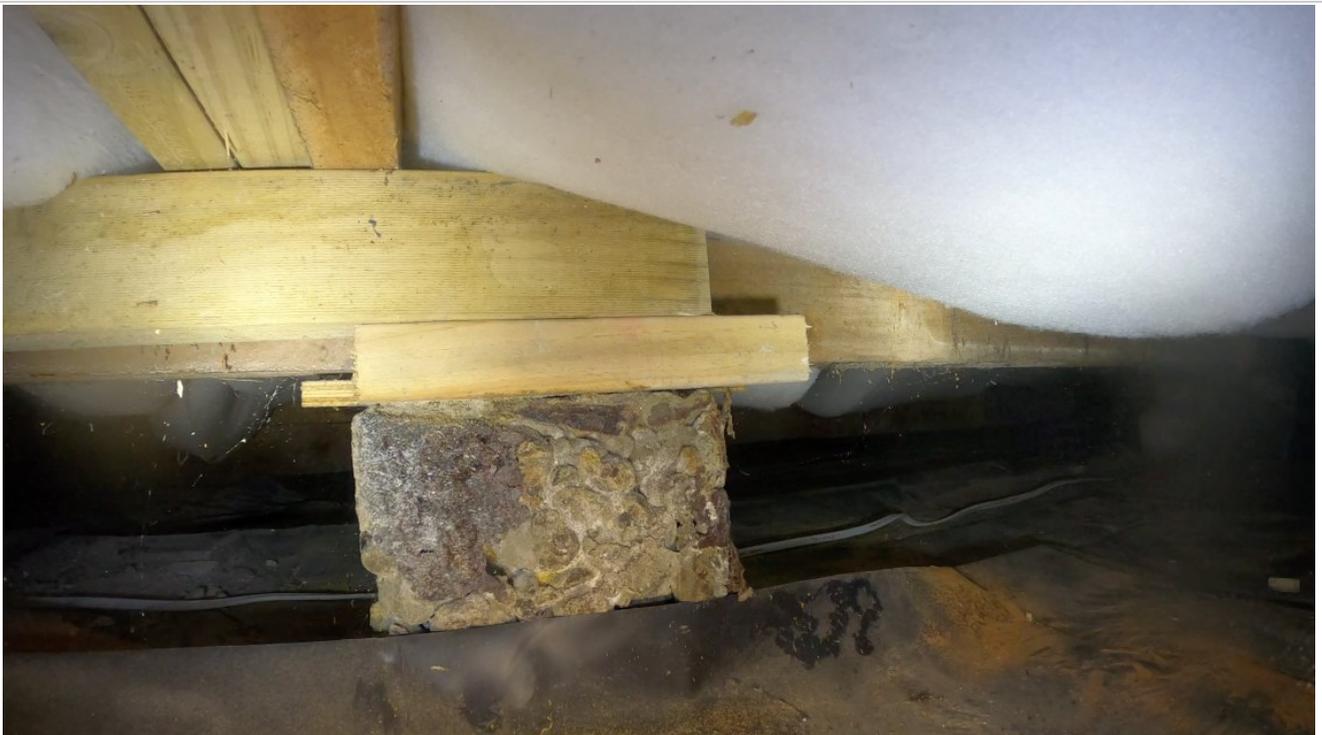
58: Jerry can pile with packing and no connection.

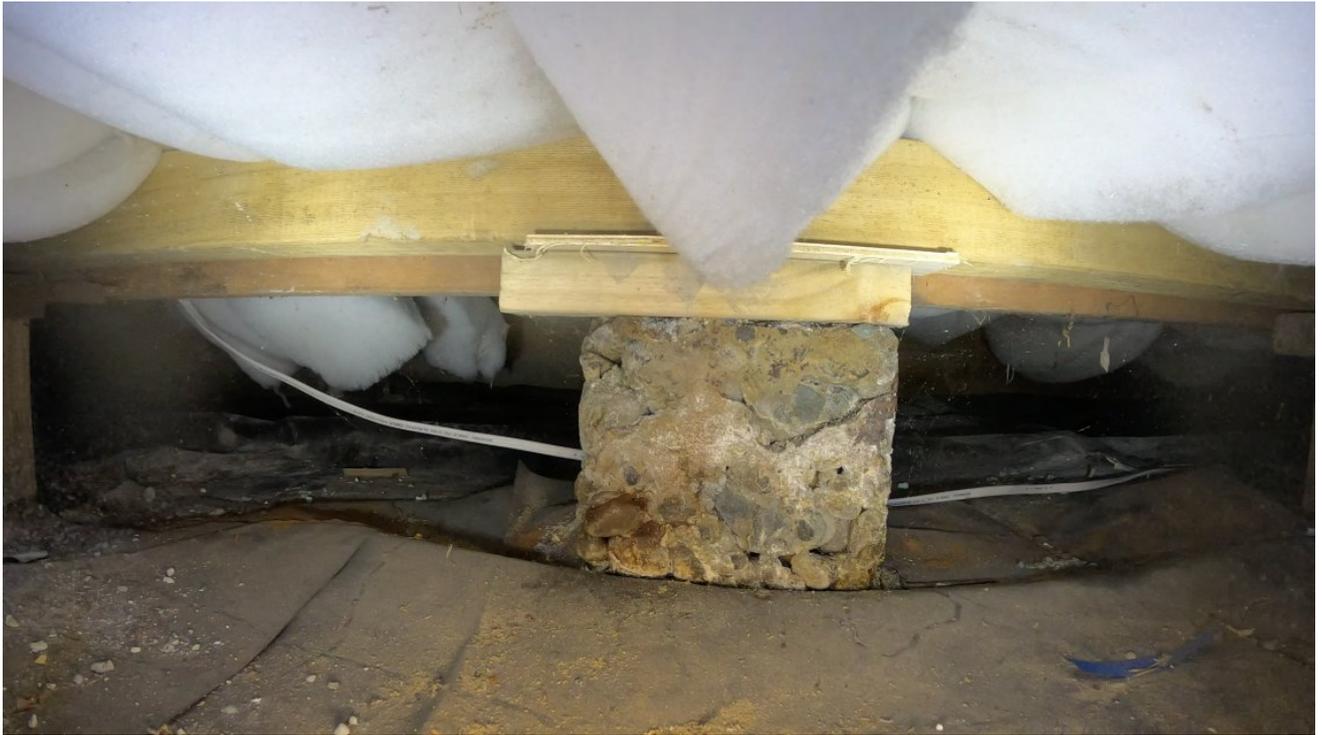
61: Jerry can pile with packing and no connection.

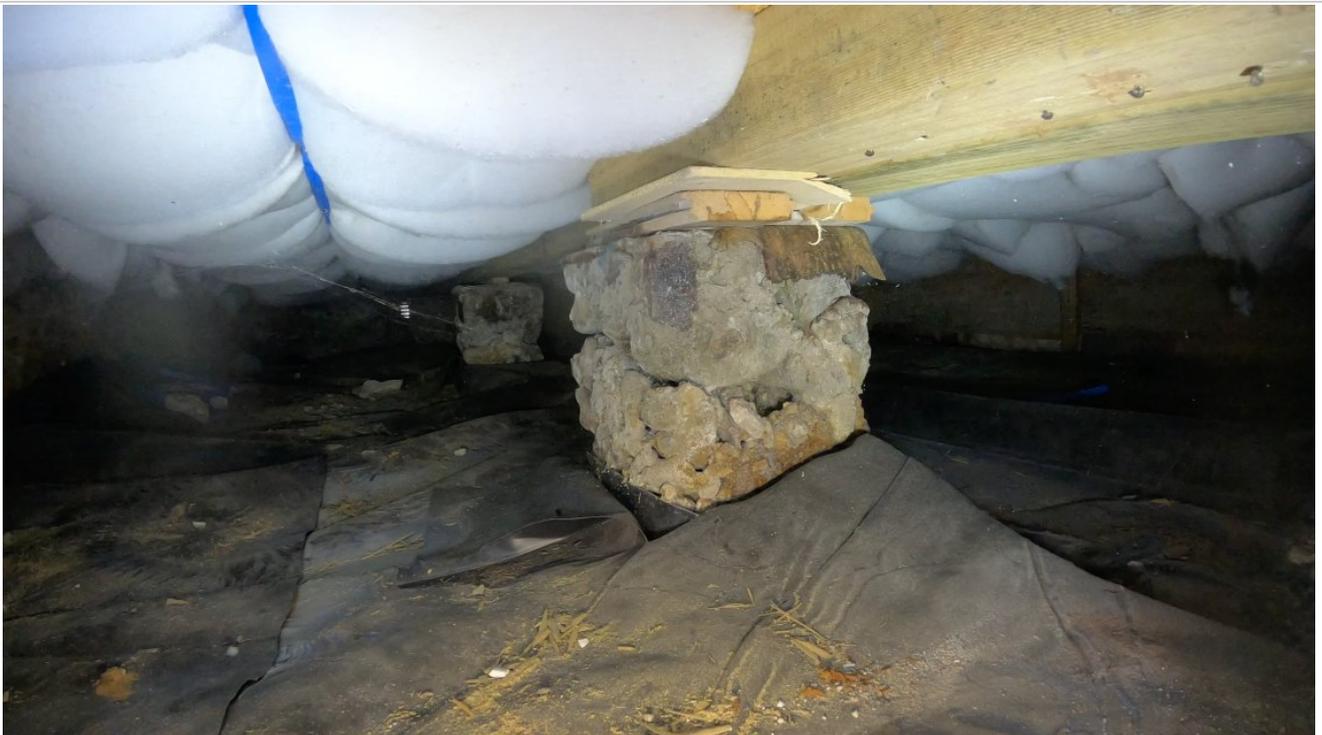
64: Jerry can pile with packing and no connection.

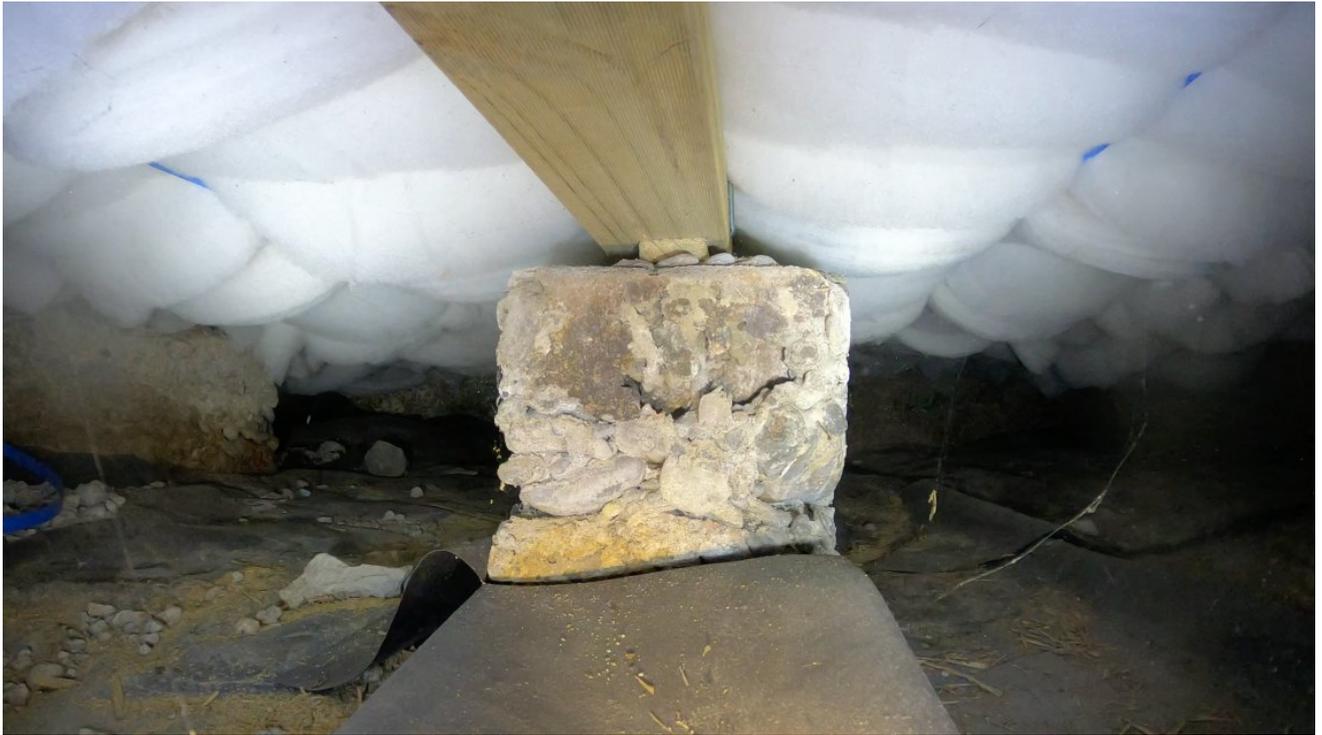
65: Jerry can pile with packing and no connection.

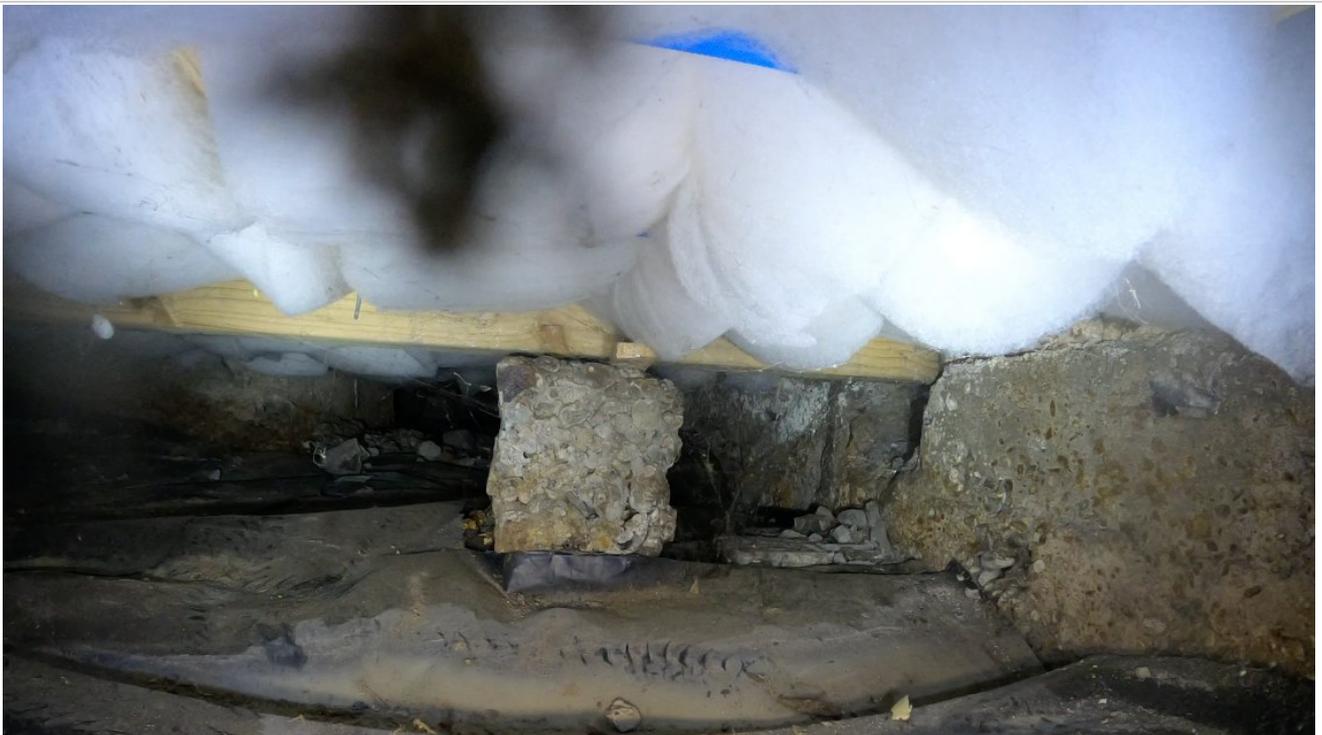
66: Jerry can pile with packing and no connection.

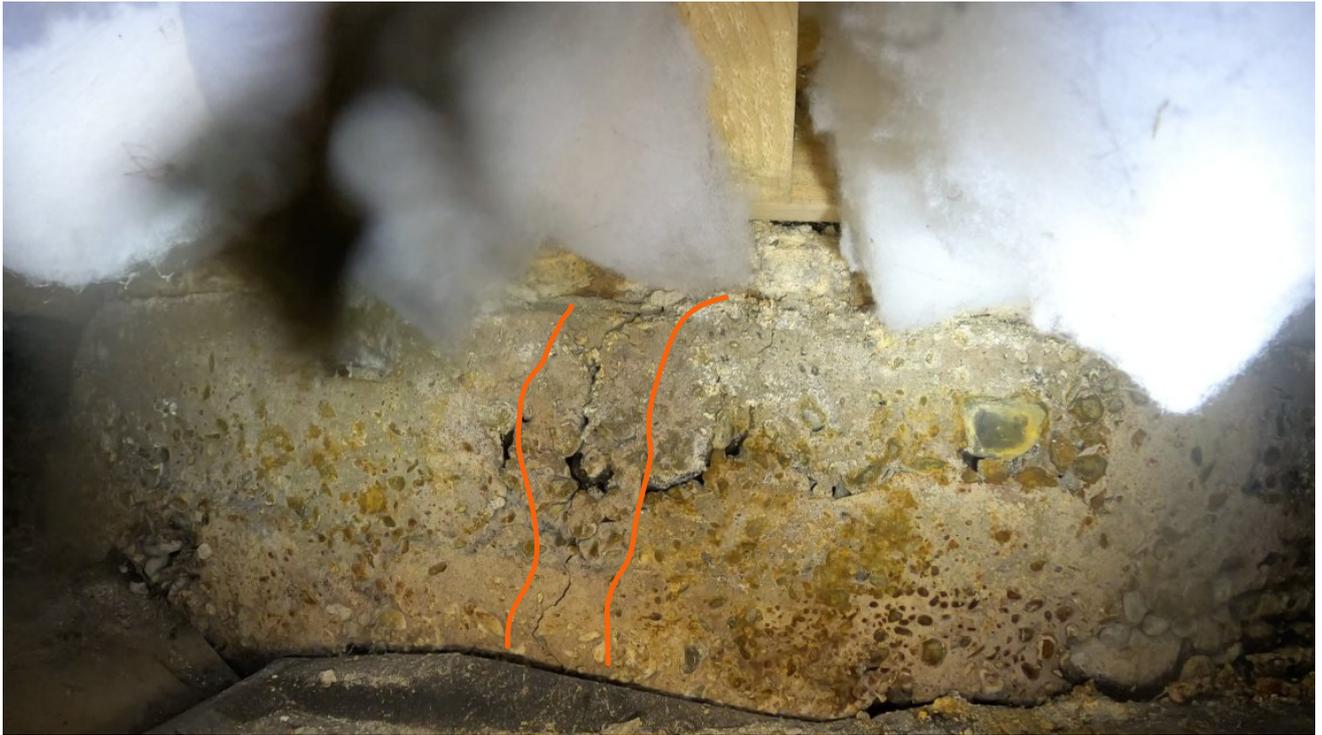
67: View of ring foundation with cracking.

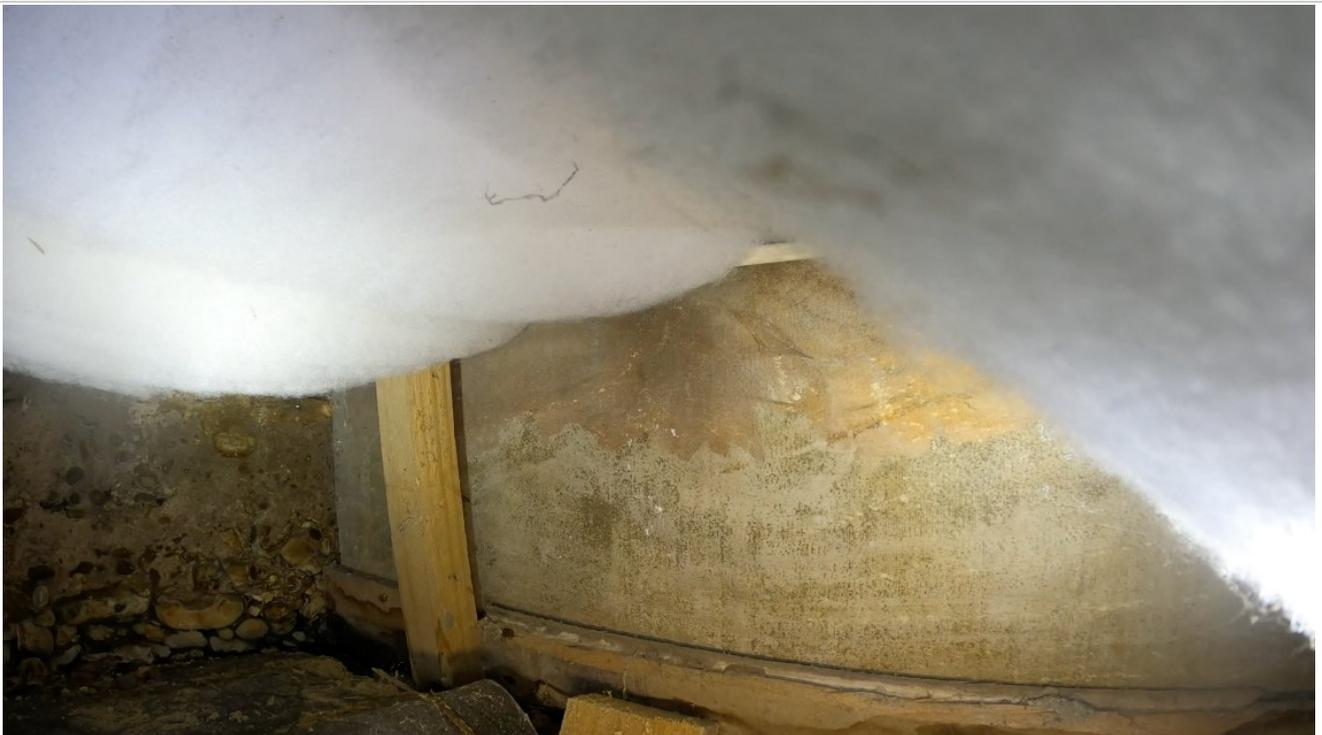
68: Here again, we see new concrete foundations but with the boxing left on.

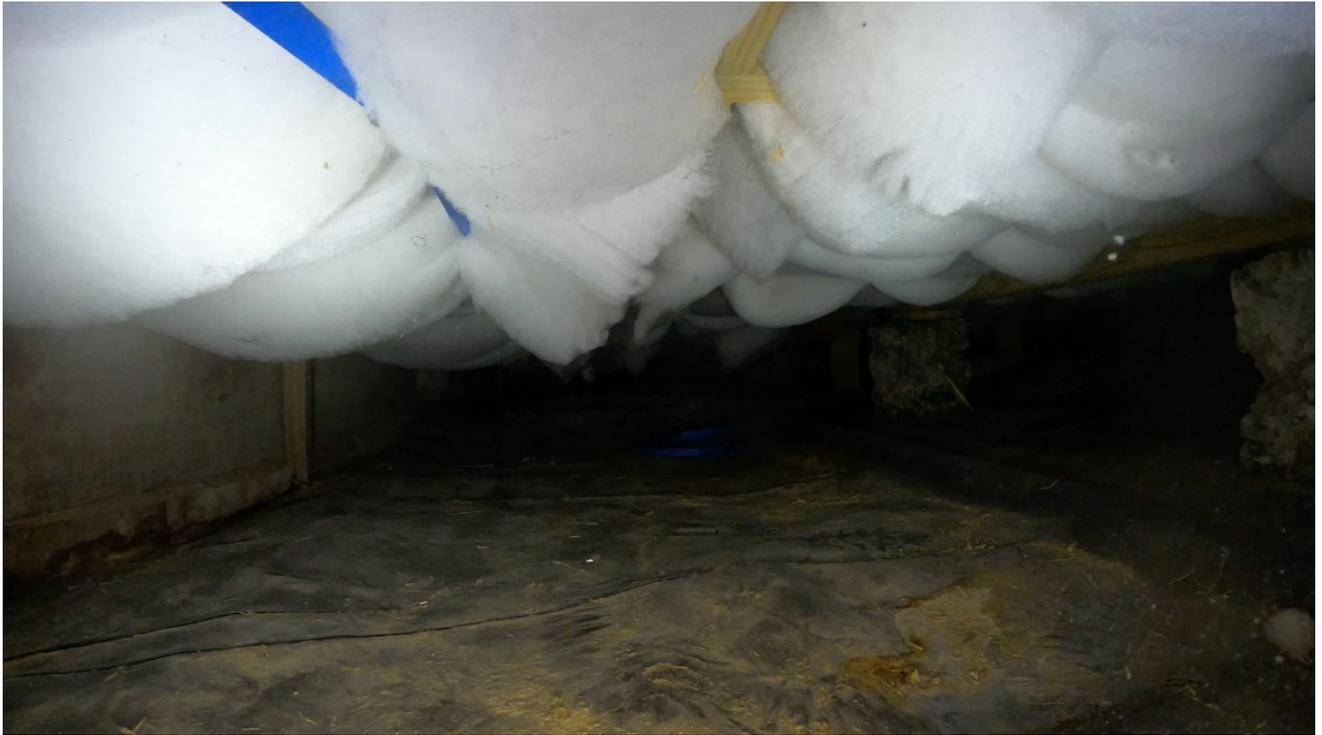
69: All the vents are blocked along this side too.

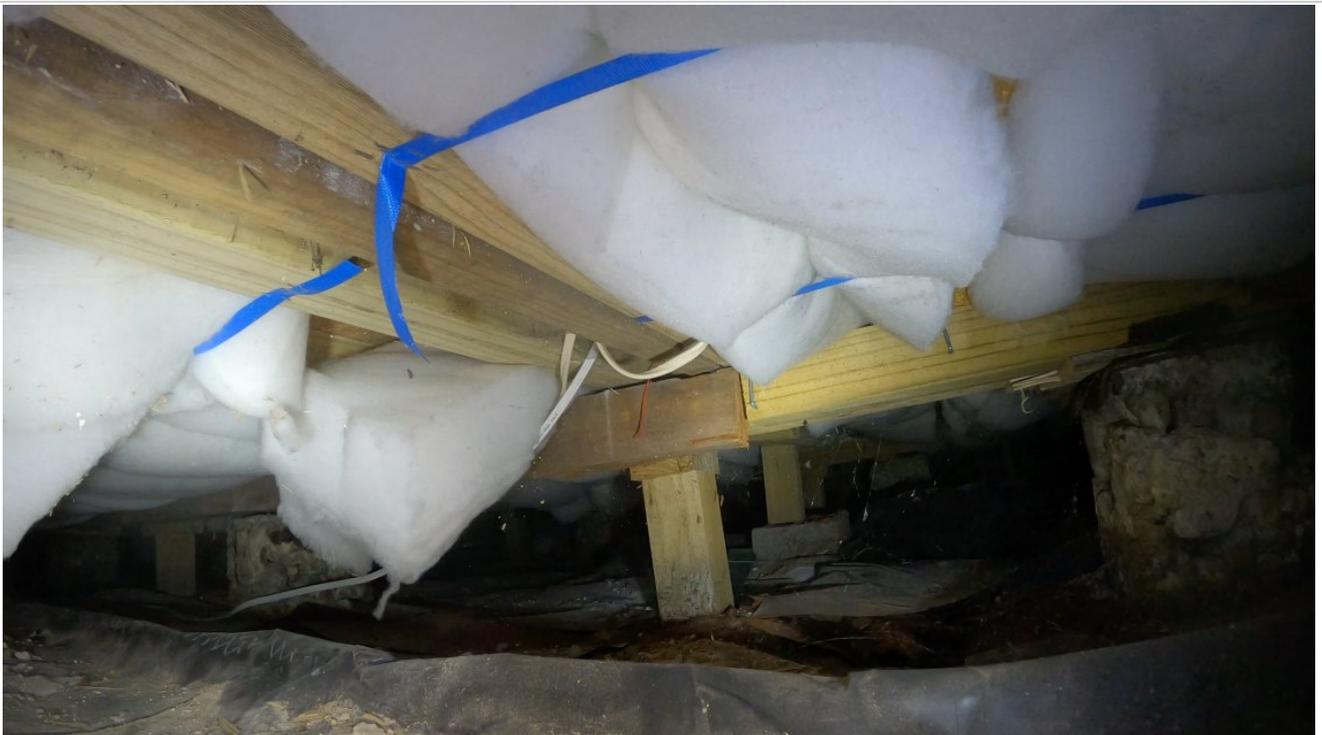
70: The cut bearer is being supported by the prop.

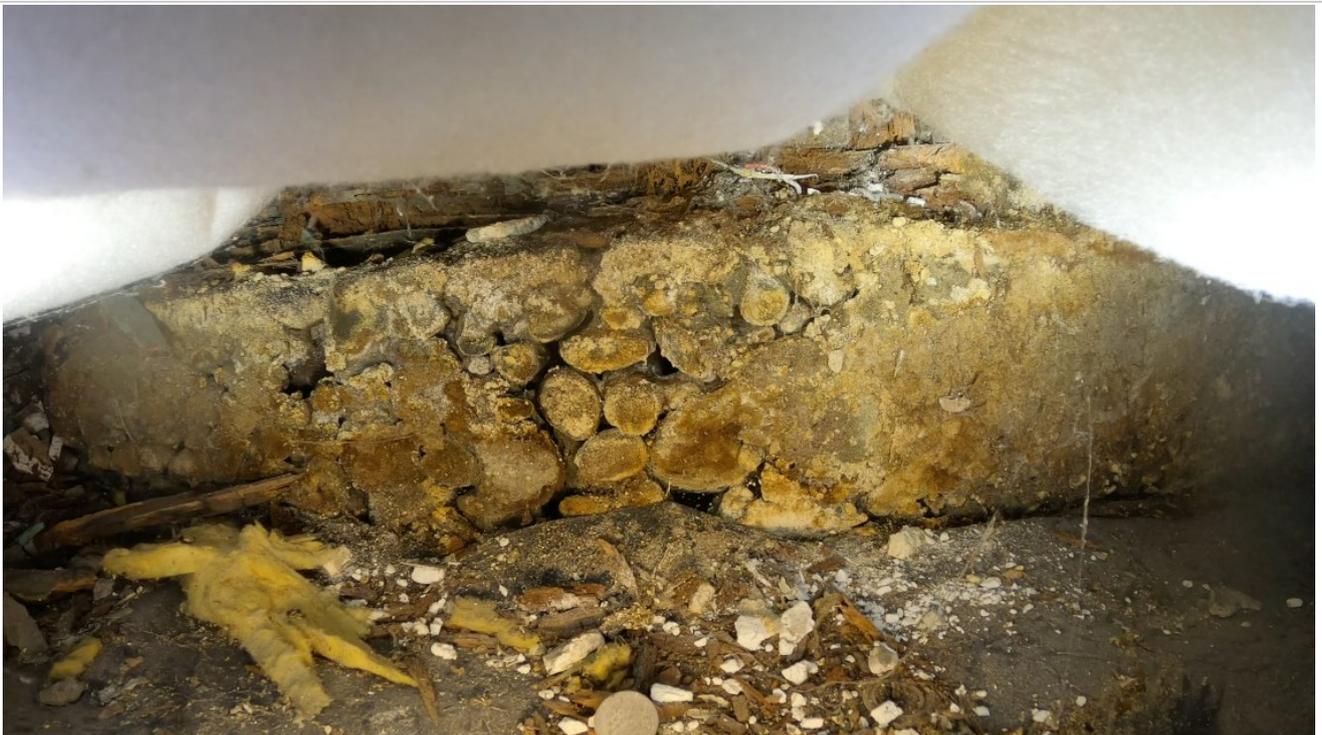
78: View of ring foundation with crack and rotten timber.
