**Information request - CLM/2010/094890 - 53 Marshall Street, Woolston, Christchurch 8023**

# Scope of Works

## Assessment of Property at 53 MARSHALL STREET, WOOLSTON, CHRISTCHURCH 8023 on 8/09/2011

## EQC Full Assessment Report

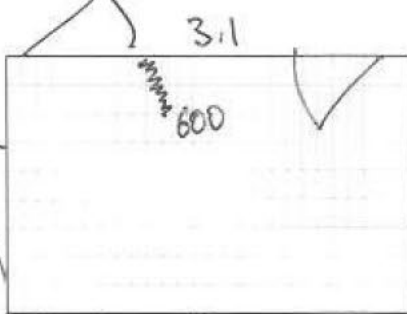
REAR ENTRANCE

Room	Earthquake Damage	Walls	Ceiling	Floor	Repair Strategy
	Y/N	✓	✓	✓	
Bedroom 4	N				
Bathroom	NA				
Toilet 1	N				
Toilet 2	NA				
Office / Study	NA				
Rumpus	NA				
Entry / Hall(s)	N				
Stairwell	NA				
Laundry	N				
Garage	N				
Rear Other Entry	Y	✓			Rake out stop paint.

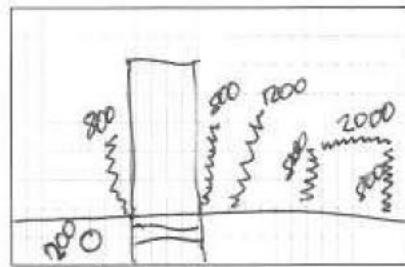
EXTERNAL WALLS NORTH

Item		Event Damage	Repair Strategy
		Y / N	
Roof		N	
EXTERNAL WALLS	North	Y	grind crack fill re stucco paint (Gabbel) Height 5.2m ✓
	South	Y	grind crack fill re stucco paint (Gabbel) Height 5.2M ✓
	East	Y	grind crack fill re stucco paint ✓
	West	Y	grind crack fill re stucco paint ✓
Decks		NA	
CHIMNEY	Base	NA	
	Ceiling Cavity	NA	
	Above Roof	NA	
	Fireplace	NA

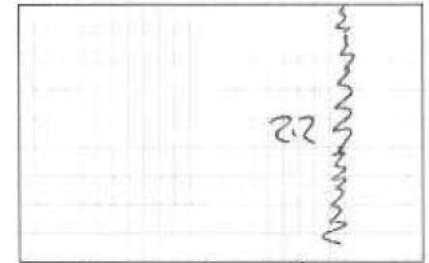
OUTBUILDING WALL EXTERIOR NORTH

Item	Event Damage	
	Y / N	
Foundations	Y	East & Nth rake out expoy fill ✓
Piling	N	
Services	N	
Other Dwelling Items	NA	
Shed Outbuildings	Y	Rake out crack re mortar paint (Nth)
Land & Retaining Walls <i>(Discuss with Supervisor)</i>	N
