EQC CLAIM DOCUMENTATION

Scope of Works

Assessment of Property at 9 GORE STREET, HALSWELL, CHRISTCHURCH 8025 on 28/09/2011

9 Gore Street, Halswell

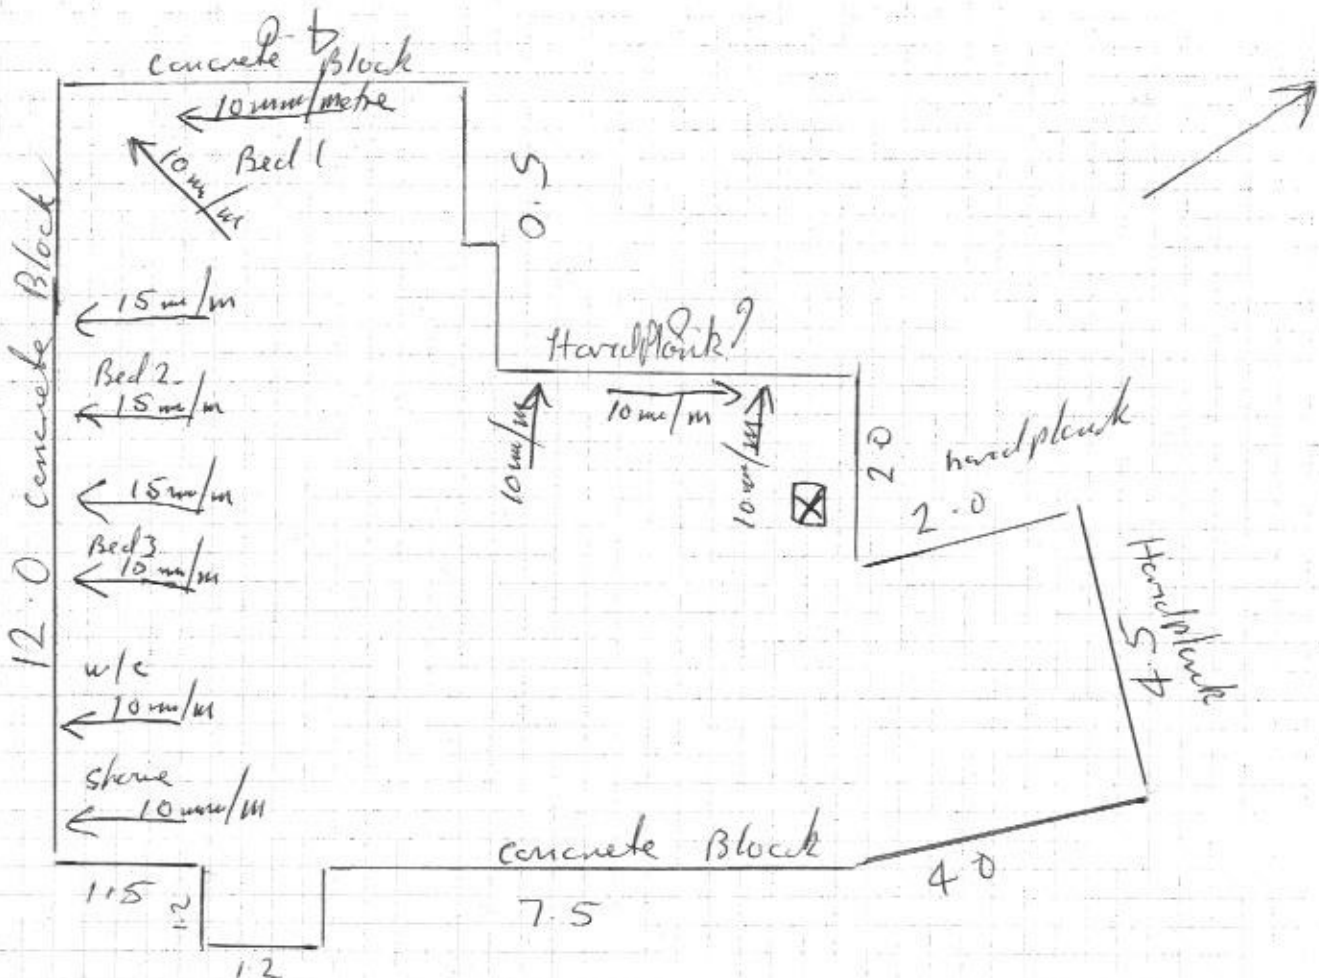
Area m ² :	125			
Stud Heights:	2.4			
Wall Finish:	Wallpaper	Plastered	Paint finish	
Other:				
Services:	Specify damage:			
Chimneys:	Construction type: Block			
	Height:			
	Damage description:	Above Roof	Below Roof	Total Repair
Foundations Damage:	Timber	Concrete Ring	Concrete Slab	Other (specify):
	Minor	Moderate	Severe	
	House moved off foundations?:			
	Concrete slab cracked?	Crack width	Crack length	
Roof:	Framed	Trussed		
	Type:	Clay Tiles	Concrete tiles	Metal tiles
			Rolled Metal	Other (specify):
	Damage:			
Cladding Type:	Weatherboard	Brick Veneer	Hardi Plank	Other

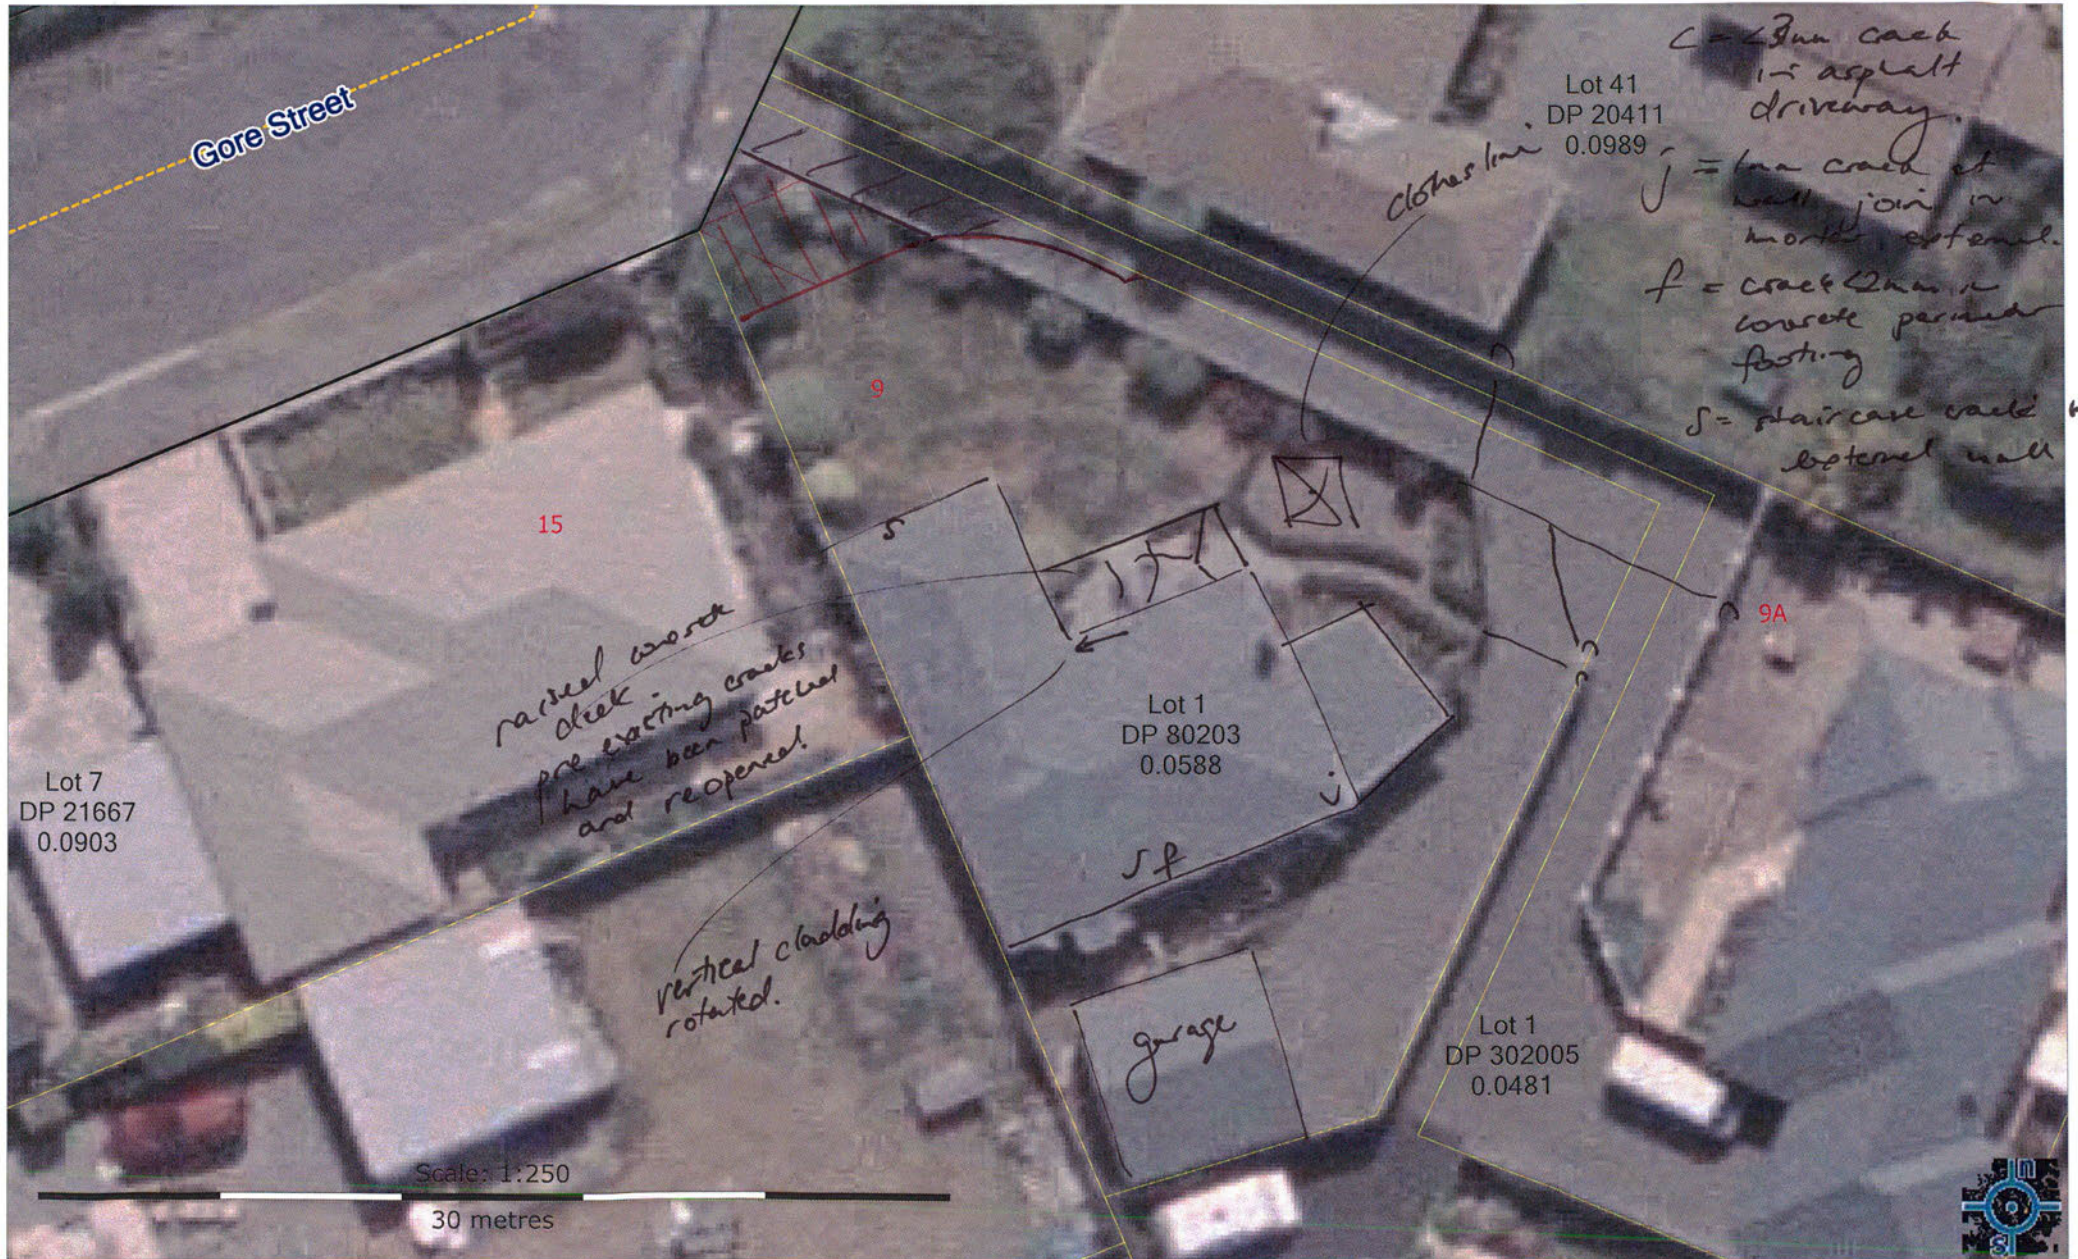
General:	CRAacking ON EXTERNAL WALLS, THROUGH TO RING BEAM. CRACKING OF STEPS. MOVEMENT OF WALLS - WINDOWS. SPARSE CRACKING ON W/E SIDES. SETTLEMENT PROBABLE AROUND THE SOUTH. NO SAND OBSERVED.
----------	--
