BUILDING INSPECTION REPORT

RED LBP PRE-PURCHASE REPORT

PRE-PURCHASE

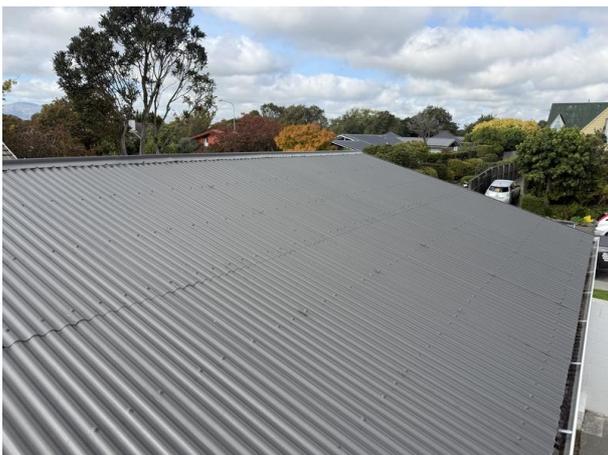
Photo 2
Roof cladding appeared in serviceable condition where visible at the time of inspection.

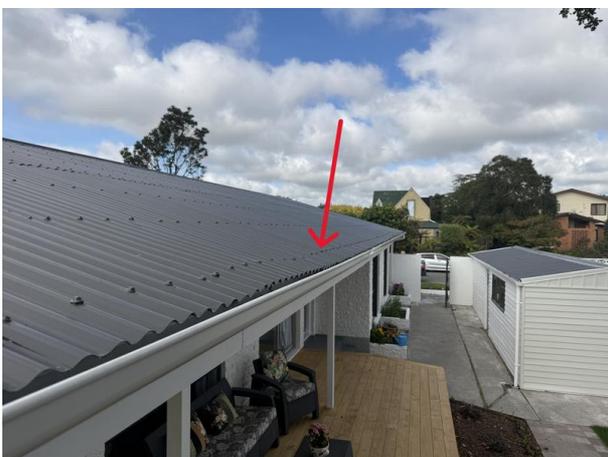
The roof is a short-run corrugated iron type, understood to be over 50 years old. Although the roof has been repainted in recent years and presents in a generally serviceable condition at the time of inspection, its age and extended service history mean the underlying material is likely beyond its designed durability, and long-term weathertightness may not be assured.

Photo 3
Deflection observed to the roof plane on the west elevation.

It is recommended to engage a Licensed Building Practitioner (Roofing) to undertake a comprehensive assessment of the roof's condition, confirm any areas requiring repair, refurbishment, or replacement, and provide a detailed scope of works to restore long-term performance and durability.

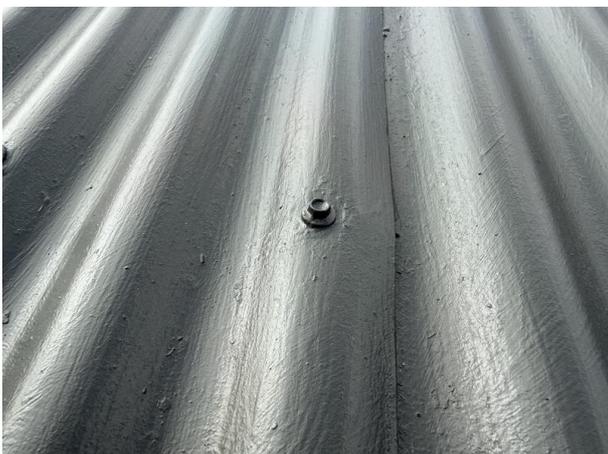
Some roof fixings appear inconsistent. Over-tightened screws can cause the rubber washers to lose elasticity or split, reducing their ability to form a weather-tight seal. Any loose, overtightened, or deteriorated screws should be identified and replaced or refastened as required to ensure proper sealing.

Photo 4
Multiple screws have been overtightend.

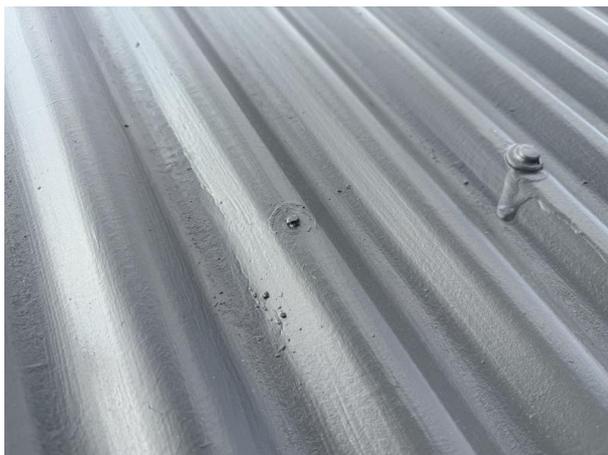
Photo 5

Some nails are missing their head caps.

Any lead-head nails with missing or deteriorated lead caps should be replaced, as the caps protect the fixing from corrosion and help maintain a secure seal. Any lifting or loose fixings should be refastened to maintain the integrity of the roofing system.

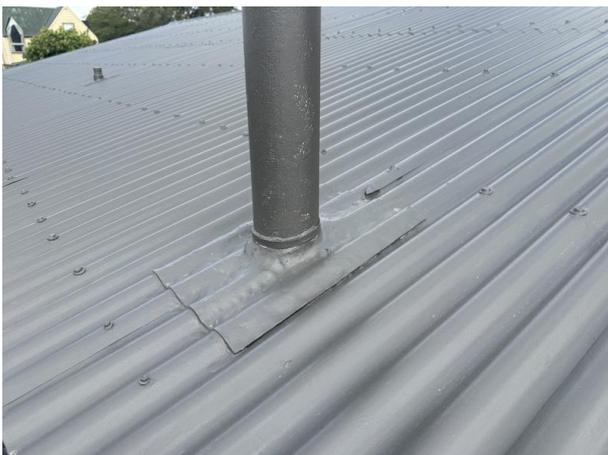
Photo 6

Lead flashing is not recommended for use with modern prepainted steel, aluminium/zinc/magnesium alloy-coated steel as it can cause accelerated corrosion of the roof sheeting in some exposure conditions.

Lead flashings installed around the roof penetrations.

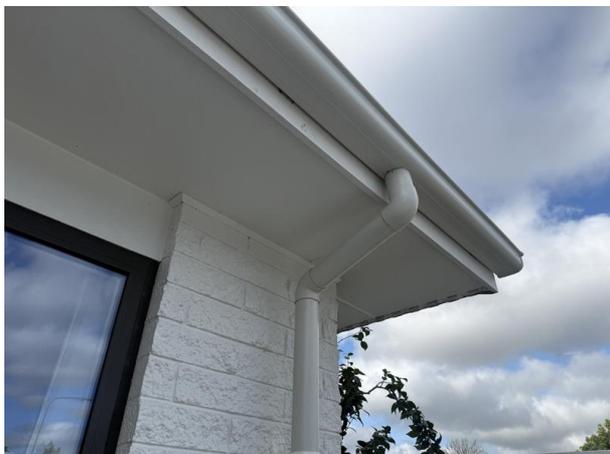
Photo 7

An example of the painted timber fascia and barge boards, profiled metal guttering and downpipes, and painted suspected asbestos containing material soffits.

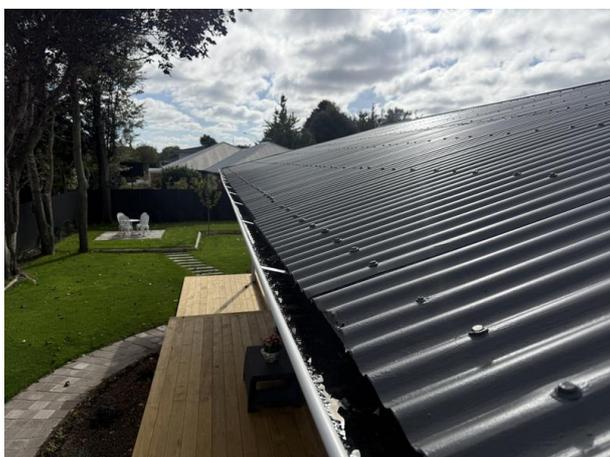
Photo 8

The guttering system has areas where water is ponding, which indicates improper alignment or sagging sections. Ponding water can lead to premature wear, corrosion, and potential overflow during heavy rainfall, increasing the risk of water damage to the property. To address this issue, it is recommended to adjust the

Guttering to the western elevation is sagging causing ponding.

alignment of the guttering to ensure a proper fall toward the droppers, allowing water to flow freely. This adjustment should be carried out by a qualified professional.

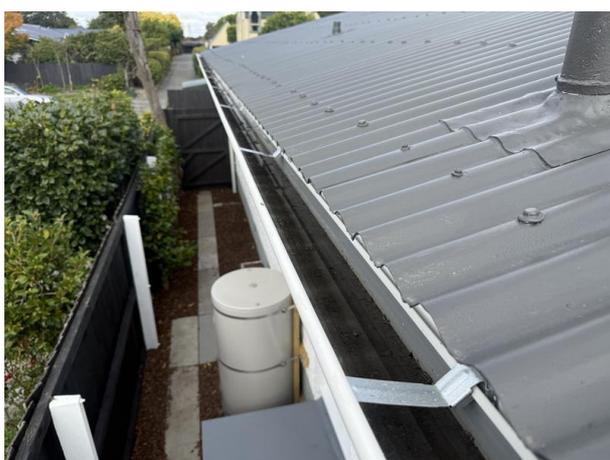
Photo 9

Guttering to the eastern elevation is sagging causing ponding.

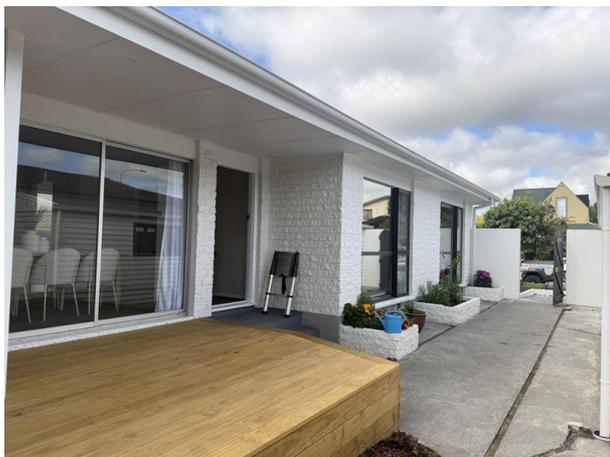
Photo 10

The dwelling is primarily clad in Summer Hill stone with a painted finish and is in a serviceable condition for its age.

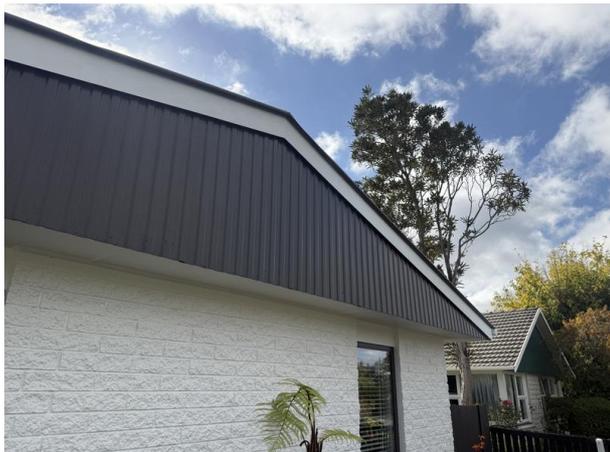
Photo 11
The gable ends are clad in a fibrous cement sheeting with a paint finish.

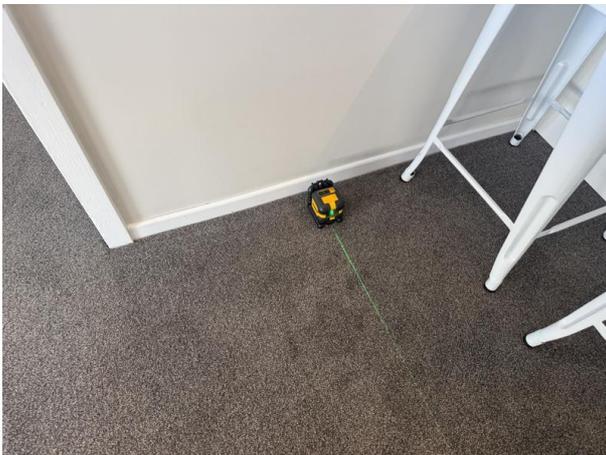
The overall level difference measured in the sampled areas was approximately 15mm. This assessment is limited to a visual, non-invasive spot-check and is not a full floor-level survey or certification of compliance.

Photo 15
Floor levels were checked using a DeWalt self levelling laser.

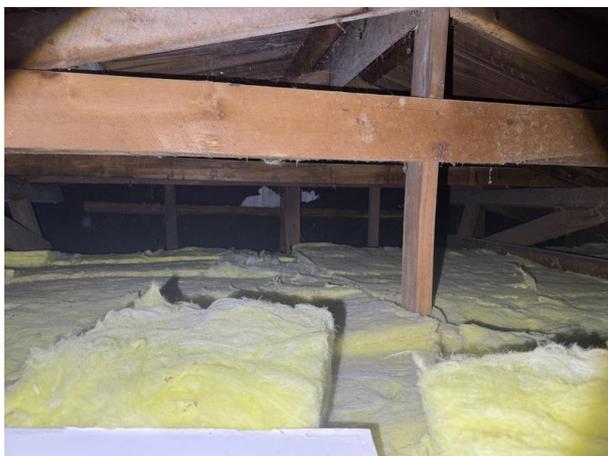
Photo 16

An example of the roof space - Torn paper to the southern gable end.

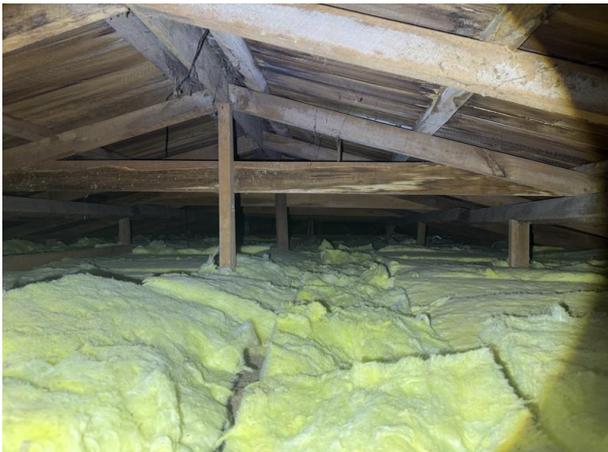
Photo 17
An example of the roof space - Historical moisture damage/staining observed to multiple roof framing members.

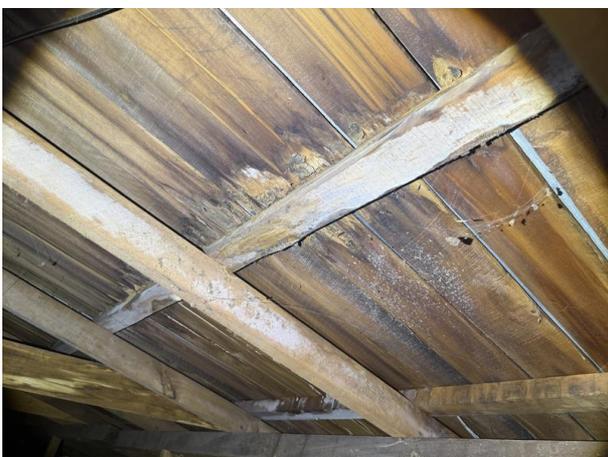
Photo 18
Historical moisture damage observed to areas of the timber sarking and purlins.

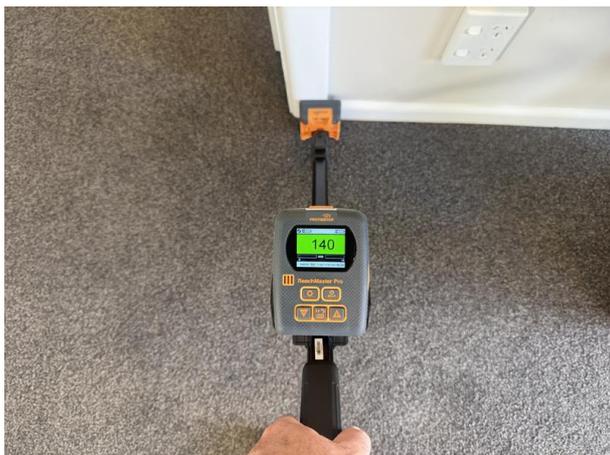
Photo 20

A base reading of 140 was taken from an internal wall using a non-invasive moisture meter. Based on industry guidelines, this is typically interpreted as a dry reading.

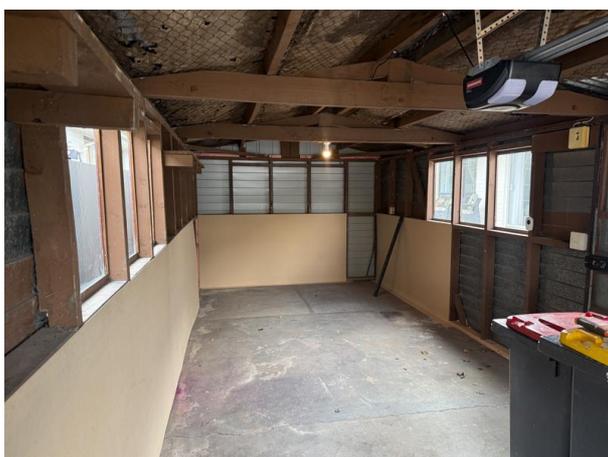
Photo 38
Garage interior - In a condition expected with age and use.

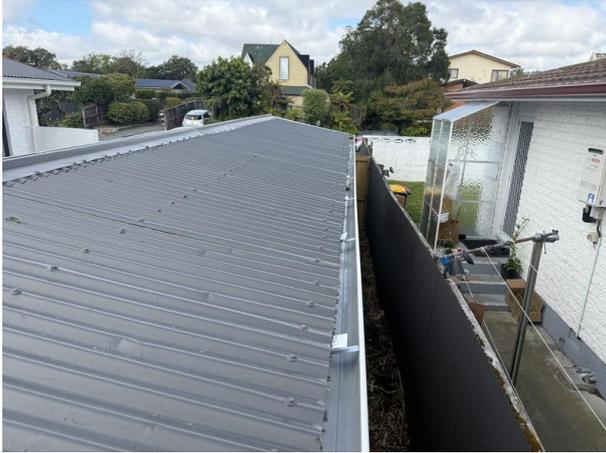
Photo 39
Garage roof - Denting observed to multiple ribs.

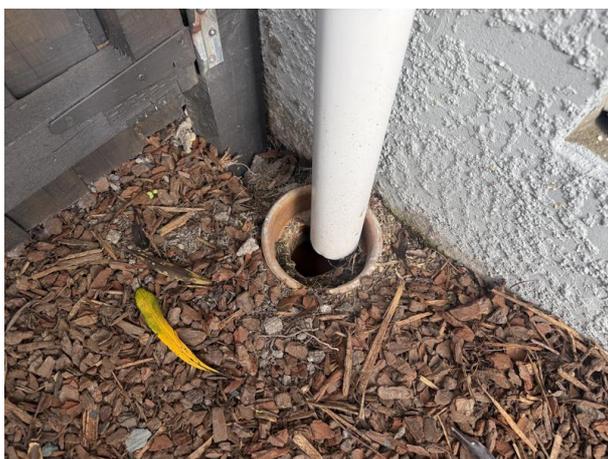
Photo 48

Earthenware stormwater risers noted on the western elevation.

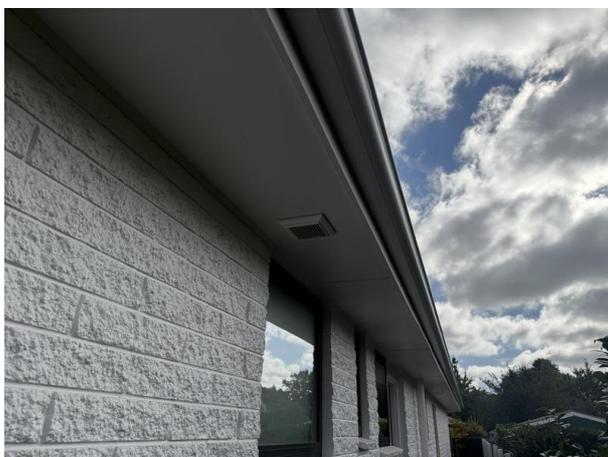
Photo 58

This product is non-friable, meaning when dry may not be crumbled, pulverised or reduced to powder by hand pressure (for example materials containing asbestos that have been mixed with cement or other hard bonding materials).

The soffits may contain asbestos.

Have this tested for asbestos before undertaking any invasive works, such as drilling, cutting or sanding.

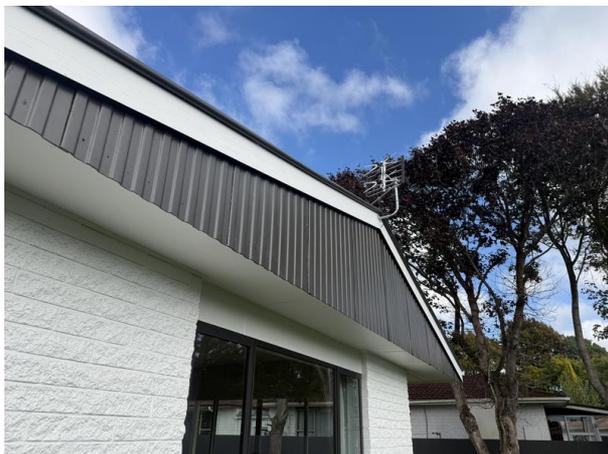
Photo 59

The gable end claddings may contain asbestos.
