RESIDENTIAL PROPERTY INSPECTION

Inspection Address: 1 Gilmore Place, Christchurch

Inspection Date: Tuesday, 17 March 2026

BuildQual NZ Ltd

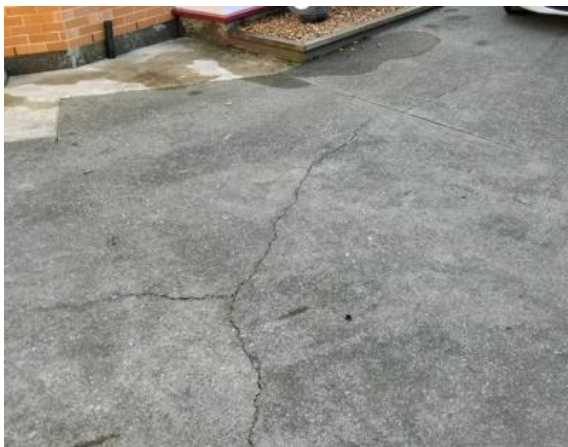
- There are cracks in the concrete driveway and paths. Crack in the concrete adjacent to the garage door
- Garden fence is in damaged condition with missing pickets. Deterioration at the base of a fence post adjacent to the driveway

Concrete driveway

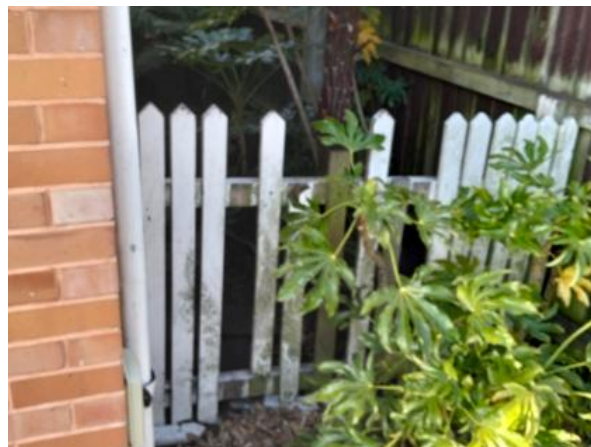
Garden fence is damaged

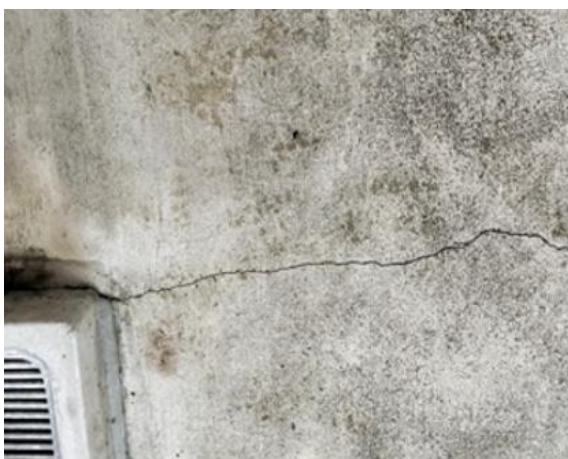
Crack in the garden path

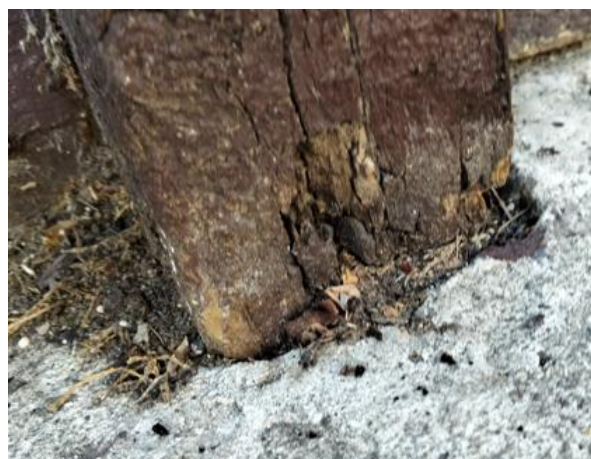
Deterioration at the base of a fence post adjacent to the driveway

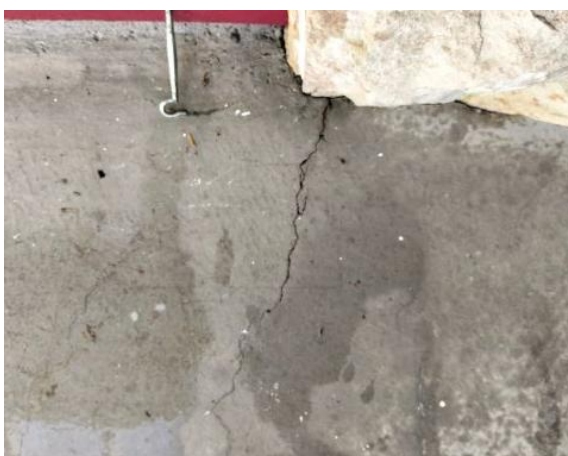
Crack on the concrete patio, there are a few minor insignificant cracks

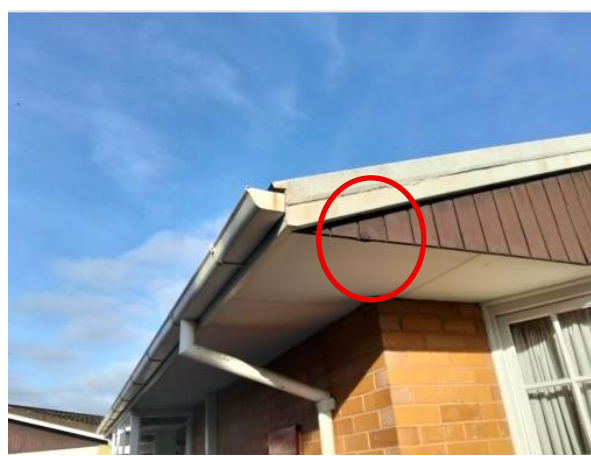
Damage to gable cladding adjacent to the driveway

- There are a few insignificant cracks in the concrete patio outside of the main entrance
- Brick cladding is generally in good condition; there are a few splashes of paint.
- Coating maintenance recommended on the weatherboard cladding on the gable ends

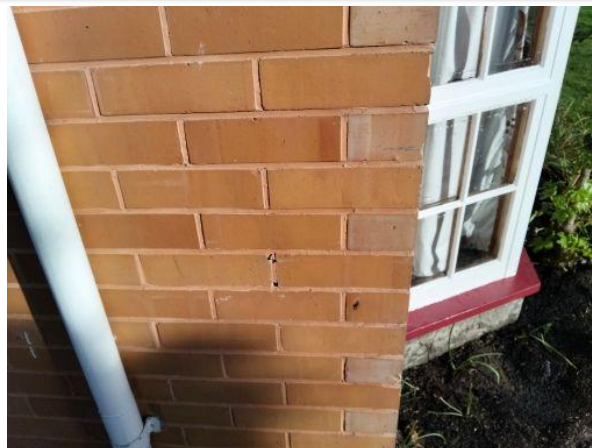
Brick cladding is generally in good condition; there are a few splashes of paint

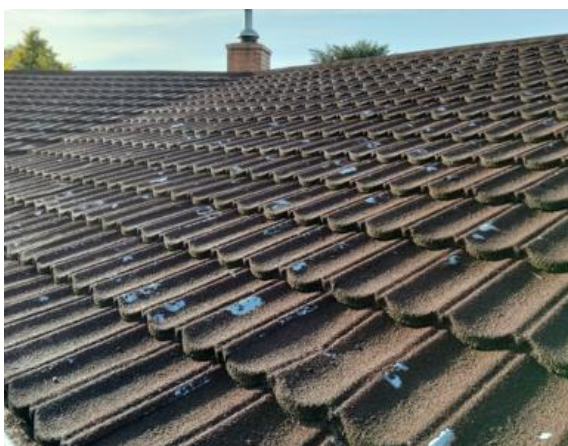
Roof – general view. Patches of coating missing

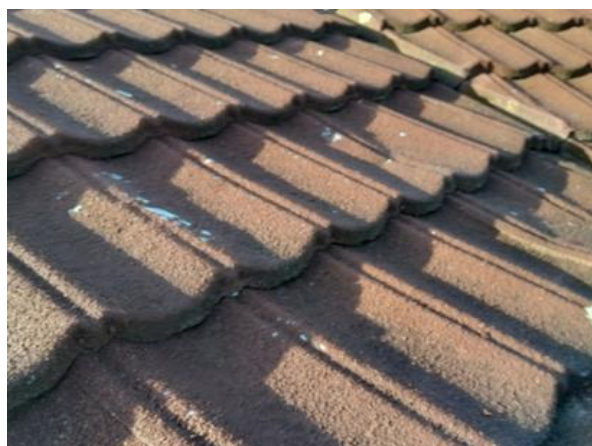
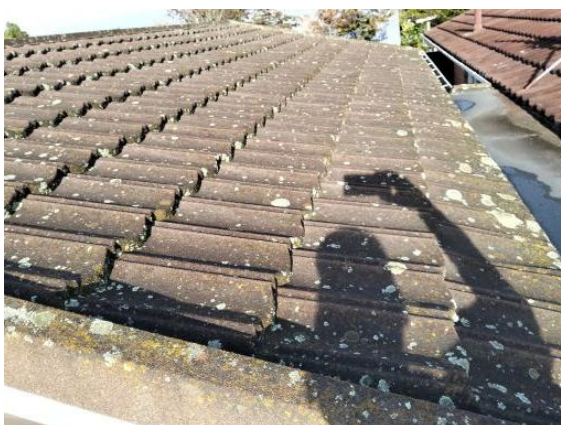
Lichen on the garage roof

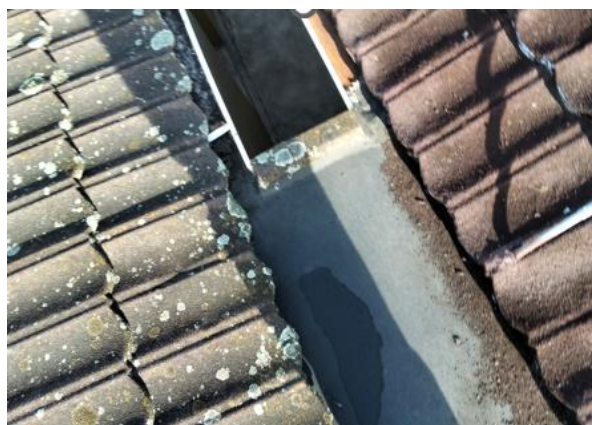
There is a rubber membrane gutter between the garage and the main dwelling that discharges into the steel gutters

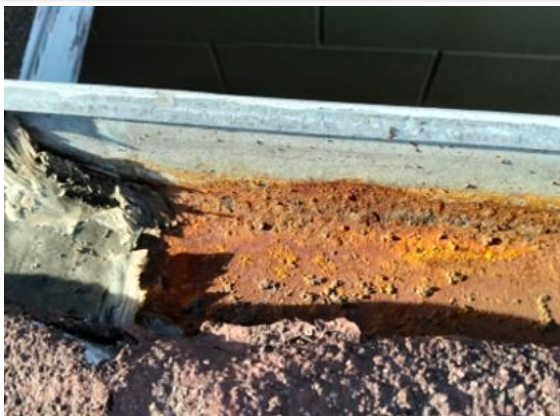
There is rust in the steel gutter just beyond the discharge point from the rubber membrane gutter

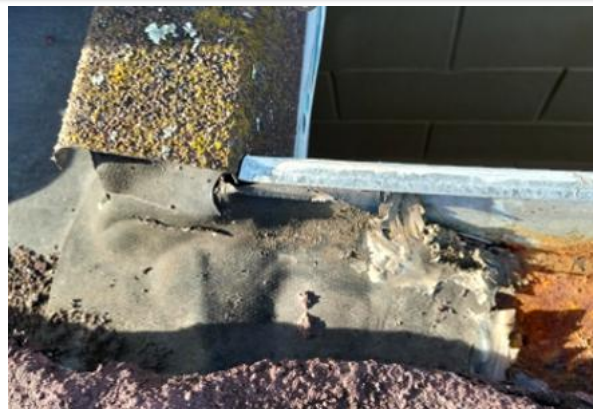
The transition from rubber membrane gutter to steel gutter is unconventional and does not appear well sealed,

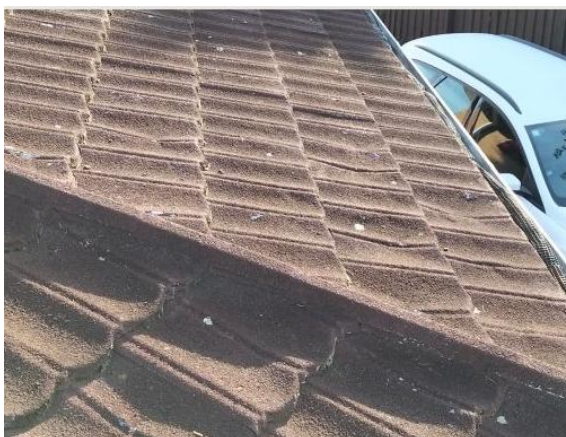
Denting on the roof tiles

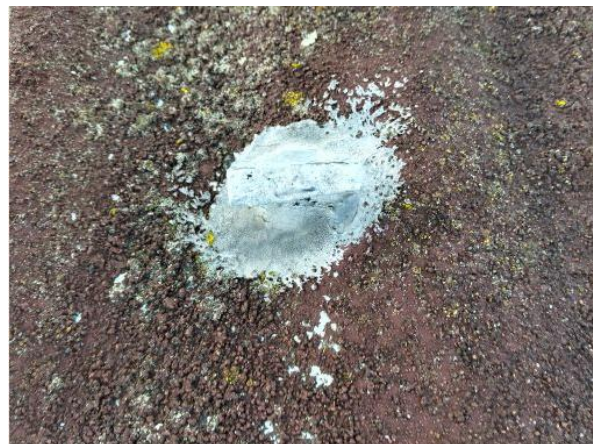
a redundant pipe penetration in the roof has been cut off and sealed

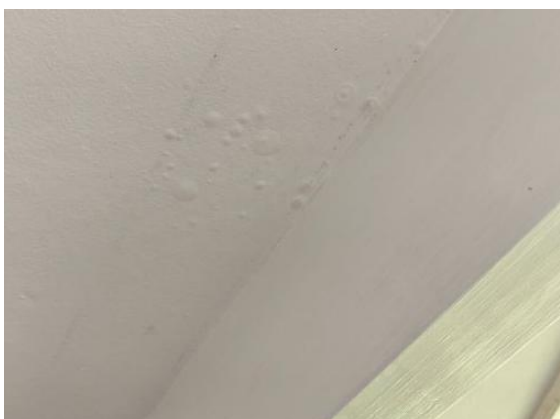
Paint bubbling on the soffit board near the main entrance

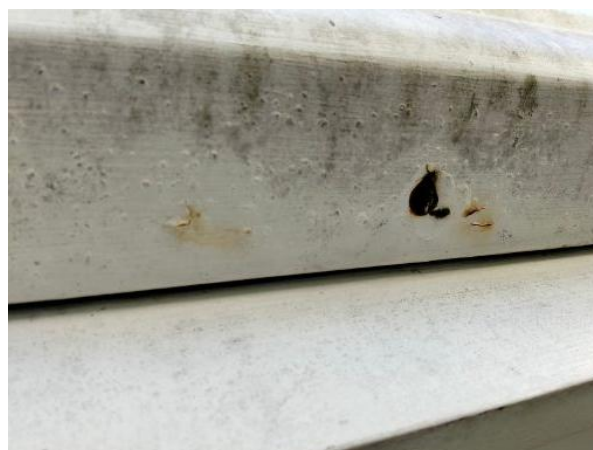
Rust on the underside of the gutter on the north side of the roof

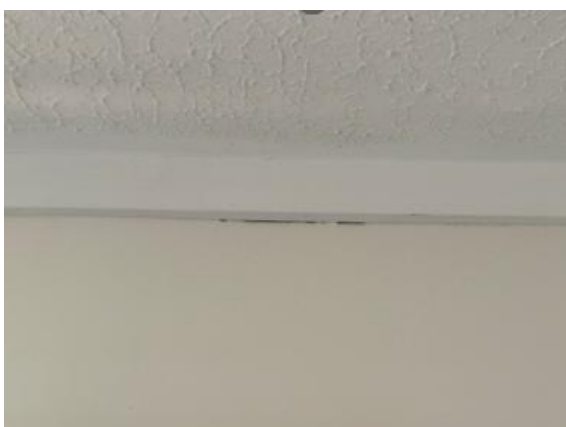
An example of a minor interior blemish, Paint cracking at the wall to ceiling junction in the living area

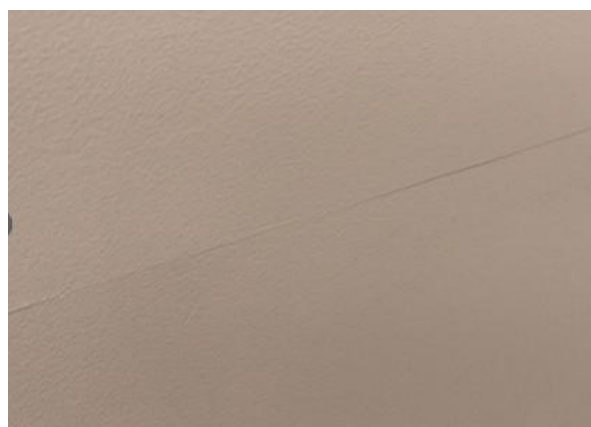
There's a horizontal crack in the wall inside the WC on the Right. Hand side

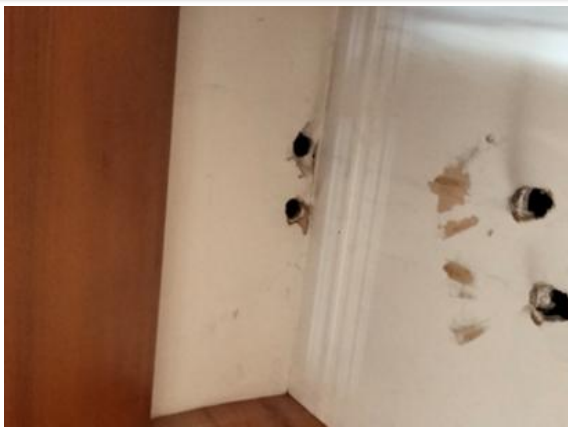
There are holes in the wall inside the entertainment cabinet in the living area

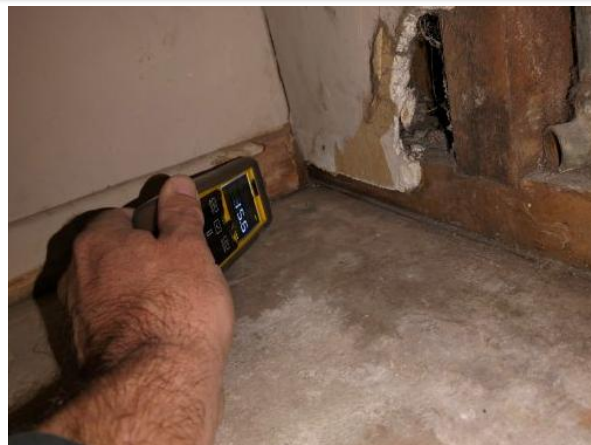
There's a hole in the wall inside the cupboard that houses the hot water cylinder. There is water staining on the skirting boards and plasterboard, this area tests in the dry moisture range

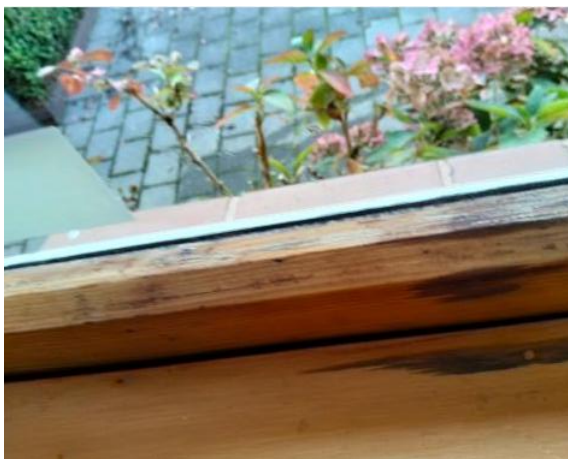
The timber windows are generally in good condition. There are some minor blemishes such as discoloration and fading of the coating

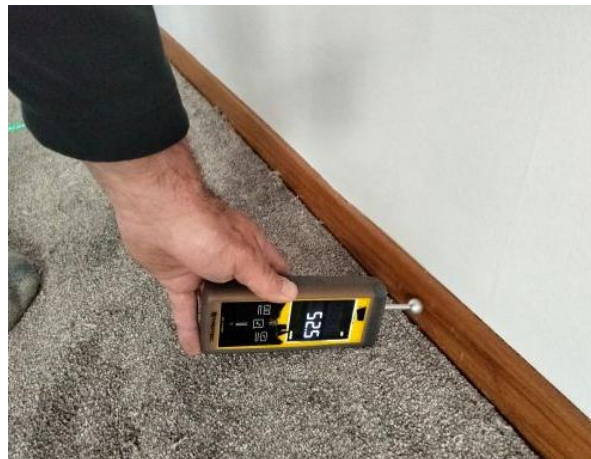
One moisture reading – slightly elevated, lounge

Further investigation should be undertaken to determine the cause of the elevated moisture readings and any remedies

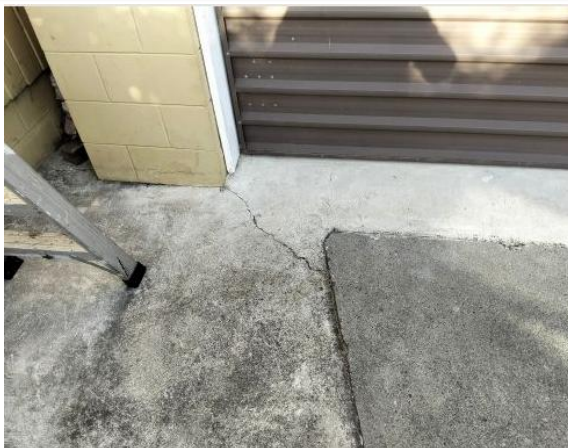
Crack and the concrete adjacent to the garage door

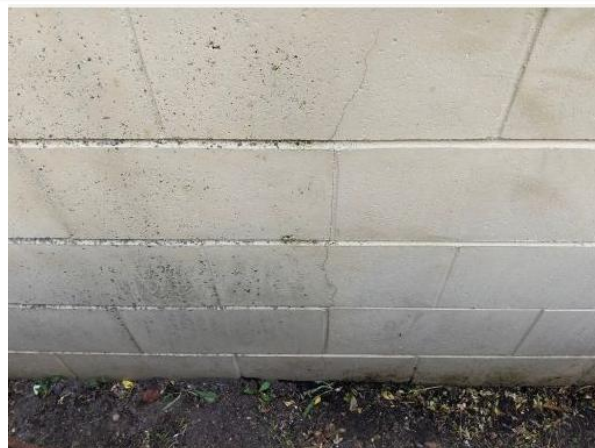
There are two vertical cracks in the blocks under the window at the back of the garage
