2026 | COMPREHENSIVE WEATHERTIGHTNESS REPORT H/V

56 Kakariki Grove
Waikanae, Wellington Region 5036

MARCH 12, 2026

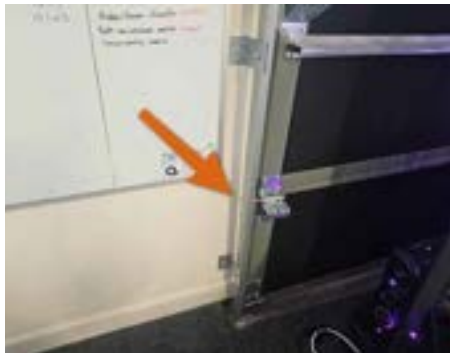
Garage - 29.6% Timber treatment

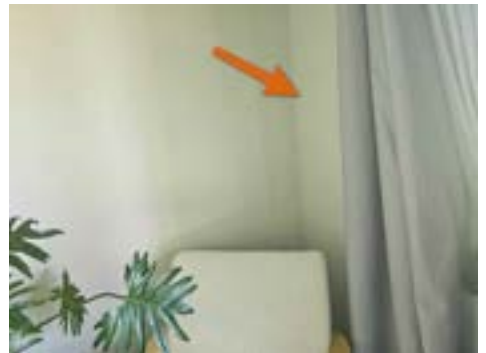
Corner Bedroom - 35.3% Elevated reading due to concrete nib wall or timber treatment

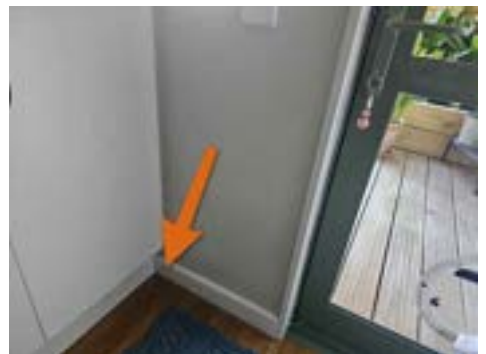
Laundry - 62.8% Elevated reading due to concrete nib wall

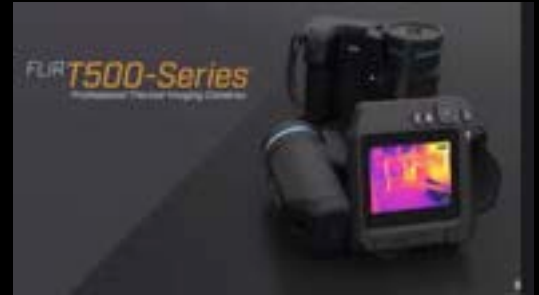
- THERMAL ANOMALIES WERE TESTED WITH THE FLIR MR60 AND MR55.
- NO CONCERNING ELEVATED LEVELS FOUND WHERE THE DARKENED AREAS ARE IN THE THERMAL IMAGES.
- NIB WALLS CAN BE SEEN IN THE THERMAL IMAGES

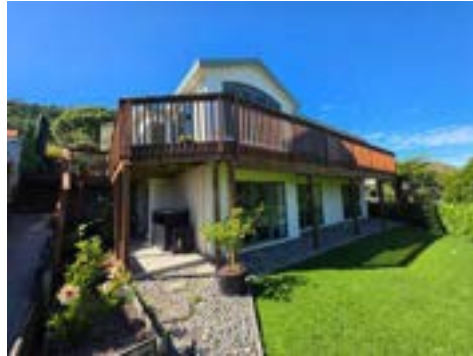
- The decking frame penetrates or is directly fixed through the cladding.
- This is a risk observation and requires monitoring
