2026 | COMPREHENSIVE WEATHERTIGHTNESS REPORT H/V

15 Runanga Grove
Waikanae, Wellington Region 5036

APRIL 1, 2026

Travis Mackay

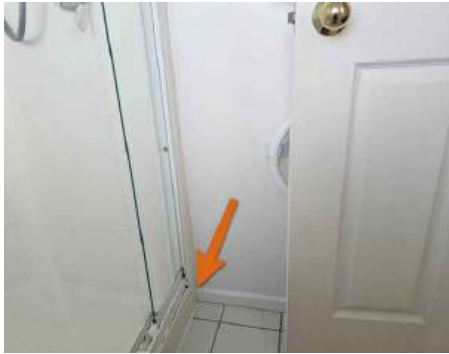
Ensuite - 19.8%

YES	NO	ISO	PREV	COMMENT:
ACCEPTABLE OVERALL MOISTURE LEVELS?	✓				
MINOR ELEVATED MOISTURE READINGS?	✓		✓		Beside ensuite shower
MODERATE ELEVATED MOISTURE READINGS?		✓			
HIGH ELEVATED MOISTURE READINGS?	✓		✓		Main Bathroom (back of shower)
SWOLLEN SKIRTING BOARDS?	✓		✓		
CONDENSATION DAMAGE SIGHTED?	✓		✓		
MOISTURE DAMAGE SIGHTED?	✓		✓		
MOULD SIGHTED IN ROOM?		✓			
MOULD SIGHTED AT JOINERY?	✓		✓		
MOULD SIGHTED AT IN WALL CAVITY?		✓

NOTES: The elevated moisture readings in the ensuite and main bathroom are not caused by a weather tightness issue.

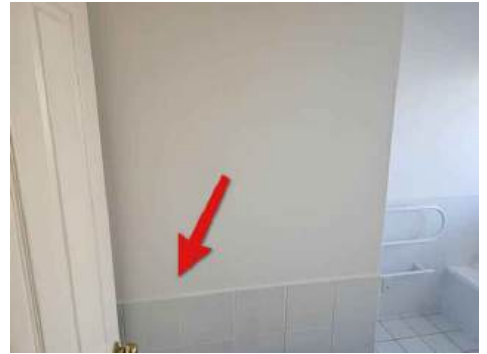
Bathroom - 85.3%

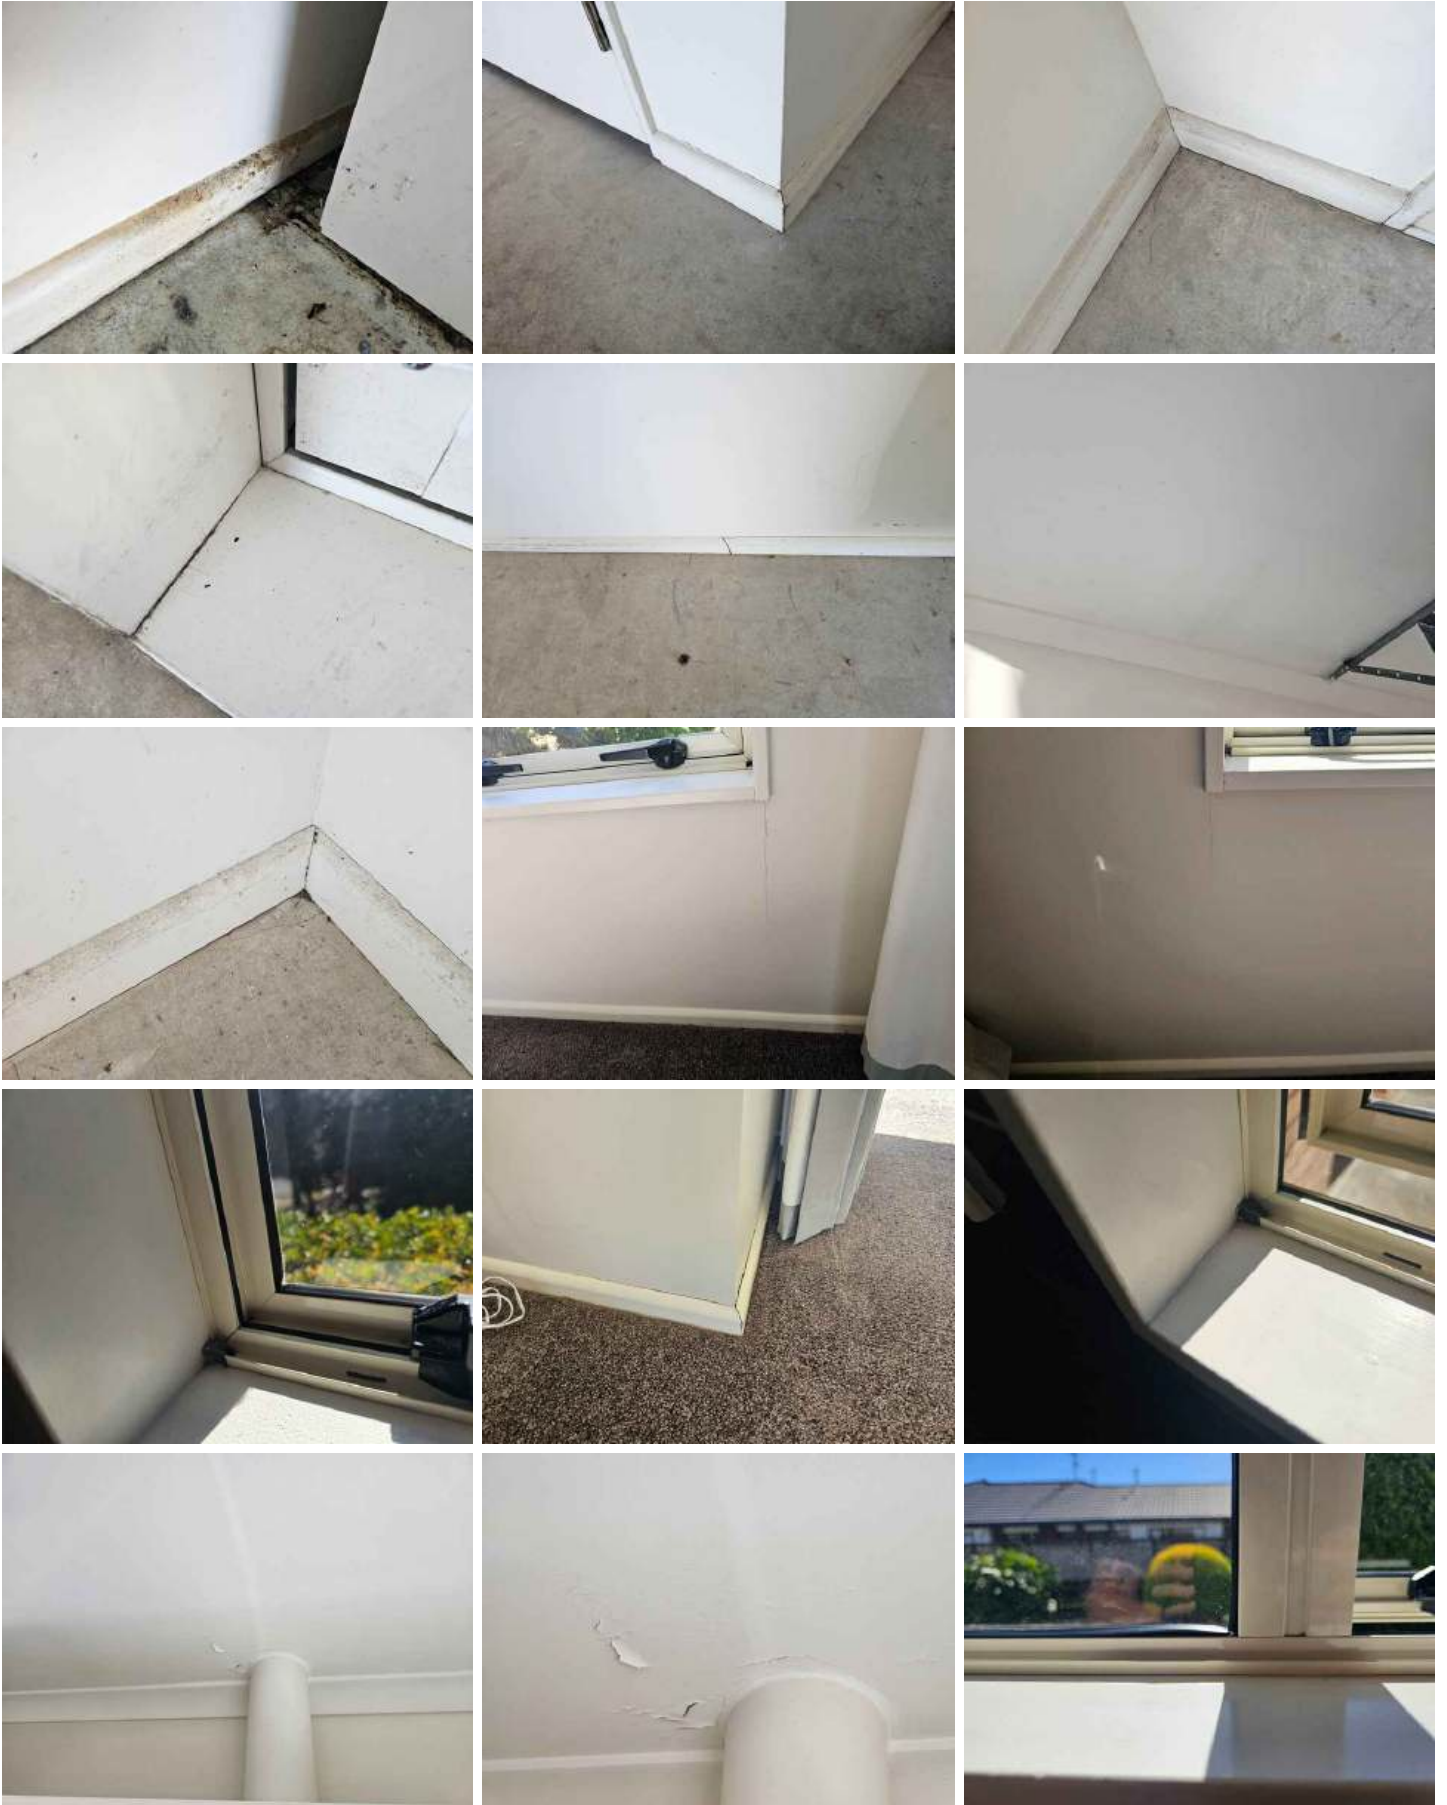
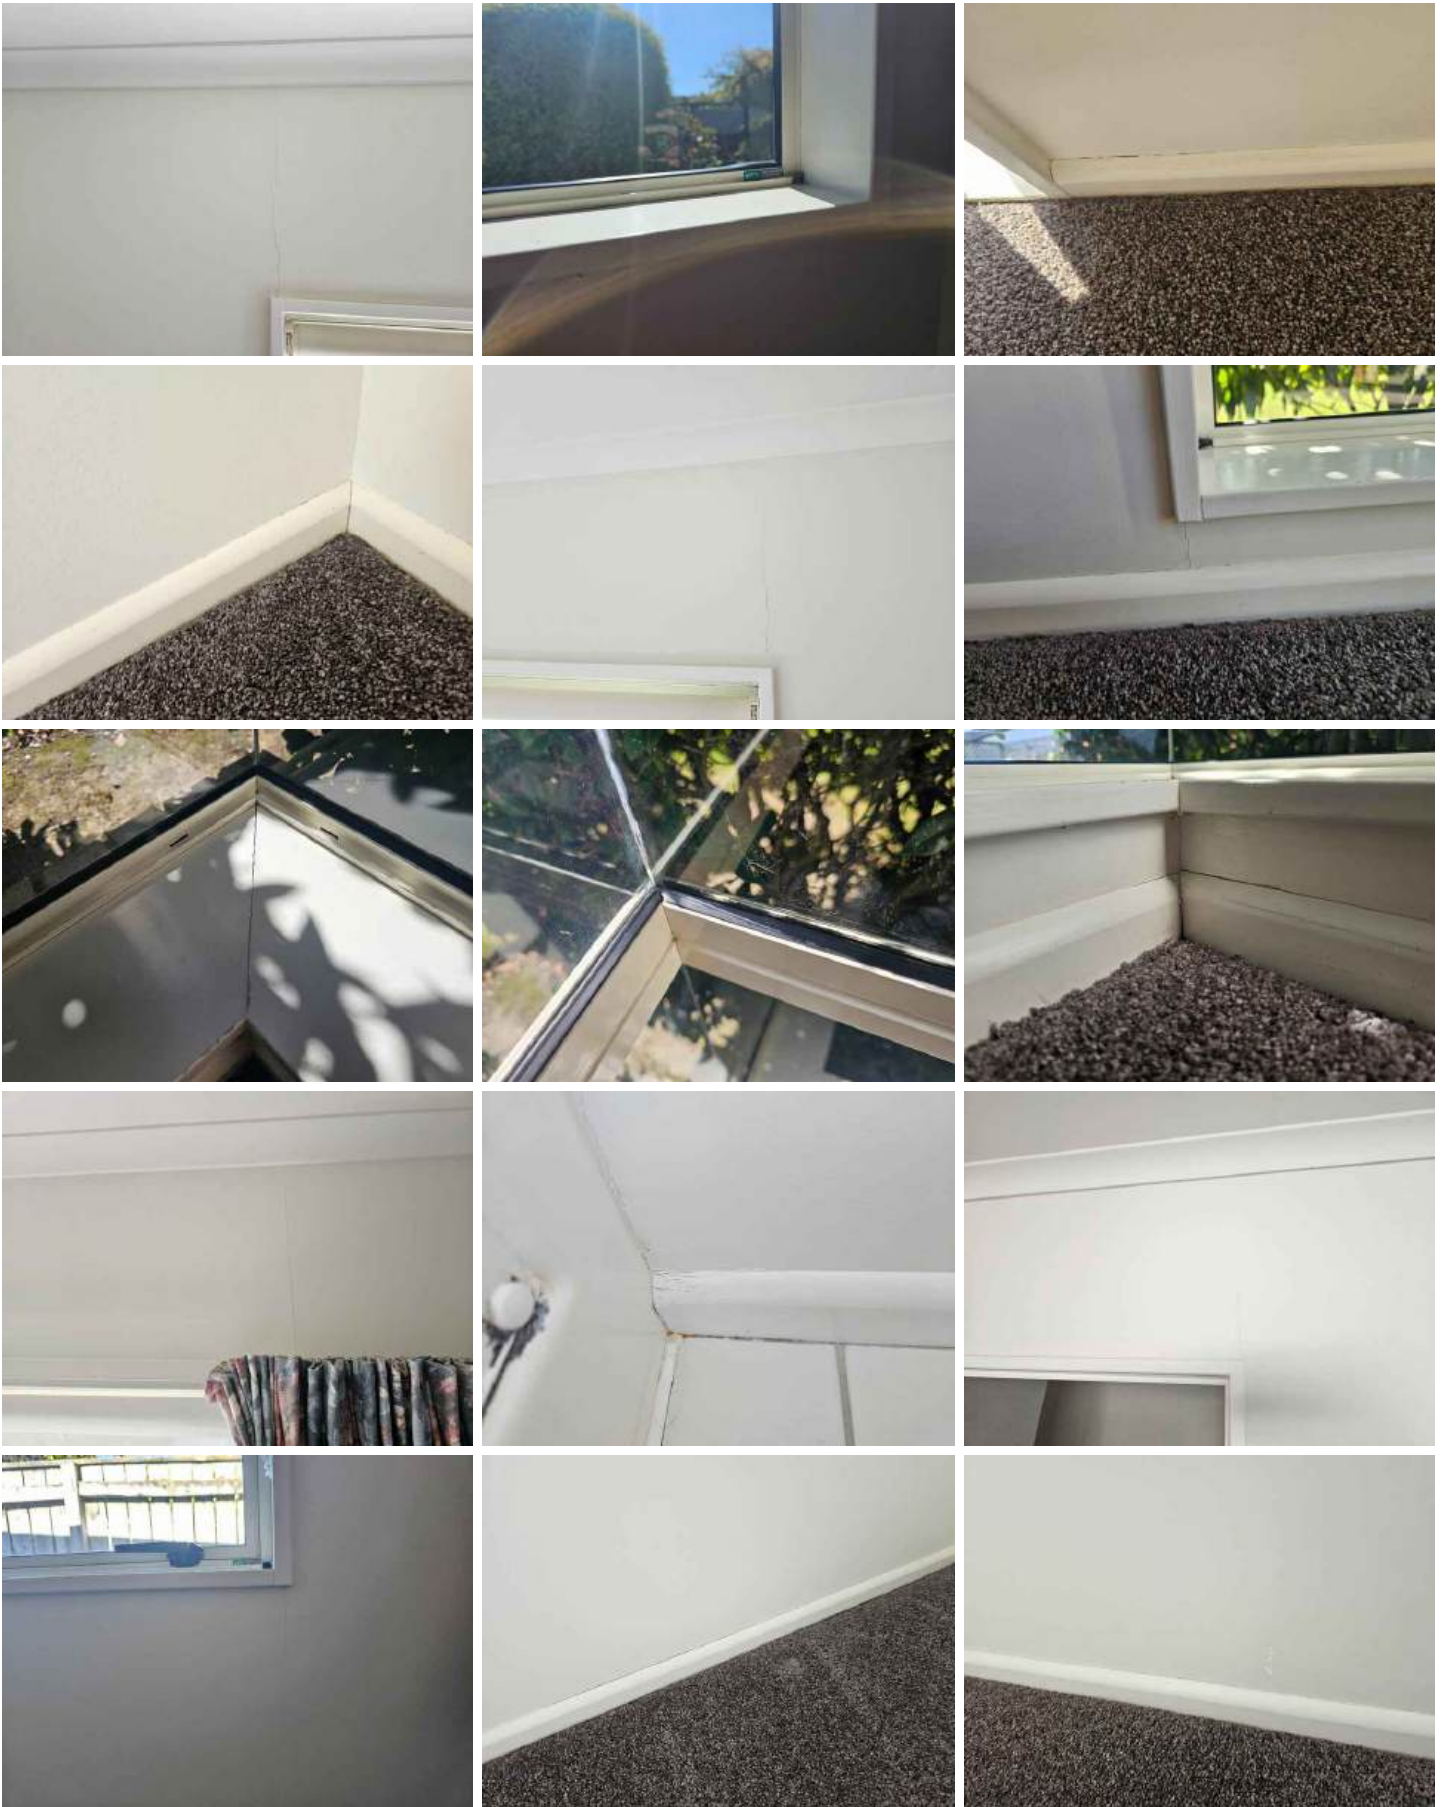
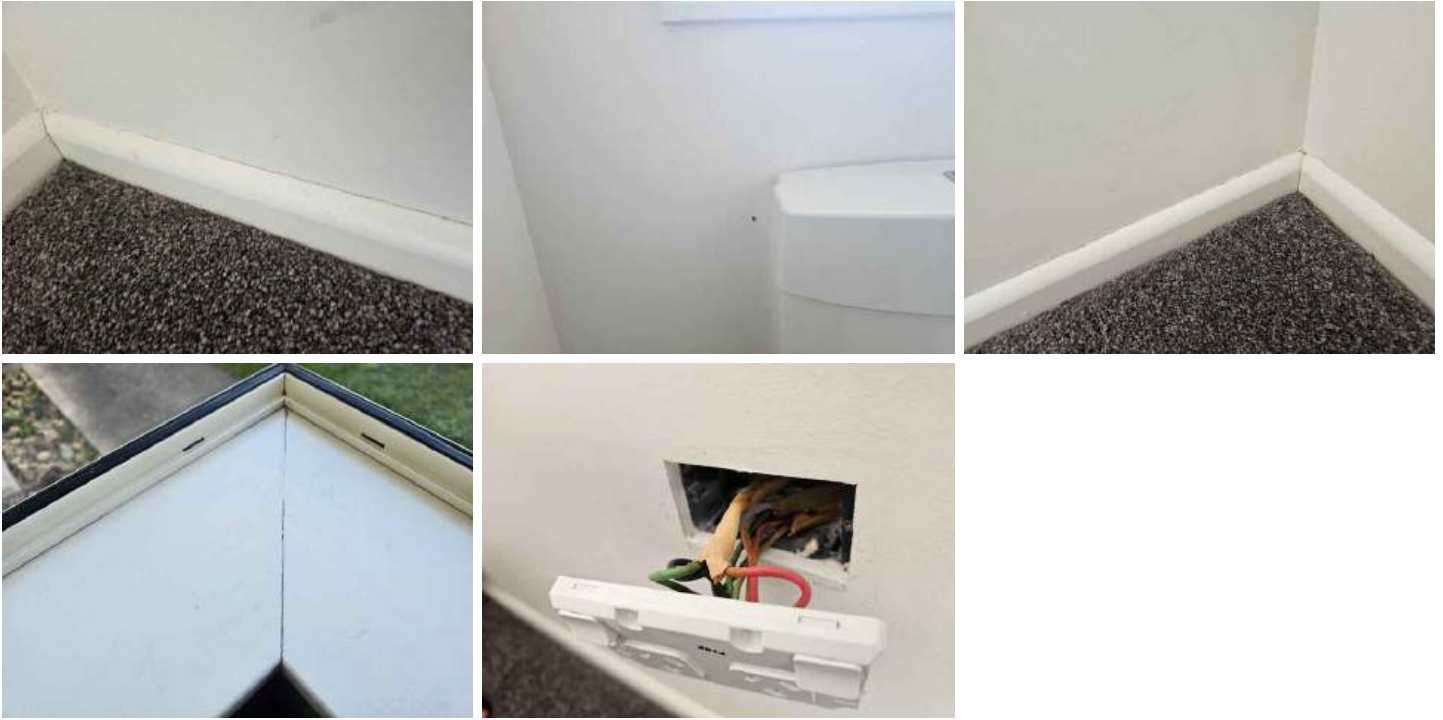
CONDENSATION DAMAGE AT JOINERY

These joinery observations may appear or be quite minor. However, we include them all because of how often we see moderate to major damage within wall cavities from condensation caused defects.

A single 1x1mtr window can produce 0.75 Litres of water "per day" in the optimum conditions. These types of observations may or may not be classed an aesthetic issue, Regardless, if it's left unsealed and/or exposed to the elements for too long it may become a much larger issue and more expensive repair/replacement. For timber joinery and/or surrounding cladding materials, buff/key the surface before applying any weather sealing paint and/or paintable silicone products.

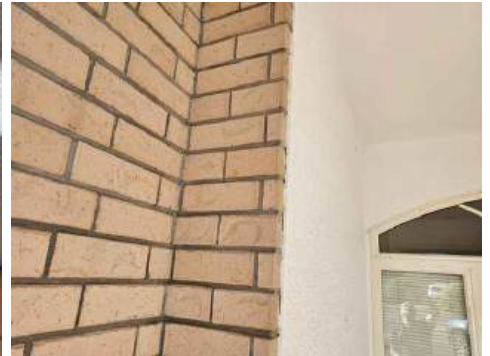
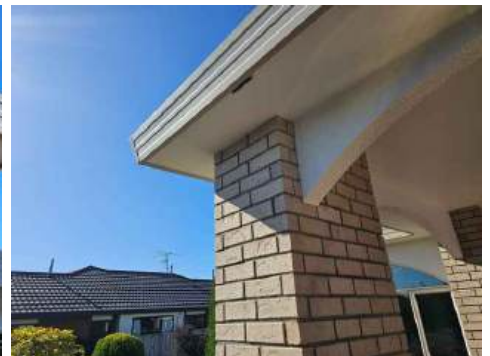
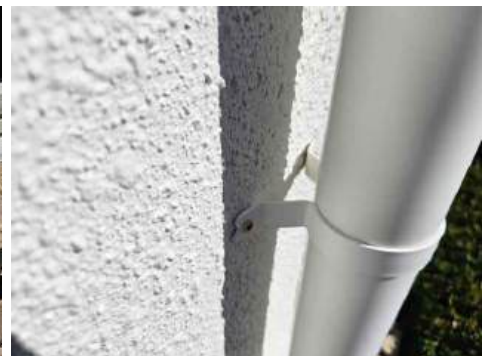
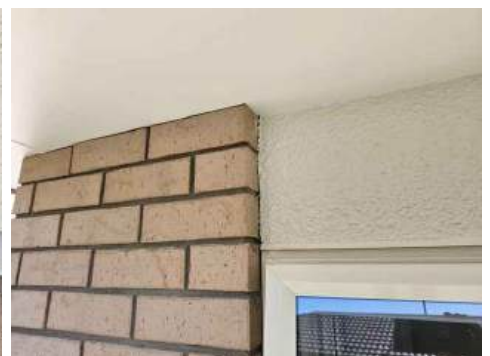
GROUND CLEARANCE

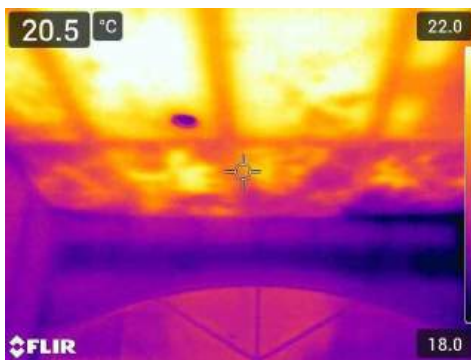
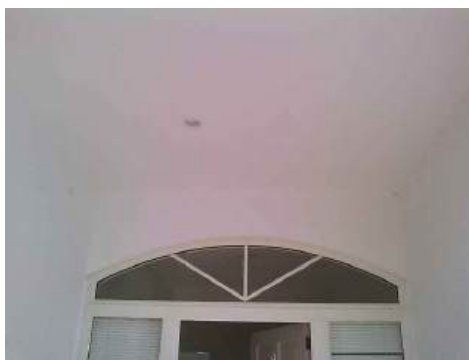
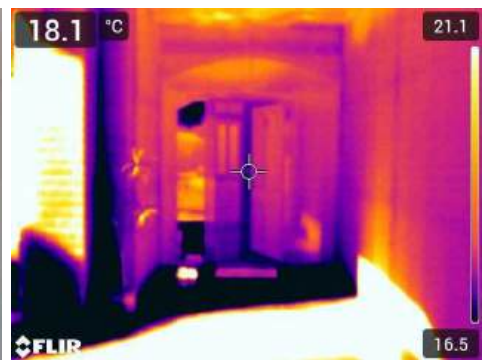
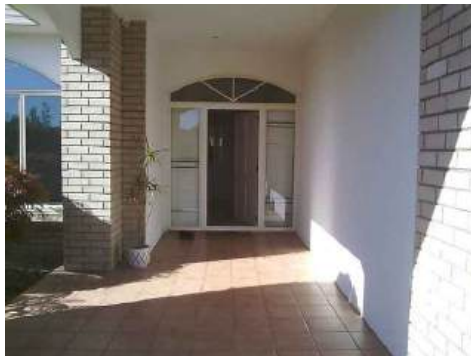
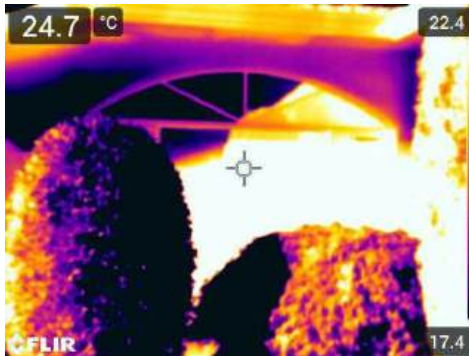
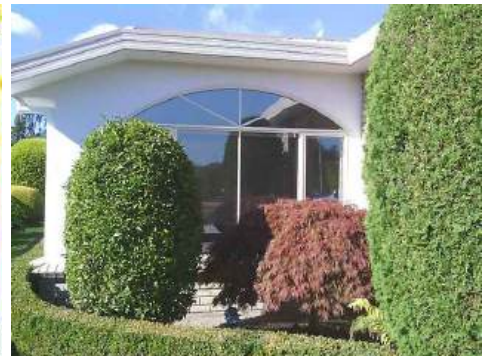
MODERATE TO MAJOR TEMPERATURE DIFFERENTIALS and/or VISUAL THERMAL ANOMALIES SIGHTED

- Moisture may or may not have been detected with definitive certainty in all these particular areas of observation. However, these areas were indicating a moderate to major temperature differential through the FLIR T560 Thermal imager and/or visual signs of moisture ingress/damage may also have been observed.
