## BUILDING INSPECTION REPORT

# **Weir Property Inspections - Building Survey Report**

<b>Client name:</b>	Adrian Taylor
<b>Date of inspection:</b>	7/04/2026
<b>Inspection address:</b>	9 Gore Street
<b>Scope of inspection:</b>	The inspection is conducted strictly in accordance with our Terms and Conditions and is limited to a visual Pre-Purchase or Pre-Sale assessment, following the guidelines of NZ4306:2005.
<b>Report number:</b>	2026/0001-02

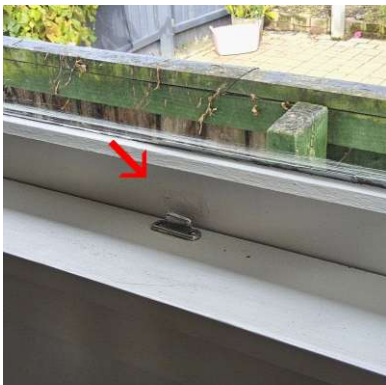
Timber. Reveals, material type. Painted. Material type unknown.  
Some of the window hardware is missing and can be replaced.

**Missing hardware**

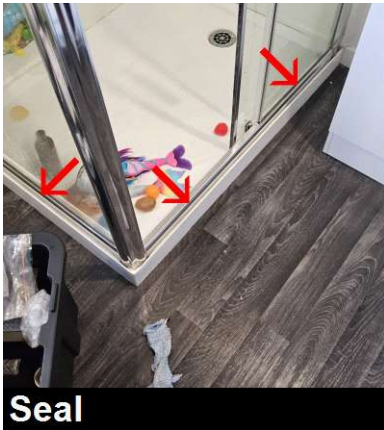
The junction between the shower door and panel and base hasn't been sealed. We recommend sealing this junction to prevent moisture, escaping the shower cubicle.

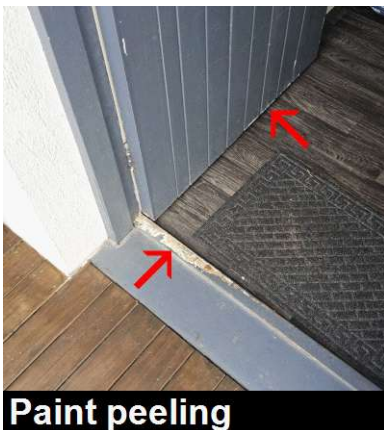
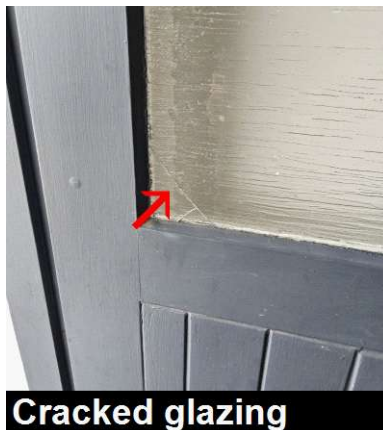
Paint is peeling on the doors. To protect the timber from moisture they can be sanded back and re-painted.

There is cracked glazing that needs to be replaced at some stage.

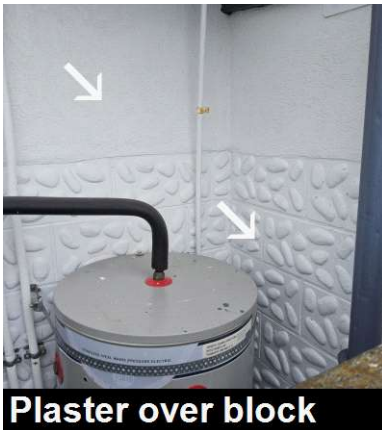
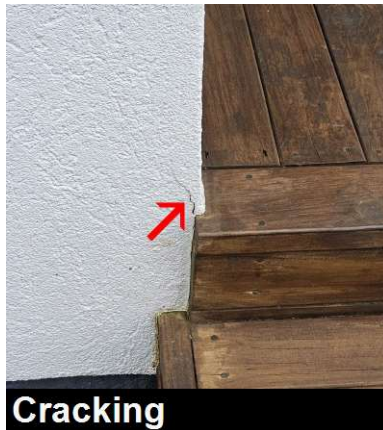
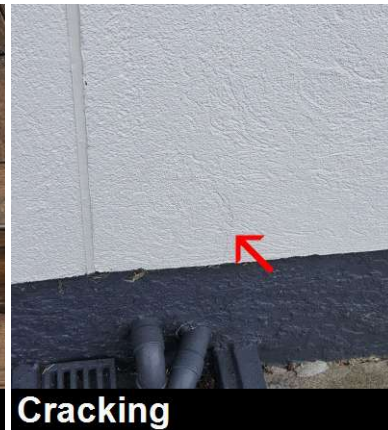
There are some cracks in the plaster. These can be repaired by a Licensed Plasterer.

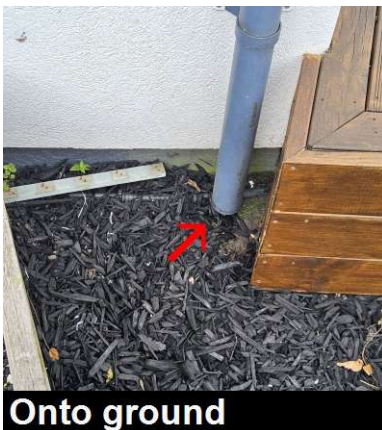
Some downpipes are discharging rain water onto the ground. We recommend all downpipes are discharging rain water into the storm water system, to prevent flooding around the house and foundations.

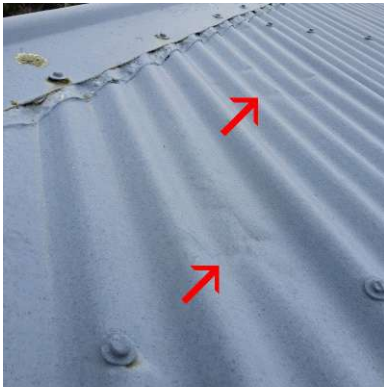
Some of the roofing has dents that require repair or replacement.

**Dents**

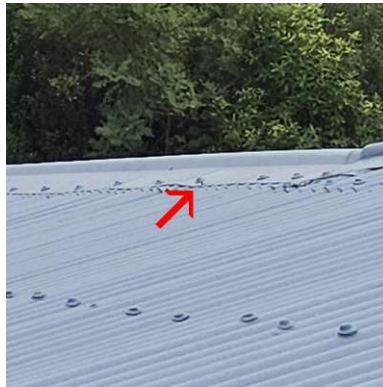
Some of the roof fixings are loose or damaged and require removing and replacing.

**Loose fixings**

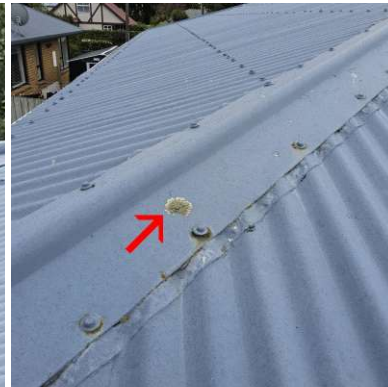
Lichen and moss growth was found. It can be treated to remove it as it can cause damage to the roof surface.

**Lichen**

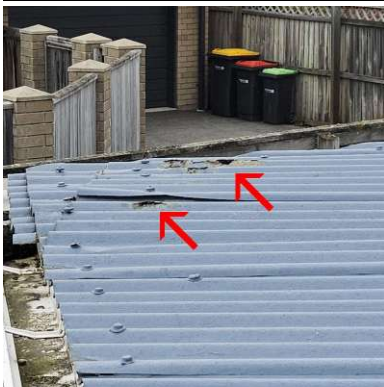
The roof has surface rust and damage, that requires repair or replacement. Some of the roofing requires fixing back in place where the laps are lifting.

**Rust damage**

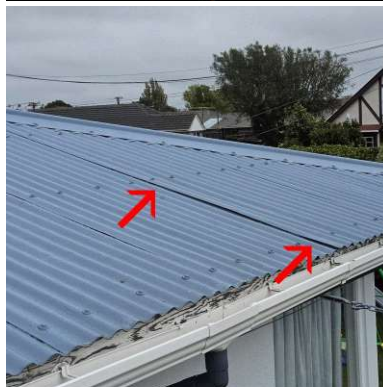
**Lifting laps**

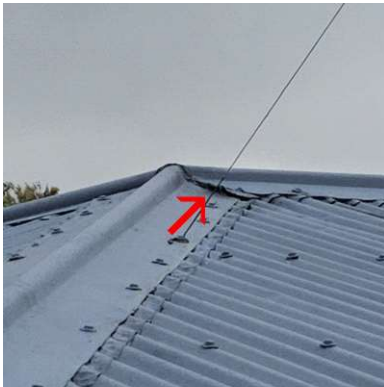
Some of the flashings requires fixing back in place where the laps are lifting.

**Lifting**

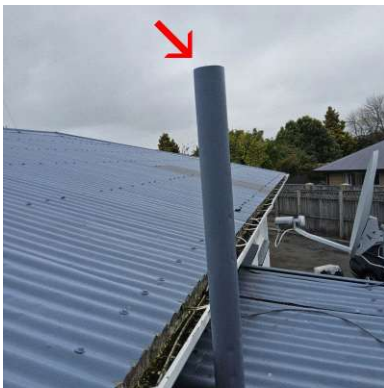
The vent pipe cap is missing and should have one fitted. These prevent birds or vermin getting in.

**Cap missing**

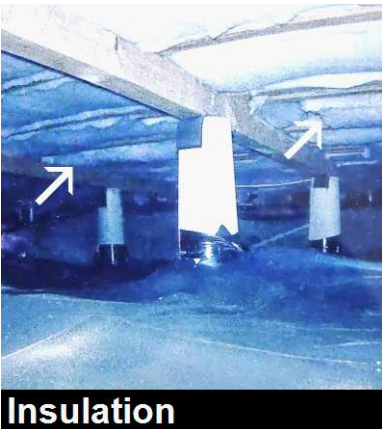
The polyester insulation prevented a thorough examination of the flooring. The insulation has a thickness of about 70 mm. Coverage: 100%, more or less.

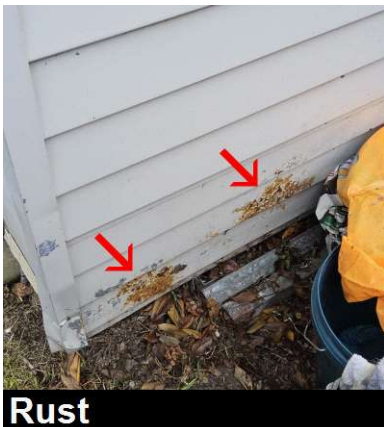
The cladding has surface rust, that needs to be sanded back, primed and painted to prevent any further damage. If any holes are found, the cladding should be replaced.

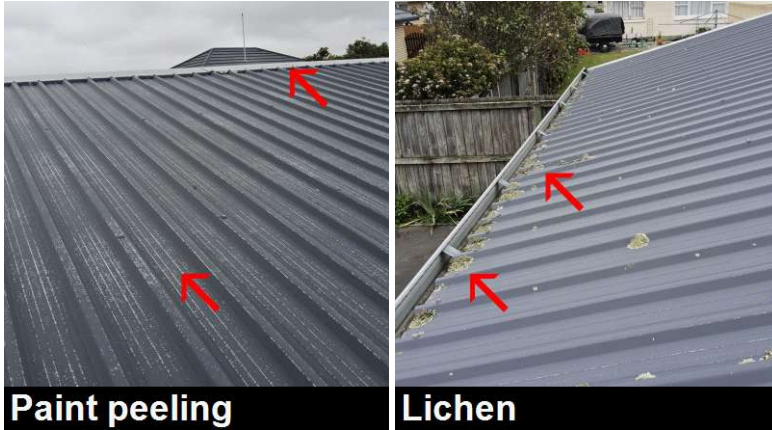
Paint is peeling in some areas, which can be prepared and re-painted.

Lichen and moss growth was found. It can be treated to remove it as it can cause damage to the roof surface.
