BUILDING INSPECTION REPORT

PROPERTY CHECK EXPRESS REPORT

Job Number	54389
Client	Olivia Harris
Property Inspected	241 Lake Terrace Road, Shirley, Christchurch
Inspection Date	15 April 2026
Building Surveyor	Darin Devanny
NZIBS Registration Number	BSI0100
Weather Conditions	Fine
Scope of Report	Visual inspection of the buildings that are listed in this report for the purpose of a residential inspection in accordance with NZS4306: Residential Property Inspections.
Report Ordered By	Olivia Harris - Vendor
Orientation	For the purpose of this report, the elevation of the house facing the road is the east elevation.

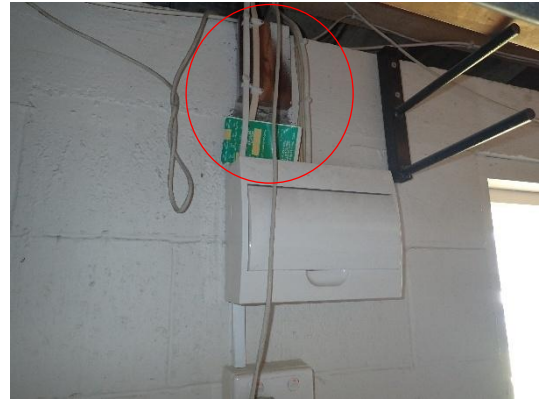
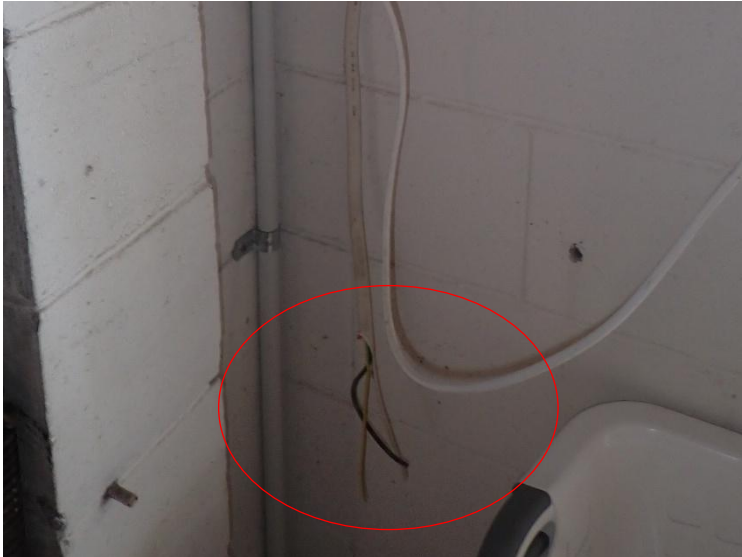
There is loose electrical cabling and wiring without mechanical protection near the fuse board in the garage. It is recommended that the loose cabling is made safe by a licensed electrician and that mechanical protection is added where required.

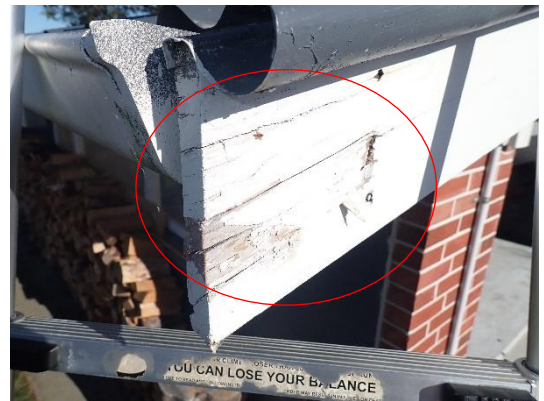
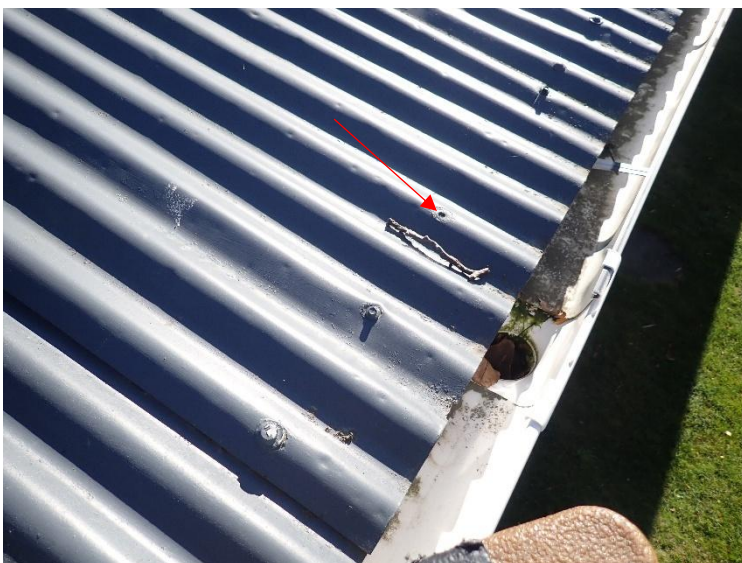
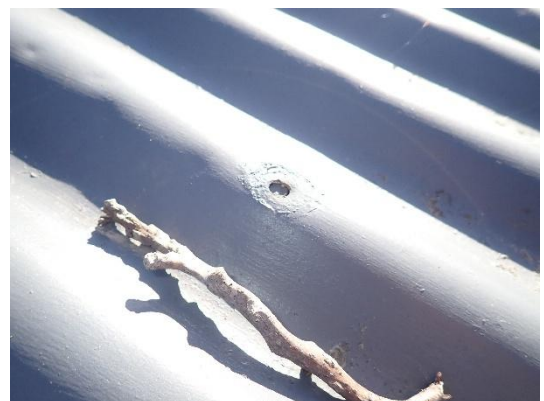
Barge board ends on the garage roof are starting to deteriorate. It is recommended that they are sanded back and repainted to extend serviceable life.

There is a missing roofing nail on the southern elevation of the roof that requires replacement to prevent the entry of water.

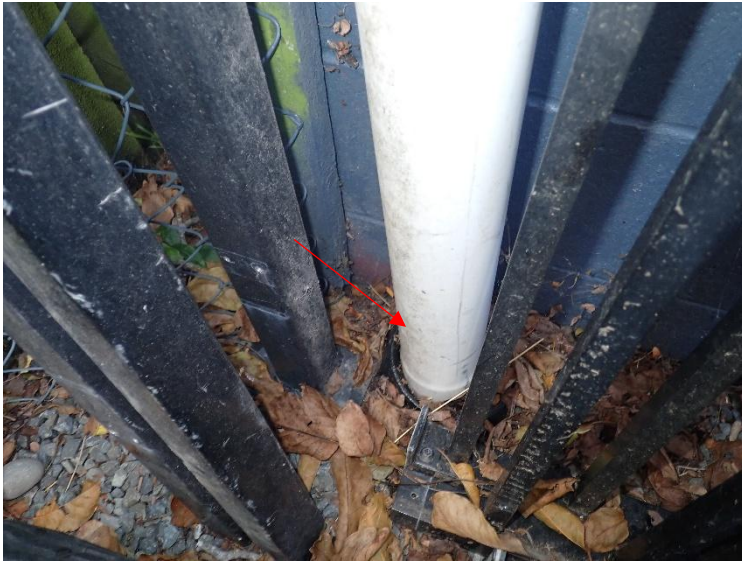
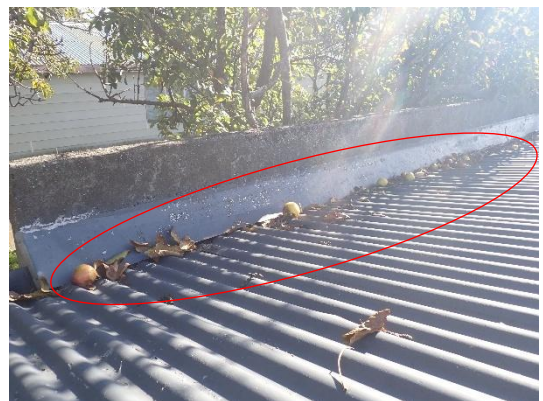
At the northeast corner of the garage roof, there is no spouting installed and rainwater is discharged directly onto the ground. Consideration should be given to installing a correct spouting system to collect this rainwater.

The riser to the northwest corner of the garage and the spouting above requires clearing out as part of routine maintenance to allow free flow of water.

This downpipe is loose. Consideration could be given to fixing this with a clip to the corner of the building to provide stability.

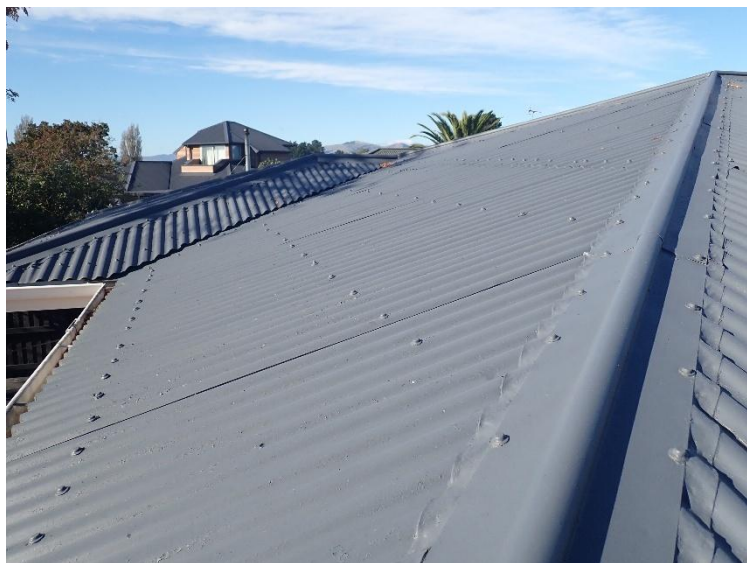
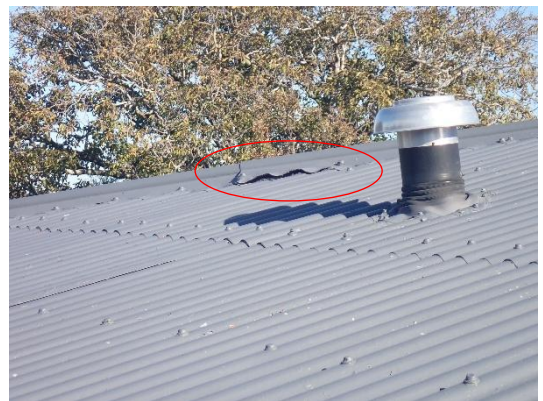
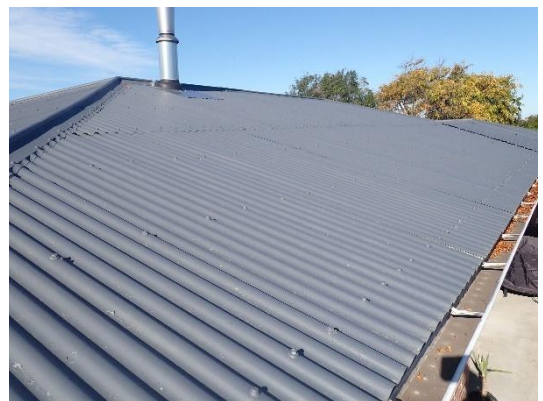
The ridge to the southwest elevation is raised and there is a gap. It is recommended that this is fixed down securely to prevent rainwater entry.

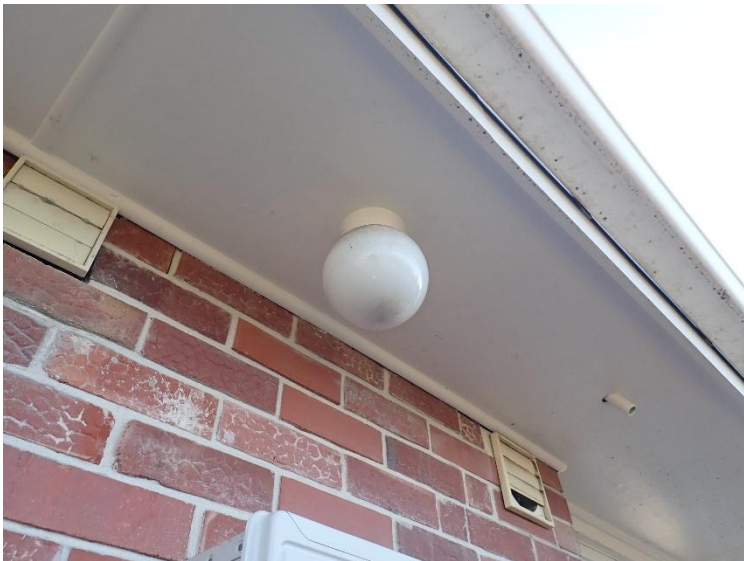
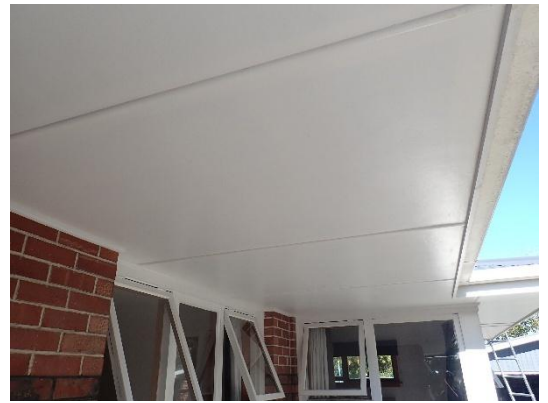
These soffits are likely to contain asbestos, so due care should be taken in the future during any repairs or replacement. No significant defects identified.
