EQC CLAIM DOCUMENTATION

EARTHQUAKE RECOVERY (EQR) DOCUMENTATION

Released under the Official Information Act 1982
EQR Property Overview Report

EQC Property ID	Property Address	Vulnerable?	Property F Status	Property Finalisation Indicator		
2010061240	41 MACKENZIE AVENUE, WOOLSTON		F3 - Complete & Finalised	Some Finalisation has taken place		
Main Contractor:	CLOSED OUT-S.K. Hand Builders Limited ***** (SC30)		Property F2'd By:	Blair Jones	F2 Completed Date:	20-06-2016
Cont Managing Hub:	Ensors	Not Vulnerable	Property F3'd By:	Blair Jones	F3 Completed Date:	20-06-2016

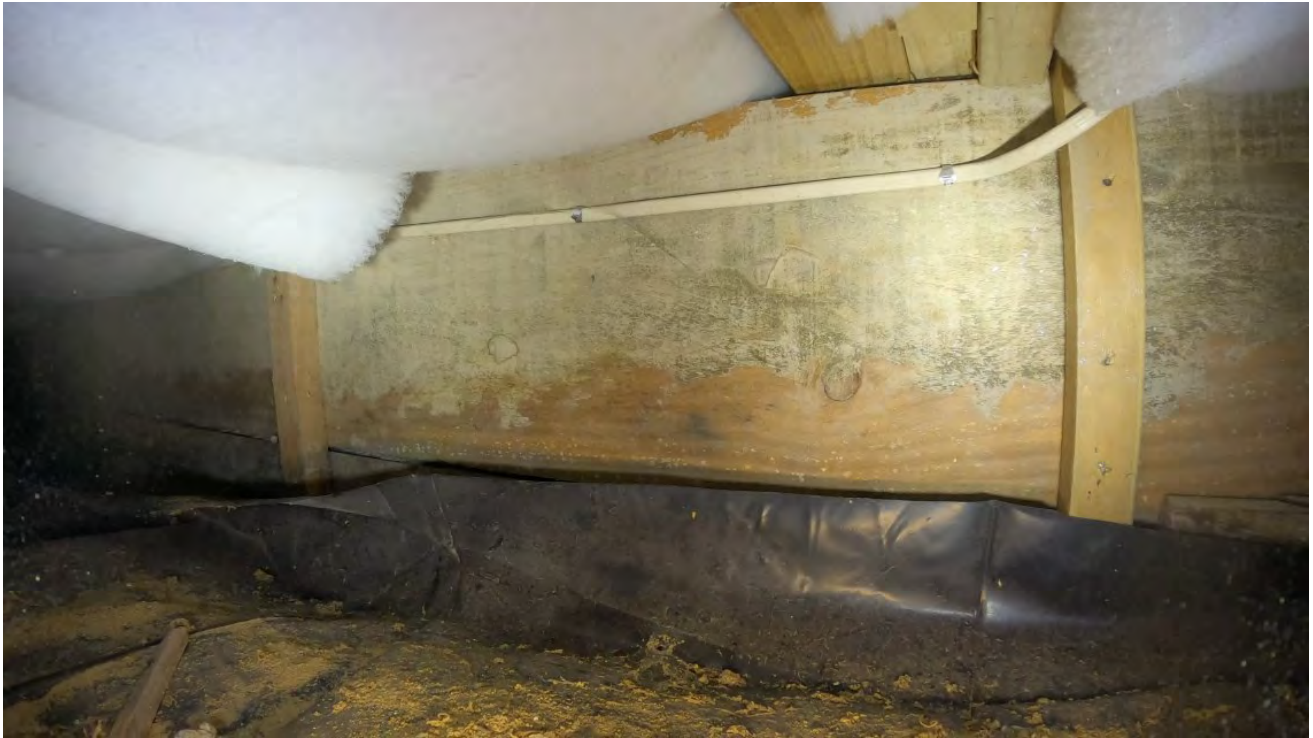
4: Here we see the rot taking hold on the boxing and damp ground conditions. It is very important to note that by leaving the boxing on every vent has been blocked, if indeed there are any on the sides of the home. These are exceptionally important and a legal requirement.

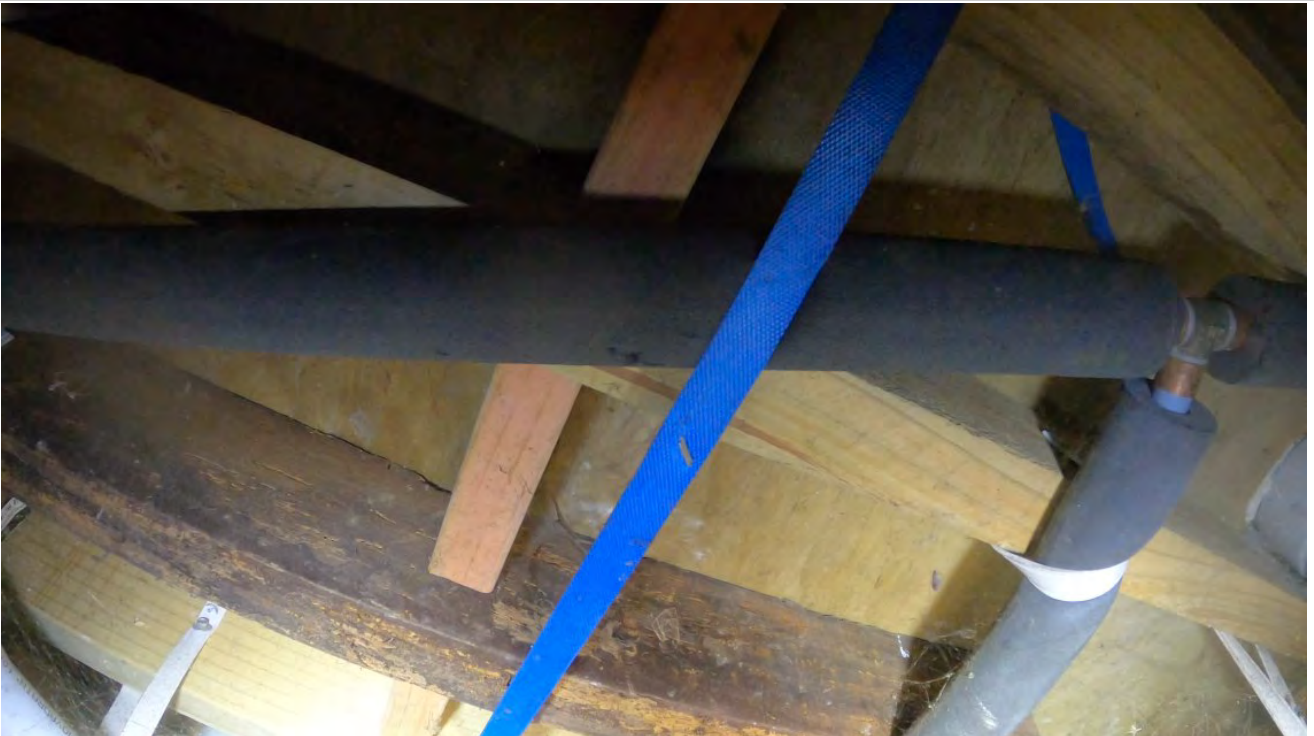
7: Most of the new timber used in the subfloor is the correctly treated H3.2 timber, however here we do see the use of some H1.2 which is not rated for use in this environment.

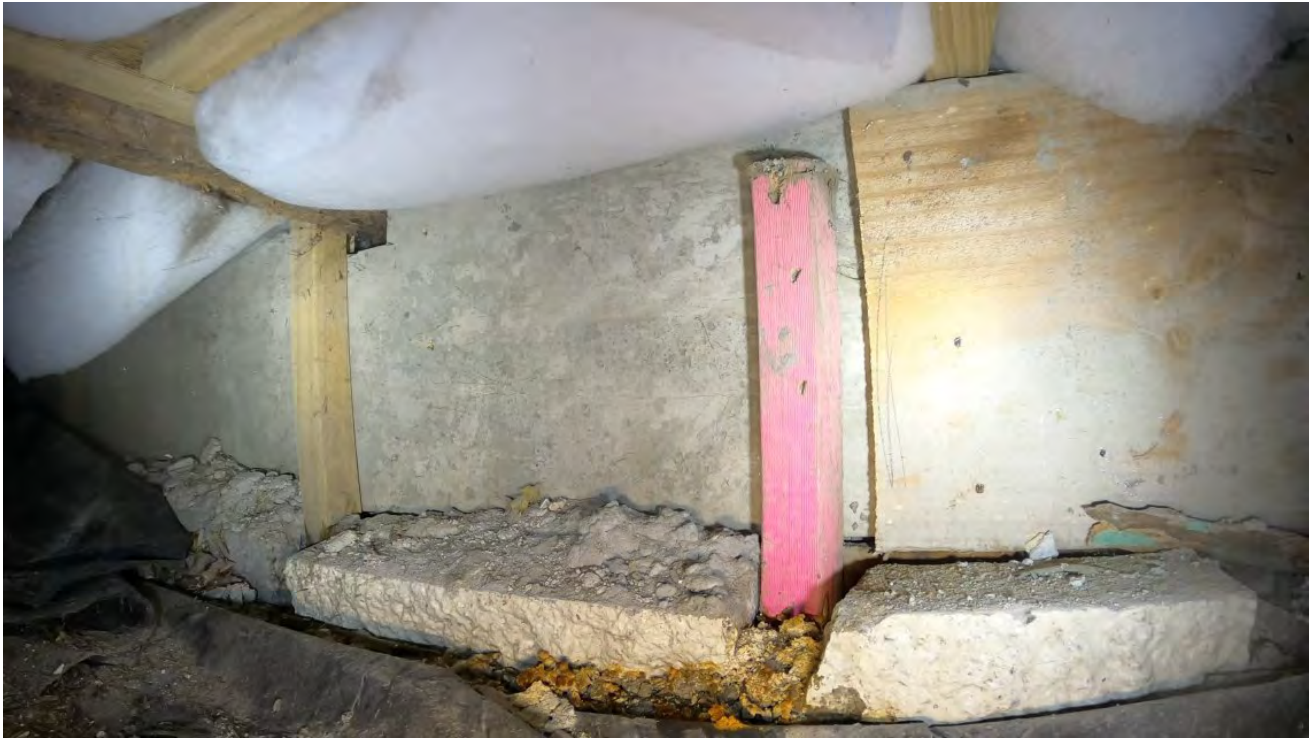
12: Here we see some original timber left in place but in poor condition.

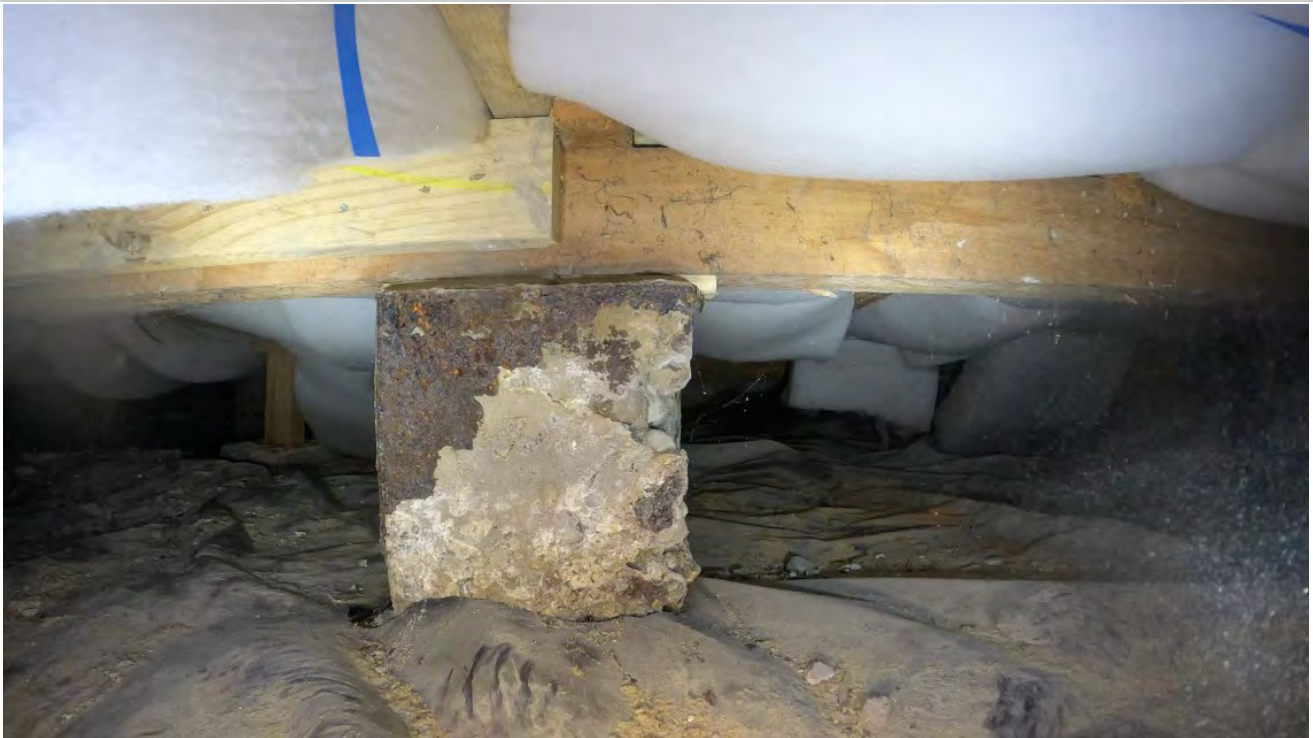
16: Right across the subfloor we see the use of these props. They are not concreted into the ground and are definitely not piles. This is very poor workmanship.

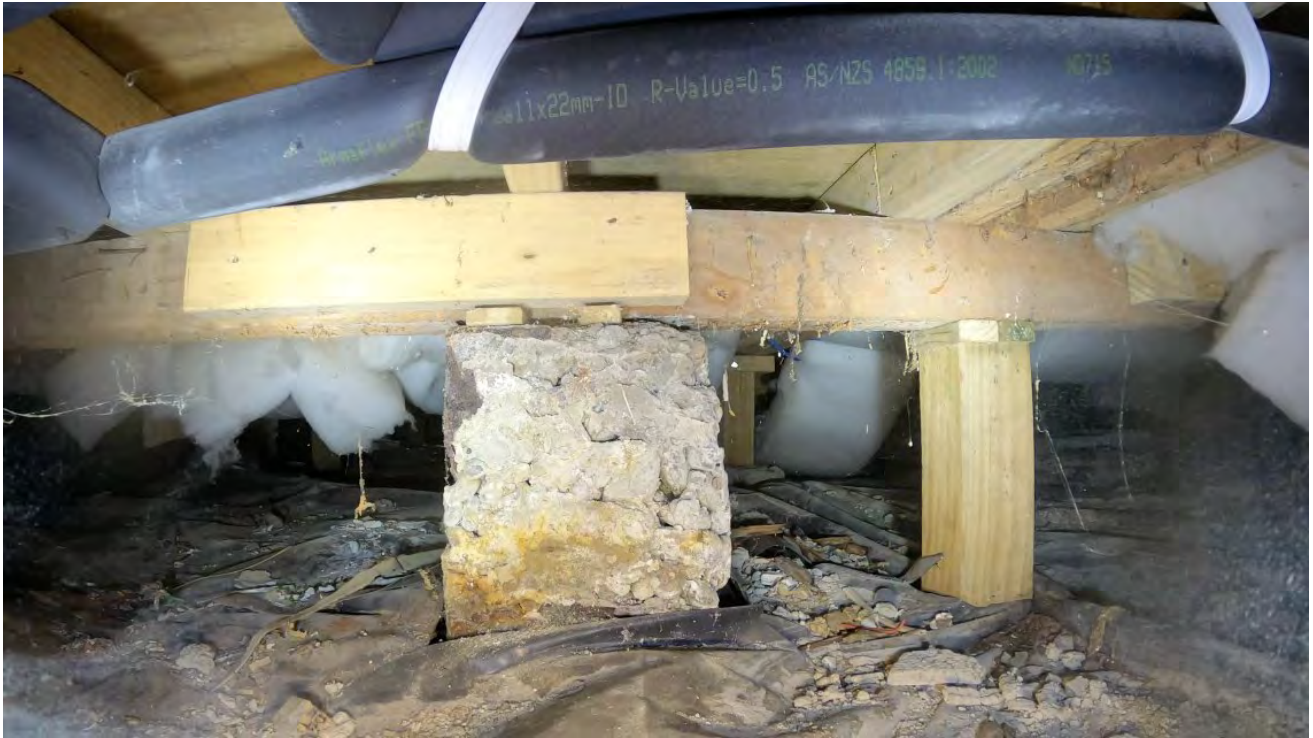
18: Here we see that the bearer is in poor condition but has been left in place with new timber being fixed to it.

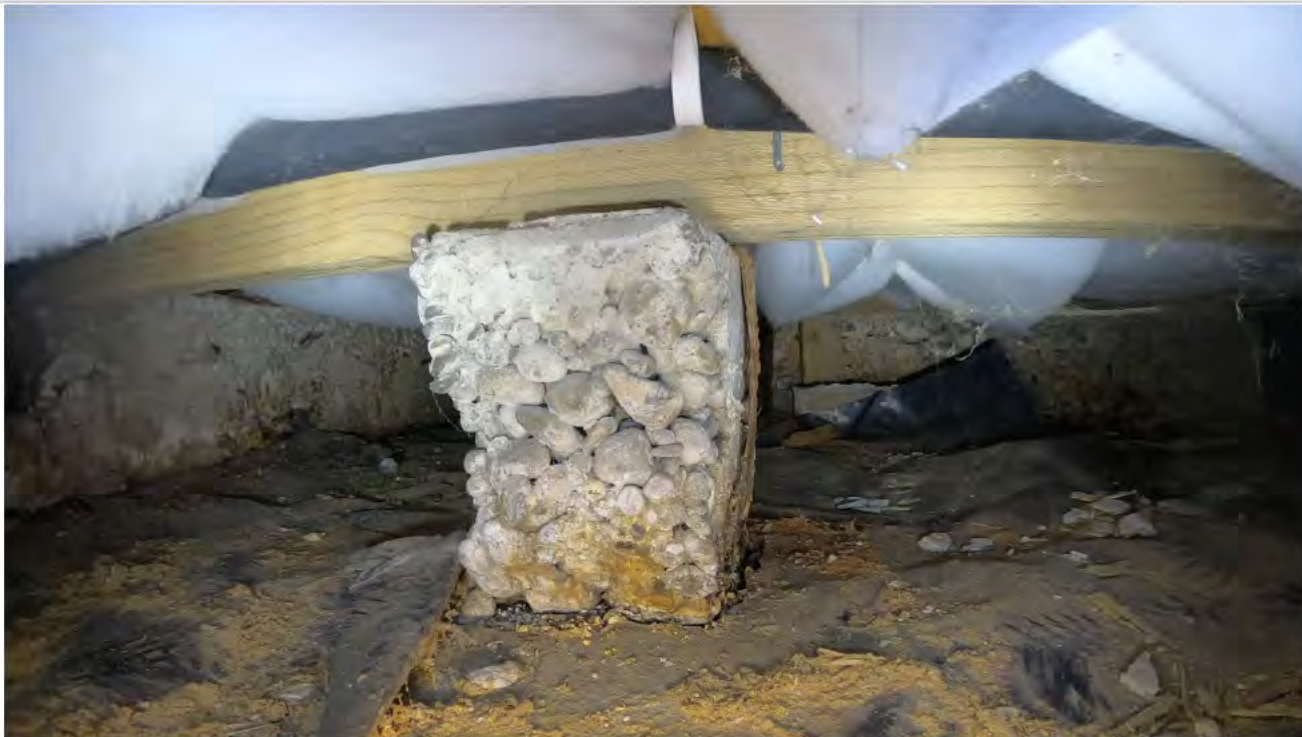
22: View of bearer meeting ring foundation with cracking. The foundations are average to poor quality type "B" rubble foundations. There has been extensive use of large stones in the aggregate. These can weaken the concrete and often create voids which affect epoxy repairs. It is not unusual to see fine cracking at the corner of vents and these existed pre-earthquakes however, the cracks we see are not just at the vents and are larger than would be expected. None show any sign of being repaired, so if the EQC scope of repairs says otherwise this would be important.

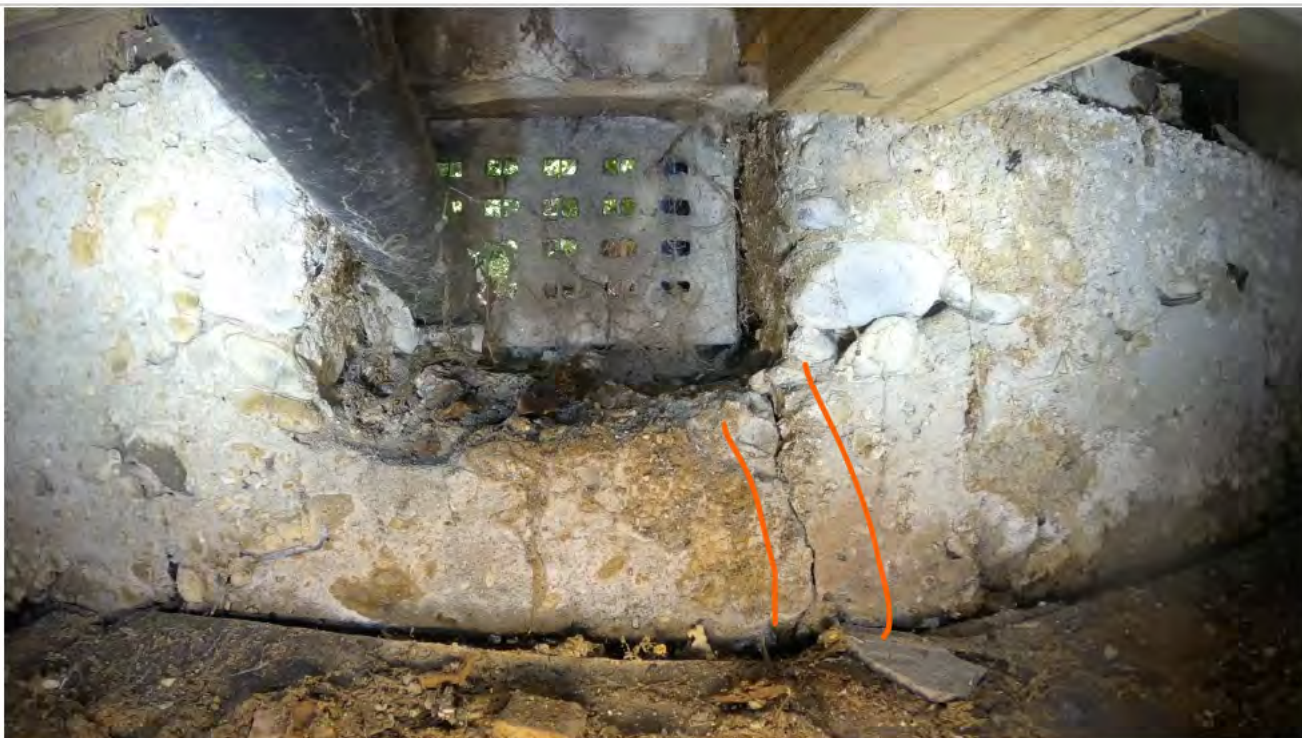
23: No damp course has been used under the bearer and it is only connected by 4 nails.

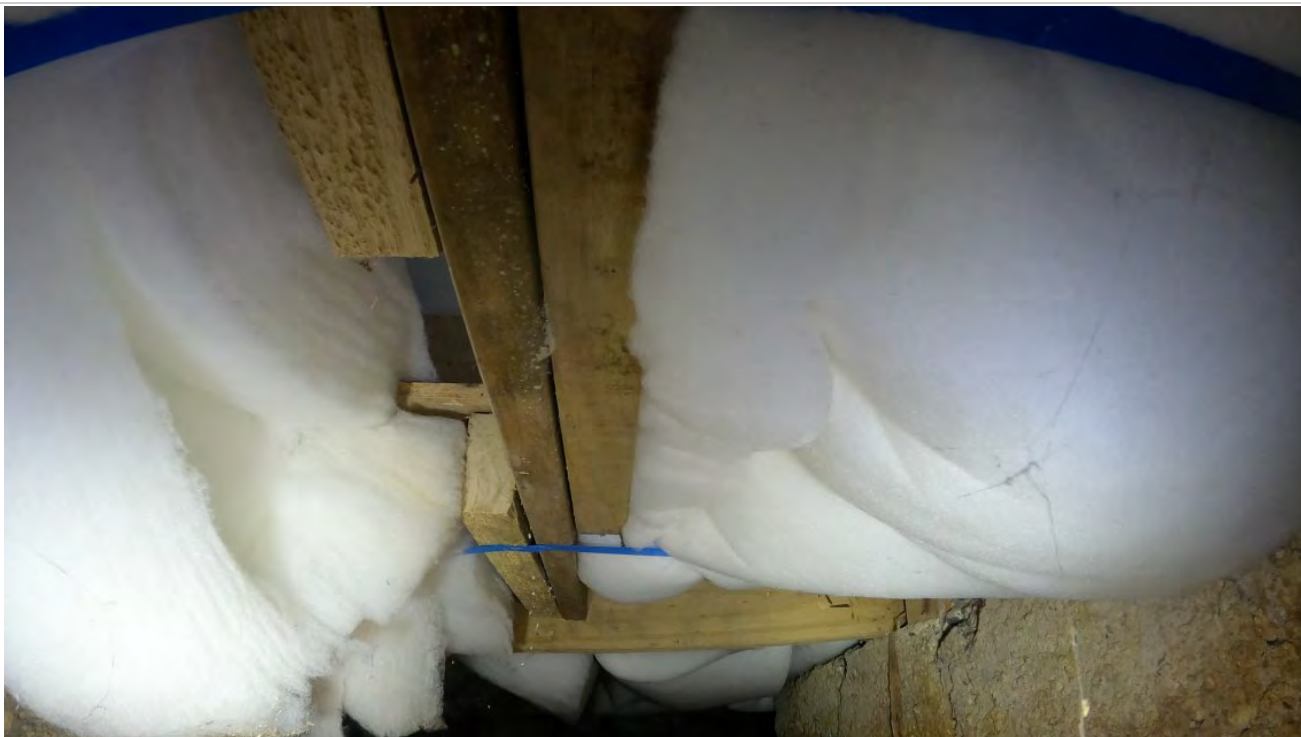
26: This is a replacement bearer, and it is not fixed to the chimney breast, nor is there any dampcourse evident.

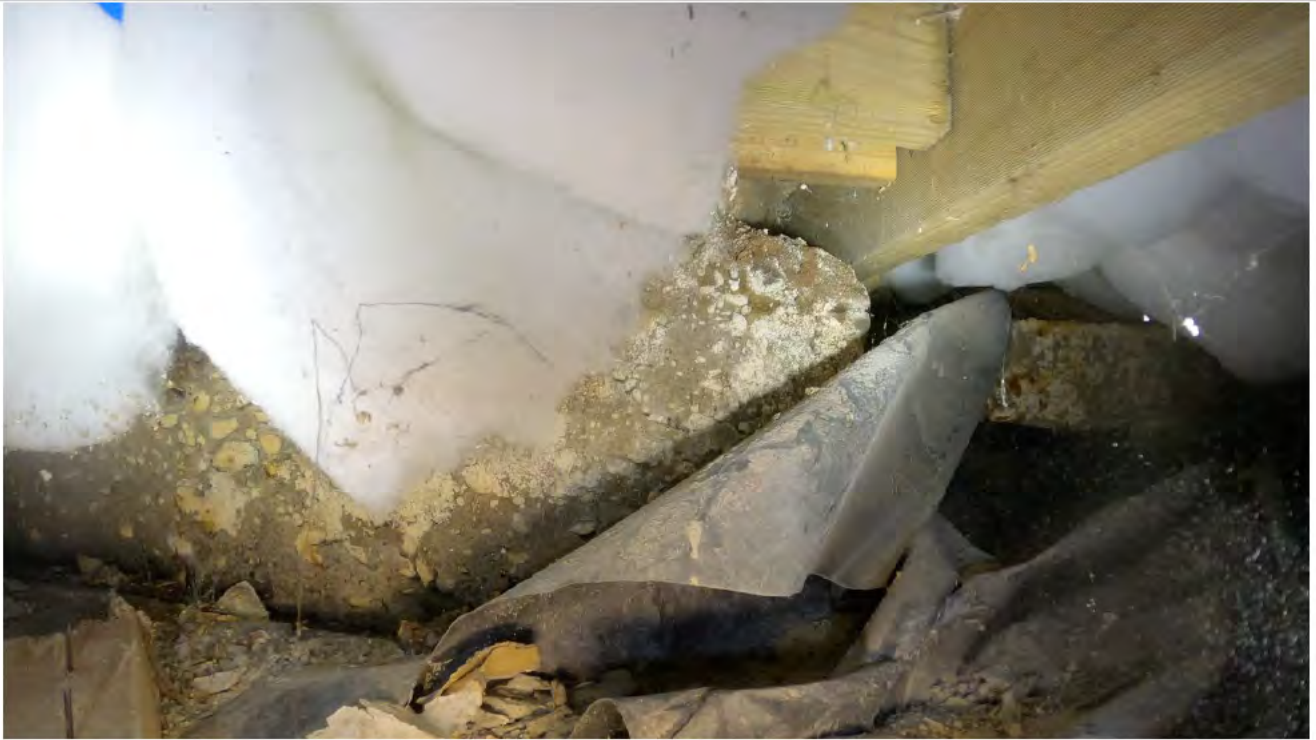
28: The water main would have come into the home here. I didn't sight a new one.

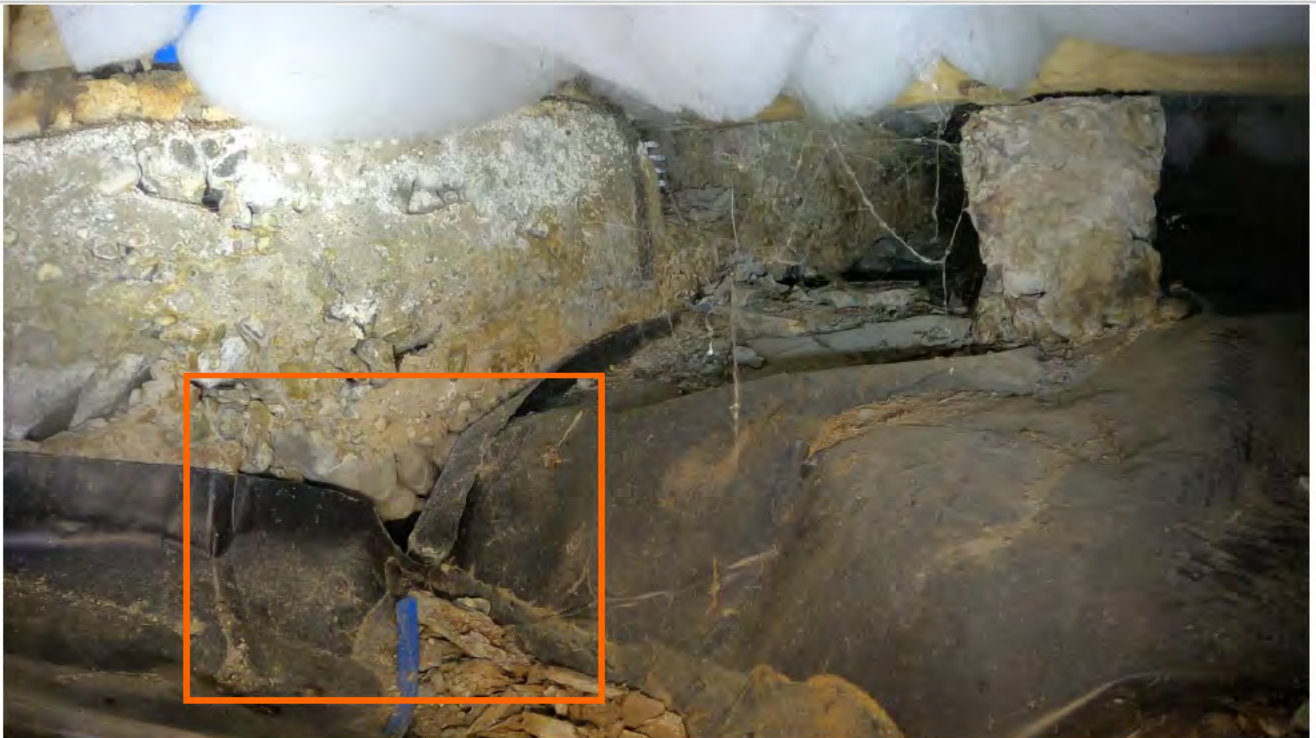
29: View of ring foundation with rotten timber.

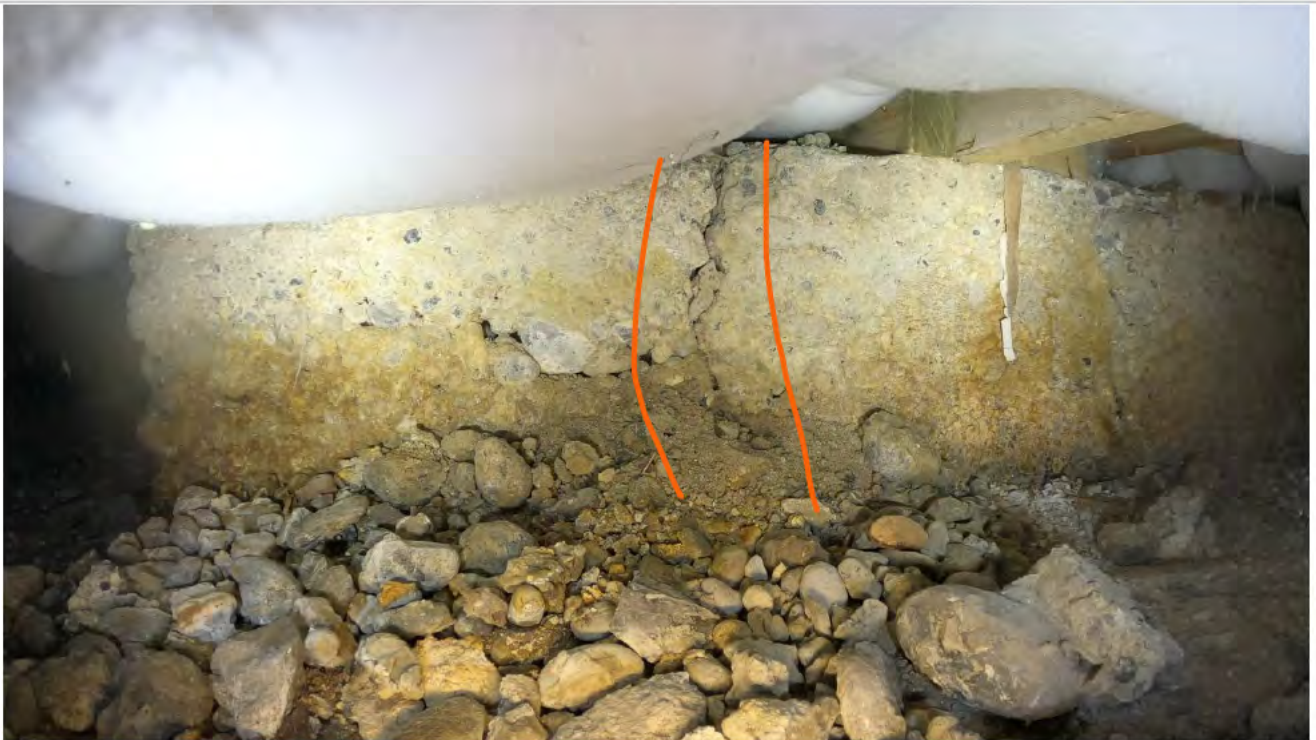
31: View of the chimney breast with cracking. Note the rotten wall plate supported on a block of timber.

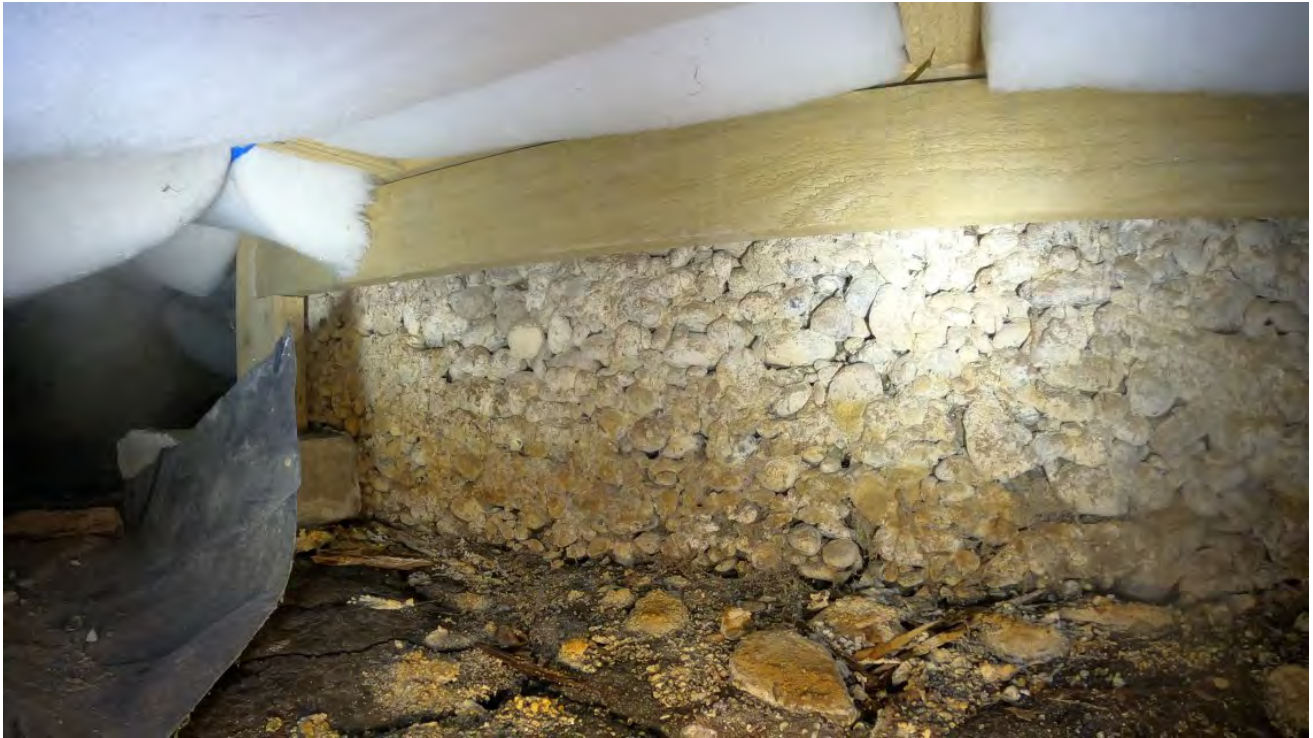
34: View of propping. In this view we can see significant ground cracking. This is typical of a subfloor that has suffered flooding and the upper layer has dried allowing it to shrink. This can have a negative effect on the grounds ability to hold the piles.

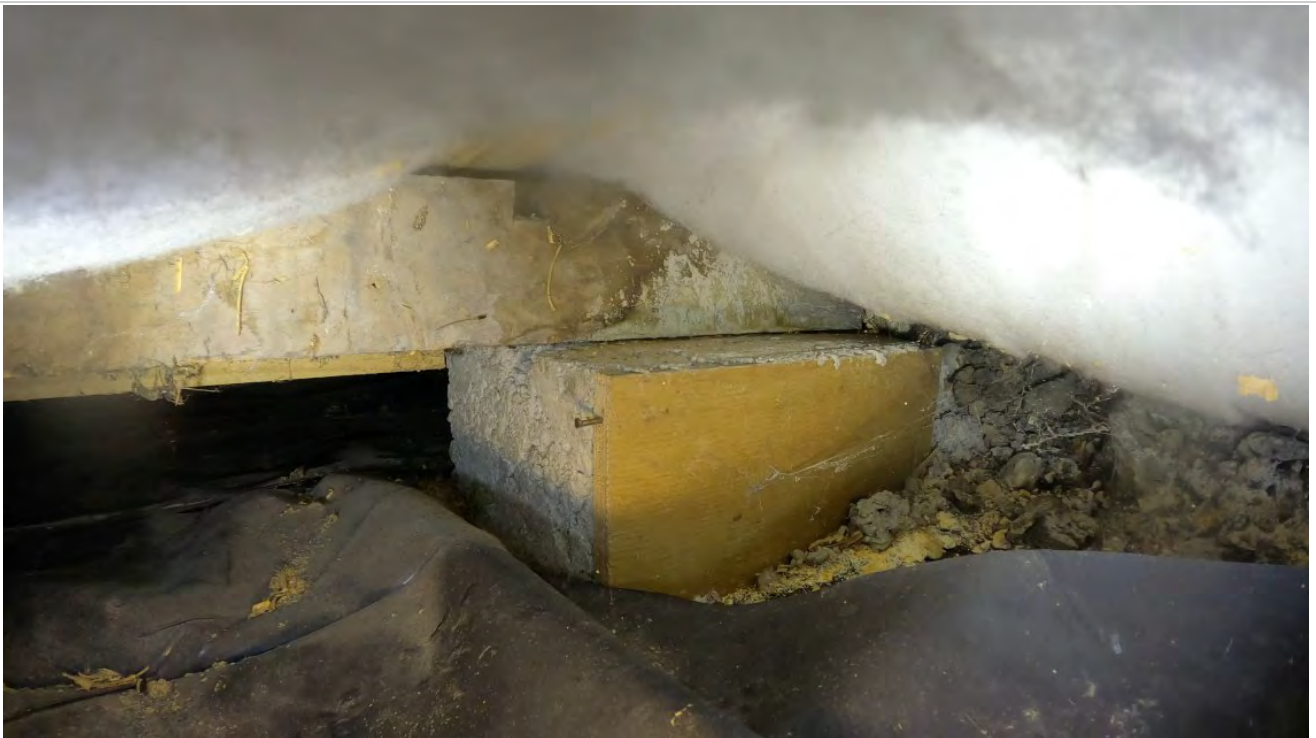
47: View of ring foundation. Note there is no evident daylight visible in one of the few vents we do see. Also, some of the insulation is falling down in areas, as seen here.

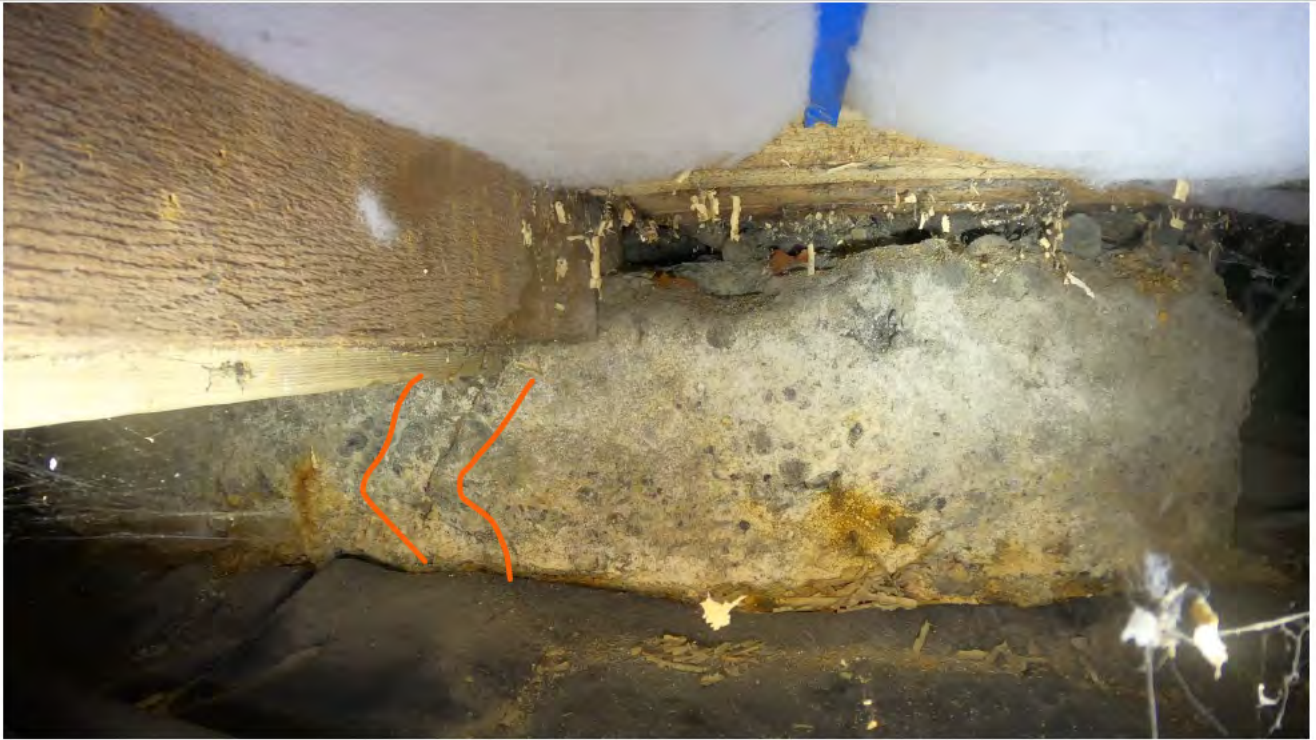
50: The bearer has been clashed on one side. The old bearer should have been removed.

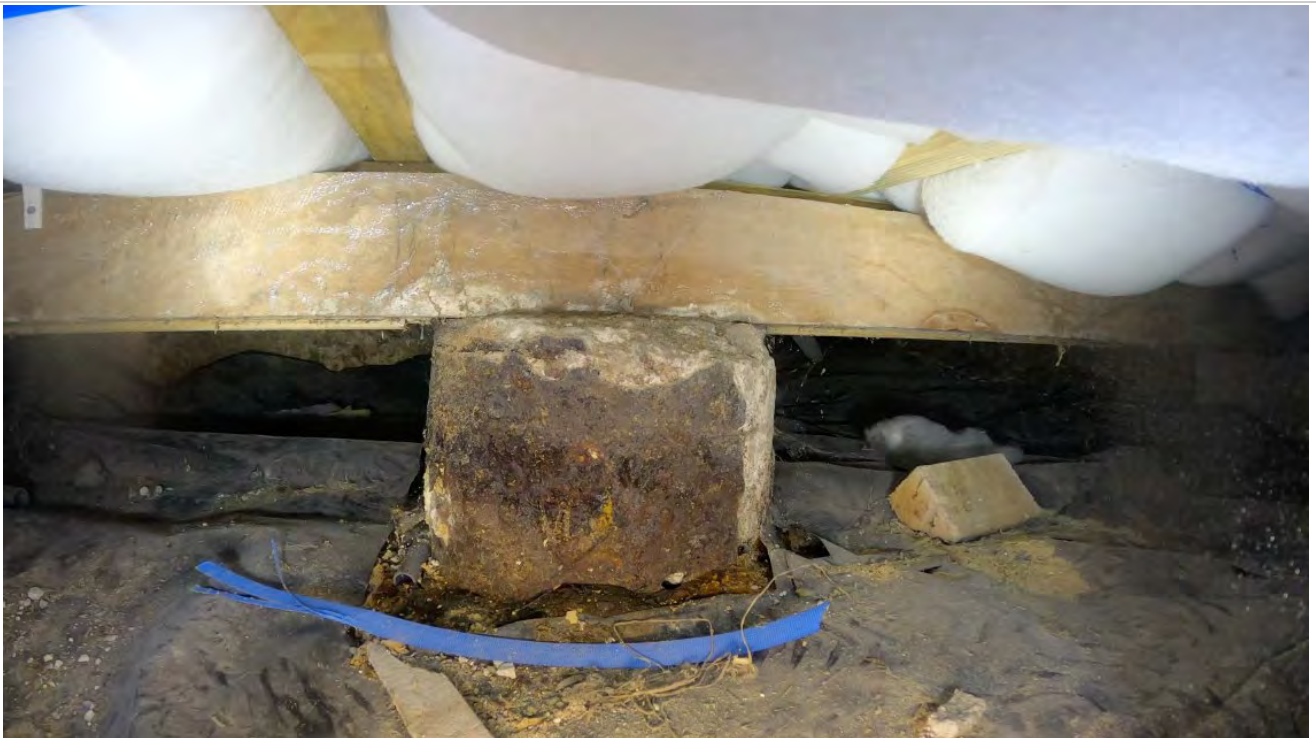
55: View of propping and the joist is cracked.

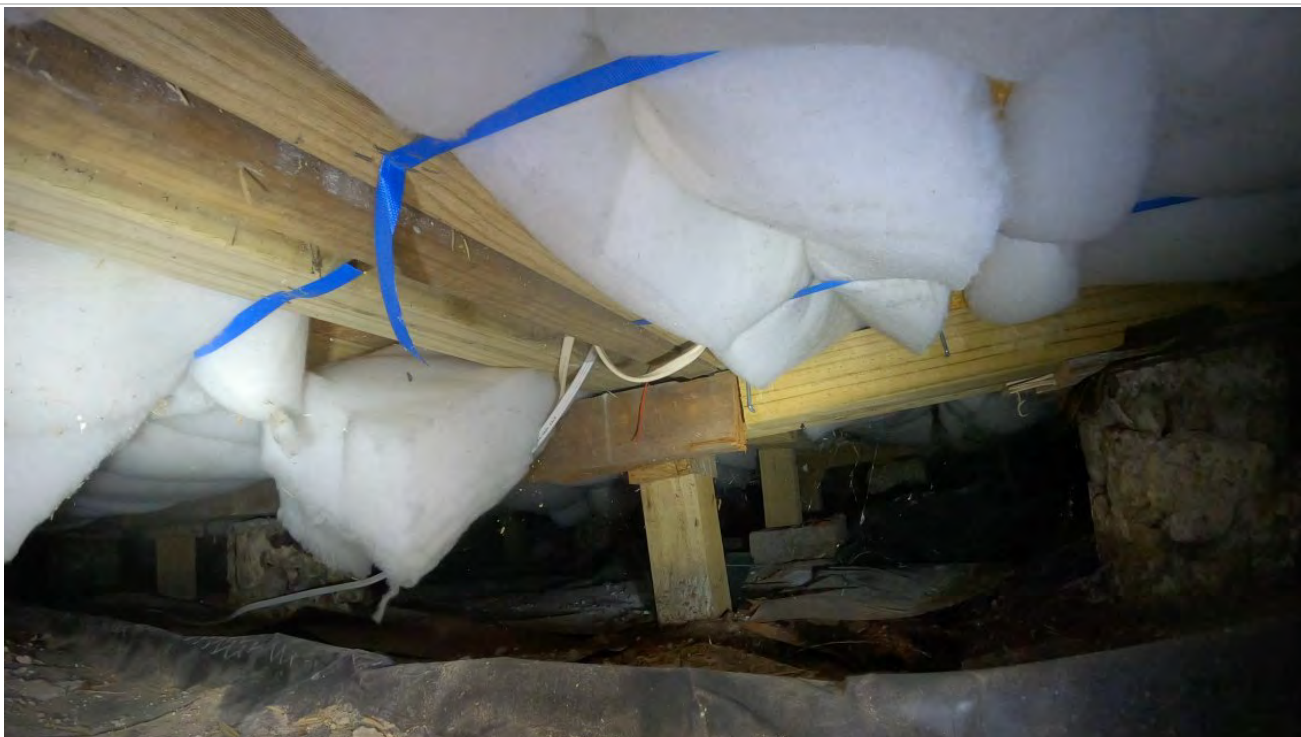
72: Here we see a rotten bearer.

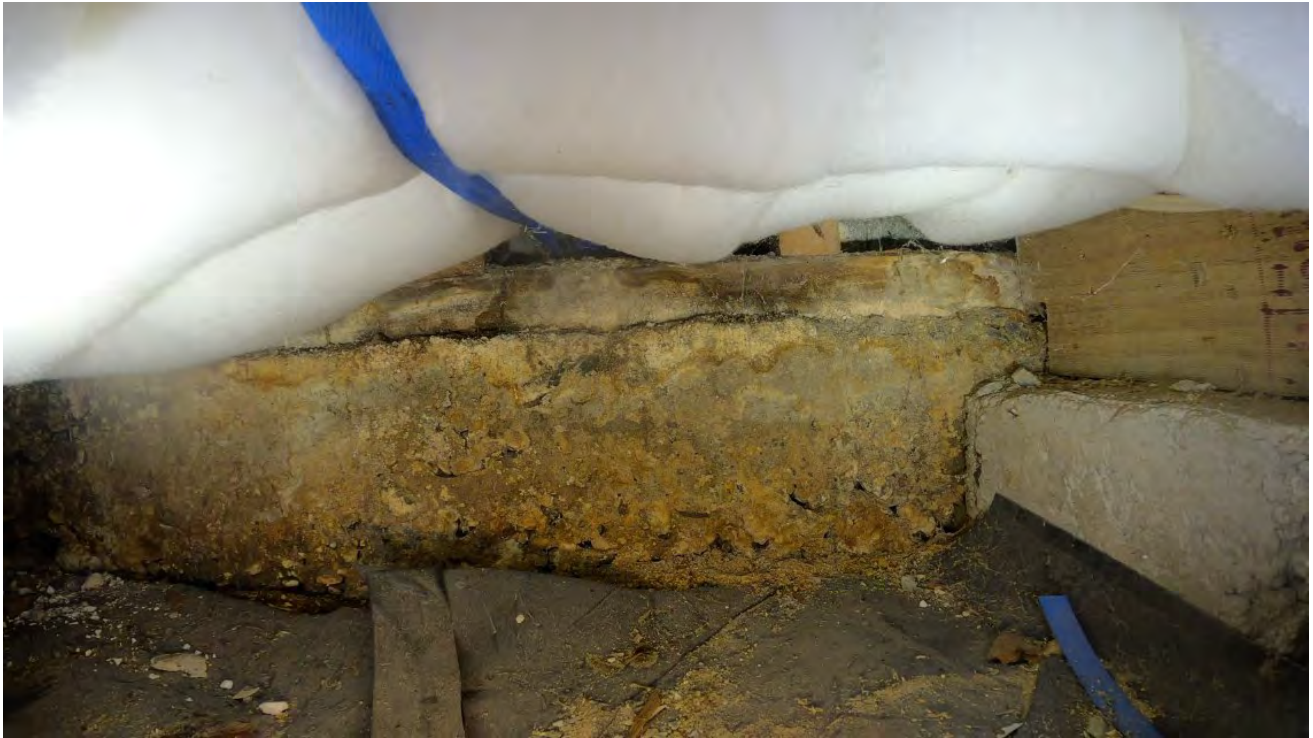
78: View of ring foundation with crack and rotten timber.
