## Building Report

21 Kanawa Street

Waikanae

**Type of inspection:** Building Inspection

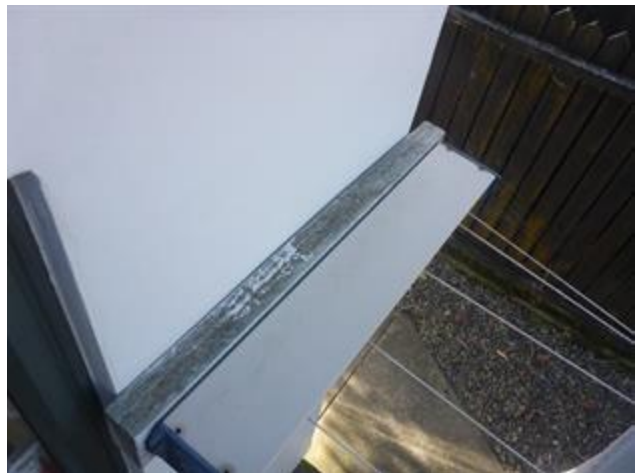
The gatepost to the fencing to the side of the dwelling and the clothesline have been direct fixed through the cladding, which is not recommended as it can be a weather tightness issue. Any wall penetrations can be a higher-risk area for ingress as moisture can find its way into the cladding through fixing penetrations. Post fixings can be modified.

Direct fixed clothesline

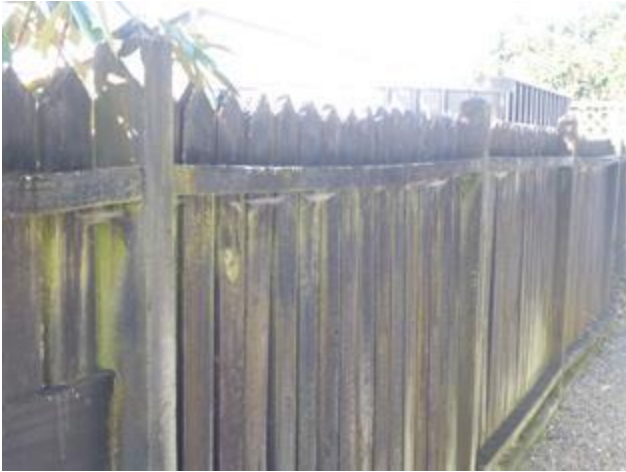
Direct fixed post

Post repair recommended

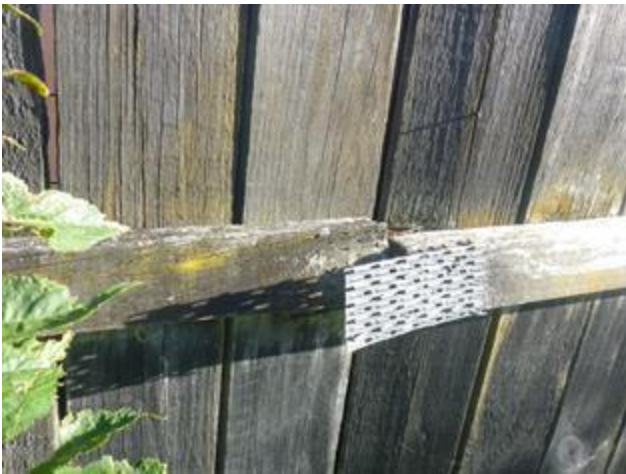
Railing repair

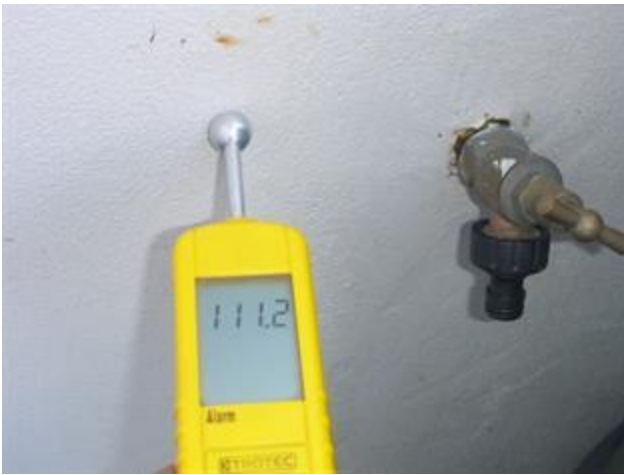
At the time of inspection moisture levels to the base and sides of the joinery penetrations and the hairline cracks were within acceptable parameters but high moisture levels were sighted to the cladding to the sides and base of the rear tap.

Rear tap high moisture levels

My recommendations are that the area to the exterior that indicated high moisture levels now have further invasive appraisal to ensure repairs can be fully carried out and any compromised material can be removed and replaced.

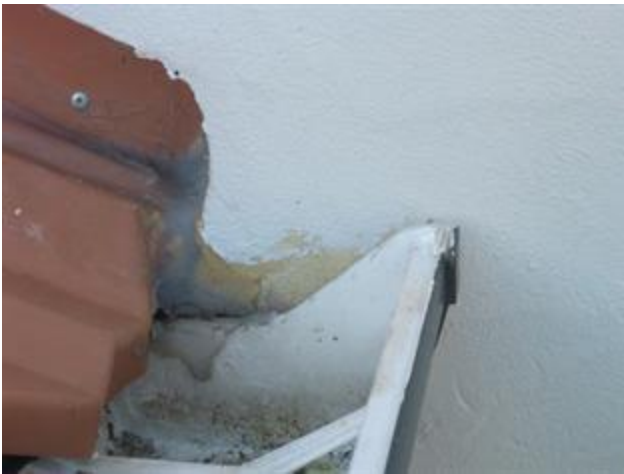
On this dwelling the roof to wall junctions don't have suitable kick out flashings installed and are relying largely on sealant for the weather-tightness. I recommend installing a kick out flashing to the roof wall junctions. The scope of work would require that the cladding at the roof to wall junction is removed and reinstated when the kick out flashing is installed. During this process the framing could be inspected and if there were any signs of moisture ingress, further invasive investigation could be carried out.

Kick out flashings recommended/ roof to wall junctions

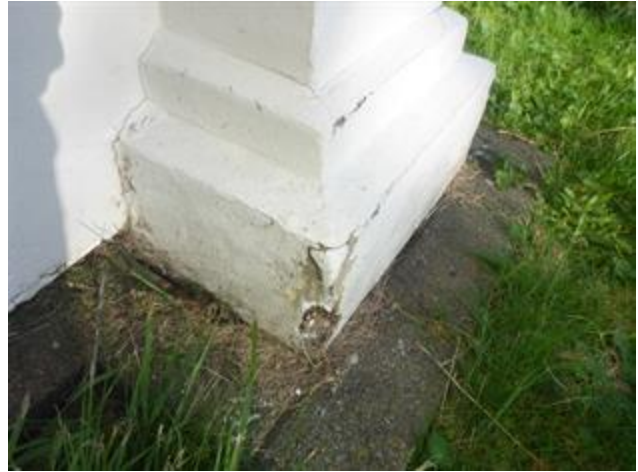
Hairline cracks were sighted to the cladding to the front and side of the dwelling and impact damage was sighted to the western side and to the front, with two hole penetrations sighted to the rear.

Impact damage front

My recommendation is that the EIFS now have further specialist invasive appraisal to give you advice about the cracks, hole penetrations, and impact damage repair requirements, for the installation of kick out flashings, for the area with indications of moisture retention, and for an indication of costs.

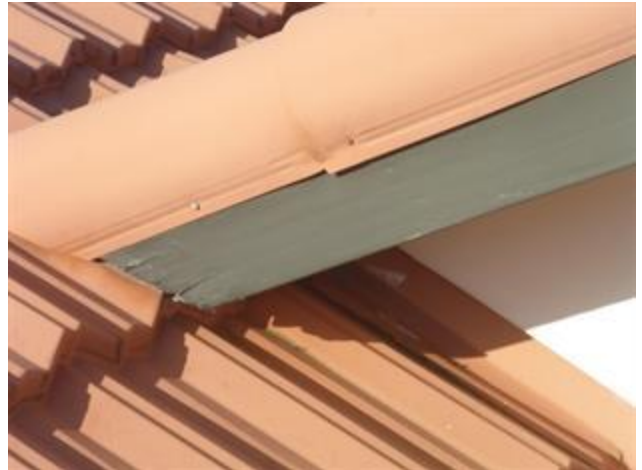
End-grain decay was sighted to the fascia where in contact.

End grain deterioration

I recommend further investigation for repair to prevent progressive damage.

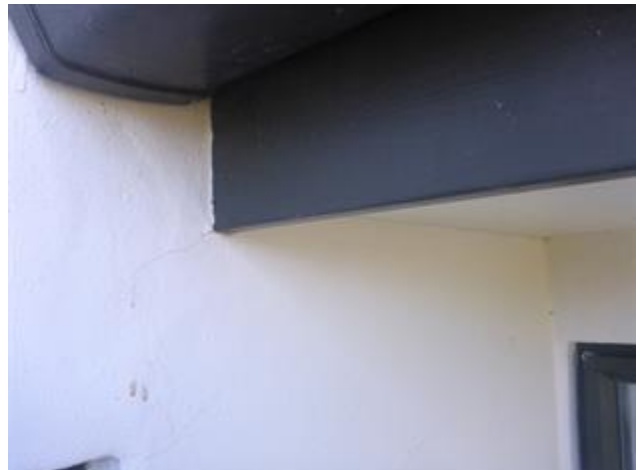
In contact/soffit deterioration

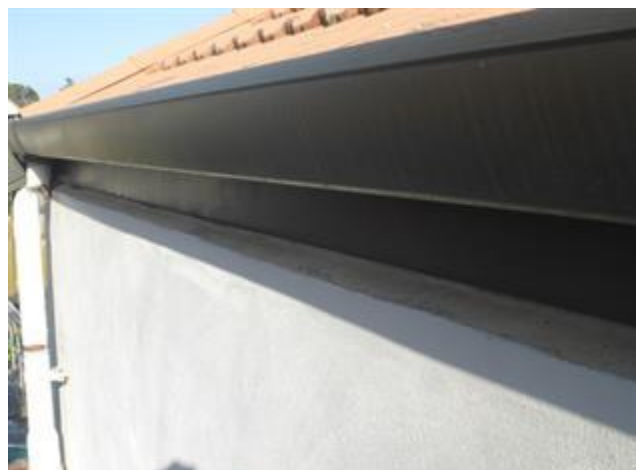
I also noted that the fascia is embedded in the cladding to the sides and rear of the dwelling. This construction can cause the small amounts of expansion and contraction to allow moisture ingress, and these areas are often modified to avoid this known issue. I recommend further investigation, modification and repairing the junctions.

Embedded fascia

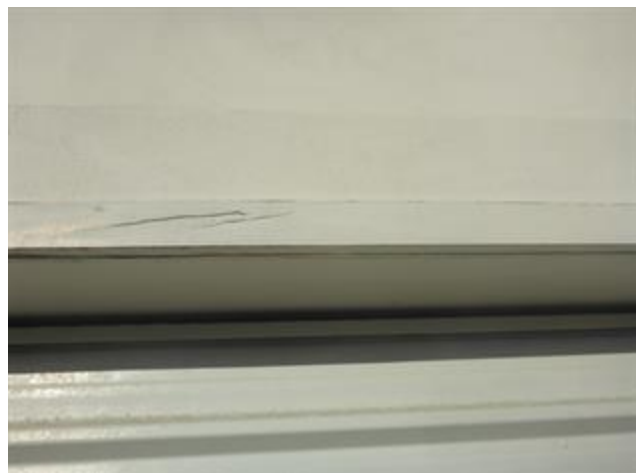
The timber batten to the garage door cladding junction had areas of decay with replacement required to prevent progressive damage.

Decay

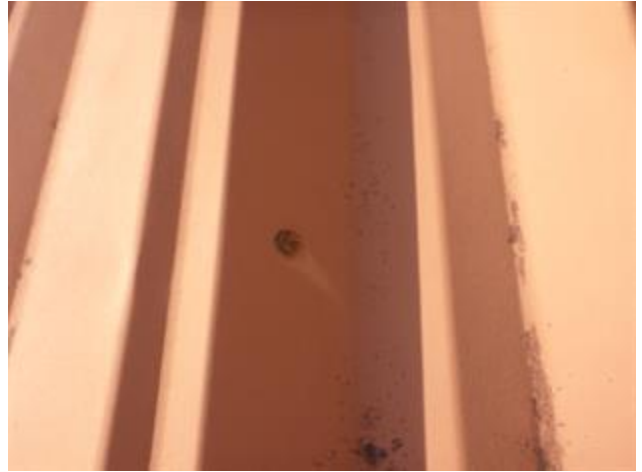
I did note that the tiles of the lower run above the spouting have been fixed through the tops of the tiles without rubber washers. This would have been compliant at the time of construction but does not meet today's standards as this can allow moisture ingress issues.

Direct fixed fastener

I recommend that the roofing material have further appraisal by a licensed roofer to give you advice on the degree of fastener / butynol / washer upgrades and potential costs.

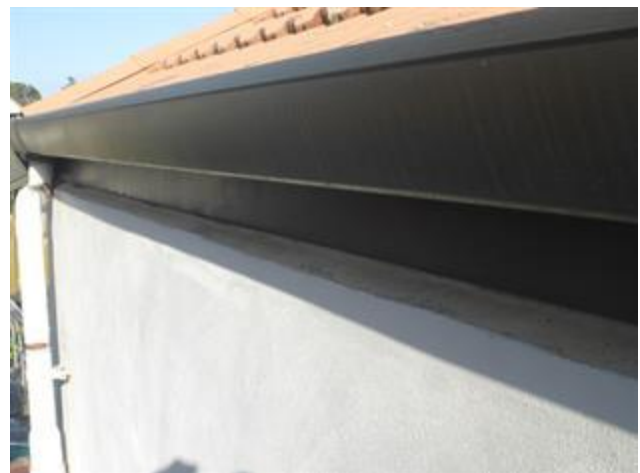
I noted one spouting bracket has popped to the side of the front door covered area and would benefit from being re-fixed.

Popped bracket

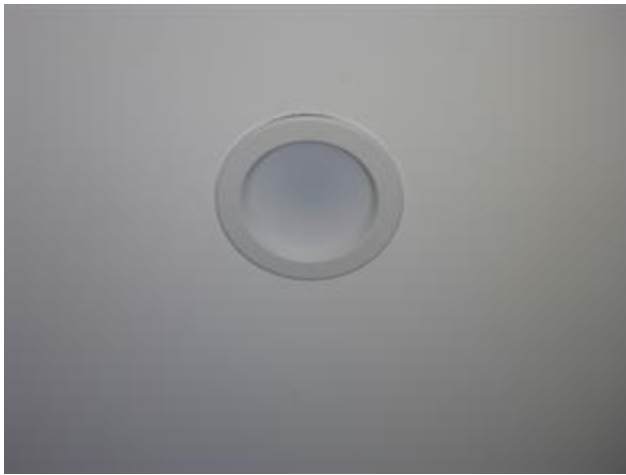
There were small areas identified in the attic space where the insulation could be fitted better as the original downlights have been replaced with LED lighting and the insulation to these penetrations has not been refitted.

LED

To gain maximum benefit from the insulation it needs to cover like a blanket as any gaps will cause heat loss. Filling the gaps would benefit the dwelling and the occupants.

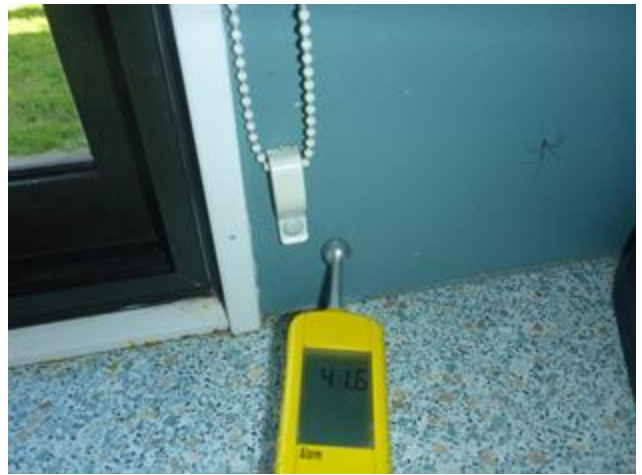
Moisture levels acceptable parameters
