RED LBP PRE-PURCHASE REPORT

PRE-PURCHASE BUILDING REPORT

Property Address	42 Trafford Street, Harewood, Christchurch 8051
Client	Elmerlito Palino Landicho Erja Arranchado
Date of Inspection	29th April 2026
Time	8:00 am
Inspector	Jamie Chapman National Certificate in Carpentry
LBP Number	BP137228
People Present	Inspector, Owner
House Occupied	Yes

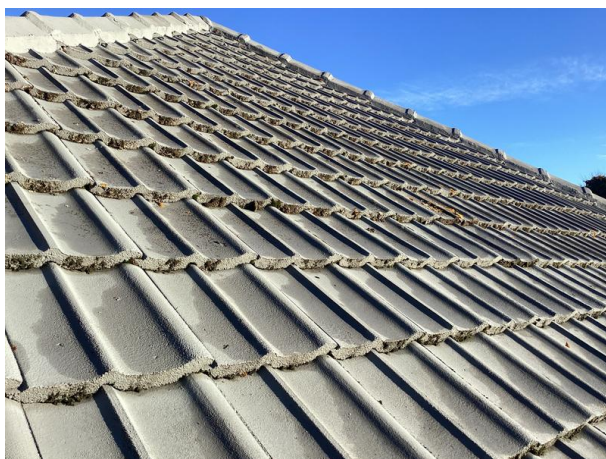
Photo 3

Masonry tiles are located over the dwelling.

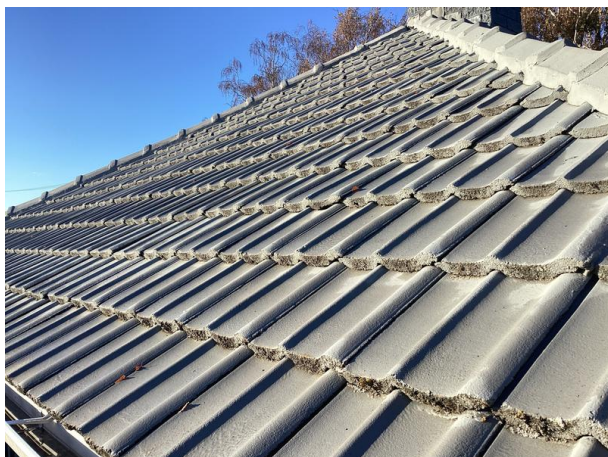
Photo 5

The masonry tiled roof is in a condition expected for age. Recommend keeping up regular maintenance.

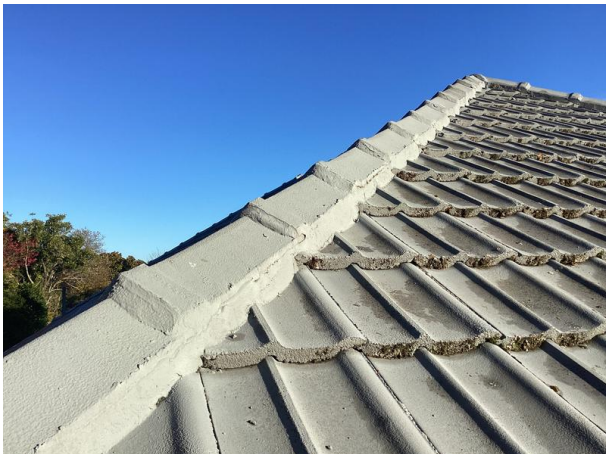
Photo 6
Typical minor mortar cracking noticed around most of the masonry tiled hips and ridges.

Minor hairline cracking in the roof mortars is normal, if the cracks widened further and/or displaced in the future. To ensure proper repairs, it is recommended that a suitably qualified LBP in roofing be consulted, and that correct materials are used for the job.

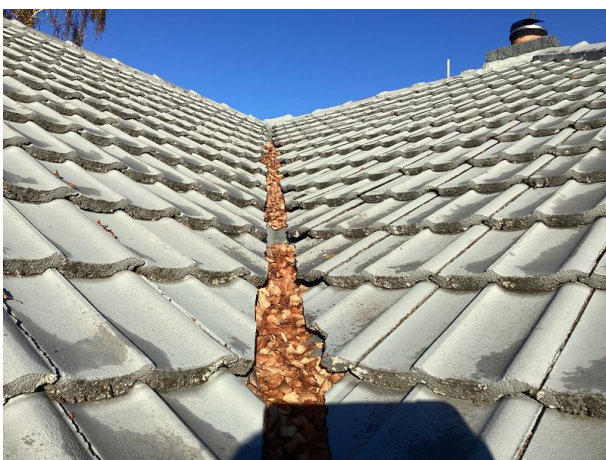
Photo 7
Recommend clearing the debris in the metal valley.

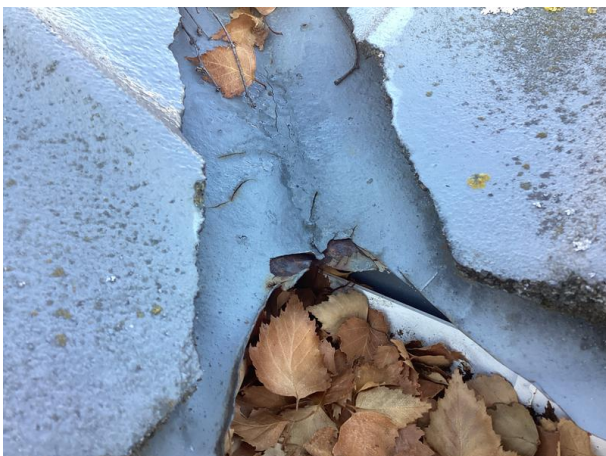
Photo 8
Corrosion visible under the paint at the end of the metal valley.

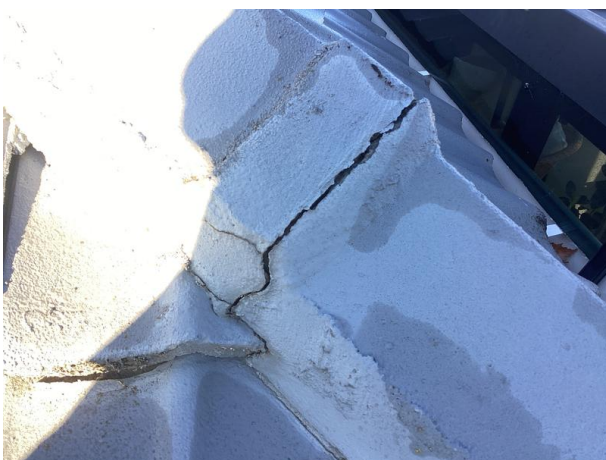
Photo 10
A larger crack was visible on the North/West hip.

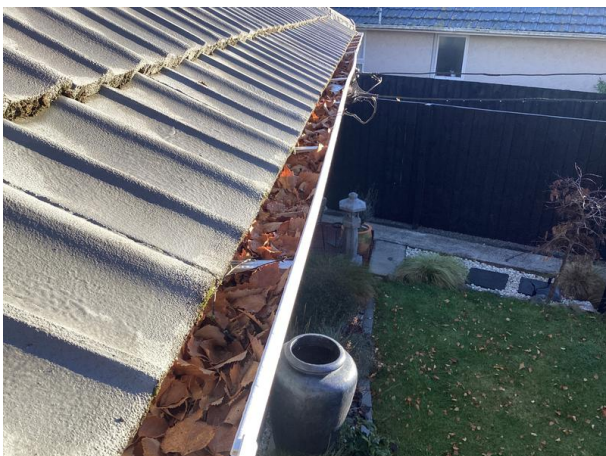
Photo 15

It is recommended to ensure the gutter systems are kept clean and clear.

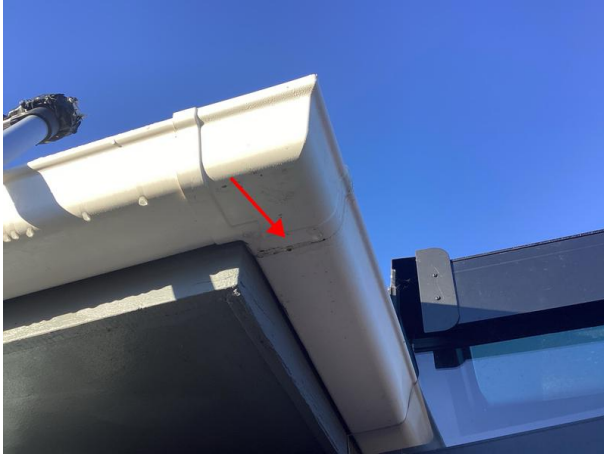
Photo 16

A gutter leak on the North/West corner was noticed. Recommend sealing.

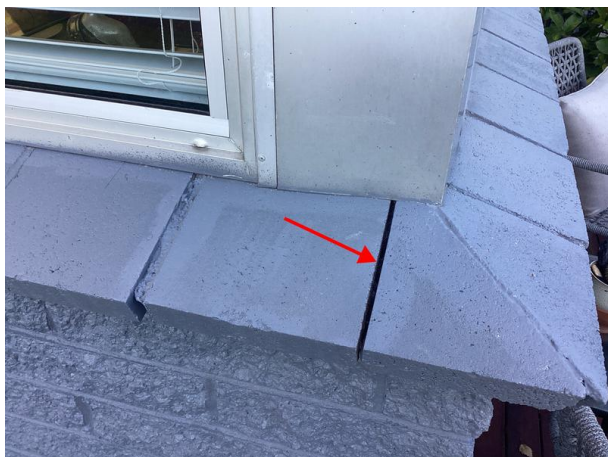
Photo 18

A couple of the brick window sills would benefit from re-pointing as missing or degrading mortar joints were noticed.

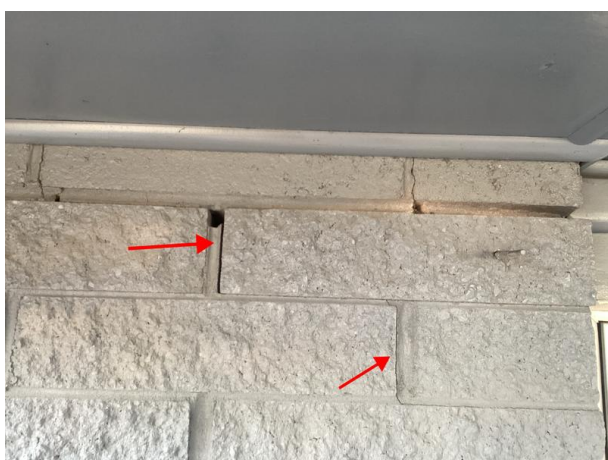
Photo 19

Step cracking has been observed within the brick veneer. At this stage, the cracks are non-displaced, indicating that no significant movement or structural failure has occurred. The cracking appears consistent with localised shrinkage or minor settlement, rather than progressive structural movement. Remedial action can be undertaken by carefully repointing and remortaring the affected joints to reinstate weather protection and maintain the veneer's durability. This work should be completed using a mortar compatible in strength, colour, and texture with the existing, to ensure an effective repair and a uniform finish.

Mortar step cracking and a couple loose bricks were noticed on the north west corner of the living room.

Ongoing monitoring is recommended to confirm no further movement occurs. Should cracks widen, become displaced, or reappear after repair, further investigation by a suitably qualified practitioner would be warranted to determine any underlying structural cause.

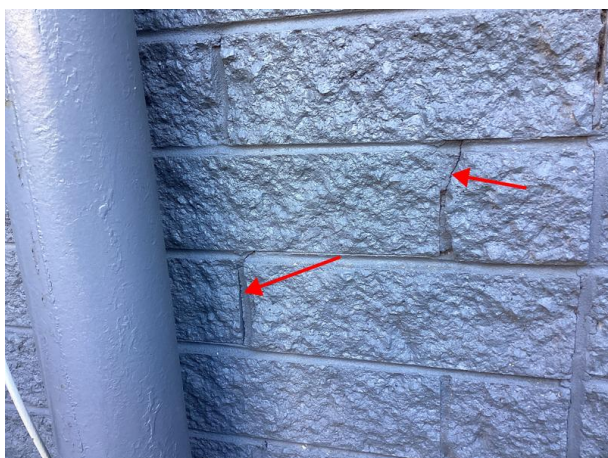
Photo 20

A couple other areas of mortar step cracking were also noticed around the dwelling.

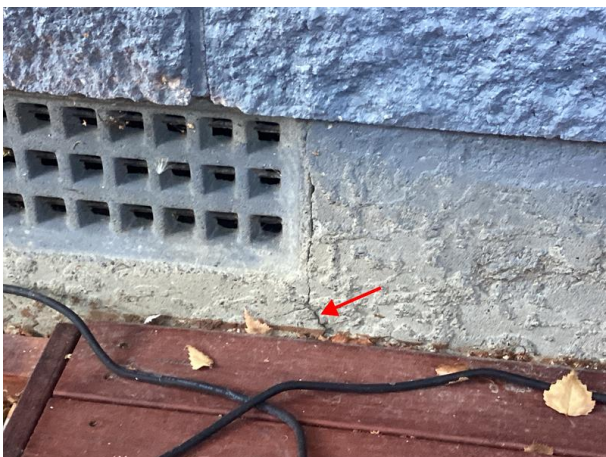
Photo 25

Couple hairline cracks were noticed around the concrete to ring foundation.

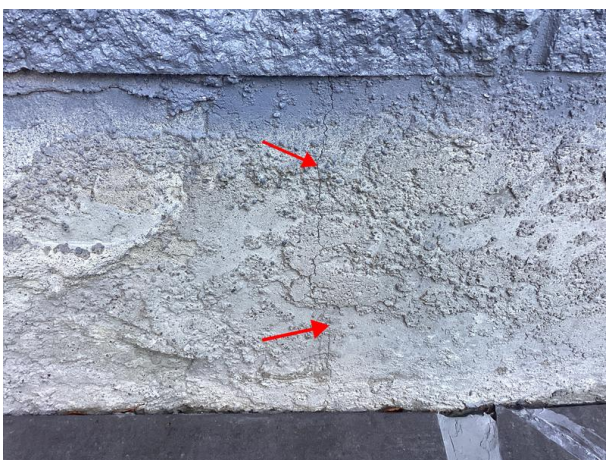
Photo 26

Example of a crack noticed on the ring foundation. Relatively typical on a dwelling of this age. Recommend monitoring, if the cracks widen, have a concrete crack repair specialist to advise further.

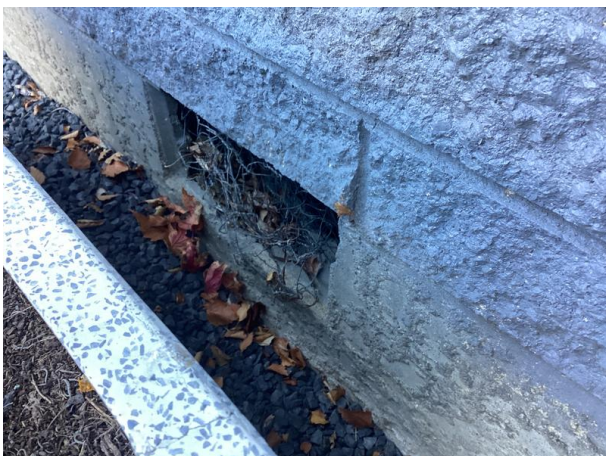
Photo 27

A couple foundation vents were missing. Recommend reinstalling to help avoid rodents from entering into the subfloor.

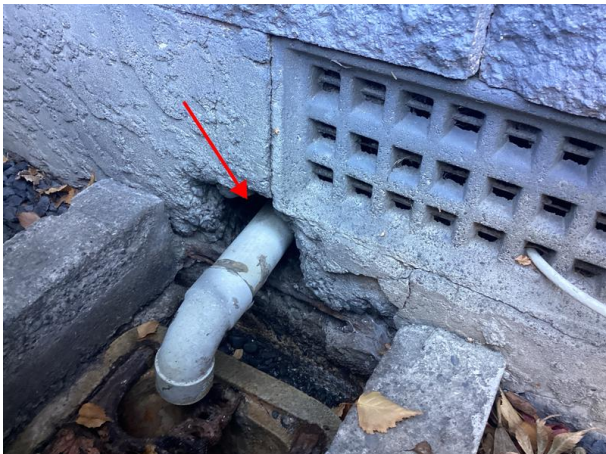
Photo 28

Gap visible around the kitchen waste pipe. Recommend filling with concrete/ mortar to close this gap and avoid rodents from entering into the subfloor.

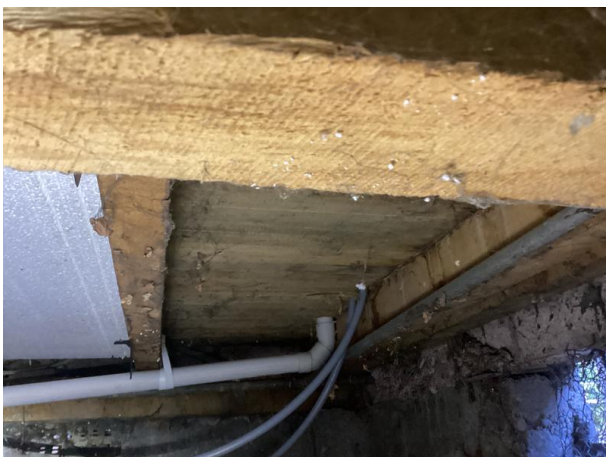
Photo 31
A couple of polystyrene insulation panels were noticed to be displaced. Recommend reinstalling.

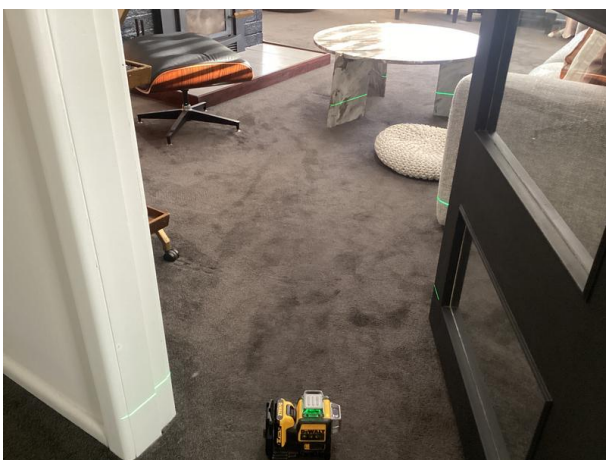
Photo 35

The overall level difference measured in the sampled areas was approximately 10/15mm. This assessment is limited to a visual, non-invasive spot-check and is not a full floor-level survey or certification of compliance.

No significant deviations observed during the inspection. The approximate overall floor level difference was 10/15mm.

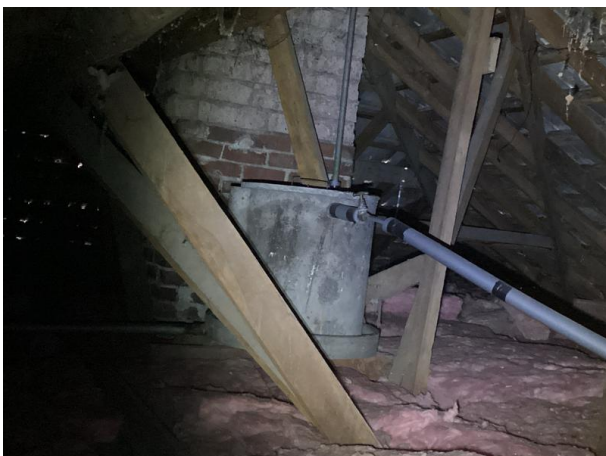
Photo 40
Concrete header tank located in the roof space. Recommend securing into place.

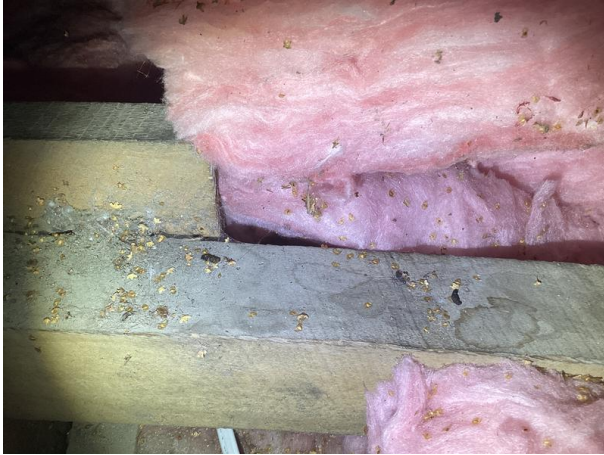
Photo 41

A couple signs of vermin droppings were noticed in the roof space by the manhole.

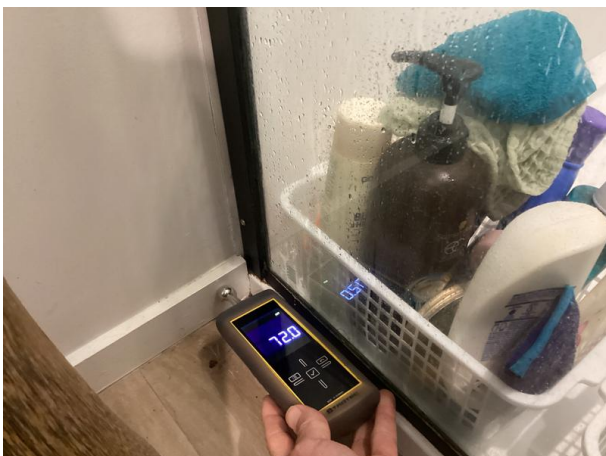
Photo 47
With indications of damp moisture readings detected beside the shower enclosure. This is detailed further within this report.

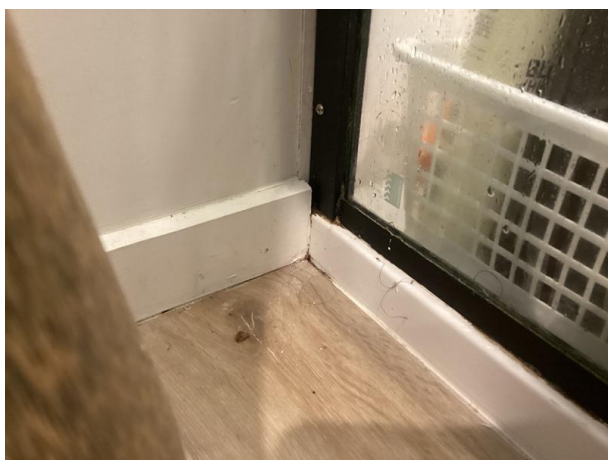
Shower - Enclosure. Water leaking through the corners of the shower.

Photo 55
Water was leaking out of the bottom corner of the shower enclosure when the showerhead was directed at this area. See the next photo.

As viewed in the photos below, water was noticed to be leaking out of the bottom corner of the shower enclosure when the showerhead was directed at it. With indications of damp moisture readings detected on the left-hand side of the shower enclosure. It is recommended to have a suitable, qualified professional to ensure the shower is sufficiently sealed.

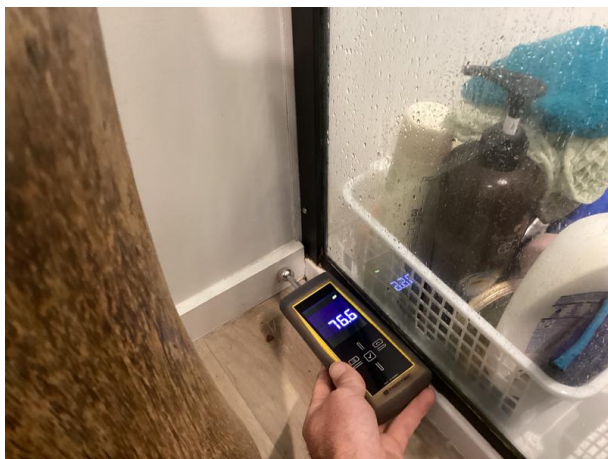
Photo 56
Indications of damp moisture readings were also detected around this area.

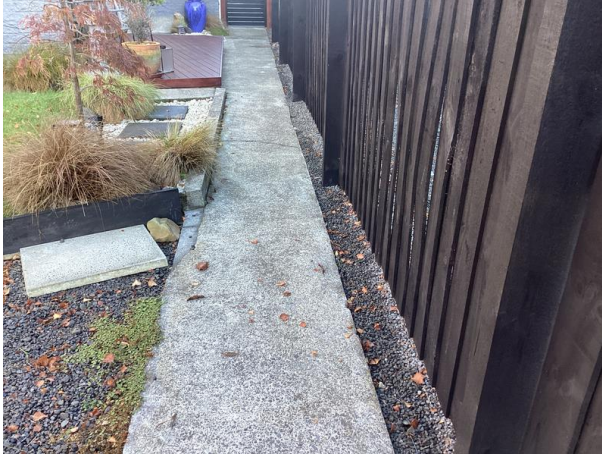
Photo 64

Concrete paths, a couple cracks noted. No significant issues.

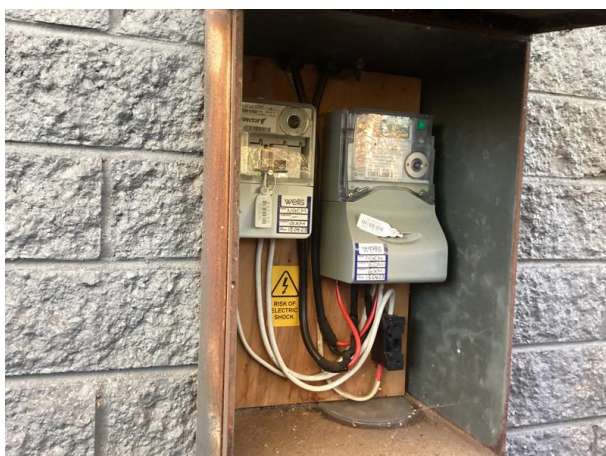
Photo 69
South side meter box. Corrosion noticed on the casing.

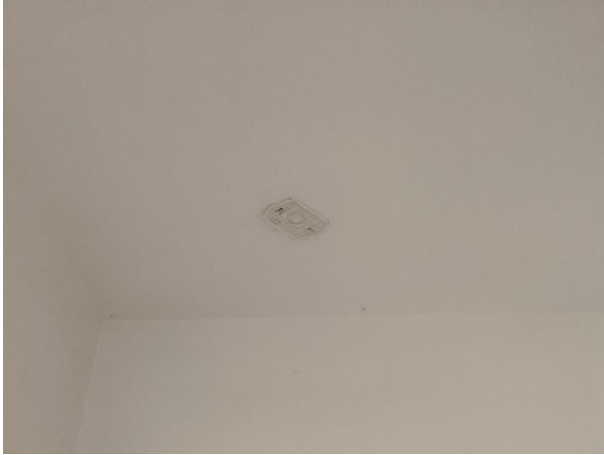
Photo 85

It is recommended to reinstall the smoke alarm that is located near the bedrooms.
