## EQC CLAIM DOCUMENTATION

**Claim Number:** CLM/2016/010270  
**Damage Address:** 18 Heathglen Avenue, Parklands, Christchurch 8083  
**Claimant:** Christopher Colvill

<b>Address</b>	18 HEATHGLEN AVENUE, PARKLANDS, CHRISTCHURCH, 8083	<b>EQC Claim Number</b>	CLM/2011/198599
<b>Hazards</b>	Nil hazards	<b>EQC Assessor (L,F)</b>	fellows, chris
<b>Inspection Date</b>	01-Jul-2011	<b>Placard</b>	No Sticker
<b>Status</b>	Current	<b>EQC Estimator (L,F)</b>	Goodall, Mike

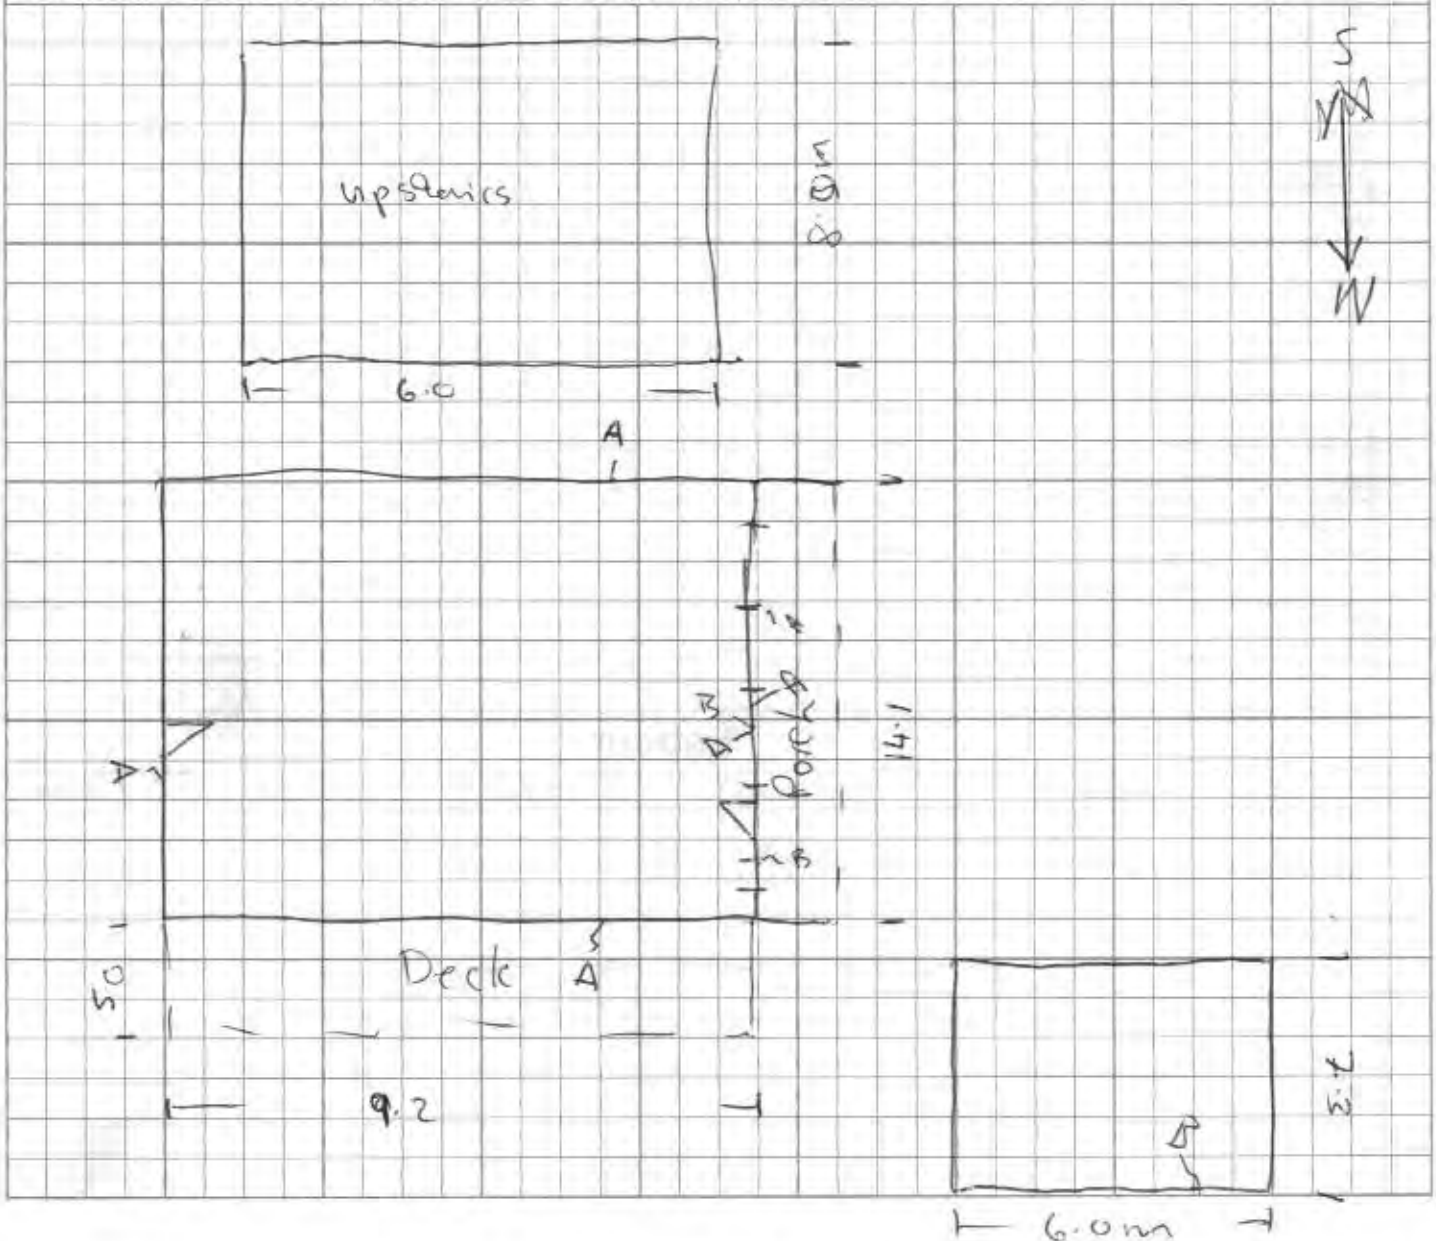
PLAN SKETCH OF PROPERTY (identify each room, indicate damage). Attach photo if available

A/ Crack foundation  
 B/ Step crack
