BUILDING INSPECTION REPORT

RED LBP PRE-PURCHASE REPORT

PRE-PURCHASE BUILDING REPORT

Property Address	9 Guyon Street, Marshland, Christchurch 8083
Client	Simon McSherry
Date of Inspection	8th May 2026
Time	12:30 am
Inspector	Jamie Chapman National Certificate in Carpentry
LBP Number	BP137228
People Present	Inspector, Owner
House Occupied	Yes

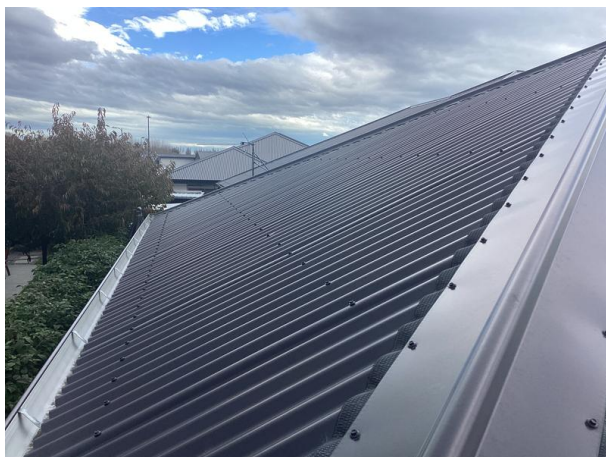
Photo 3

A profiled metal roof with screw fixings is located over the dwelling.

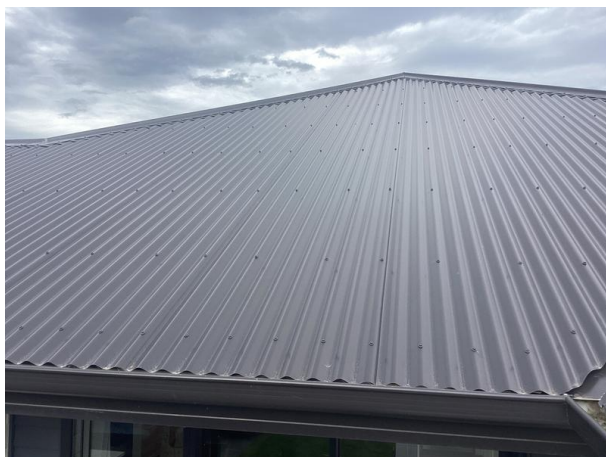
Photo 4

No significant issues identified with the roof system during the inspection.

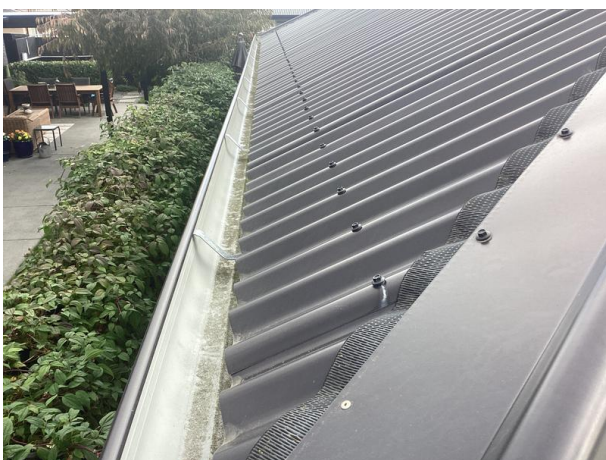
Photo 9
The gutter system was clean and clear during the inspection.

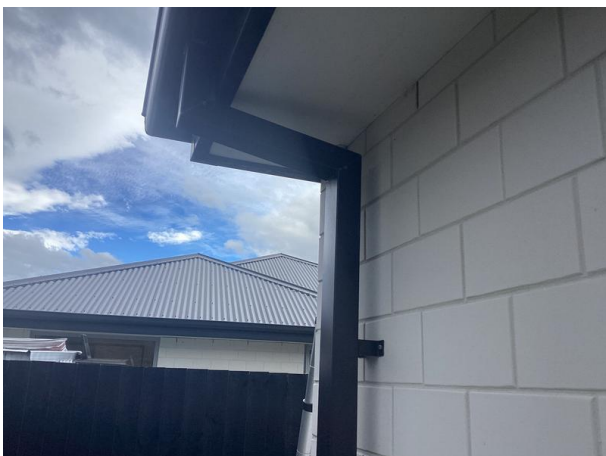
Photo 10
Profiled metal downpipes were securely attached to the dwelling during the inspection.

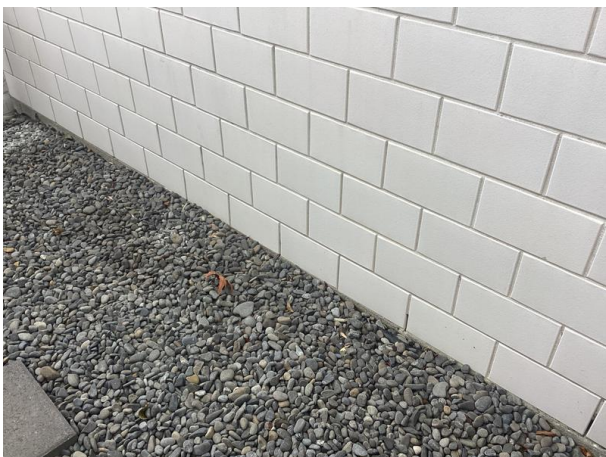
Photo 13
Limited ground clearance noticed on the west side. Areas of the ground levels are within close proximity to the brick weep hole.

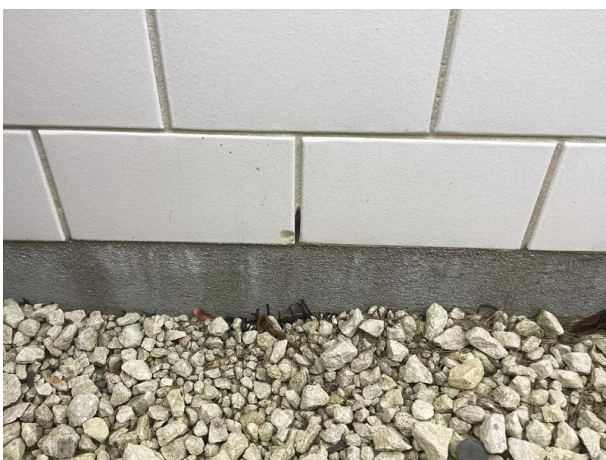
Photo 14
Example of a brick weep hole with the ground level sufficiently below it. Recommend achieving this around the dwelling.

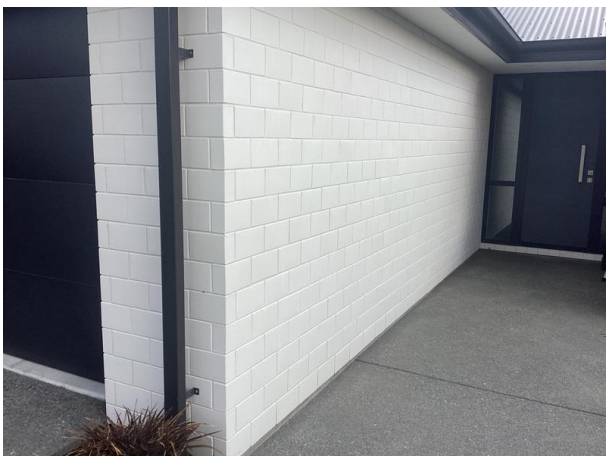
Photo 15
No significant issues identified with the brick veneer during the inspection.

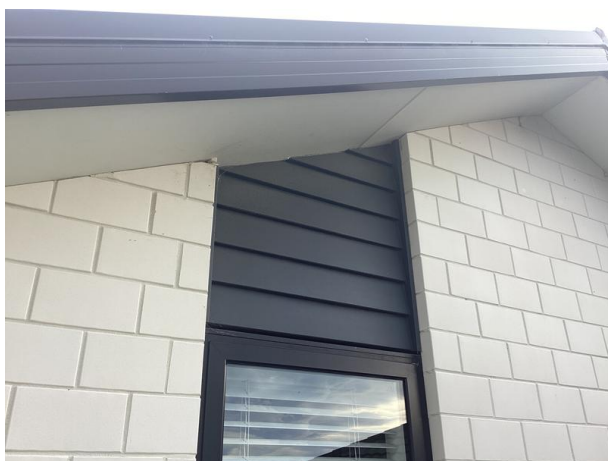
Photo 17
No significant issues during the inspection with the fibre cement weatherboards.

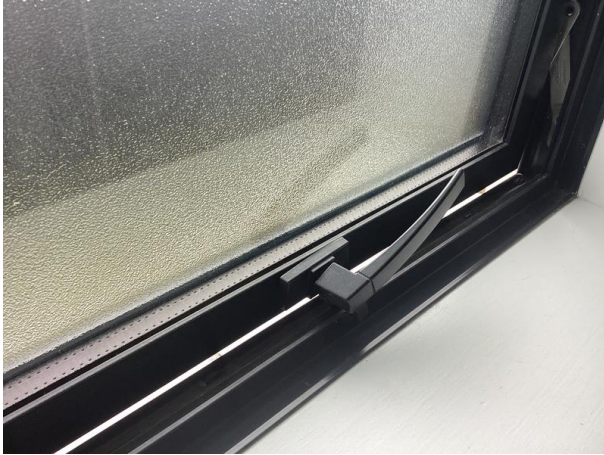
Photo 20

Loose window hardware noticed in the ensuite. Recommend tightening.

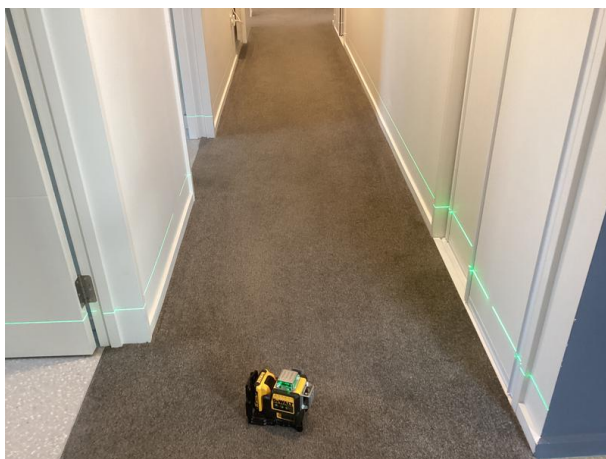
Photo 22

The tolerance ranges noted are provided as general guidance only and are commonly referenced for new concrete slabs within the early period after construction. In the sampled areas inspected, no significant faults or defects were identified at the time of the inspection. The overall level difference measured was approximately 10mm.

No significant deviations were observed during the inspection. That approximate overall floor level difference was 10 mm.

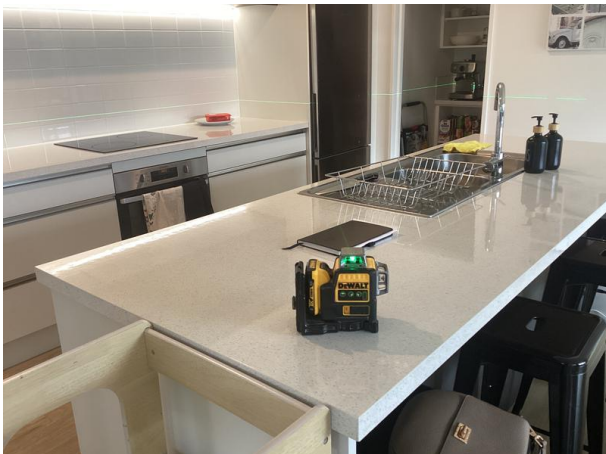
Photo 23
The kitchen bench tops were checked and were level.

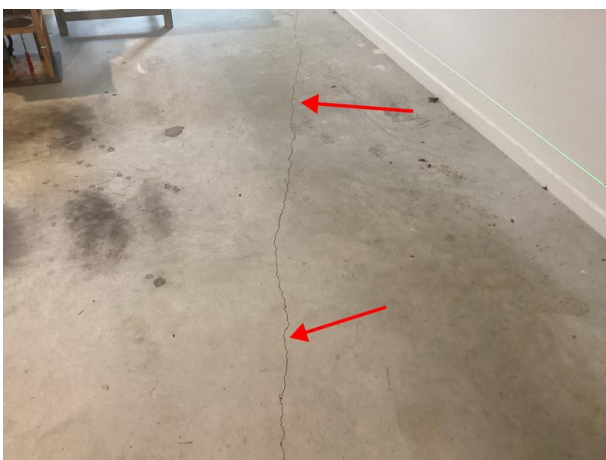
Cracking - As observed in the garage.

Cracking - Shrinkage cracking in concrete floors is common. Plastic shrinkage cracks are due to the too rapid loss of moisture from the surface of the concrete, e.g. during hot, dry and windy conditions. Thus, they are a form of drying shrinkage crack. Usually, they form without any regular pattern as shown in the photos below.

Photo 24
A shrinkage crack was noticed in the garage coming from the internal corner near the back garage door.

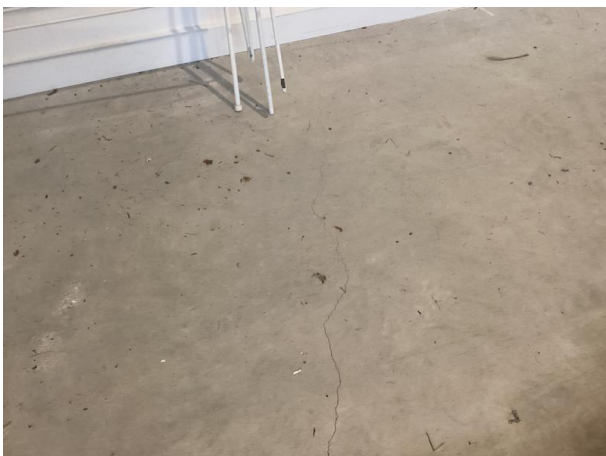
Photo 25
The shrinkage crack visibly gets smaller and disappears by the garage internal door.

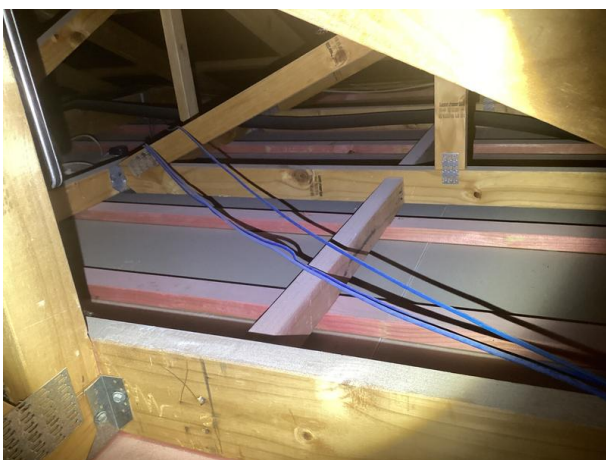
Photo 28
No insulation installed over the garage which is common.

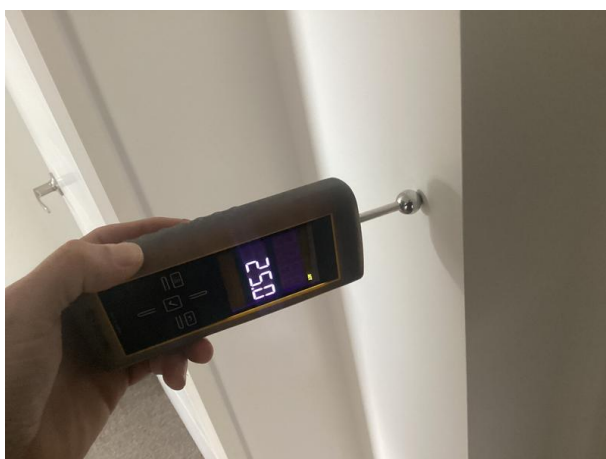
Photo 31

Example of a base reading that was taken on an internal wall. This was the average moisture reading for this dwelling during the inspection.

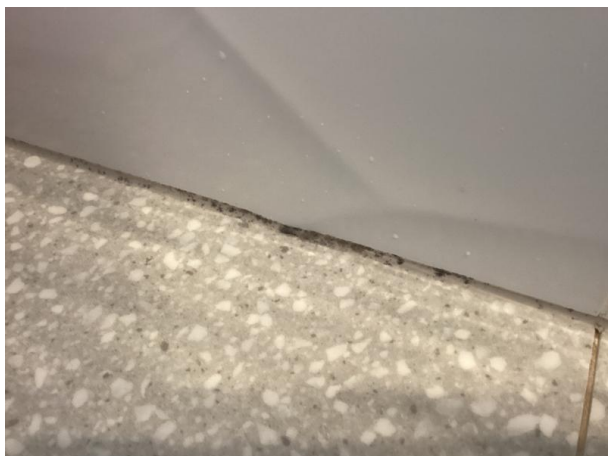
Photo 44
Minor mould is starting to appear on the silicone in the shower. Keep up regular maintenance.

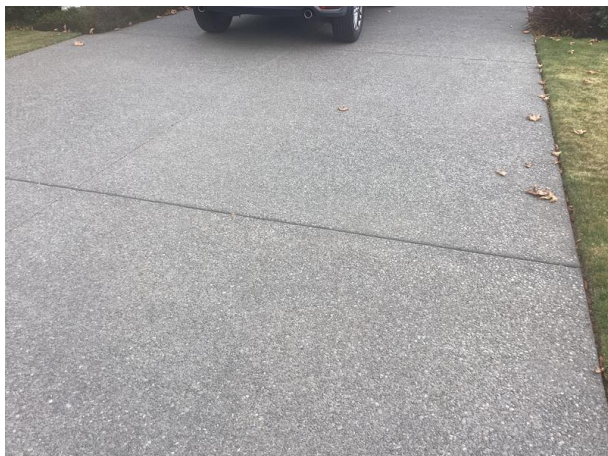
Photo 49
Concrete driveway, no significant issues.

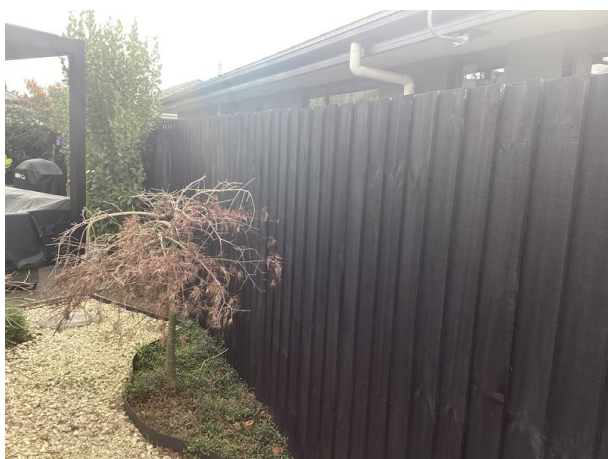
Photo 50
Timber fences, no significant issues.

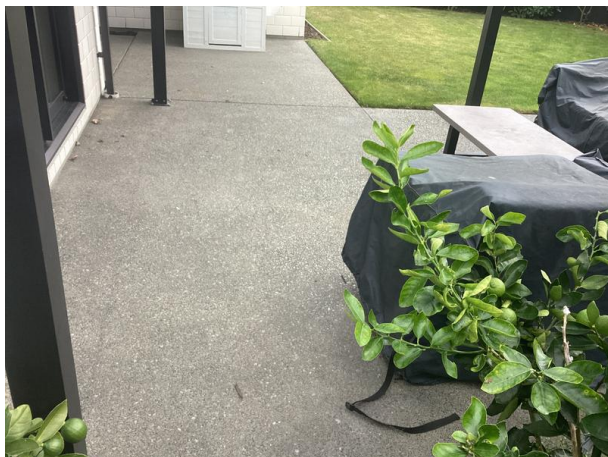
Photo 51
Concrete patio, no significant issues.

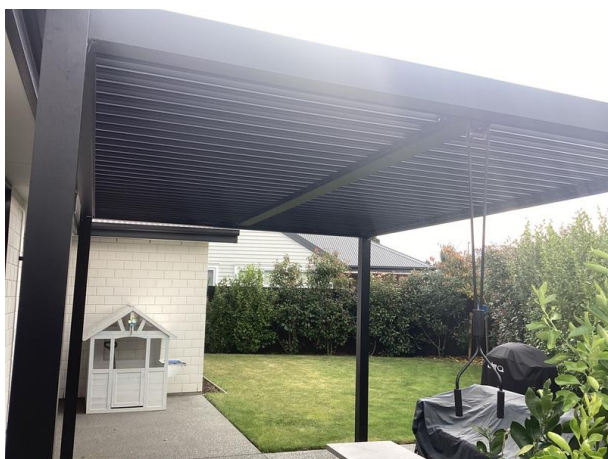
Photo 52
Louvres located over the patio, no significant issues.

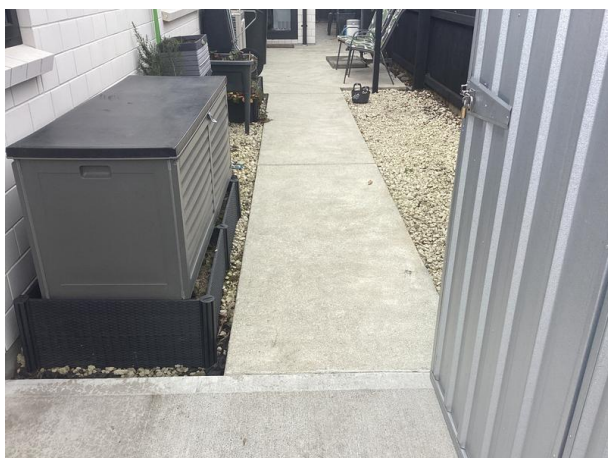
Photo 53
Concrete paths, no significant issues.
