Building Report

14B Realm Drive

Paraparaumu

Building Consultant: Ian Hall, NZIBI
Present for inspection: Ian Hall
Weather at time of inspection: Showers
Date/s of inspection: 06-May-2026
Type of inspection: Building Inspection
Name of property inspected: 14B Realm Drive
Paraparaumu
Report prepared for: Eddie Cook

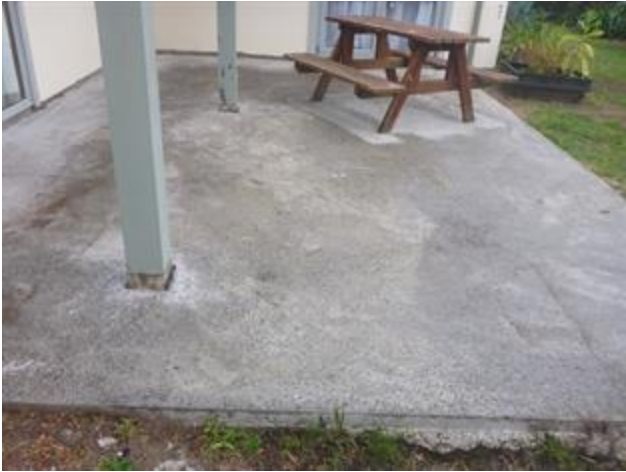
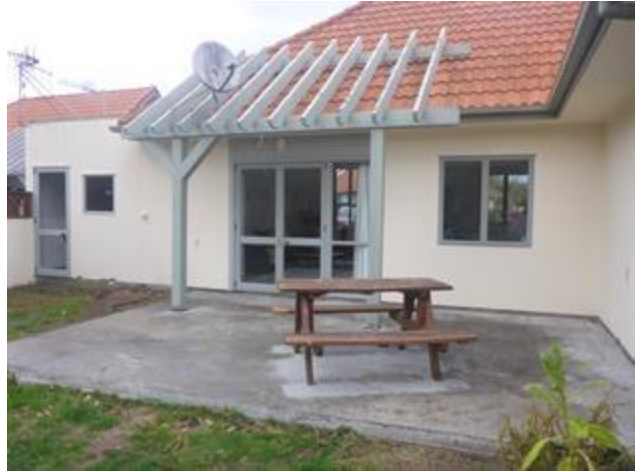
At the time of inspection there were no visible signs of deterioration, but these areas can be modified by reducing the ground surface.

Cladding in contact to the front

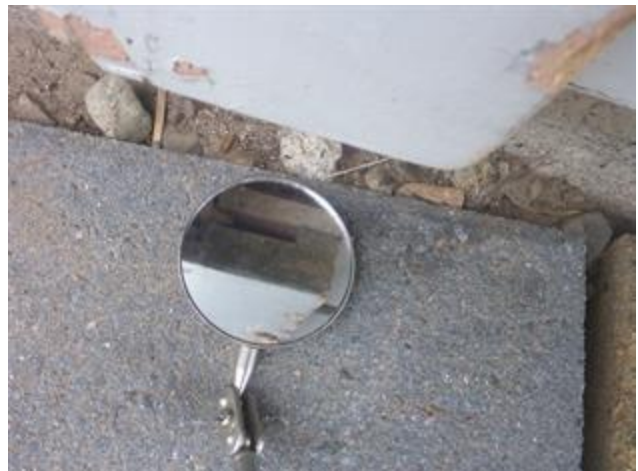
The lower edge of the end-grain of the timber corner battens have not had a paint seal. Sealing these areas is recommended to prevent the end grain splitting and to maintain the integrity of the timber.

No paint seal

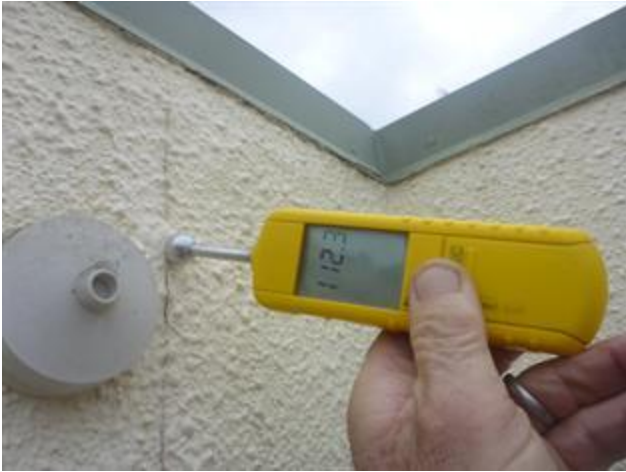
At the time of inspection moisture levels to the base and sides of the joinery penetrations and the cladding cracks were within acceptable parameters except the crack to the right side of the garage door where high moisture levels were recorded to the crack and the cladding at ground level where the cladding is in close to contact to the ground surface.

High moisture levels recorded to the cladding crack /front of the garage

My recommendation is that the monolithic cladding now have further specialist appraisal for a more invasive investigation of the cracks and for the correct repair requirements.

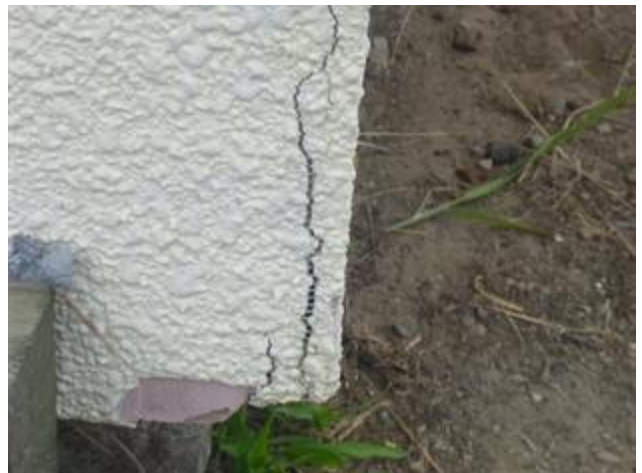
Some impact damage was also sighted to the cladding to the rear of the garage but fortunately the framing was not exposed to the elements.

Impact damage side of dwelling

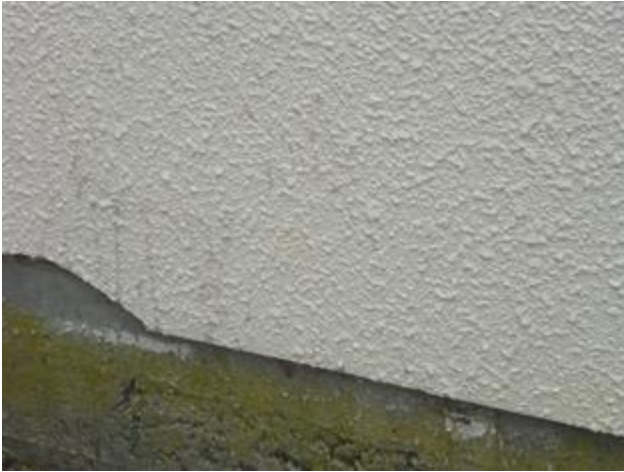
Impact damage rear of dwelling

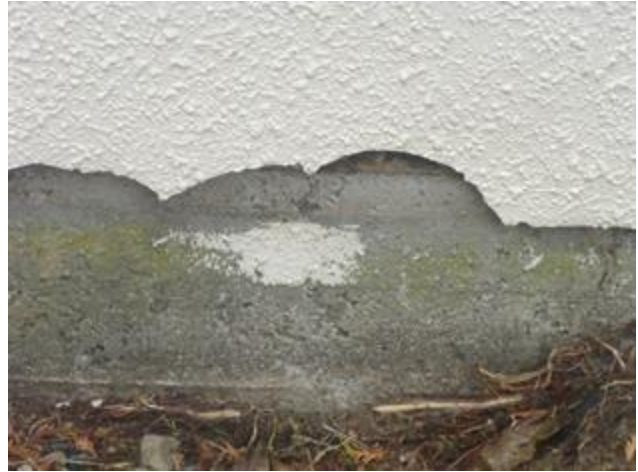
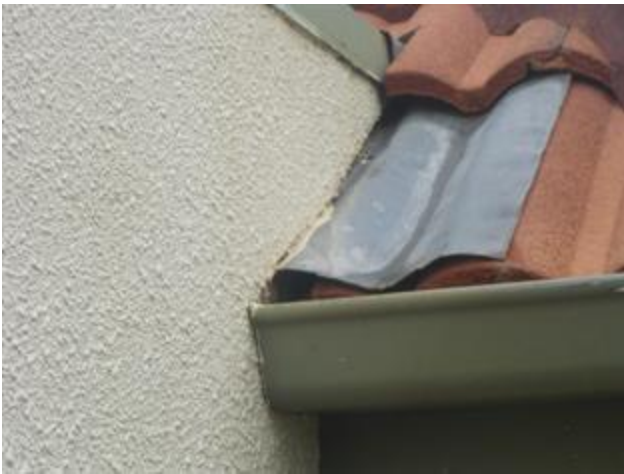
I also noted that a small area to the rear of the dwelling is in close contact to the sloping roof. It is now required that cladding where over a sloping roof have a 35 mm clearance from the bottom of the cladding. This is because if the gap is not maintained then water can wick-up behind and through the cladding and reach the framing. A solution can be to cut the cladding to ensure there is clearance. A 50 mm overlap is required to any framing at the base of the wall.

Sloping roof area/rear of dwelling

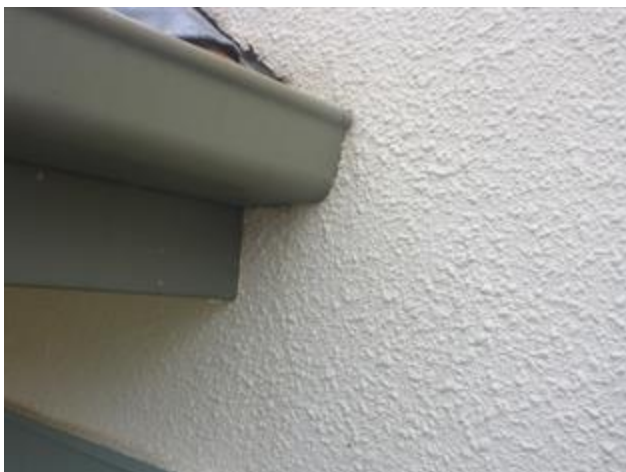
The fascia is embedded in the cladding to an area to the front and rear of the dwelling. A clear separation is now recommended to allow for expansion or contraction of the material as this can cause cracking that can lead to moisture ingress. These areas can be modified, and I recommend this is included as part of the specialist appraisal.

Areas of embedded fascia/further appraisal recommended

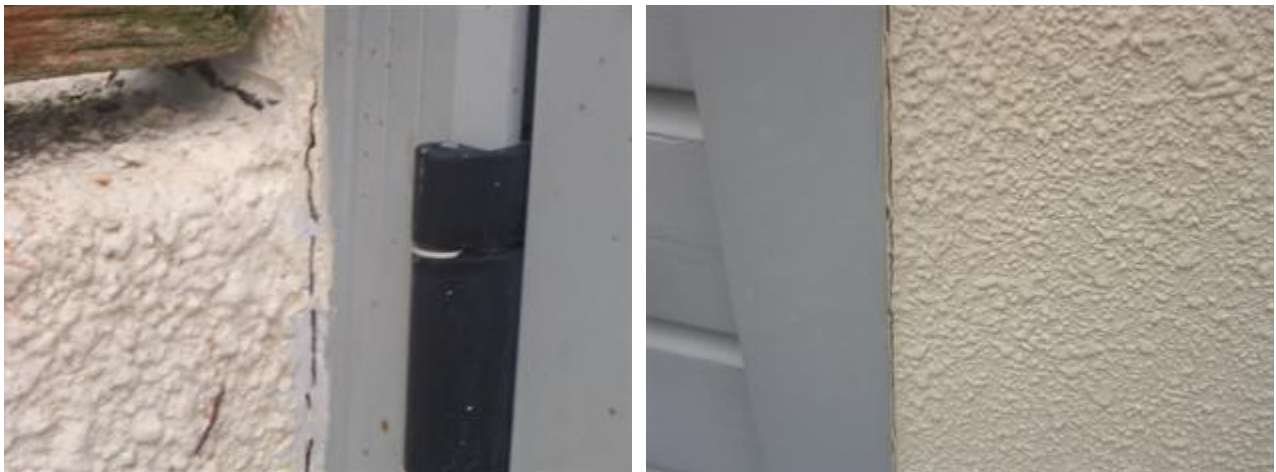
My inspection noted that some of the seals between the transition from the monolithic cladding to the joinery now require renewing. Wind drive moisture ingress has the potential to breach these transitions, and I recommend further appraisal for repair.

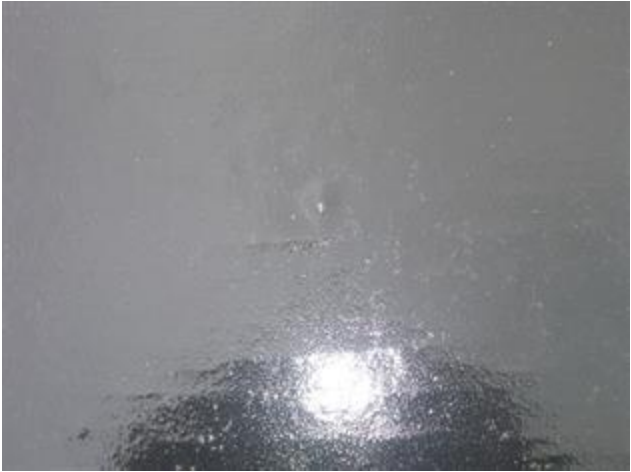
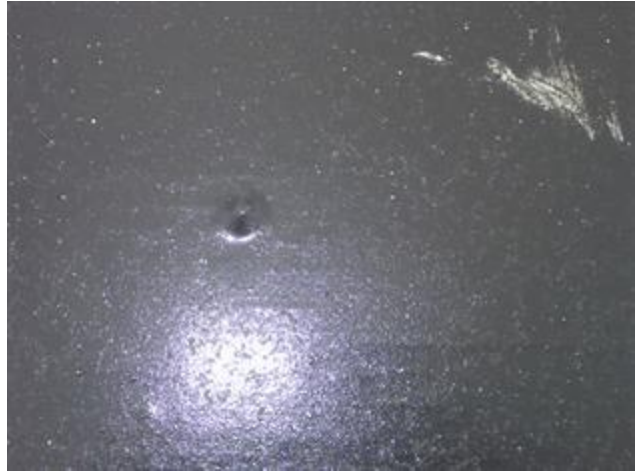
The substrate appeared solid when walked on but the fasteners fixing the substrate in place have popped in places and will in time penetrate the membrane. Pin holes and hairline cracking can appear that are difficult to sight. Material damage may already be present beneath the lining, but this cannot be known with a visual-only inspection. Corresponding moisture levels where accessible below the area were within normal parameters.

Substrate fastener penetration

My recommendation is that the butynol roofing material now have further appraisal by a licensed roofer to give advice on the degree of repair, upgrades and costs as the membrane is now 32 years old.

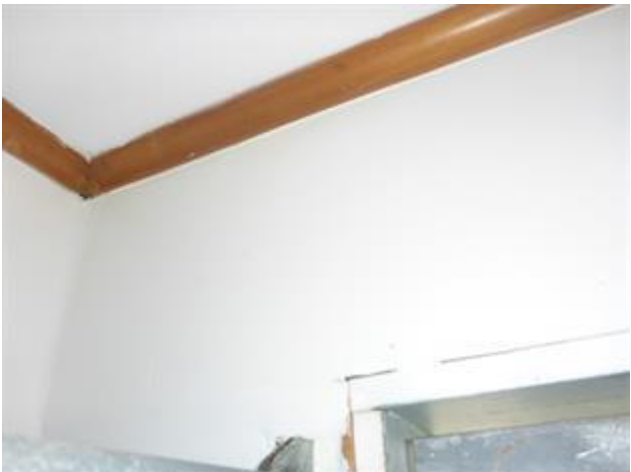
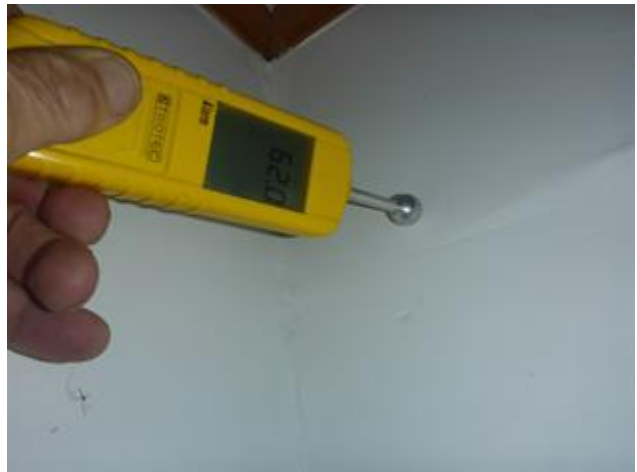
Moisture levels /acceptable behind the crack

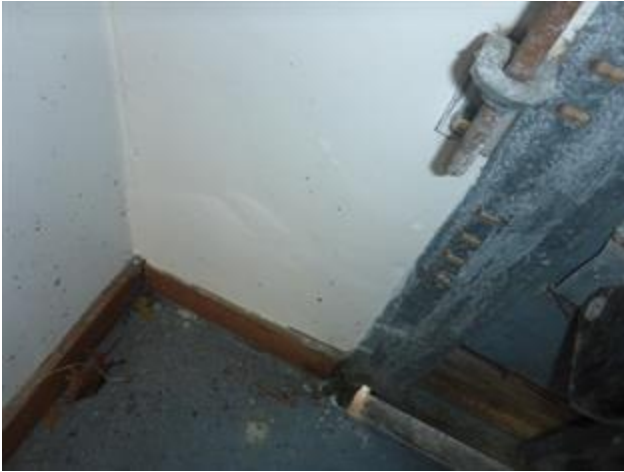
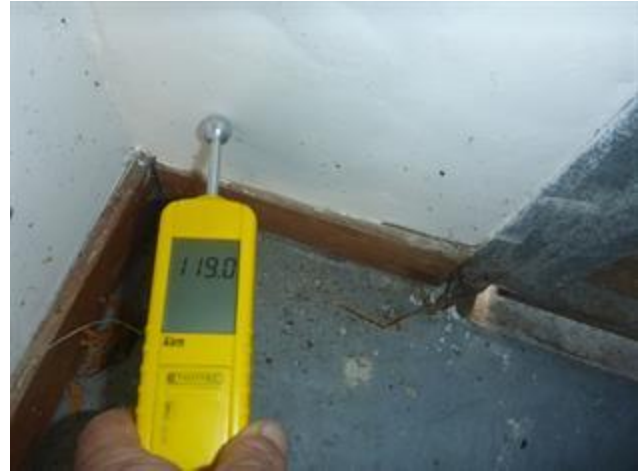
All moisture readings were within acceptable parameters at the time of inspection except to the wall lining to the left side of the garage door where high moisture levels were recorded at the top to the exterior and the base to the exterior and interior.

High moisture levels recorded ground level

As moisture retention can lead to decay, I recommend further invasive appraisal of the area.

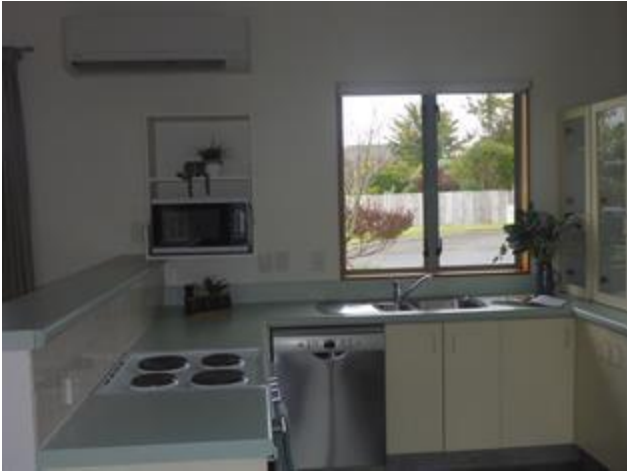
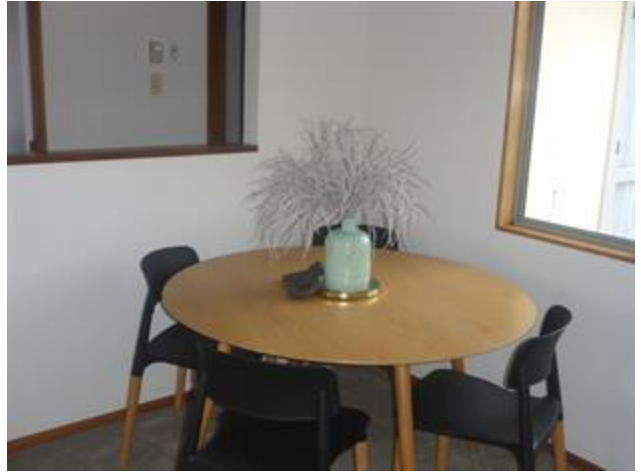
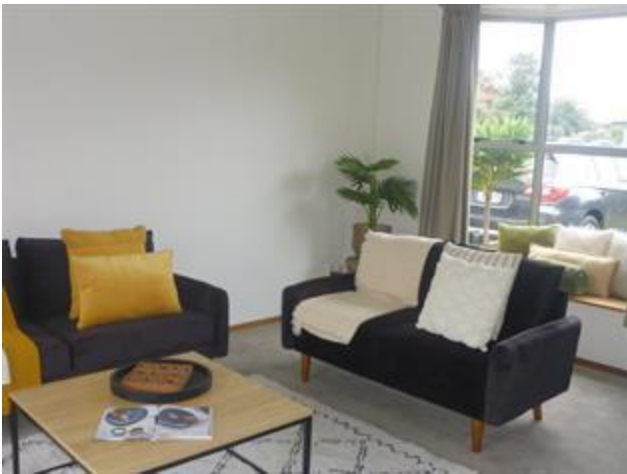
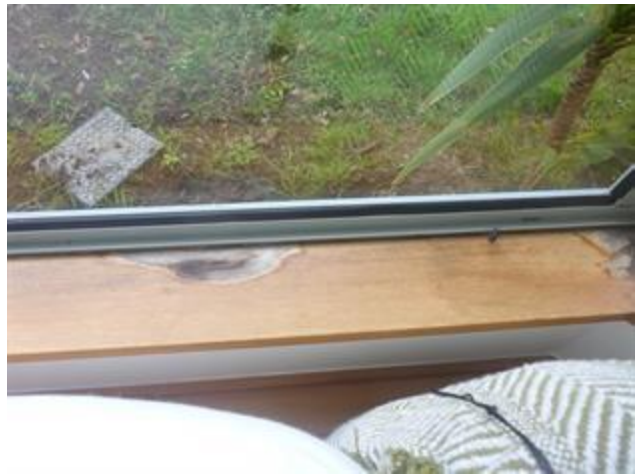
The signs of moisture/UV damage were noted on some of the windowsills. It is likely that condensation has pooled in these areas and has over time broken down the integrity of the paint.

Moisture / UV damage
