Building Report

3 Bressay Way
Waikanae

Building Consultant: Ian Hall, NZIBI
Present for inspection: Ian Hall / vendor
Weather at time of inspection: Fine
Date/s of inspection: 12-Dec-2025
30-Jan 2026
Type of inspection: Building Inspection
Name of property inspected: 3 Bressay Way
Waikanae
Report prepared for: Sarah Searancke

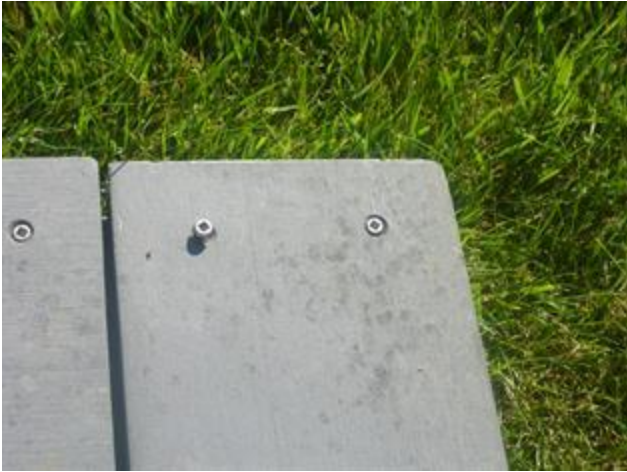
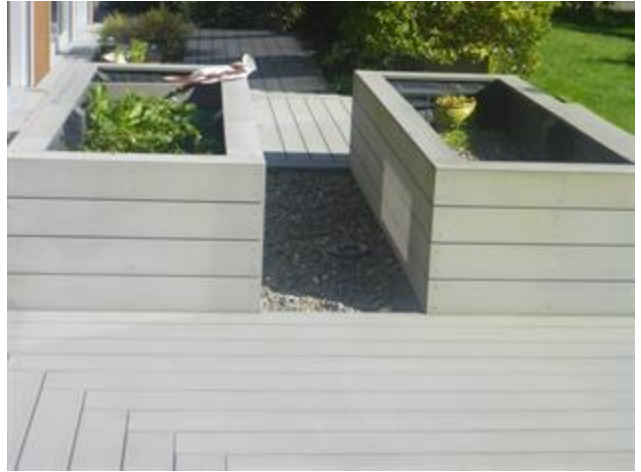
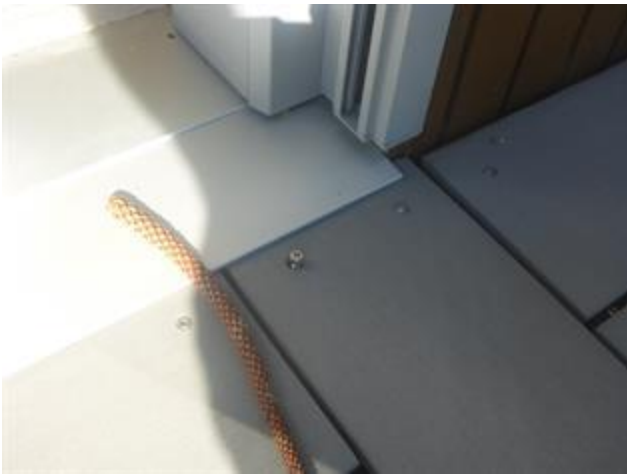
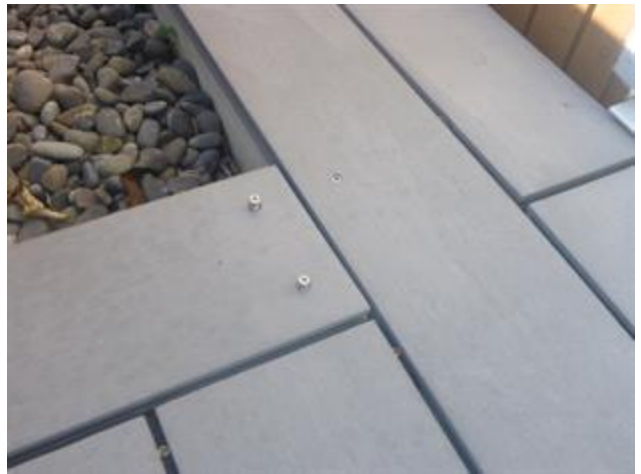
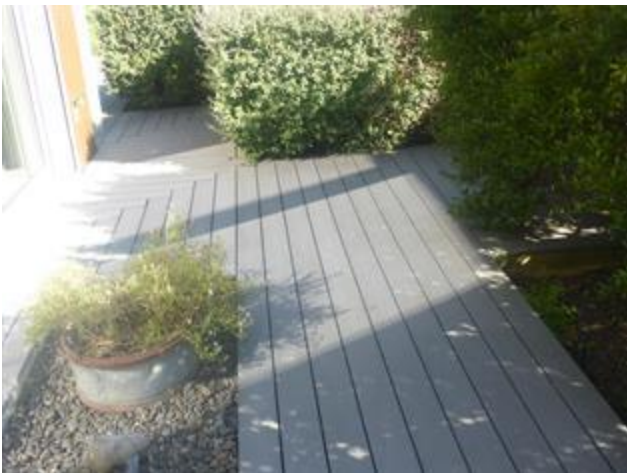
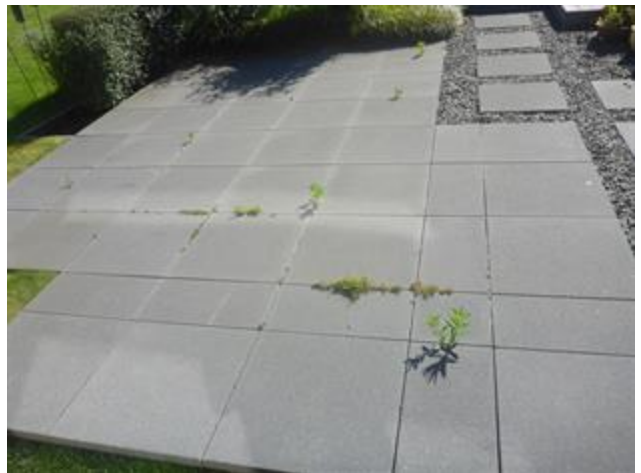
Loose fasteners

The decking was in good condition. Permadeck composite decking is virtually maintenance free, needing only periodic cleaning. The product does not require any painting or staining over the life of the product. Several screws require re-fixing as part of the dwelling's maintenance.

***Update 20/1/26 the decking has been re-fixed where required.**

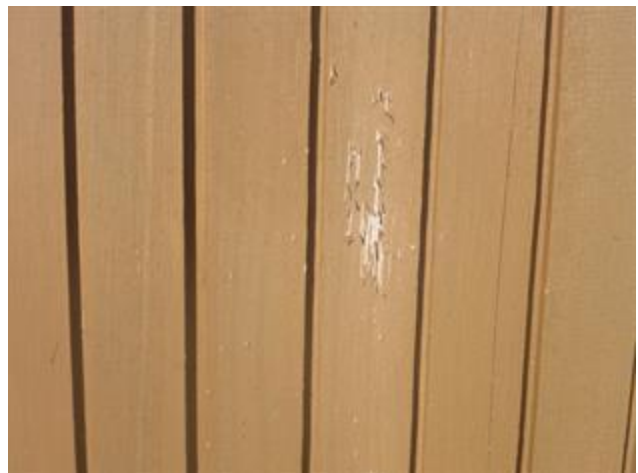
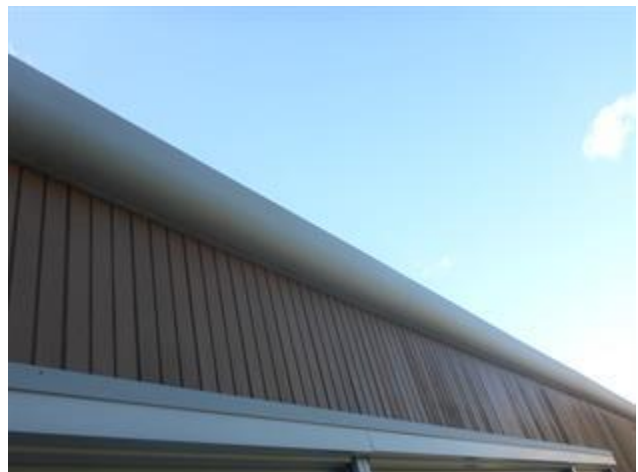
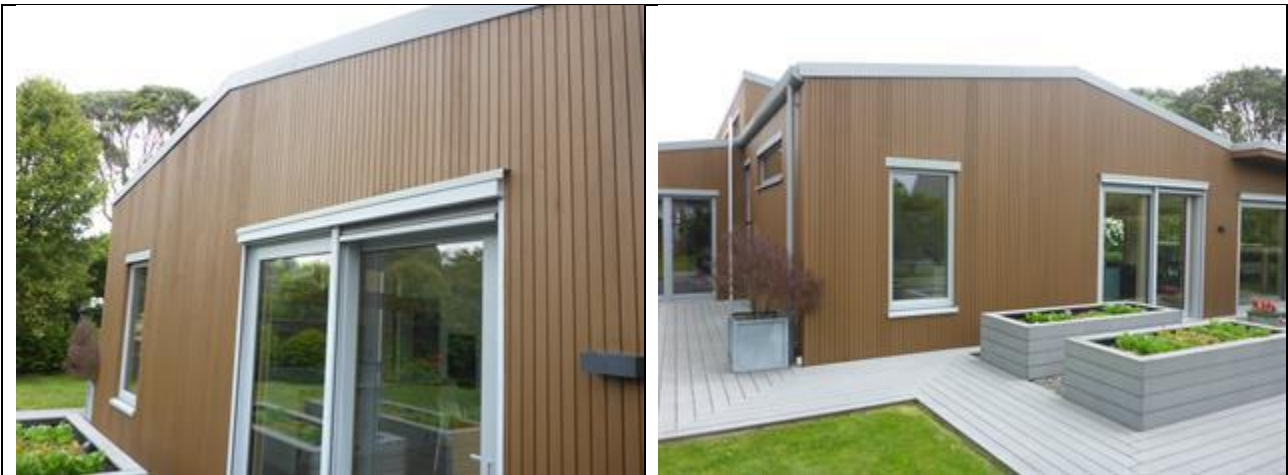
The cladding was in good condition with no visible signs of decay with an aging paint finish mainly to the sunny side of the dwelling.

In terms of maintenance planning, implementing a painting program to repair the areas that require some attention now and to maintain a good paint finish to the dwelling is recommended.

***Update 20/1/26 A new paint finish has been applied where required to a good standard.**

<p>*Update 20/1/26 New paint seal applied</p>	
--	--

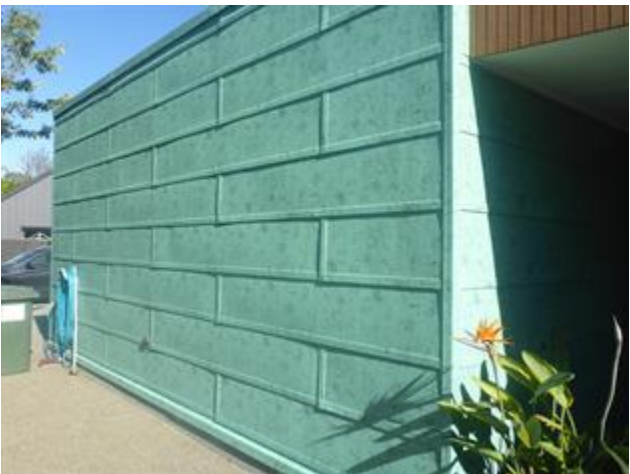
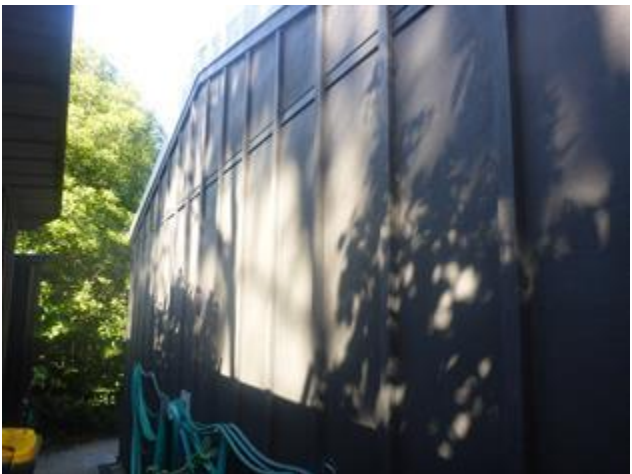
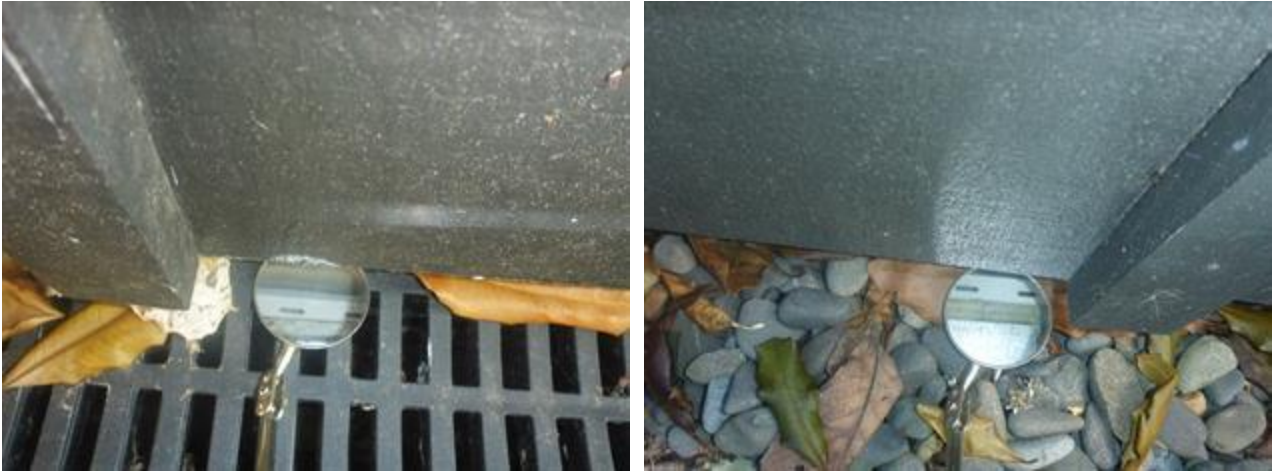
The lower edge of the plywood cladding and battens has not had a paint seal. A paint seal will help prevent end-grain deterioration of the battens and seal the plywood cladding.

The colour was assessed to have an approximate light reflective value {LRV} of less than 50%. The manufacturer recommends the LRV should be above 50%. If a colour with a LRV that is less than 50% is used it increases the chance of aesthetic surface deterioration and the resultant deterioration if not adequately maintained.

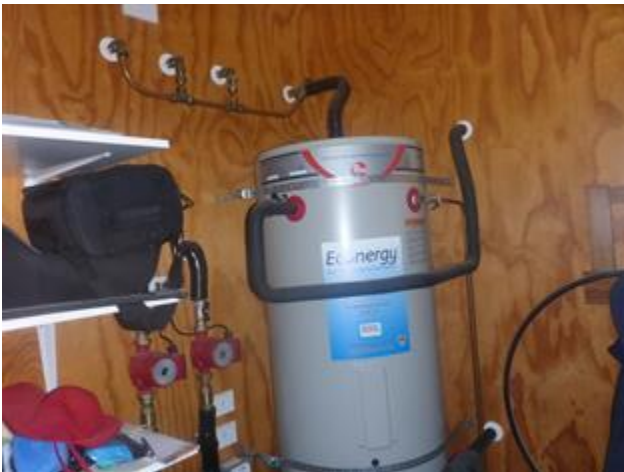
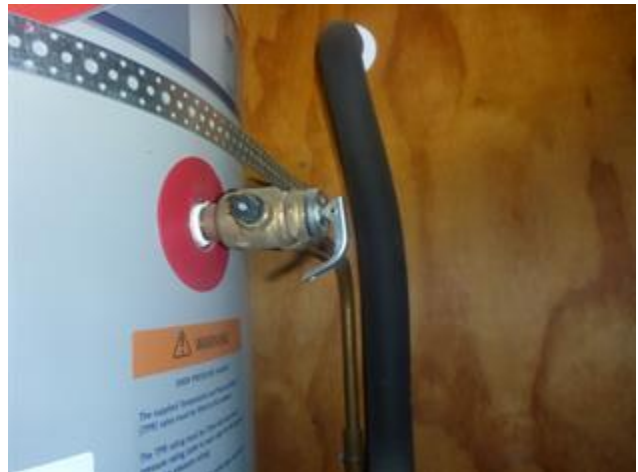
Pressure relief valve

Located on the side or top of the cylinder is a valve to relieve pressure in the hot water cylinder. It is recommended that the relief valve be checked for adequate performance or replaced at intervals not exceeding 5 years, or more frequently in areas where there is a high incidence of water deposits and that the valve easing gear be operated at least every six months.
