## EQC CLAIM DOCUMENTATION

## Assessment of Property at 20 ROBIN STREET, BURWOOD, CHRISTCHURCH 8083 on 1/08/2011

## EQC Full Assessment Report

**Claim Number:** CLM/2011/105168  
**Claimant:** G DITFORT  
**Property Address:** 20 ROBIN STREET  
 BURWOOD  
 CHRISTCHURCH 8083

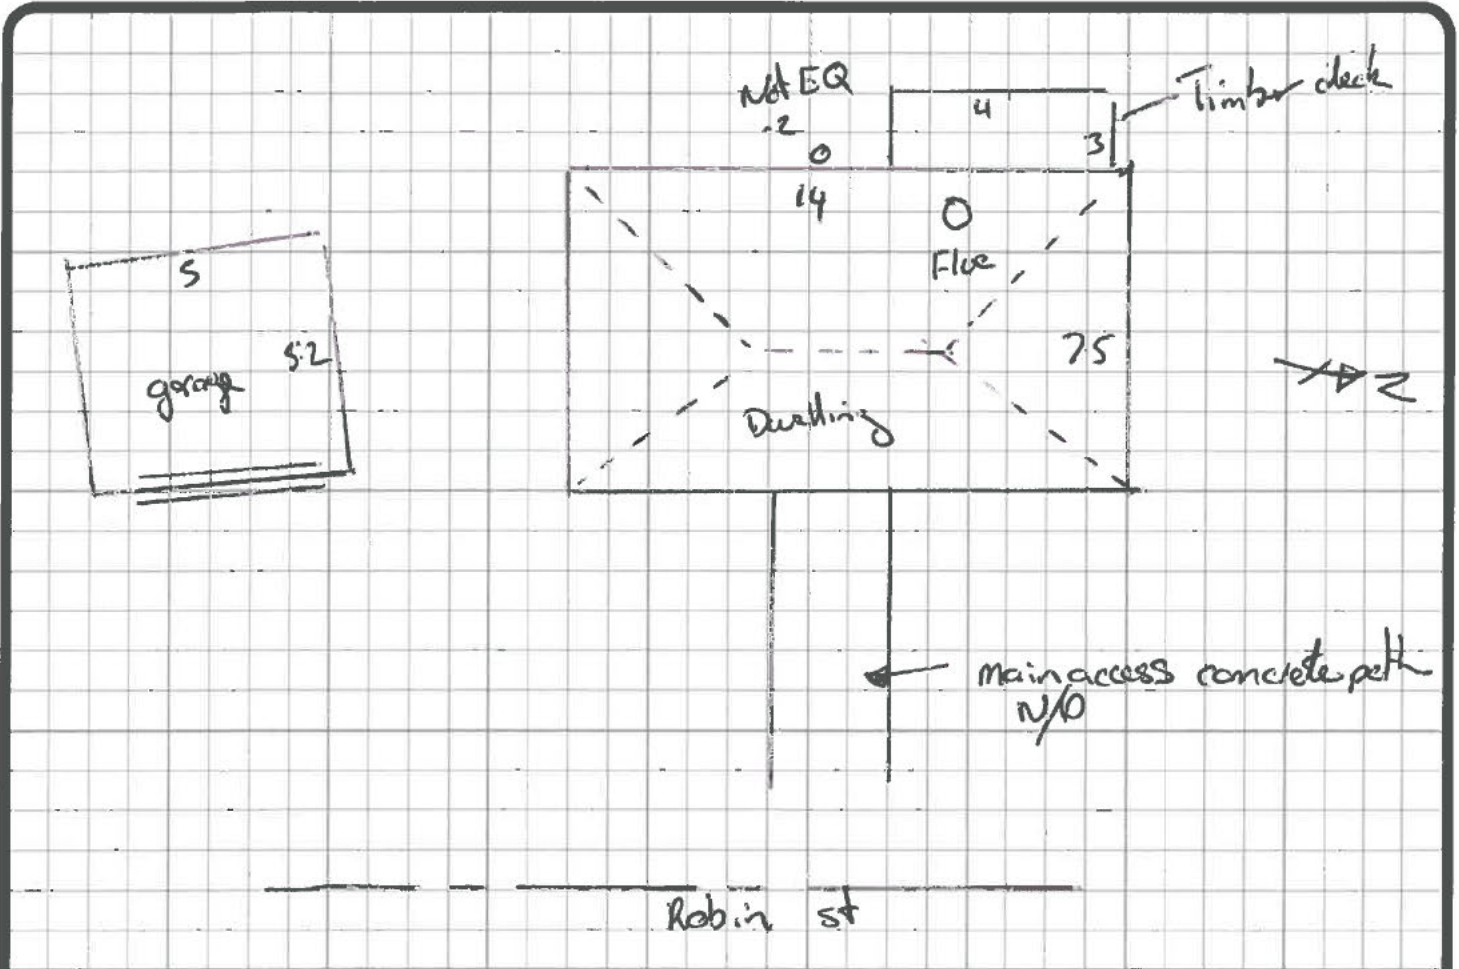
**Dwelling Inspection Checklist: Show measurements indicate damage**

—	Crack to ceiling (show length)
~	Crack to wall (show length)
X	External damage
○	Foundation damage

Area m2:	105
Stud Heights:	2.4
Wall Finish:	Wallpaper      Plastered <u>Paint Finish</u>
Other:	
Services:	Specify Damage:
Chimneys:	Construction Type: <u>Flue inside brick to roof line</u> Height N/O Damage Description: Above Roof    Below Roof    Total Repair
Foundations Damage:	Timber <u>Concrete Ring</u> Concrete Slab    Other (Specify): Minor    Moderate    Severe House Moved off Foundations? Concrete Slab Cracked? Crack Width: ..... Crack Length: .....
Roof:	<u>Framed</u> Trussed N/O Type: Clay Tiles <u>Concrete Tiles</u> Rolled Metal    Other Damage:
Cladding Type:	<u>Weatherboard</u> <sup>pointed</sup> Brick Veneer    Hardi Plank    Other N/O
