NEWCASTLE
STRATA INSPECTIONS PTY LTD

Pre-Purchase Strata Inspection Report

Strata Plan: 82167

**Address: 170-172 Gosford Road, ADAMSTOWN NSW
2289**

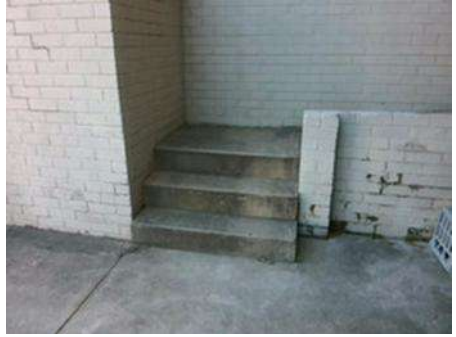
No.	Floor Level / Unit No	Location	Hazard and Recommendation	Photo	Risk Rating
1	G	Stairs	<p>Hazard Identified: There is no handrail / barrier installed. - This is a Slip Trip Fall hazard.</p> <p>Recommendation: Install handrails to the steps.</p>

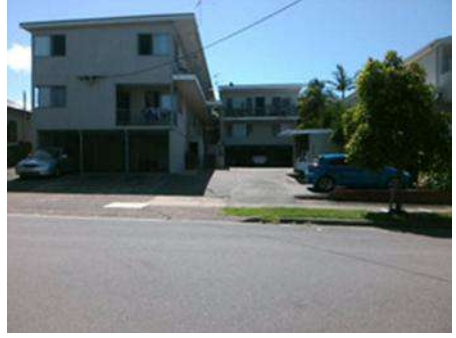
2	G	Entrance to Complex	<p>Hazard Identified: No speed limit sign or shared zone sign to indicate that speed should be reduced for the safety of pedestrians. - Physical injury and vehicle damage hazard.</p> <p>Recommendation: It is recommended to install a 5km/ph speed sign or for smaller complexes a shared zone sign at the driveway entrance in a visible location.</p>

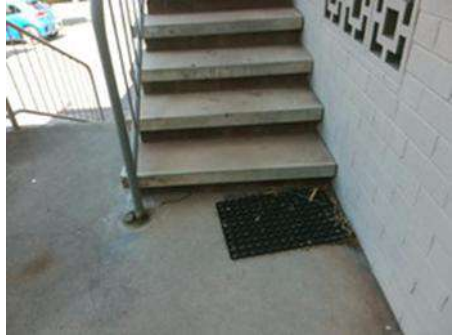
No.	Floor Level / Unit No	Location	Hazard and Recommendation	Photo	Risk Rating
3	G	Stairs	<p>Hazard Identified: The Rises (height of the step) to the stairs are not consistent throughout the whole set of steps. - This is a Slip Trip Fall hazard.</p> <p>Recommendation: A qualified builder should be engaged to assess the stairs and develop plans for the replacement/ redesign of the stairs to ensure they have consistent rise heights throughout the set of stairs. Until such time as repairs are completed, signage and yellow markings should be installed to notify all persons using the stairs that the rises are not consistent and pose a safety risk to anyone using the stairs.</p>

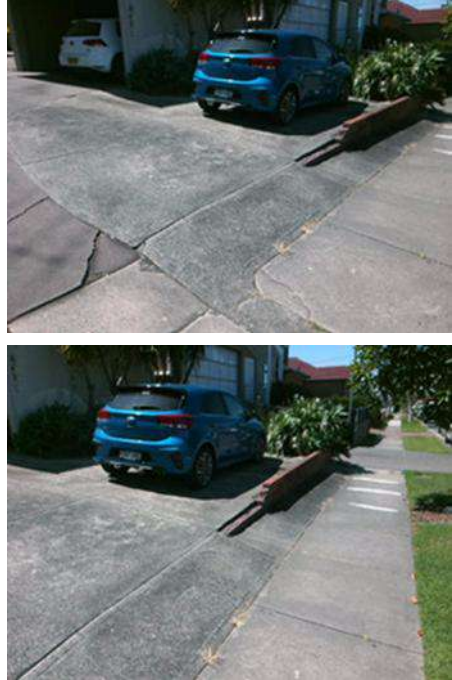
2
6	G	Driveway / Car parking	<p>Hazard Identified: The driveway is raised above surrounding ground. - This is a Slip Trip Fall hazard.</p> <p>Recommendation: Fill the surrounding ground to be close to level with the top of driveways and pathways OR paint a 100mm wide line along all edges where it is raised above the surrounding ground.</p>

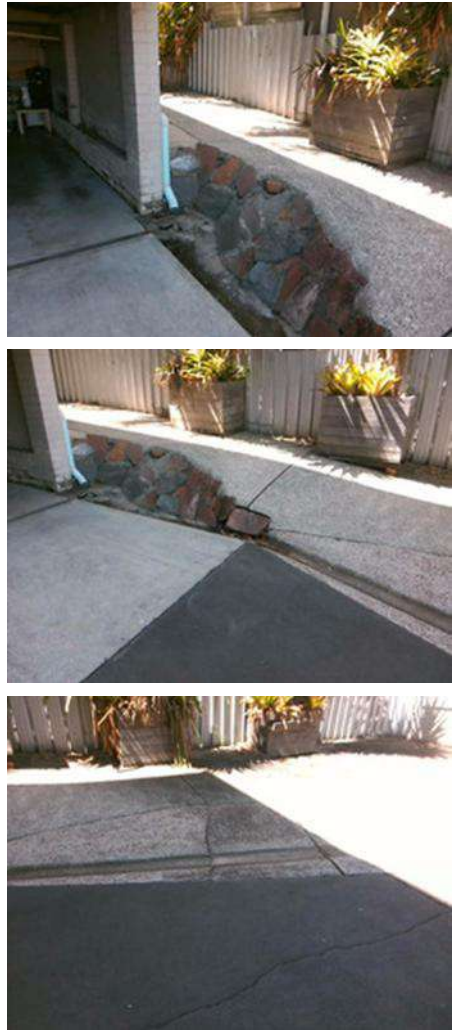
No.	Floor Level / Unit No	Location	Hazard and Recommendation	Photo	Risk Rating
15	G	Pathways	<p>Hazard Identified: Pathways are raised above surrounding ground. - This is a Slip Trip Fall hazard.</p> <p>Recommendation: Fill the surrounding ground to be close to level with the top of the pathway OR paint a 100mm wide line along all edges where it is raised above the surrounding ground.</p>

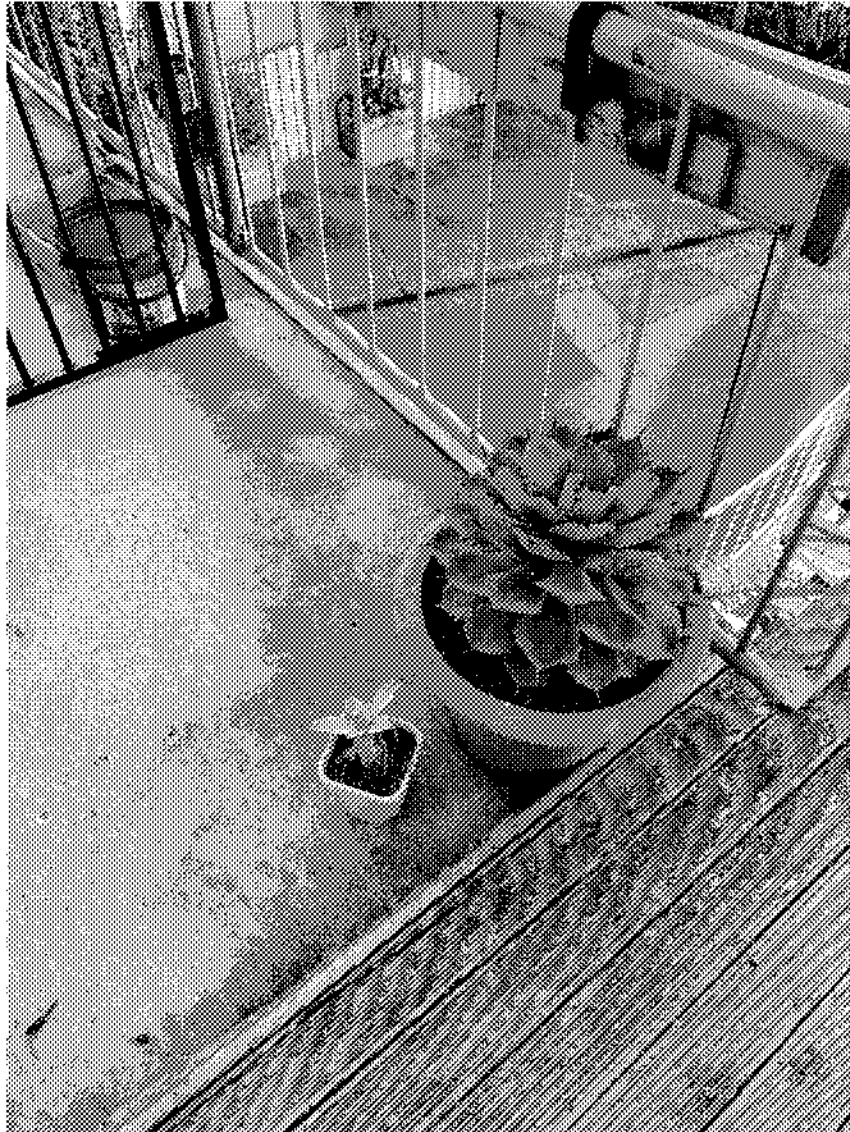
Figure 6 - Upper walkway surface - note change to solid sheeting to rear unit

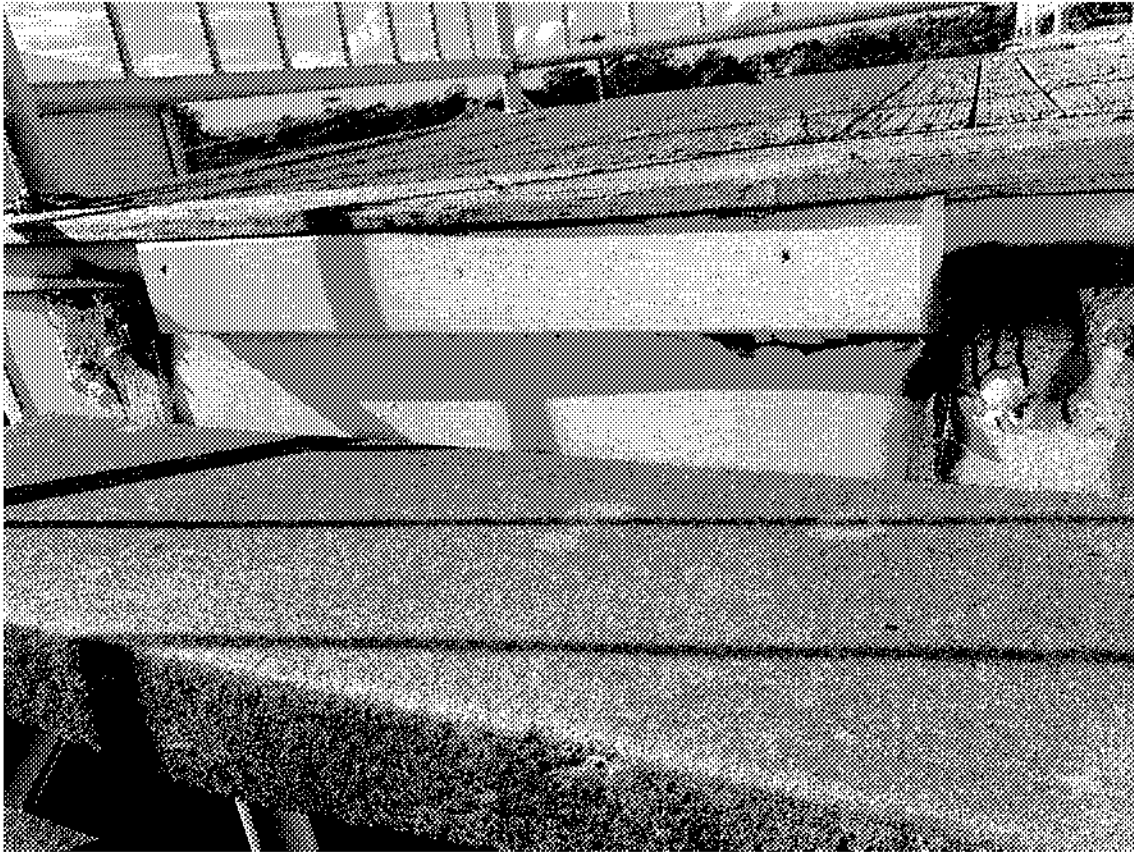
Figure 7 - Connection at top of upper front stair

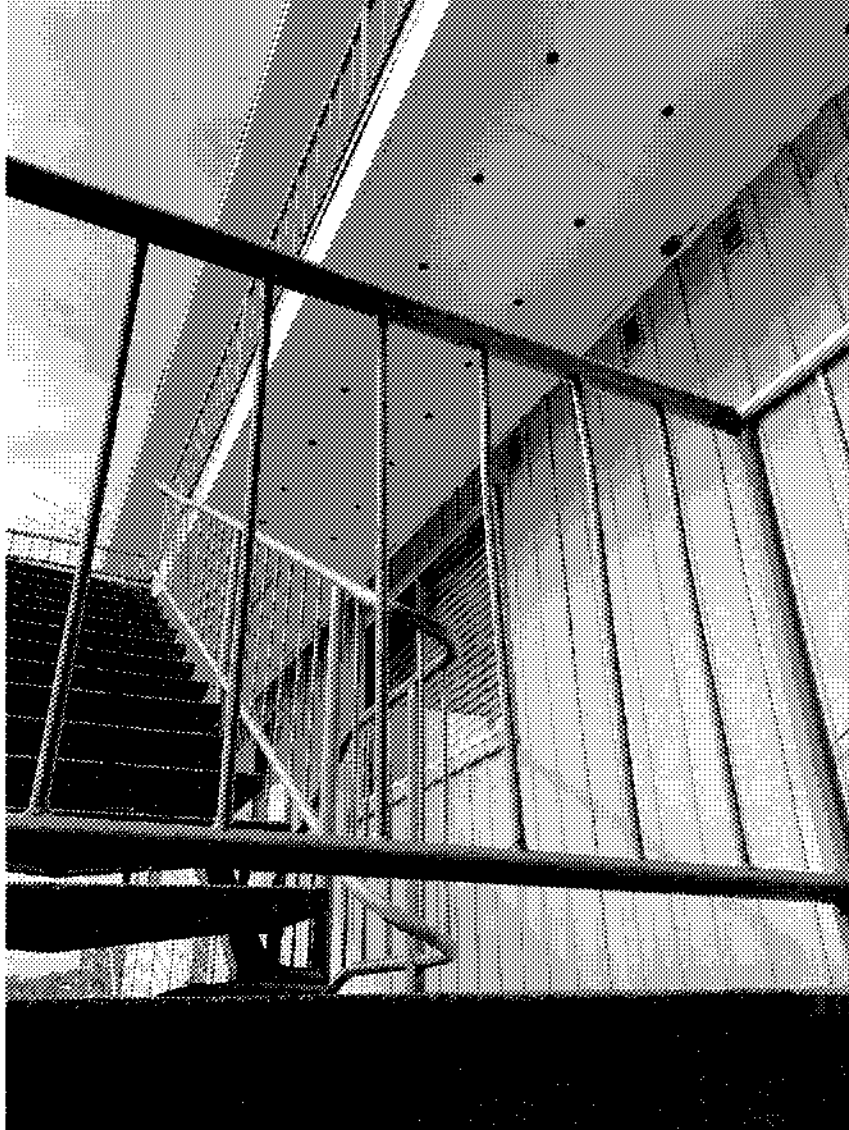
Figure 8 - View of underside of upper walkway from base of upper front stair

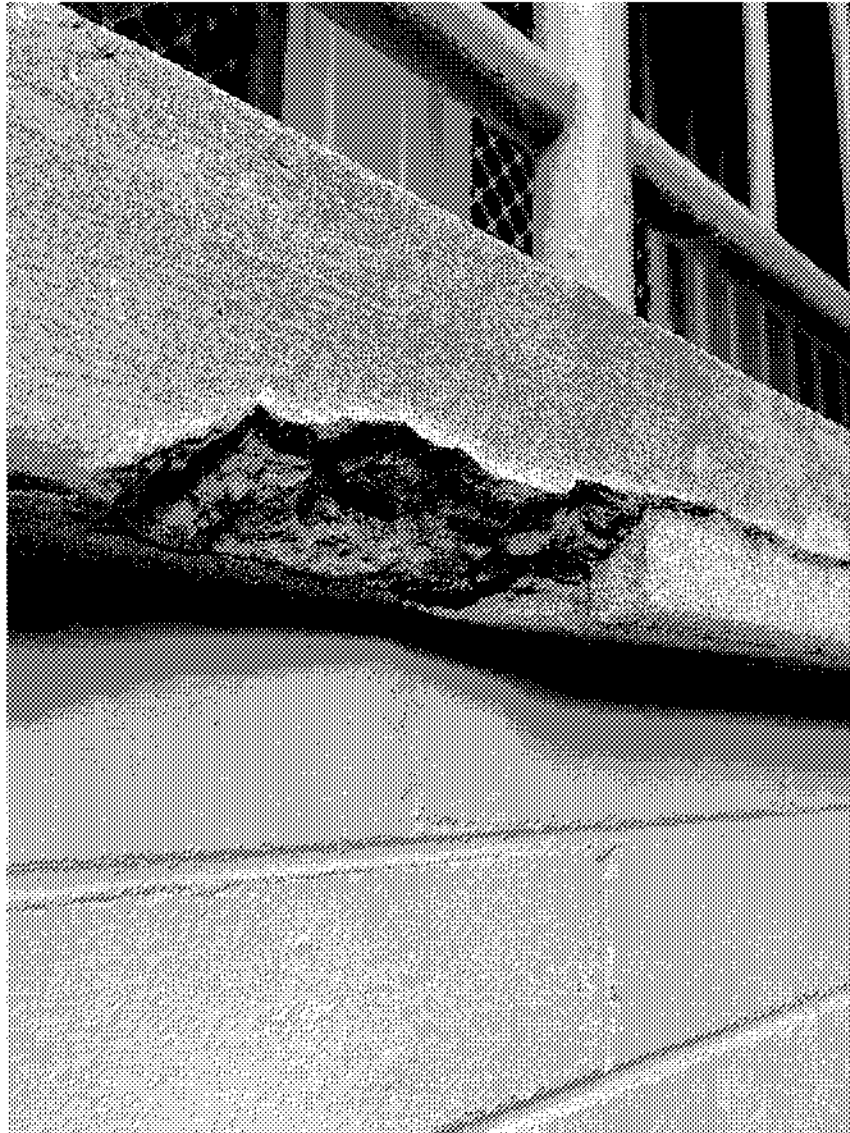
Figure 9 - Corrosion and spalling to lower walkway slab
