Vendor Supplied Building Report

Statement Of Passing Over

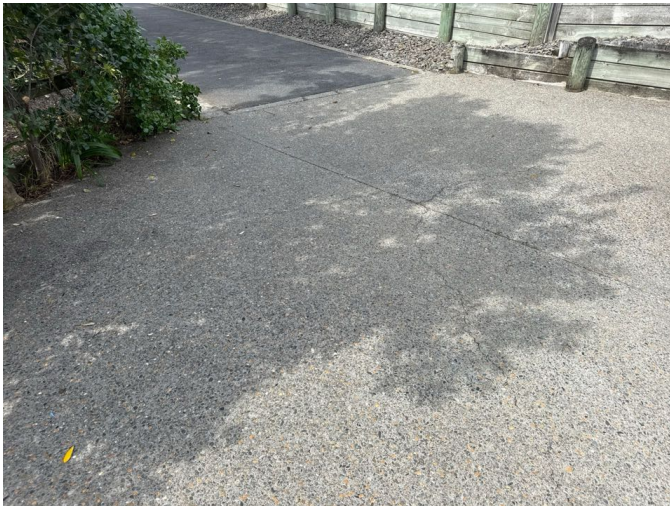
The driveway has some common shrinkage cracking but no significant damage

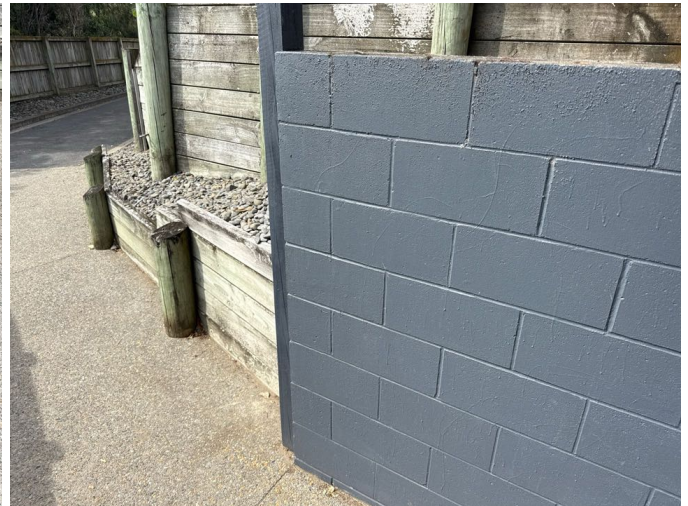
The condition of the retaining walls is consistent with the age of the property.

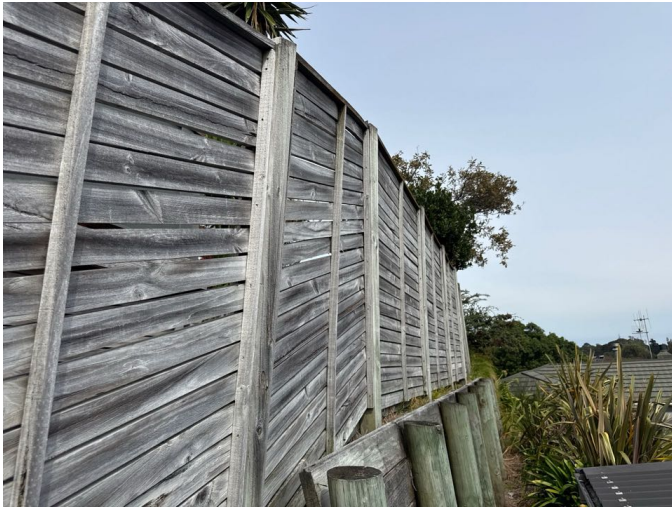
The perimeter fencing is solid and intact.

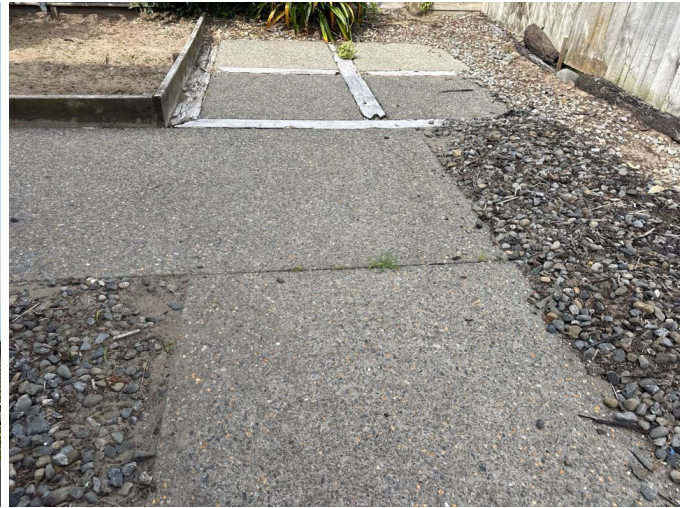
The paths are tidy and functional. Deterioration to the timber inserts at the southwest corner noted. Mainly cosmetic.

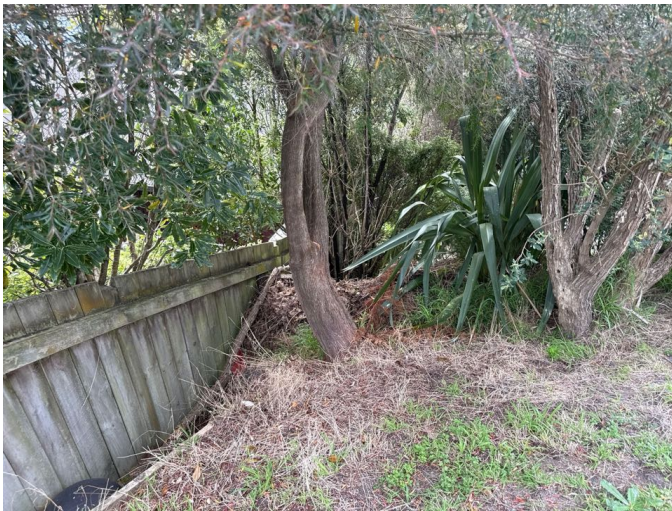
T.H.I.S is unable to comment on the condition of the fencing or retaining walls that are concealed by vegetation.

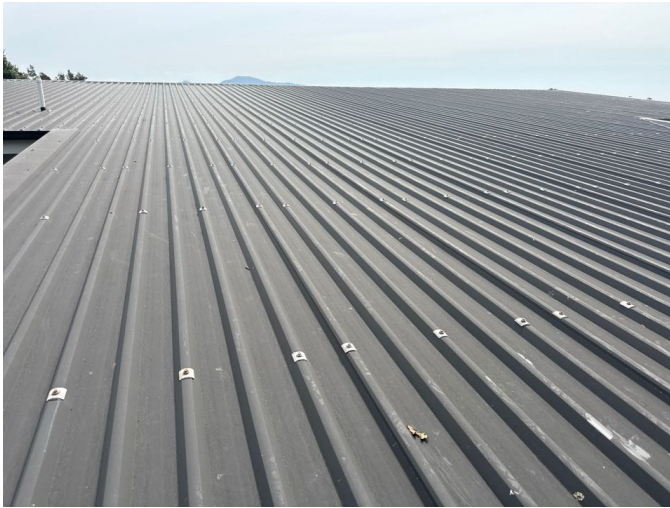
A once or twice yearly soft wash will help maintain the roofs surface condition and prevent premature deterioration

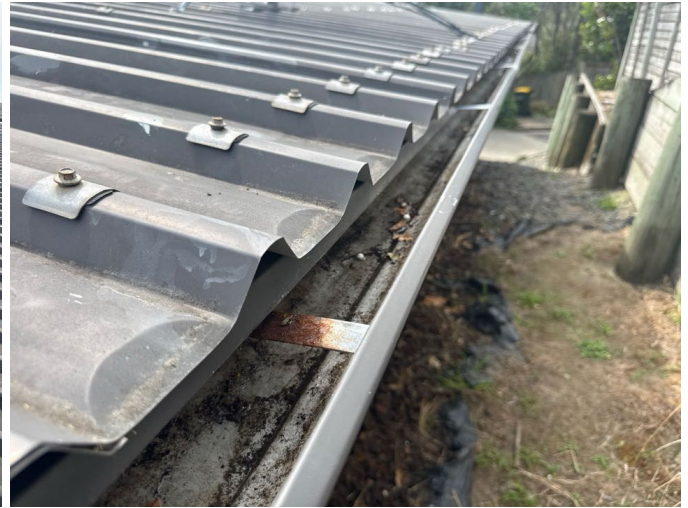
The spouting is in an average condition and is clear. The effectiveness of the spouting will need to be checked during rainy periods. Due to the dry conditions that were evident on the day of our inspection we cannot comment on any leaks that maybe evident to the spouting or down pipes. Rust affected brackets should be treated with rust converter to slow the deterioration. NOTE: The owner disclosed that these have been treated since the original inspection.

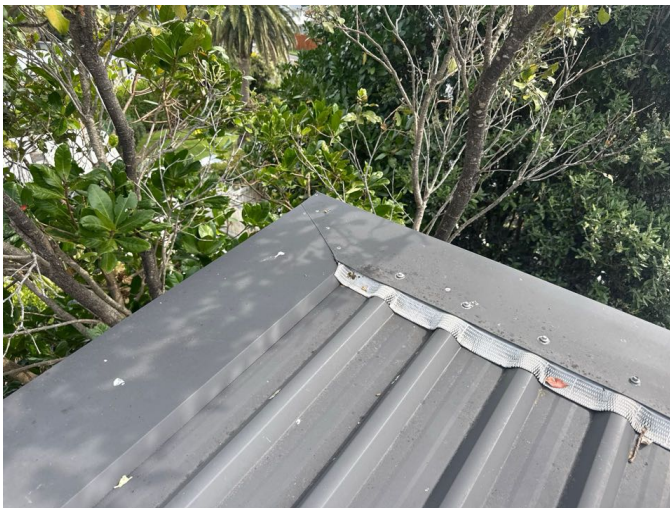
The roof flashings are secure, intact and are effective. No sign of failure could be found beneath where accessible to view.

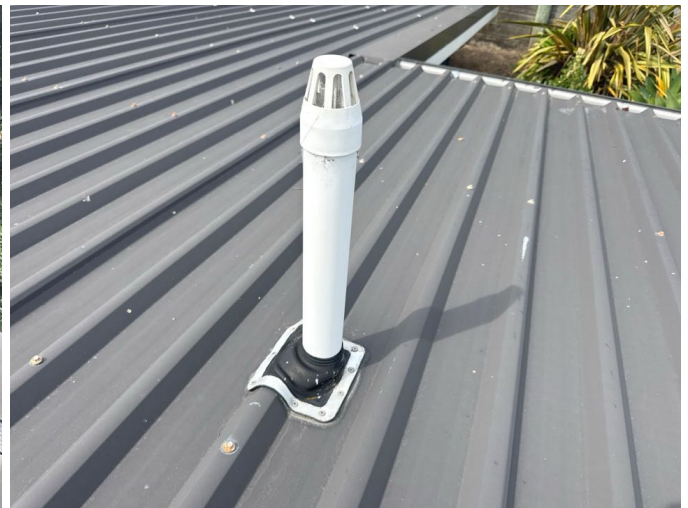
The roof penetrations are effectively sealed. The perimeter of the boot flashing at the base is finished with silicone which has a limited lifespan. The condition of the silicone seals should ideally be checked periodically and some replacement should be expected over time.

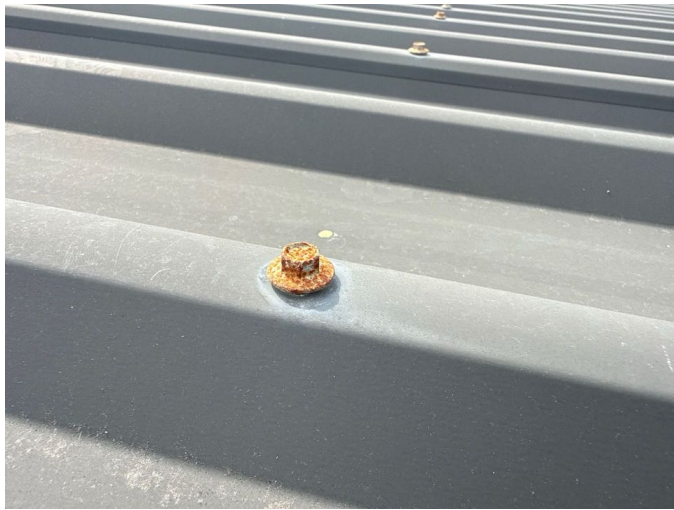
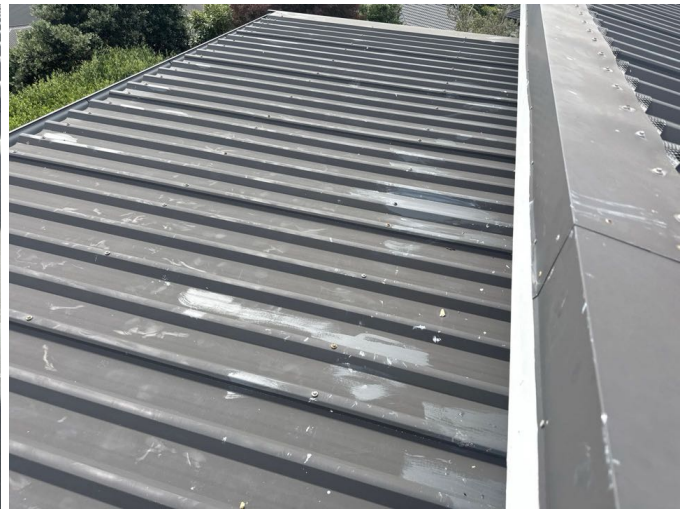
The rust affected screws should be treated with rust converter or replaced to prevent the rust spreading.
NOTE: Rust affected areas have been treated and painted since the original inspection.

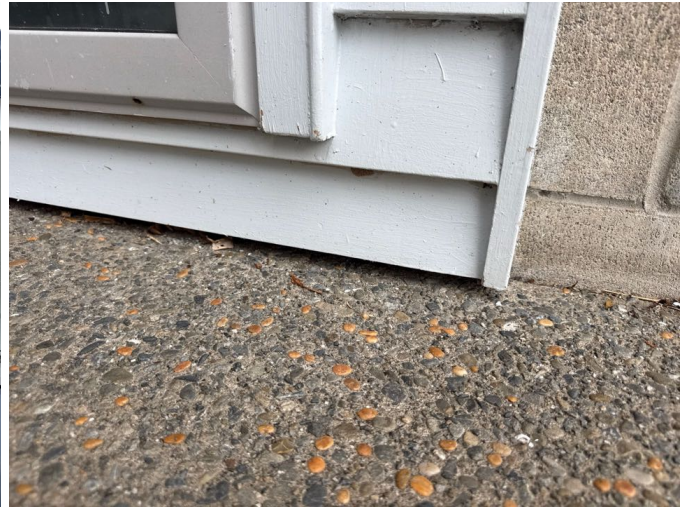
Example. Timber in close contact with the ground is at risk of premature deterioration and must be kept thoroughly sealed. Good current condition noted.

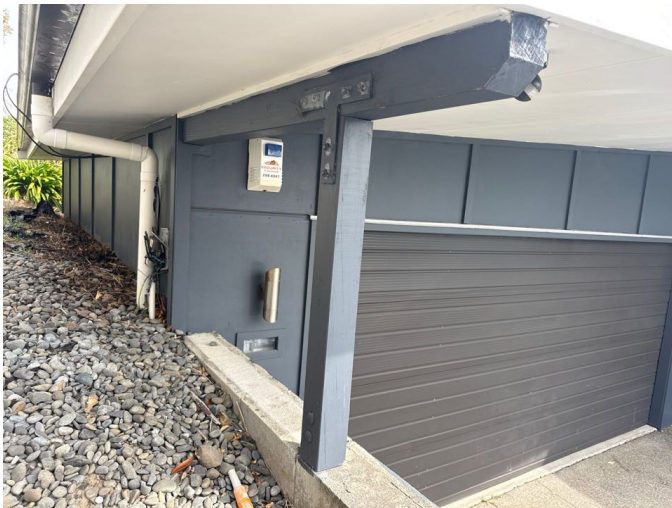
The timber roof support is solid and secure

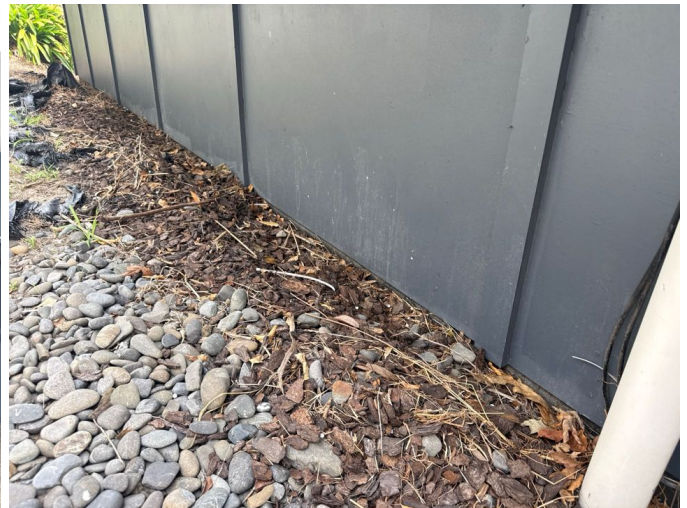
The ground levels should be cleared right away from the base of the cladding to prevent premature deterioration and the risk of water ingress issues. At the time of the inspection all non invasive moisture tests completed to the bottom plate at these locations presented within the acceptable range. NOTE: The ground levels have been lowered since the original inspection.

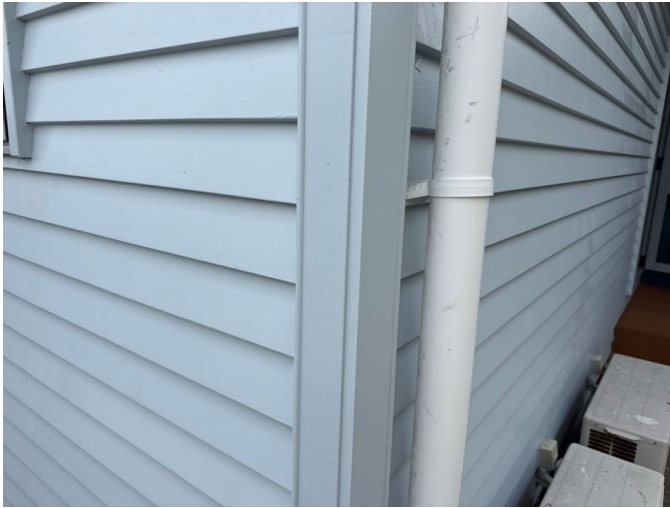
Timber box corner and scribe detail to the external corners. Box corners protect the external weatherboard joins from deterioration and is a second layer of weather protection. Well installed and sealed throughout.

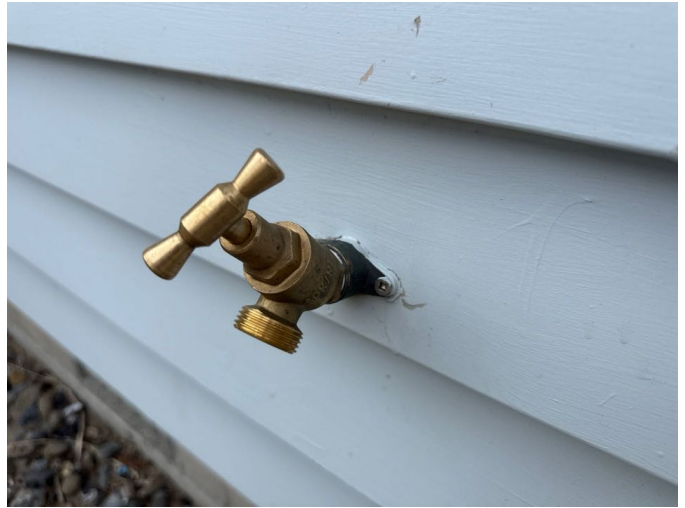
Cladding penetrations in general are a weather tightness risk area. Penetrations such as taps, screw fixings, gas or water pipes etc. A good seal must be maintained around all cladding penetrations over time to prevent issues. No evidence of failure could be found.

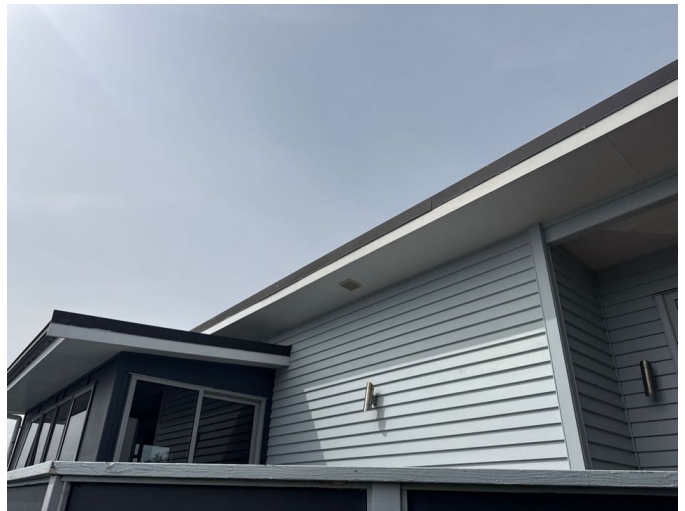
Good eave protection noted

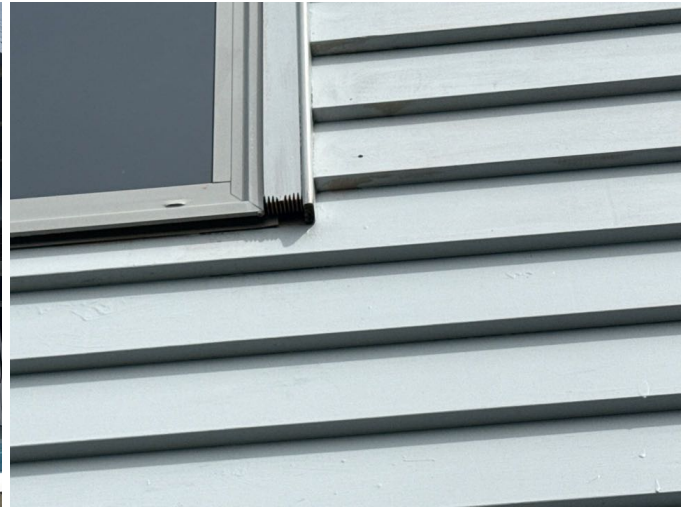
The base of the finger jointed window facing has broken off leaving the timber exposed. The facing and the scribe should be thoroughly sealed to prevent the risk of rot damage. NOTE: This has been painted since the original inspection.

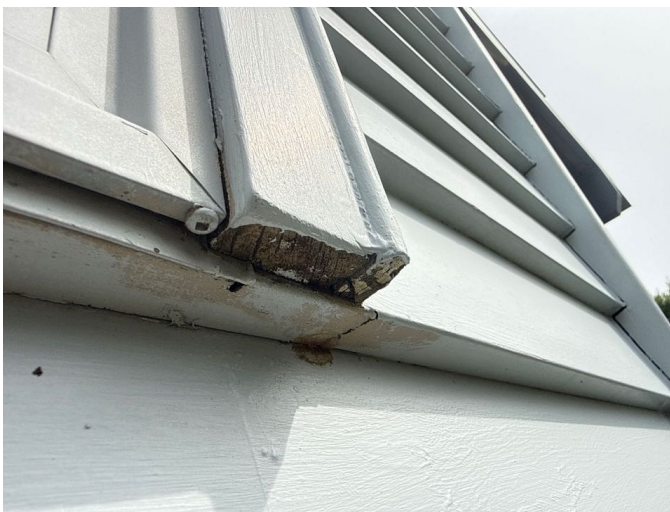
Lower level. Another example of the facings and scribes which require thorough sealing improvements. The end grain of the timber is highly susceptible to rot damage if it is not sealed effectively. NOTE: This has been painted since the original inspection. These comments are left in for disclosure purposes.

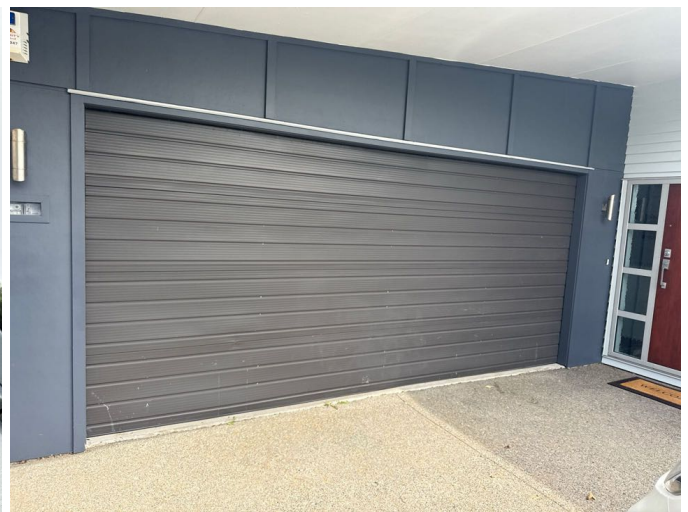
The surface condition of the garage door is average

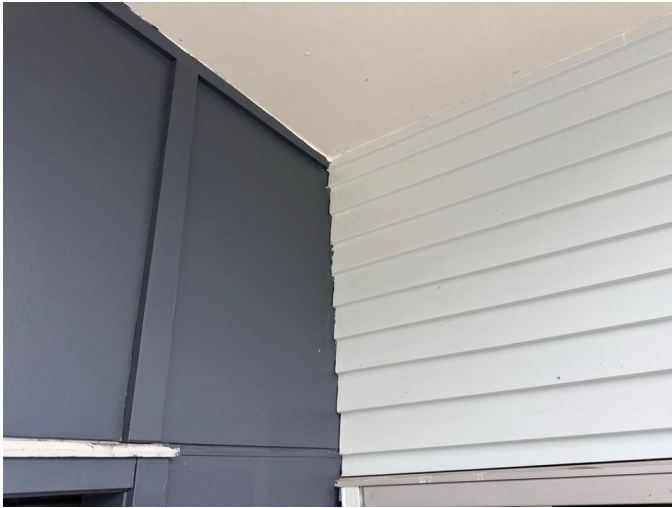
Good overall paint quality to the exterior noted

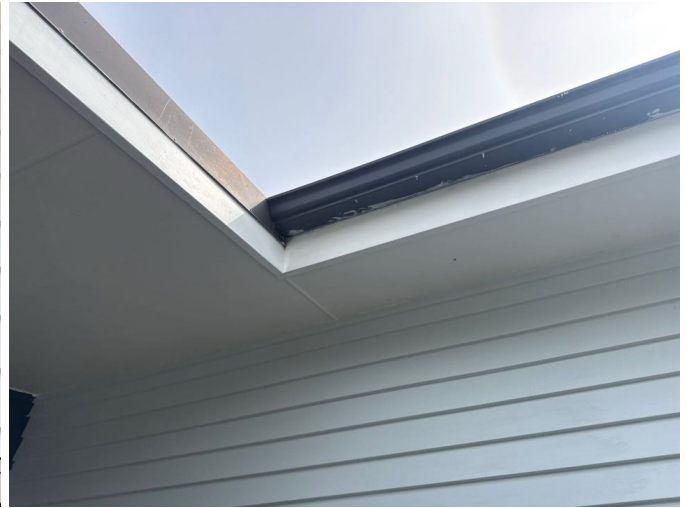
Generally good paint seal to the timber barge boards, fascia and fibre cement soffit linings

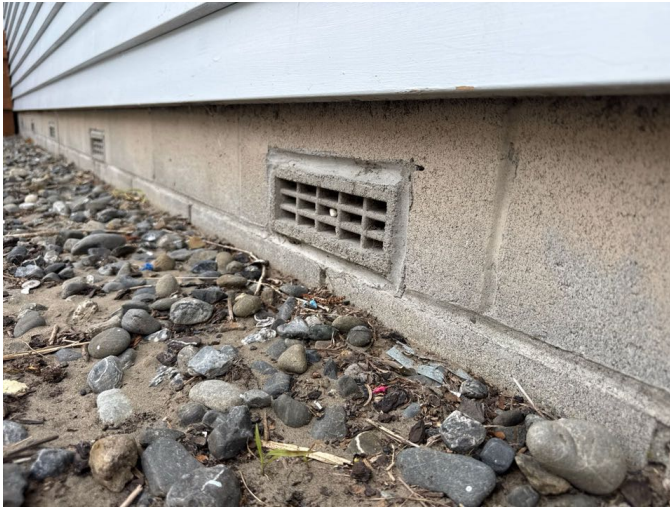
The concrete block ring foundation is in a typical condition for the age. No sign of cracking or significant stress.

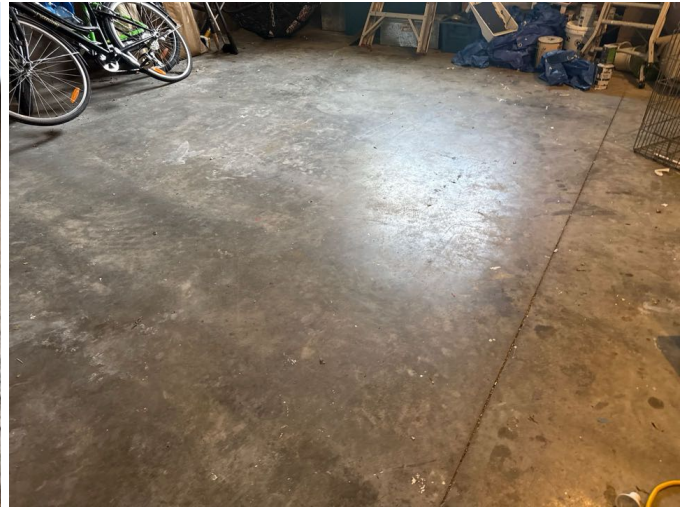
The exposed concrete slab in the garage is in an average condition for the age. No damage sighted.

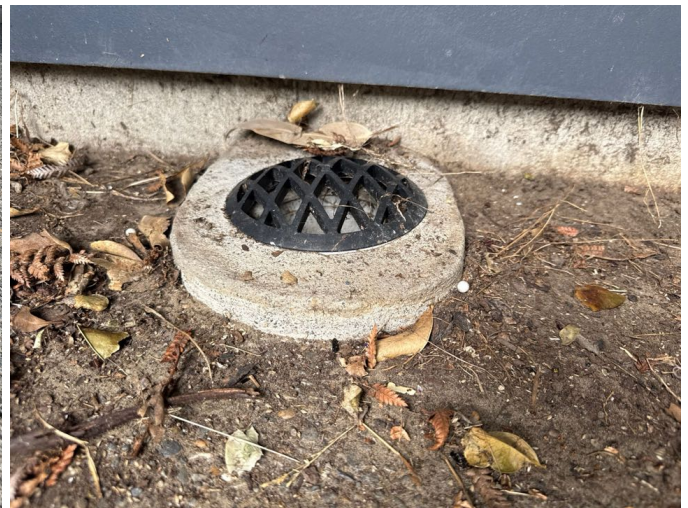
The overflow relief gully is an external outlet for waste in case of internal blockages. No sign of recent overflows. Good height noted.

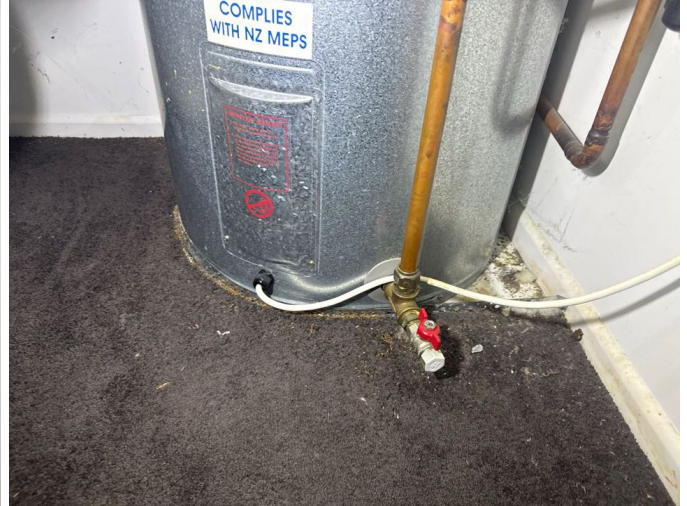
No sign of leaks at the base of the cylinder at the time of inspection

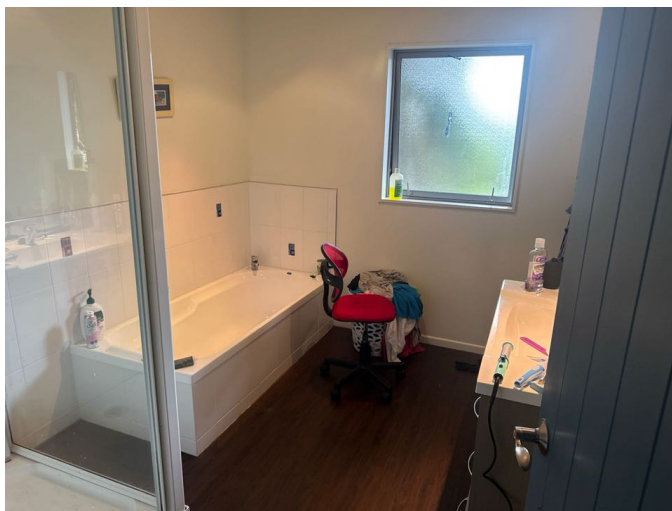
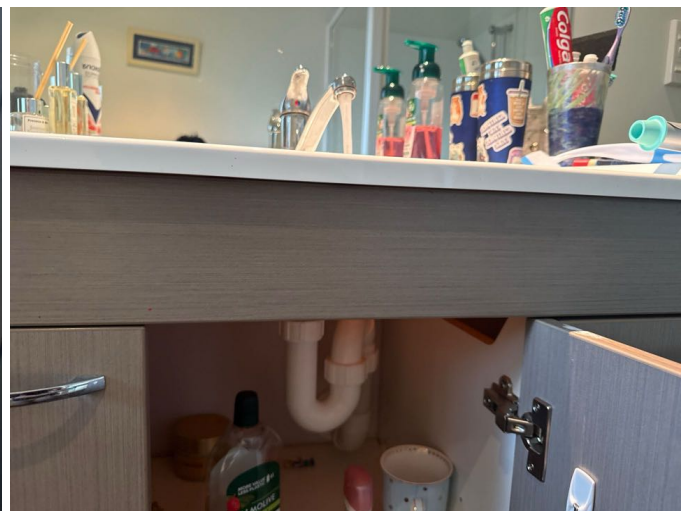
The rear edge of the vanity is well sealed. The tap is functioning well. No concerns with the water feeds or waste under the vanity

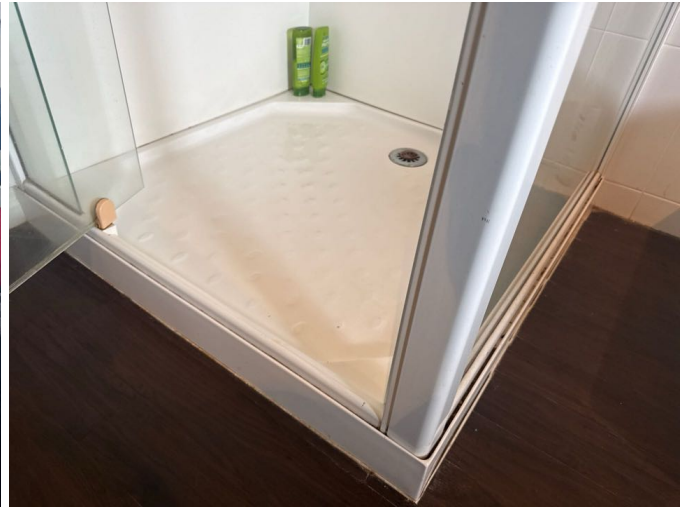
The base of the shower is well sealed. There was no evidence of damage to the shower base at the time of the inspection.

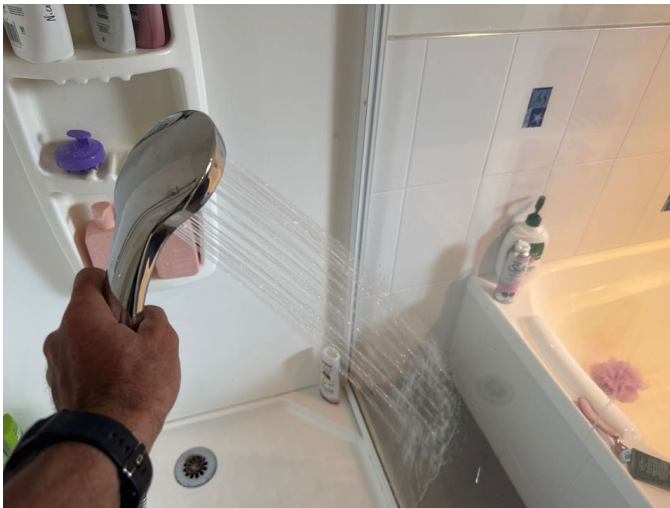
Good water pressure noted. No sign of current leaks from the shower frame during water testing.

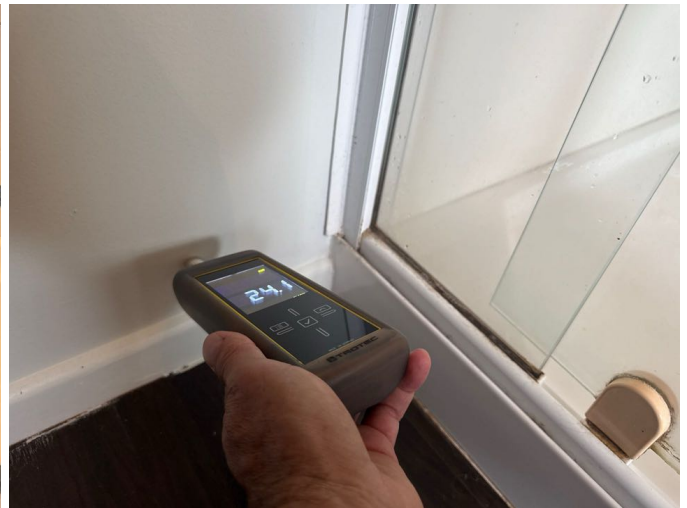
The common fail areas of the shower and plumbed areas were checked for elevated moisture. Moisture levels were within the normal range.

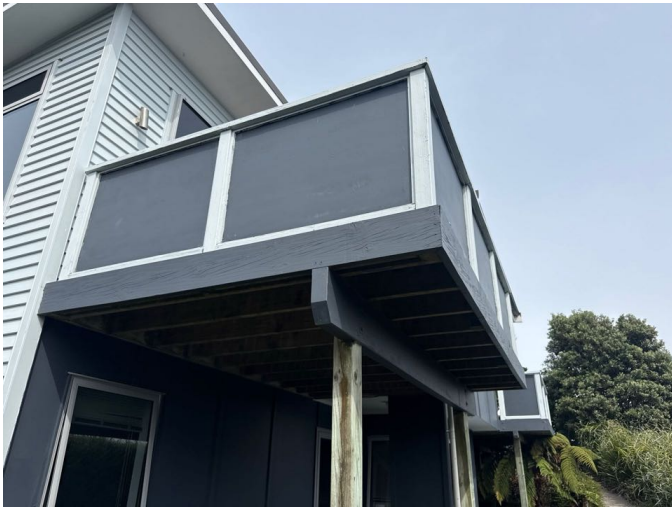
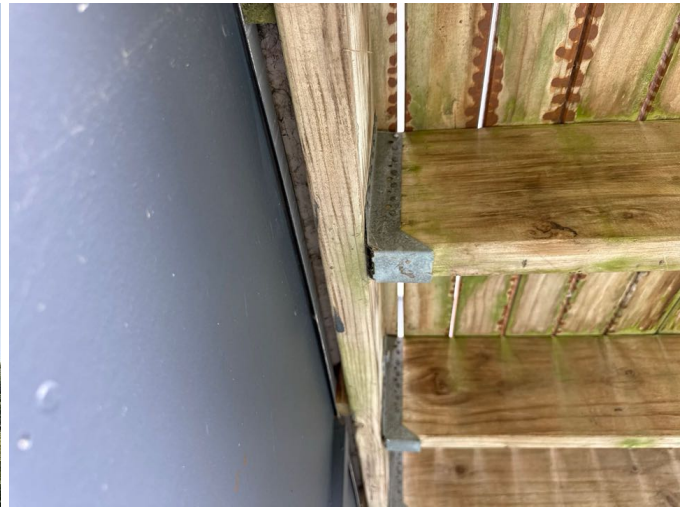
Good clearance gap between the deck and cladding. This will allow water to escape and will prevent premature deterioration. Solid construction noted.

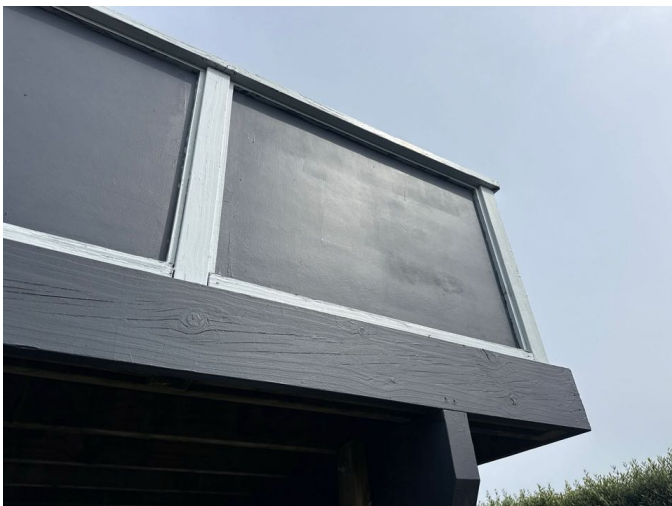
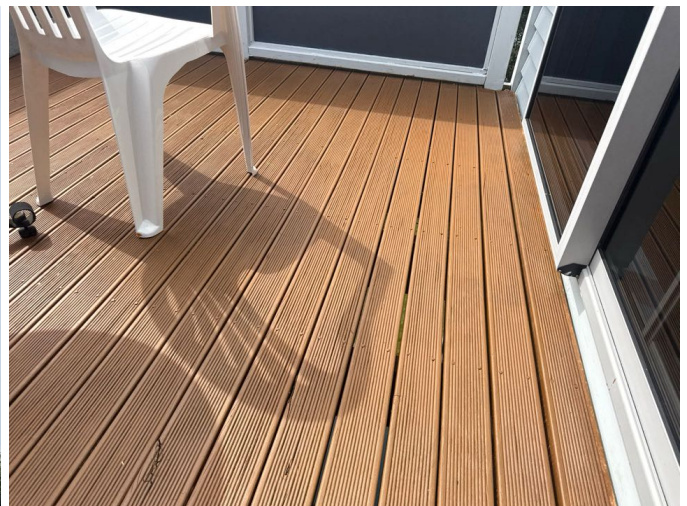
The balustrade is solid and connected sufficiently at the base. The balustrade has some paint deterioration which requires attention.

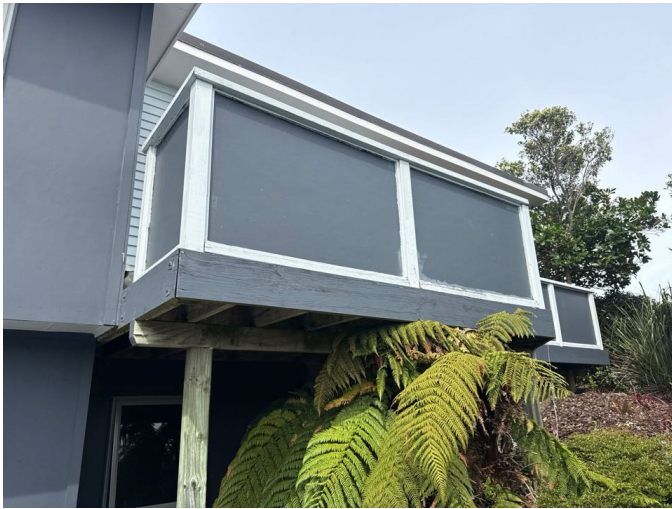
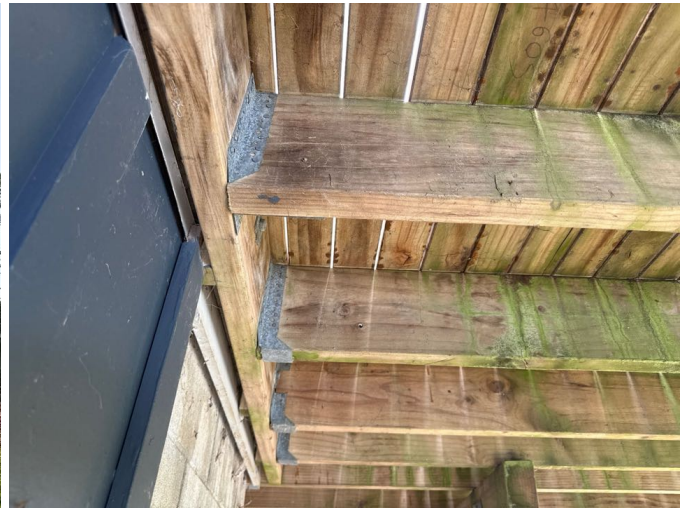
Good clearance gap between the deck and cladding. This will allow water to escape and will prevent premature deterioration. Solid construction noted.

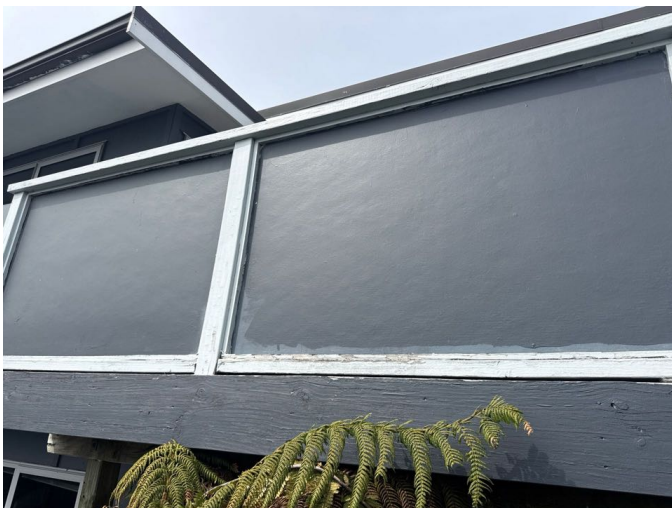
The balustrade is secure. Areas with paint deterioration require a paint upgrade.

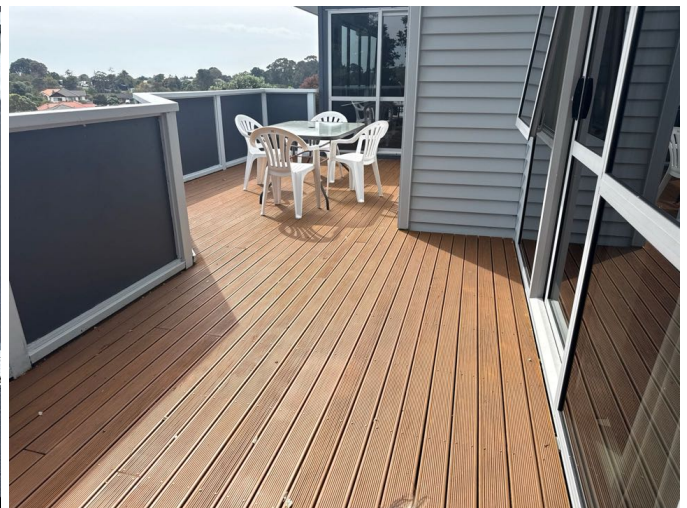
The decking is in good condition

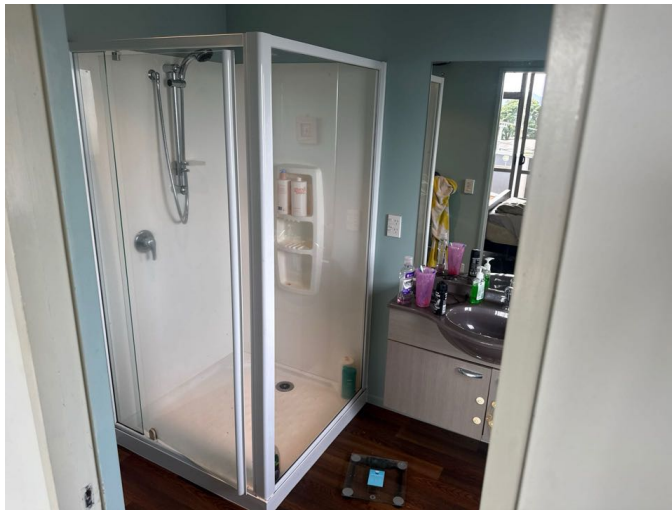
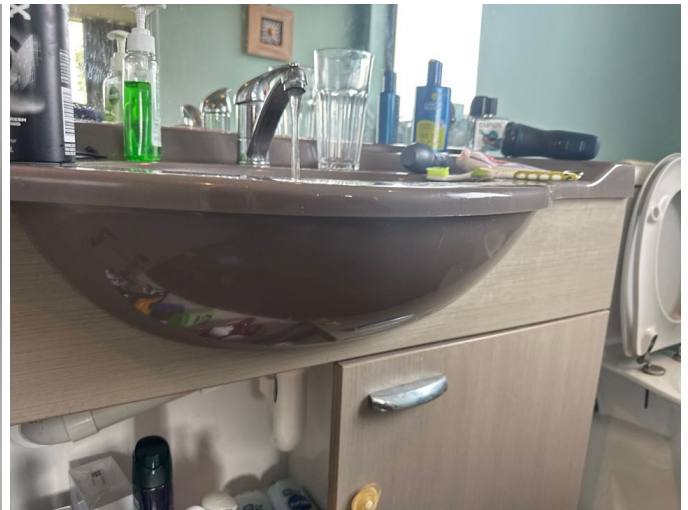
The rear edge of the vanity is well sealed. The tap is functioning well. No concerns with the water feeds or waste under the vanity

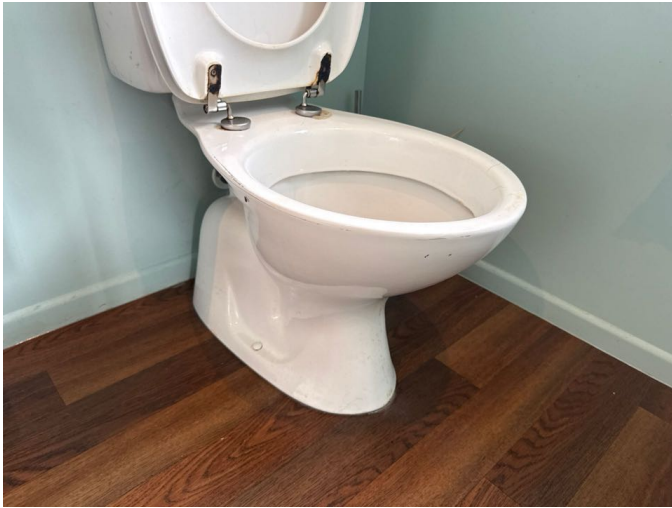
The base of the toilet is well sealed and secure. The toilet is in a functioning condition.

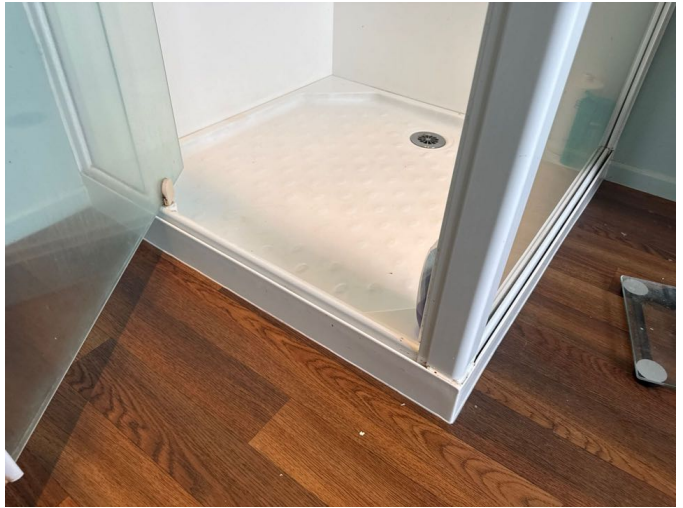
The base of the shower is well sealed. There was no evidence of damage to the shower base at the time of the inspection.

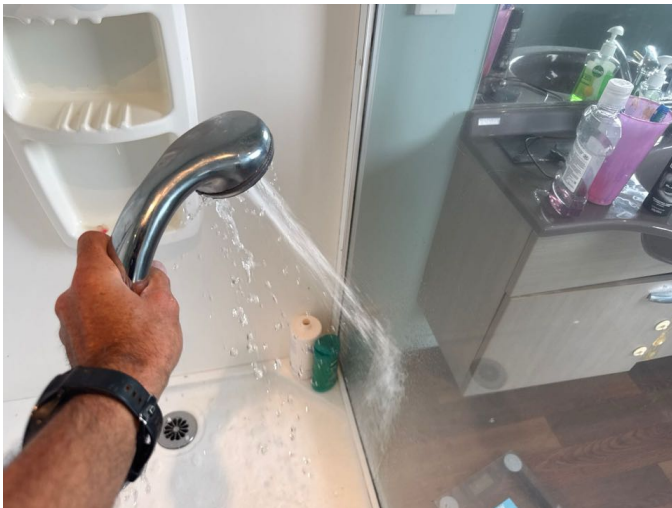
Good water pressure noted. No sign of current leaks from the shower frame during water testing.

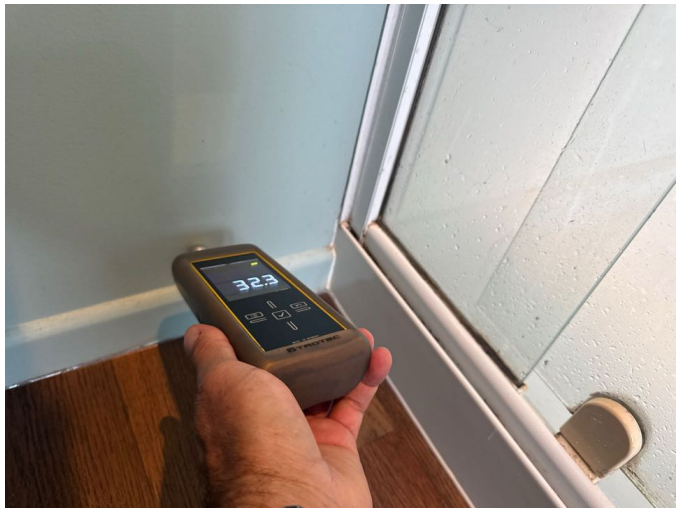
The common fail areas of the shower and plumbed areas were checked for elevated moisture. Moisture levels were within the normal range.

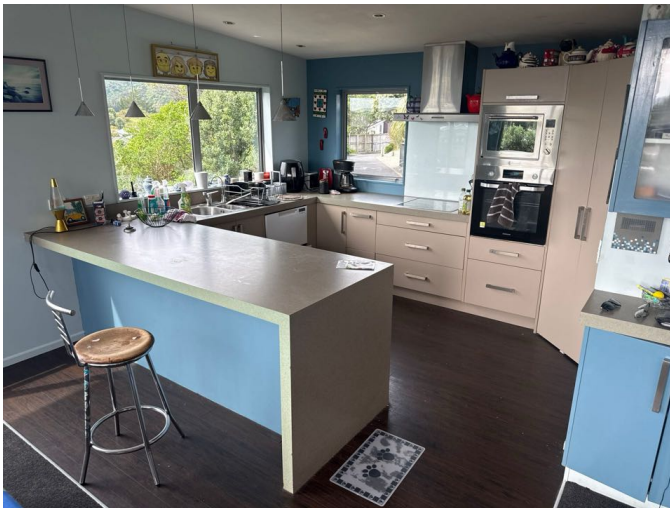
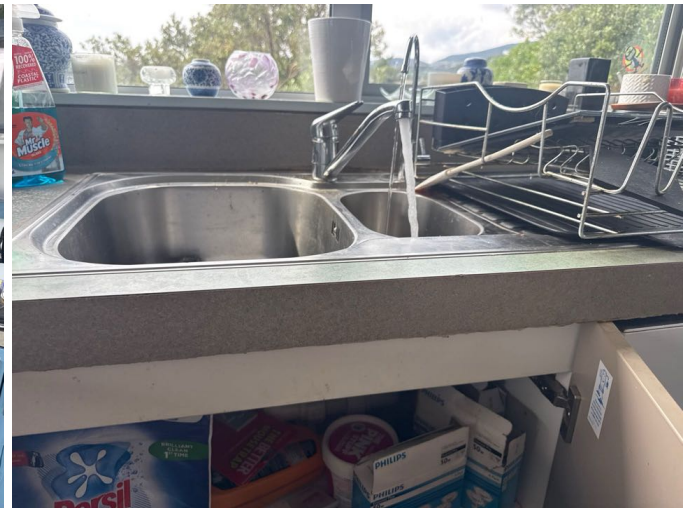
The taps are functional.
Water filtration system installed. Regular servicing recommended to ensure a clean water supply is maintained.

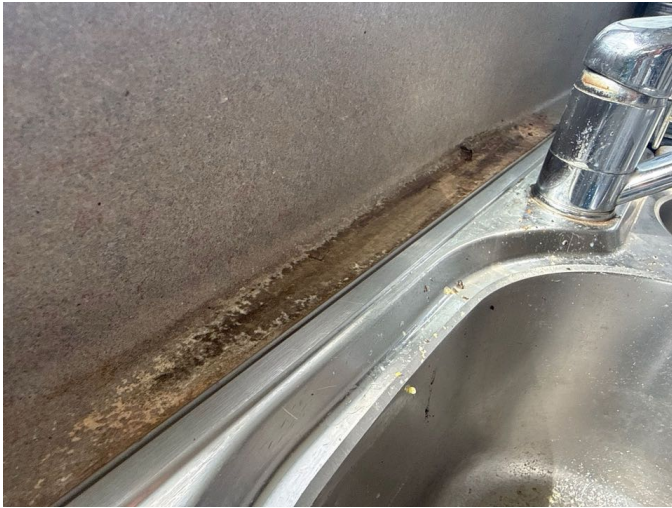
Wear to the bench at the back of the sink in particular. This is at risk of further damage. Thorough sealing improvements should be completed or the bench replaced in the near future.

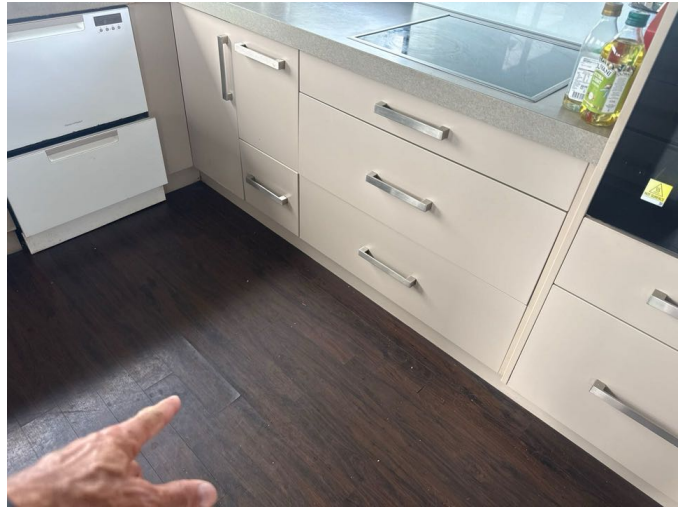
The vinyl plank flooring is starting to lift in areas and will need to be monitored.

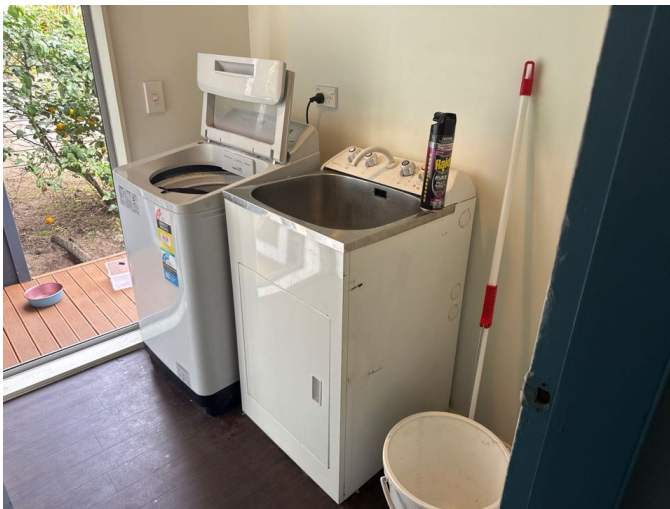
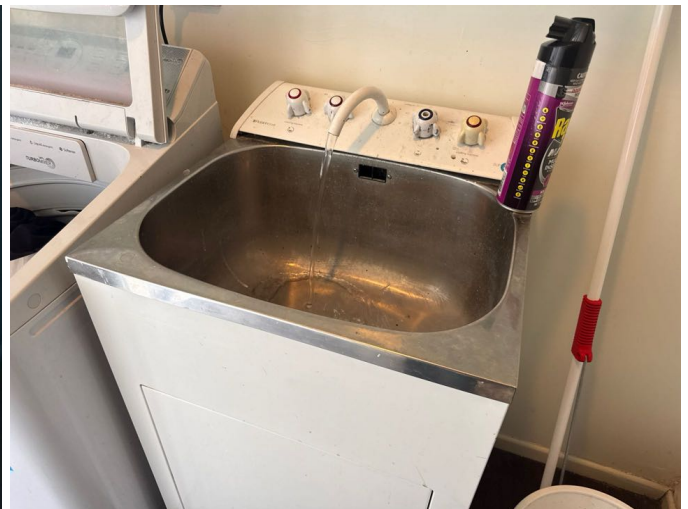
The tub is visibly is in an average functioning condition

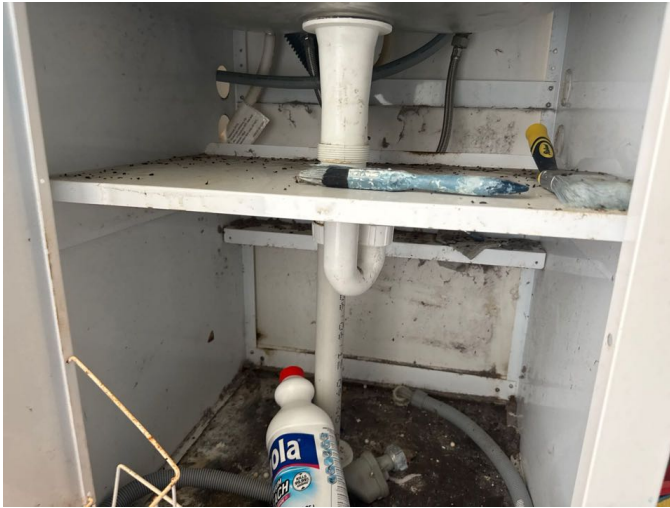
No concerns with the waste or water feeds beneath the tub

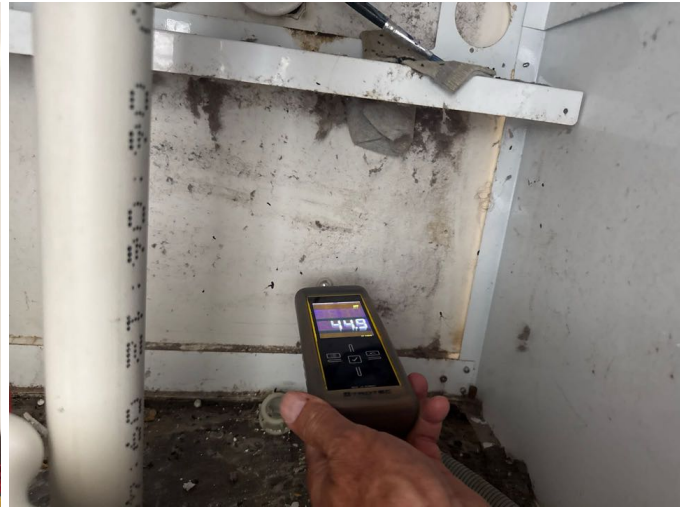
Moisture levels in the laundry were within the normal range at the time of inspection.

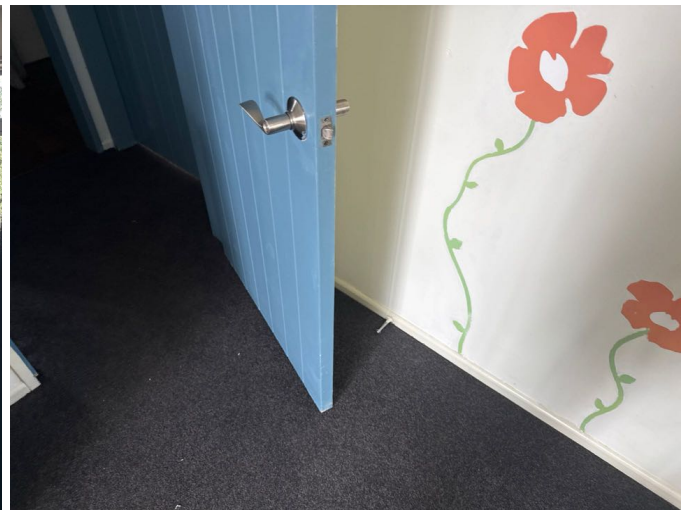
The internal doors are functioning well. Door stops installed behind the doors. Rubber stoppers should be installed where missing.

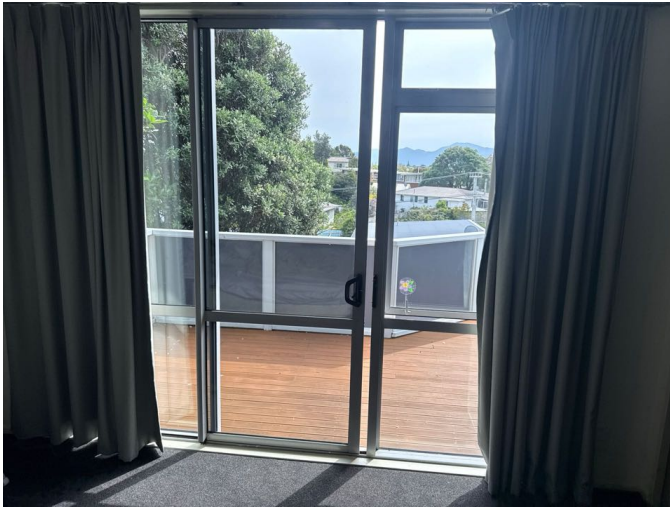
The sliding door is functional

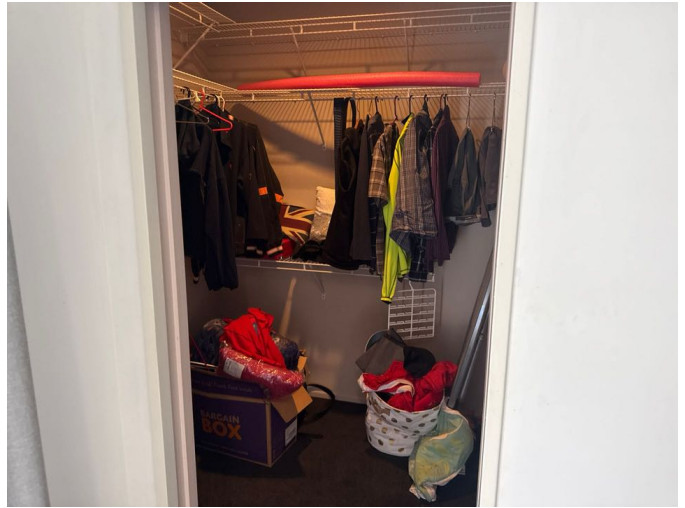
Walk in wardrobe noted

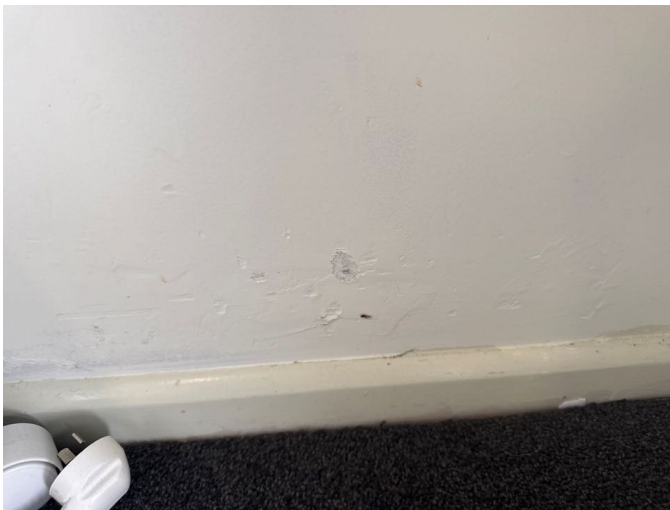
Example. Minor cosmetic defects noted.

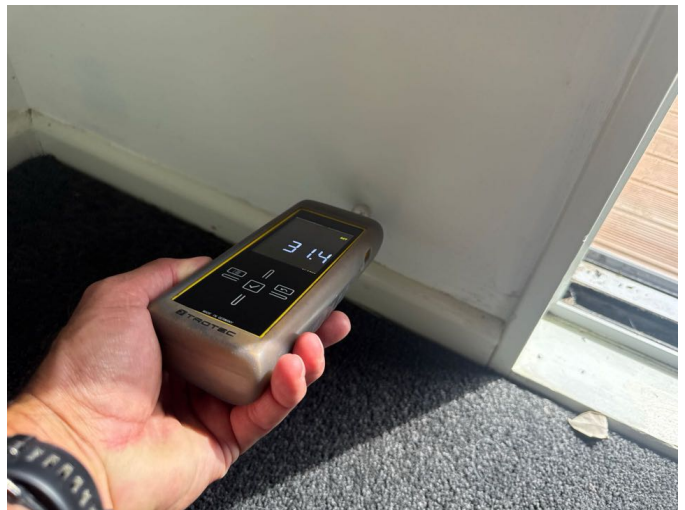
Moisture levels to the external walls were within the normal range at the time of inspection

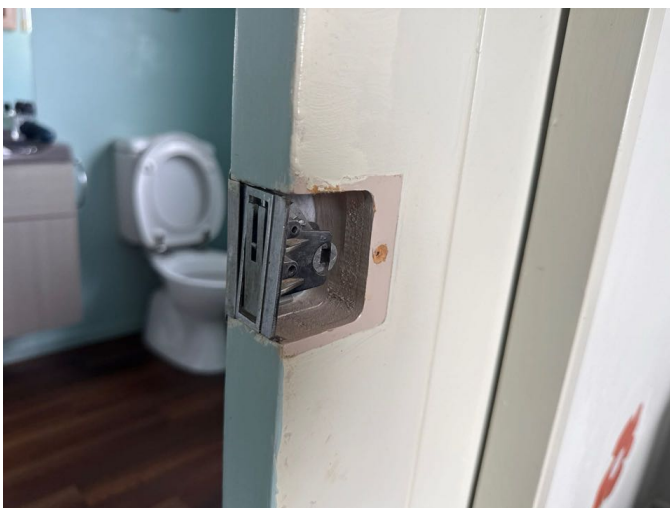
Part of the cavity sliding door handle is missing. The door is still functional as it is however it should ideally be replaced.

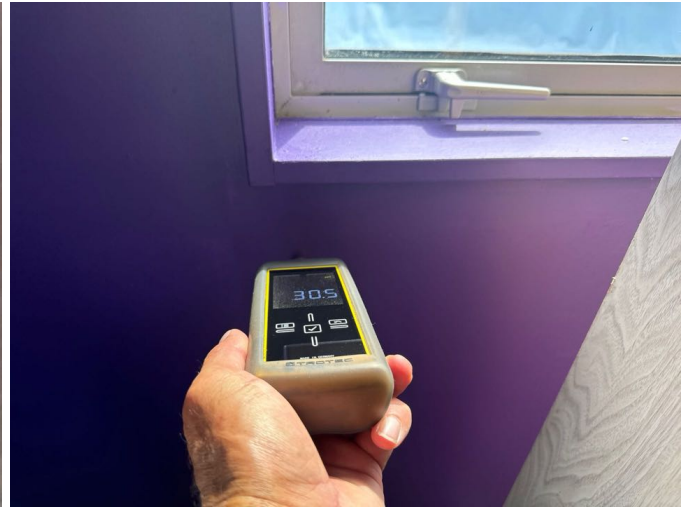
Moisture levels to the external walls were within the normal range at the time of inspection

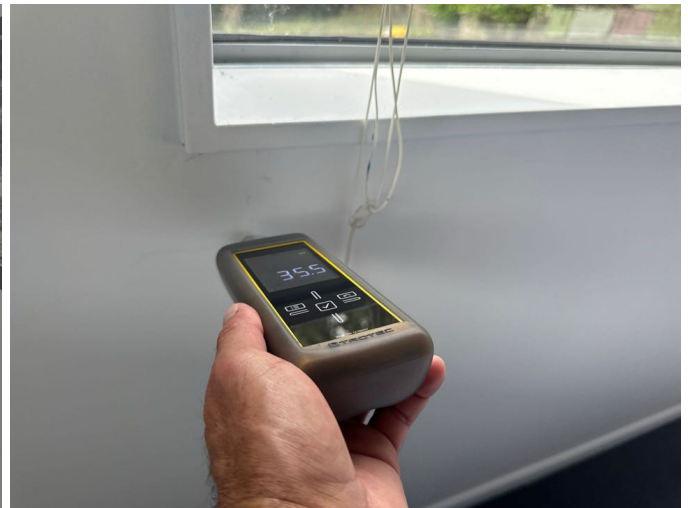
Moisture levels to the external walls were within the normal range at the time of inspection
