Vendor Supplied Building Report

Statement Of Passing Over

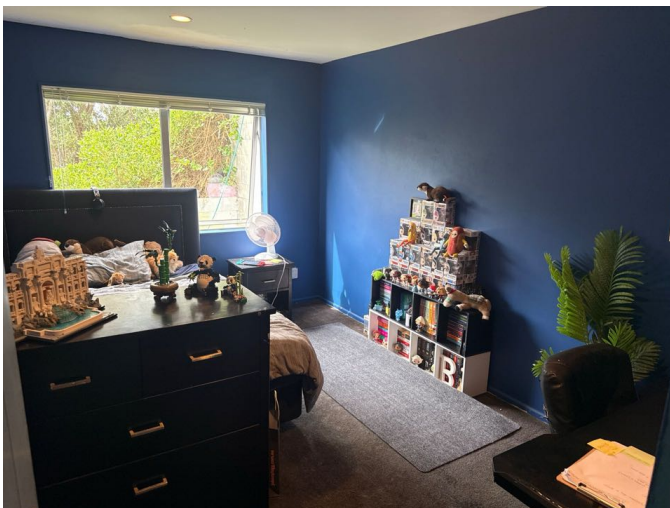
Moisture levels to the external walls were within the normal range at the time of inspection

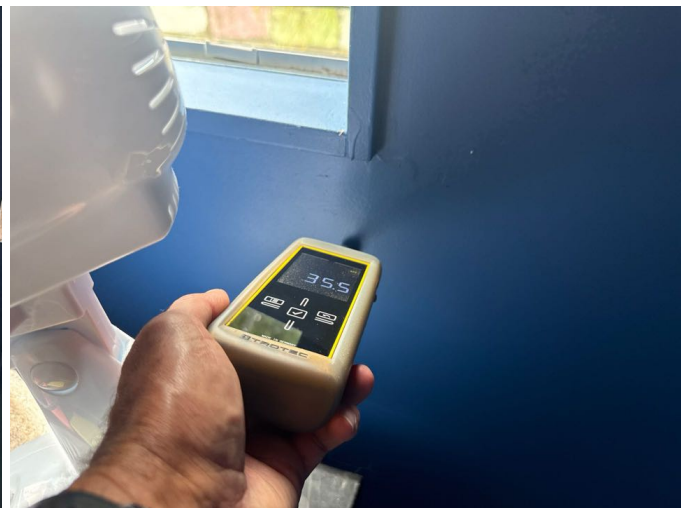
Moisture levels to the external walls were within the normal range at the time of inspection

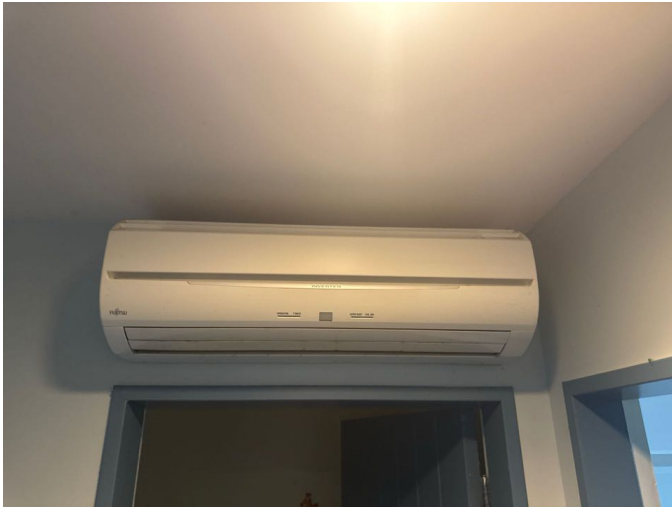
Heatpump/air conditioner to the ground floor hallway.
Untested.

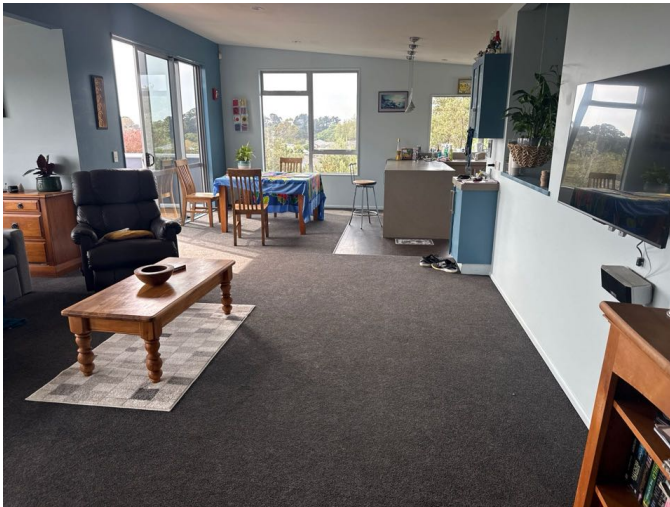
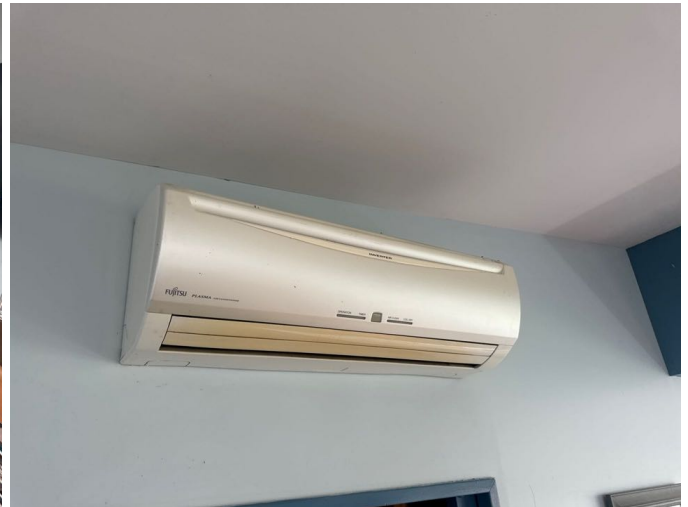
Heat pump installed, untested.
Heat pumps require regular servicing to be efficient.
The manufacturers instructions should be checked and understood with regards to future servicing requirements.

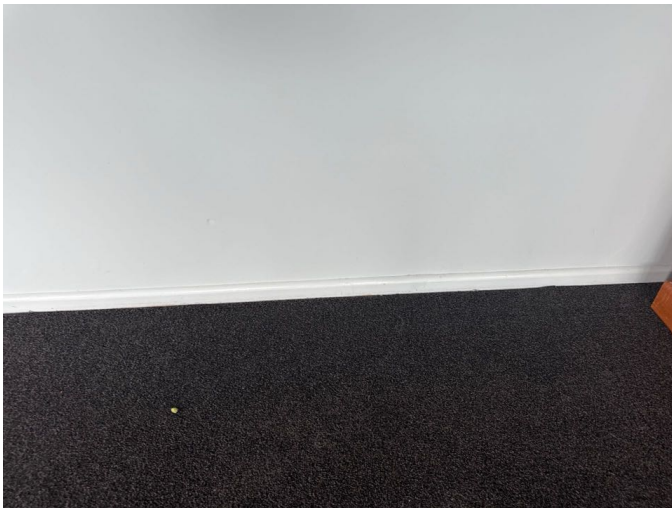
The wall and ceiling linings and carpet are in a tidy condition

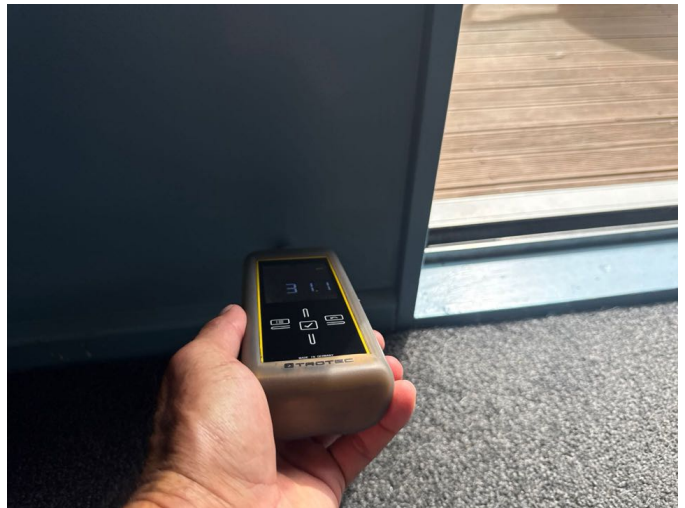
Moisture levels to the external walls were within the normal range at the time of inspection

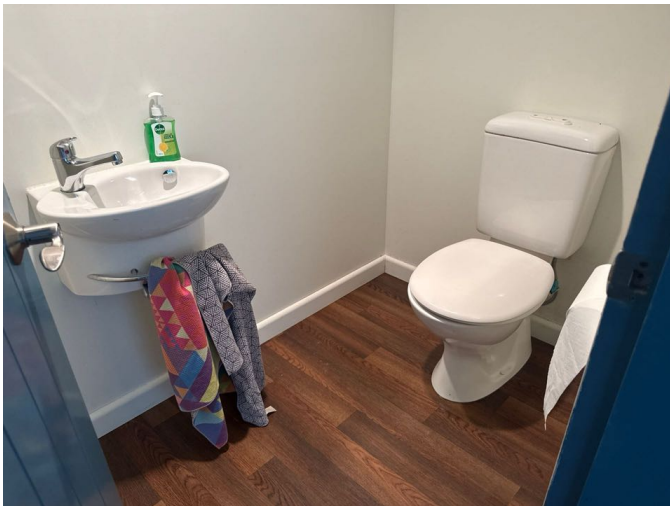
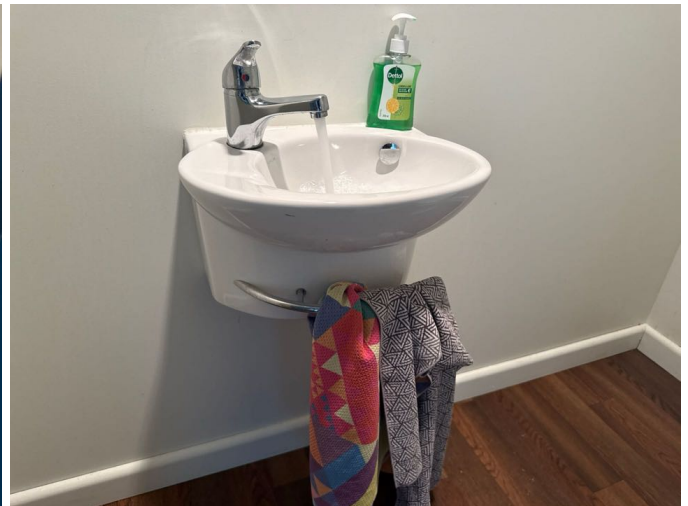
The sink is well sealed to the wall. The tap is functioning. No visible concerns with the water feeds or waste beneath the sink.

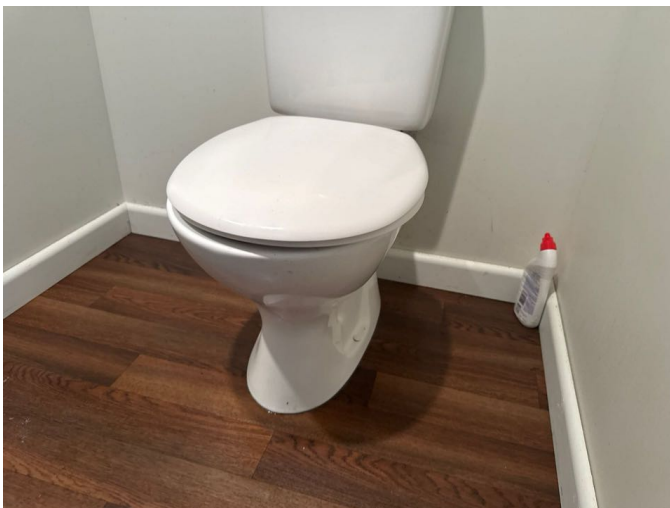
The base of the toilet is well sealed and is secure. The toilet is in a functioning condition.

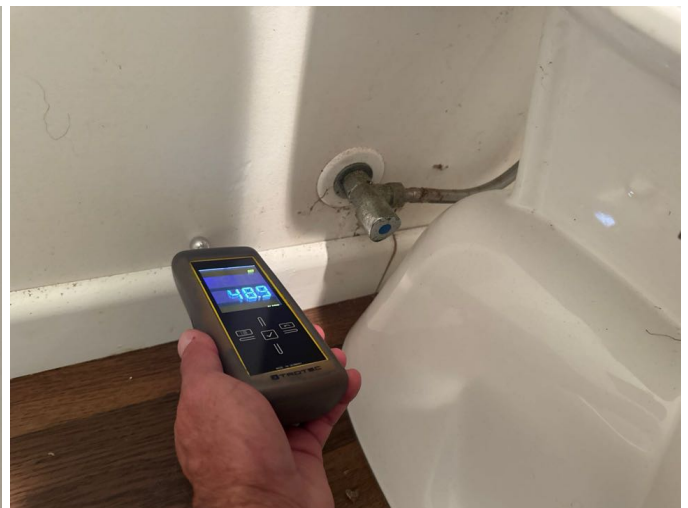
Moisture levels behind the toilet were within the normal range at the time of inspection

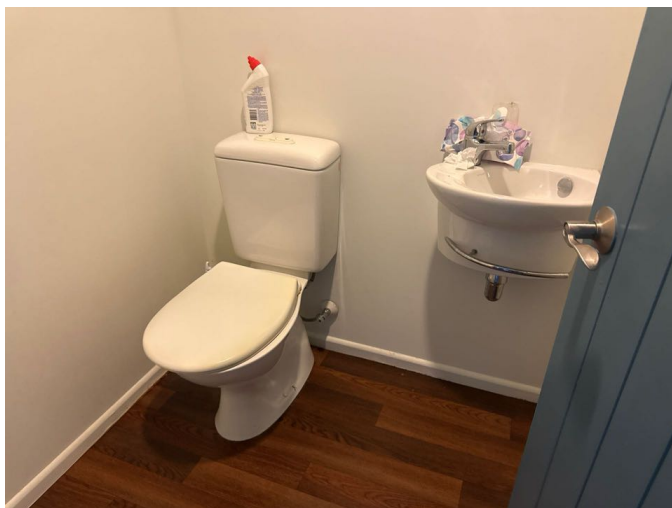
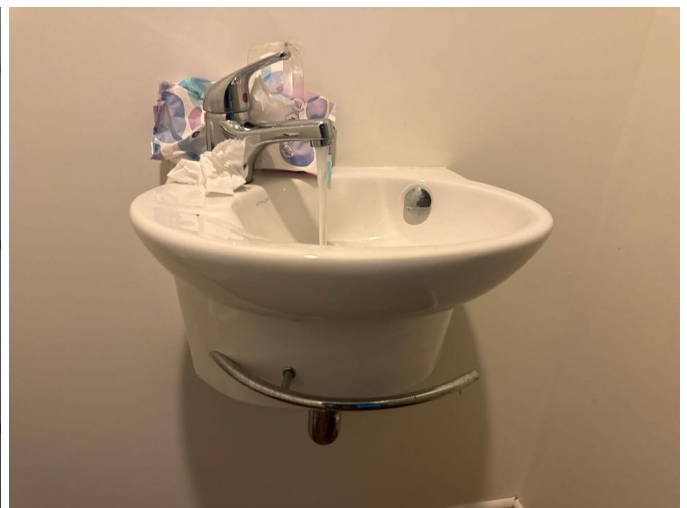
The sink is well sealed to the wall. The tap is functioning. No visible concerns with the water feeds or waste beneath the sink.

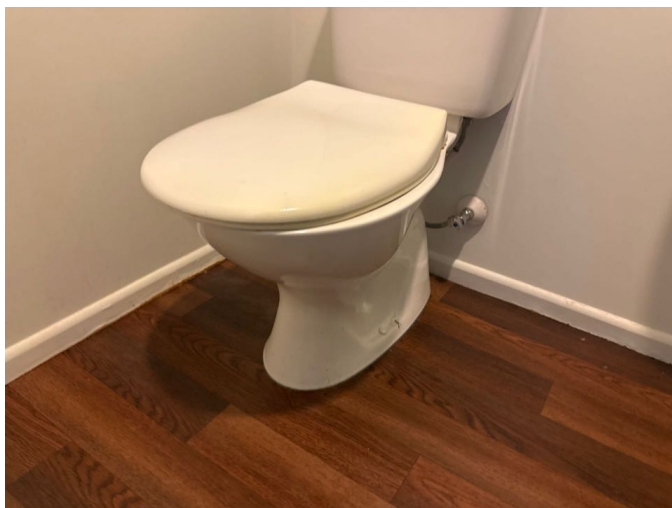
The base of the toilet is well sealed and is secure. The toilet is in a functioning condition.

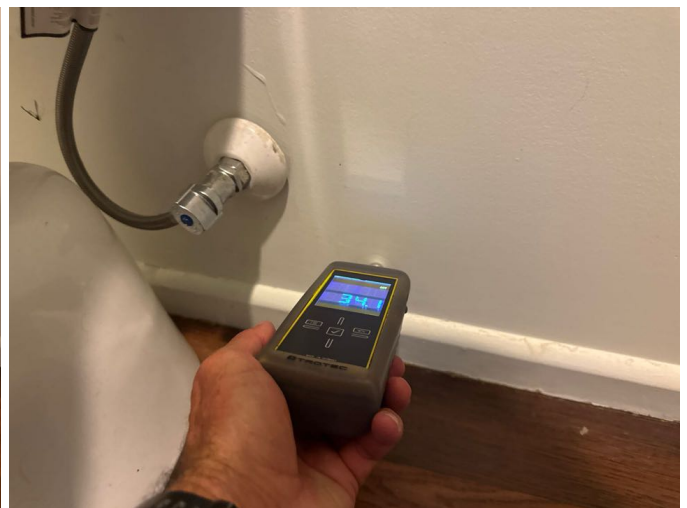
Moisture levels behind the toilet were within the normal range at the time of inspection

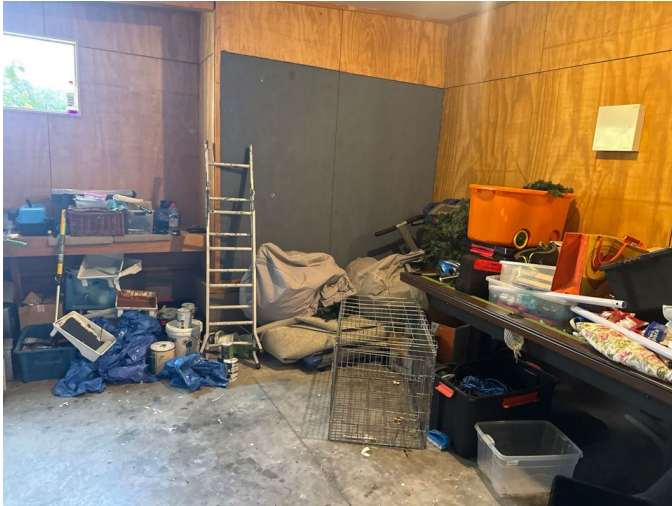
Not all areas of the garage could be fully inspected due to the presence of stored items. A full inspection is recommended once cleared. This applies to all concealed locations throughout the house.

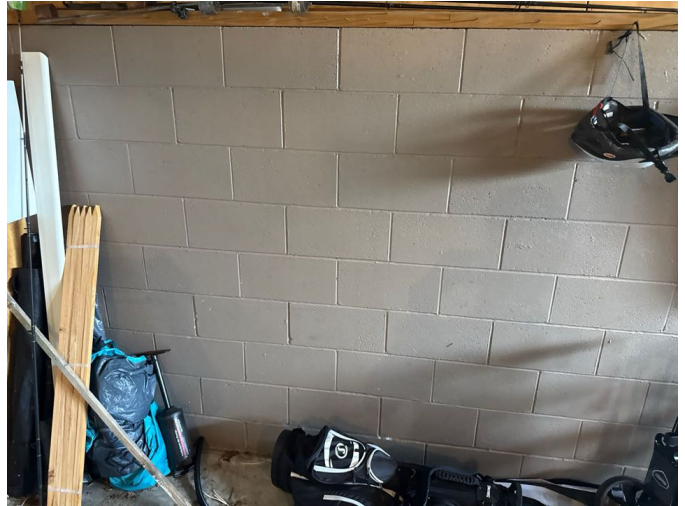
There was no evidence of moisture transfer through the concrete block wall in the garage

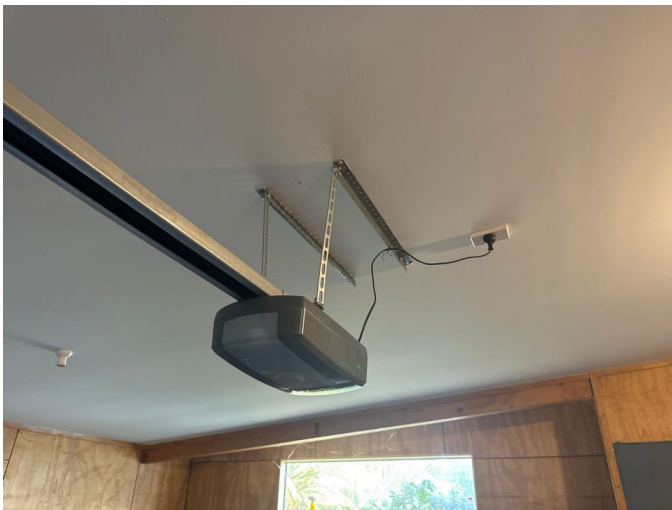
The electric garage door is functioning

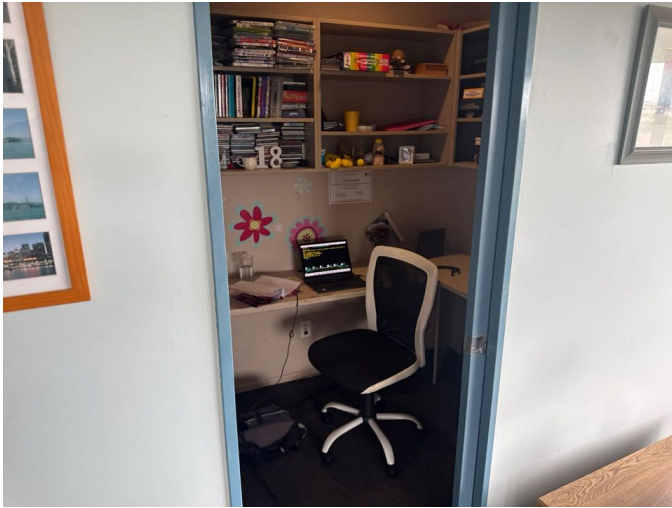
The office is generally tidy. Built in shelving noted.

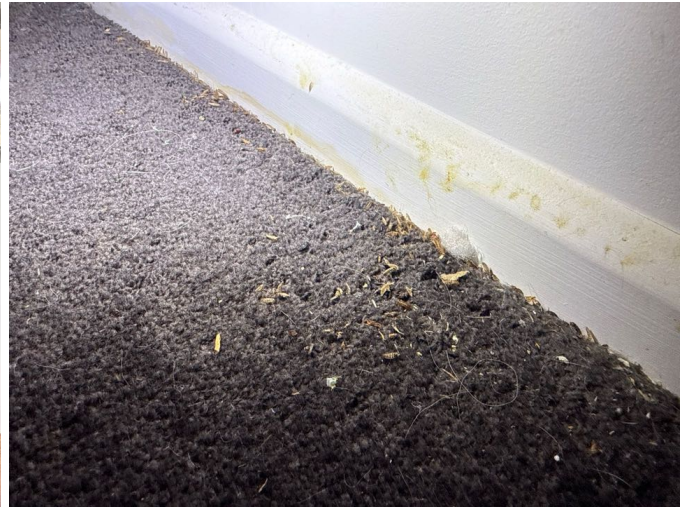
Carpet beetle activity by the hot water cylinder noted. A suitable chemical treatment should be applied to prevent further damage.

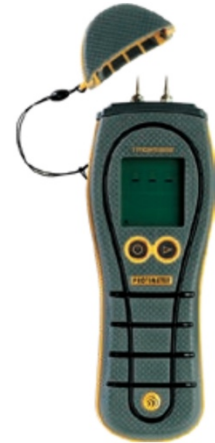
TROTEC T660 MOISTURE METER

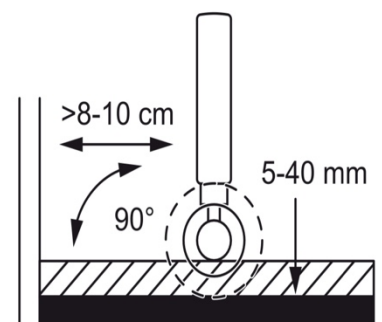
GENERAL ROOF MAINTENANCE

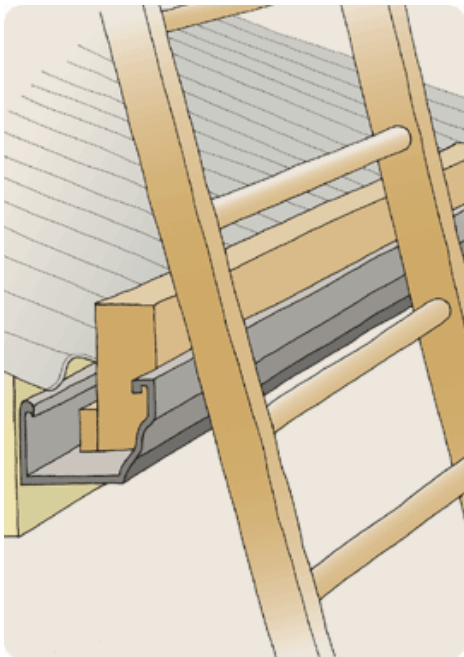
When working on a roof:
