# Independent Builders Report

Total Home Inspection Services Porirua City Ltd

Mon 18 May 2026

## **34 Clunie Ave, Raumati South, Paraparaumu, 5032, New Zealand**

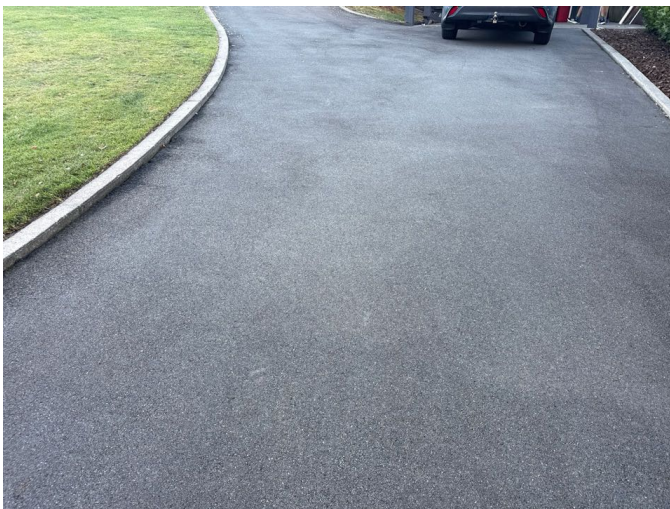
The sloping driveway is in good condition

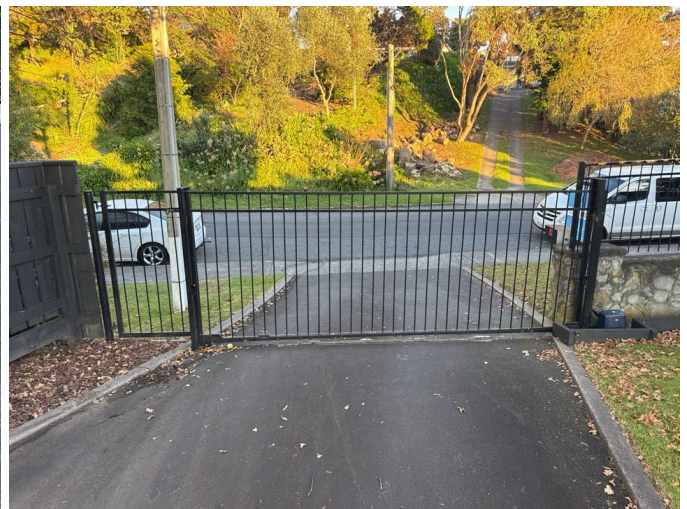
The gates to the driveway are functional. The vehicle gate is electric.

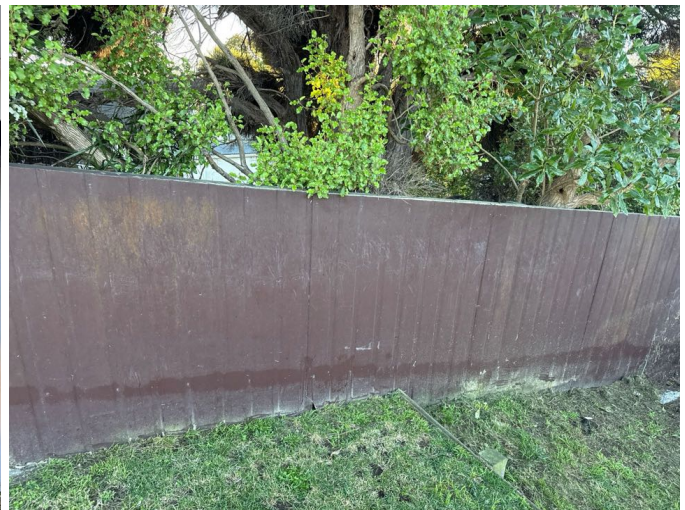
North side. Due to the age of the home some of the materials used in the fences construction may contain Asbestos. Safe in an inert state (well encapsulated and not disturbed) but if any repairs are needed to areas that may contain Asbestos then there are certain health and safety precautions that must be followed.

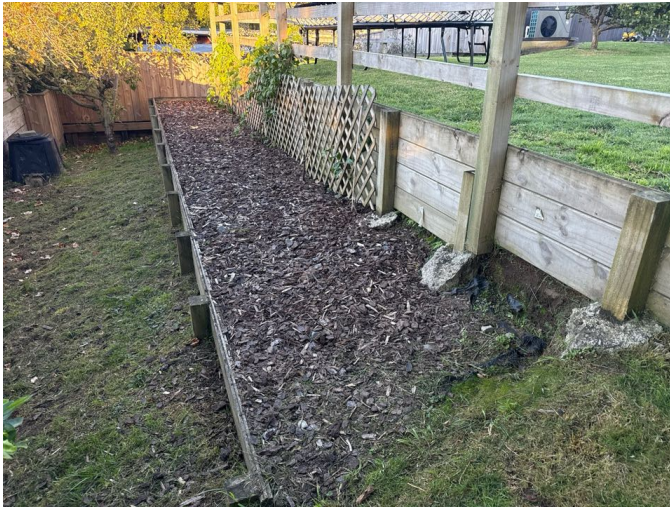
Solid timber retaining walls to the east side.  
No sign of significant movement or damage.

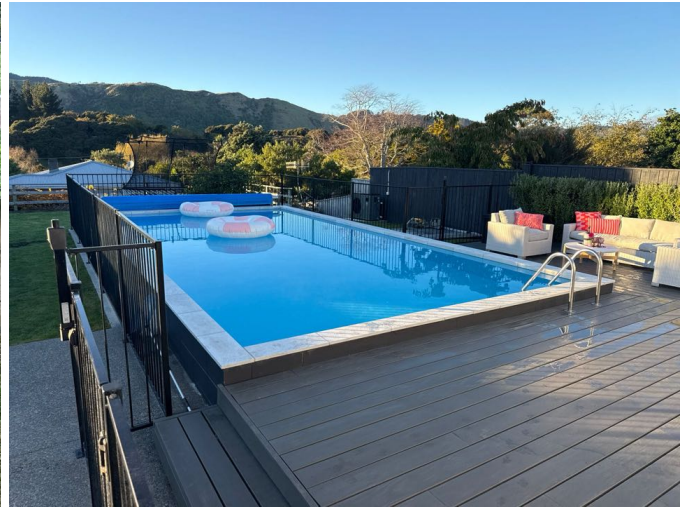
The condition of the pool and pumps etc were not checked as part of this inspection process. The fence is secure and the security gate is functioning. The timber deck is in good condition.

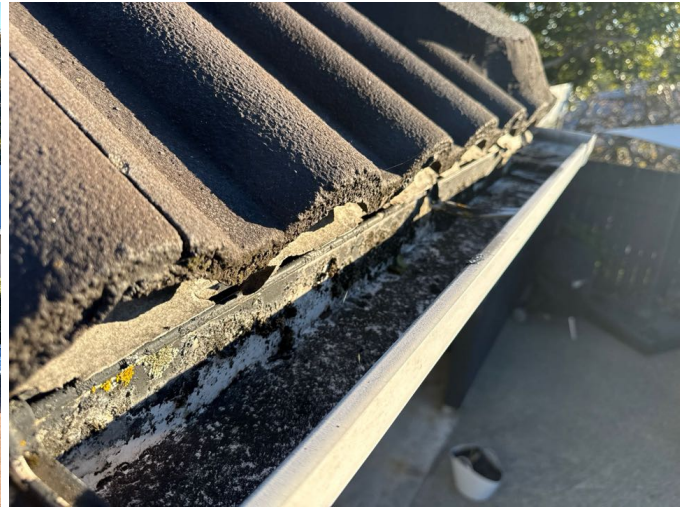
The spouting is in an average condition and was clear. The effectiveness of the spouting will need to be checked during rainy periods. Due to the dry conditions that were evident on the day of our inspection we cannot comment on any leaks that maybe evident to the spouting or down pipes.

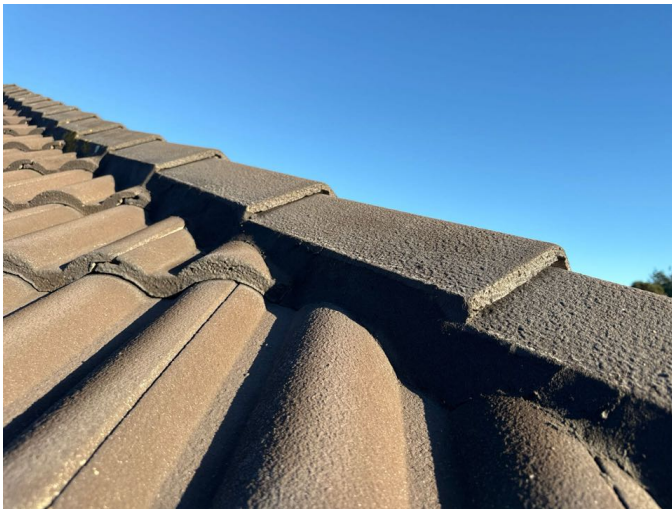
The ridge caps tiles are sealed with mortar which is prone to cracking. Well maintained current condition noted. Periodic monitoring is required. When cracking becomes evident, engage a roof rejuvenation professional to re-point any areas of concern.

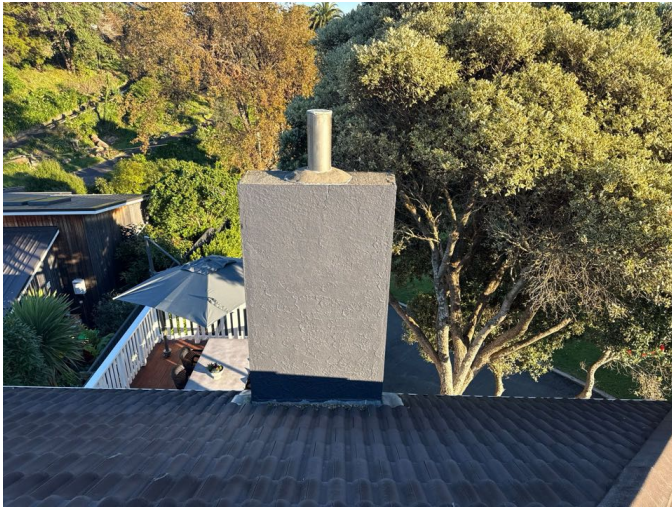
The decommissioned concrete chimney was intact and solid at the time of inspection. There was no evidence of cracking or structural concerns. The condition of the chimney should be checked after earthquakes.

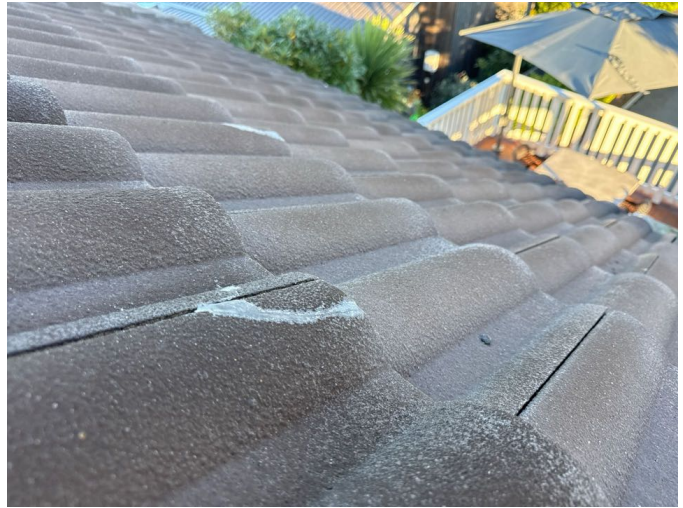
There are a few cracked tiles which have been sealed with sealant. The cracks are in a low risk area however they will need to be monitored.

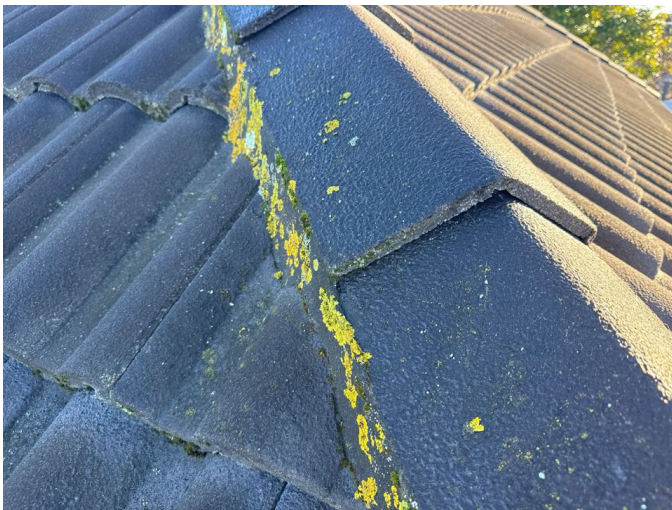
The Lichen should be chemically treated to prevent it spreading. A chemical treatment may be required every 2-3 years as part of ongoing roof maintenance. Lichen will speed up deterioration to the roof surface and will need to be monitored and treated as required.

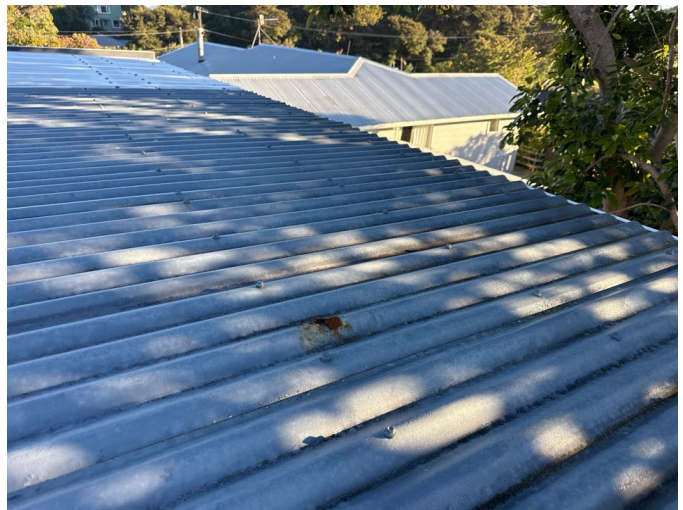
There is one rust hole to the carport roof which requires a patch repair.

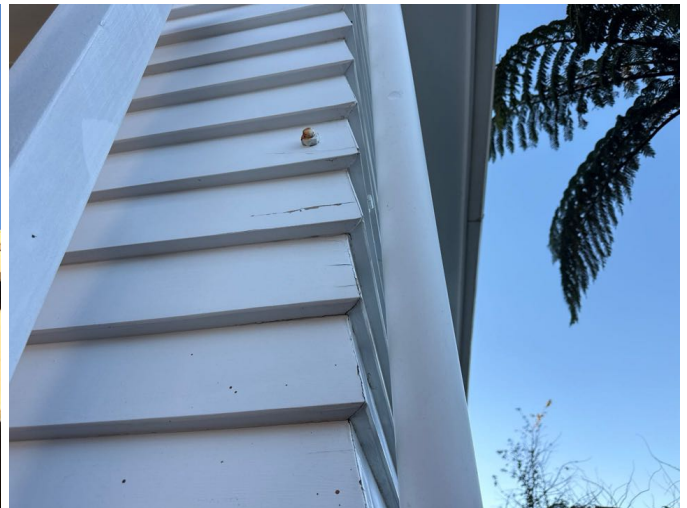
Example. Early stage surface deterioration to the paint in some areas.

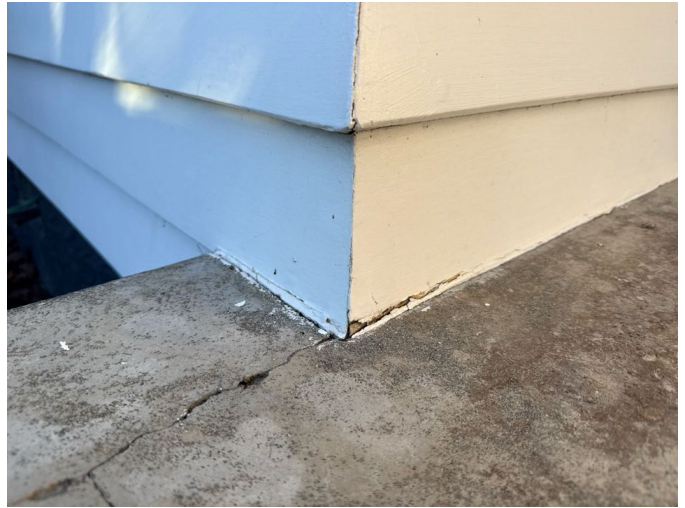
Timber in close contact with the ground is at risk of premature deterioration and must be kept thoroughly sealed. Paint improvements are recommended anywhere that surface wear is present.

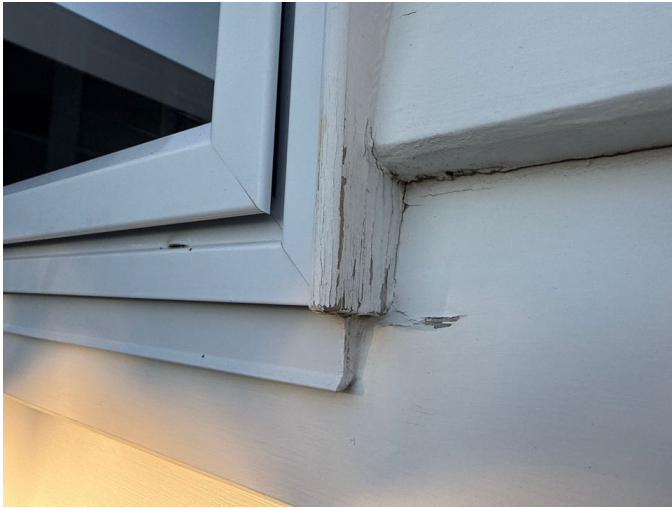
Paint deterioration to the timber scribes

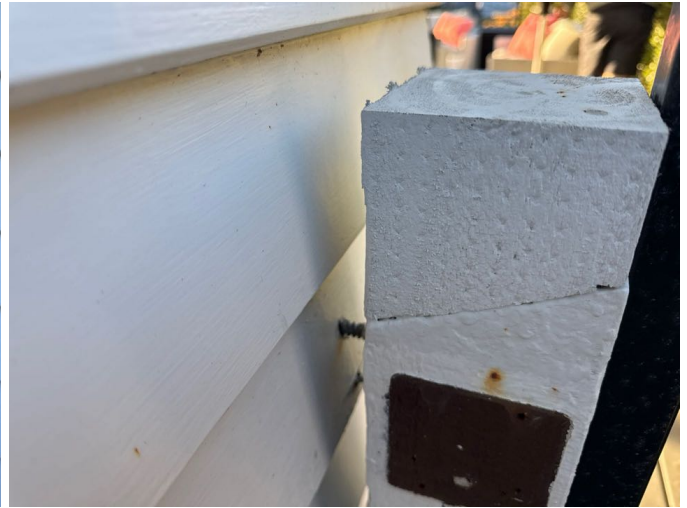
It is not recommended to directly fix objects through the cladding as the fixing points are a weather tightness risk. A builder should modify the detail to prevent the risk of potential issues. There was no evidence of failure found.

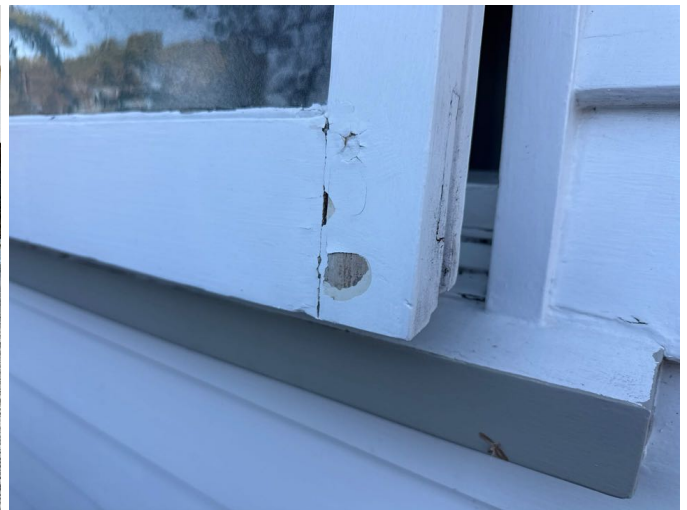
Paint deterioration to the timber joinery in some areas

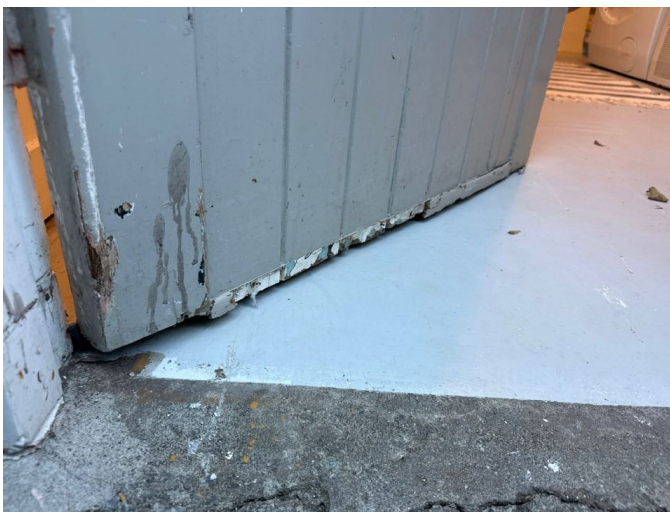
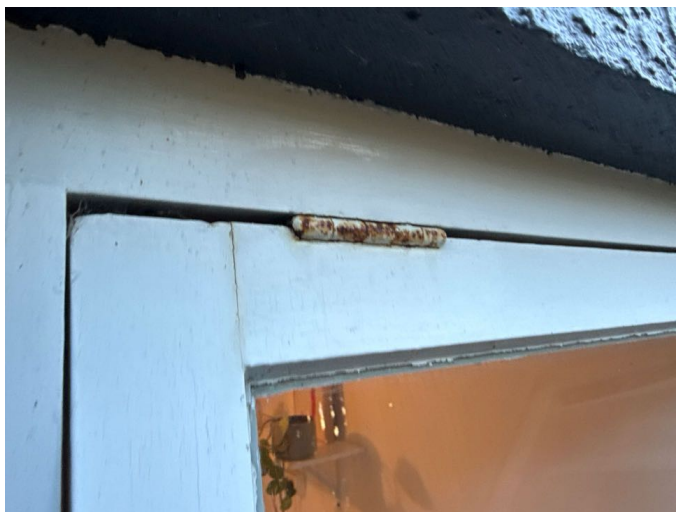
Some of the homes head flashings have superficial corrosion. This will get worse if left and requires the corrosion to be removed before sealing with rust converter and painting. Risk of water ingress issues if left to deteriorate.

Installing an angled weather trim at the base of these 2 doors would be a good improvement as the angle would deflect water away from the threshold.

Rust affected hinges should be treated with rust converter or replaced

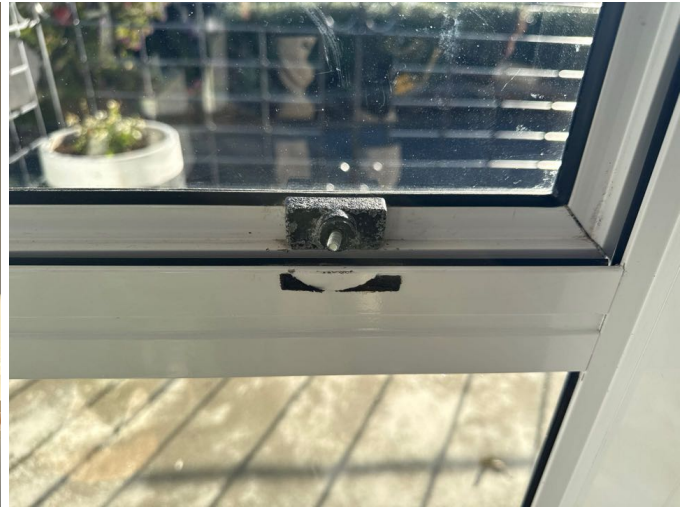
The broken window handle should be replaced

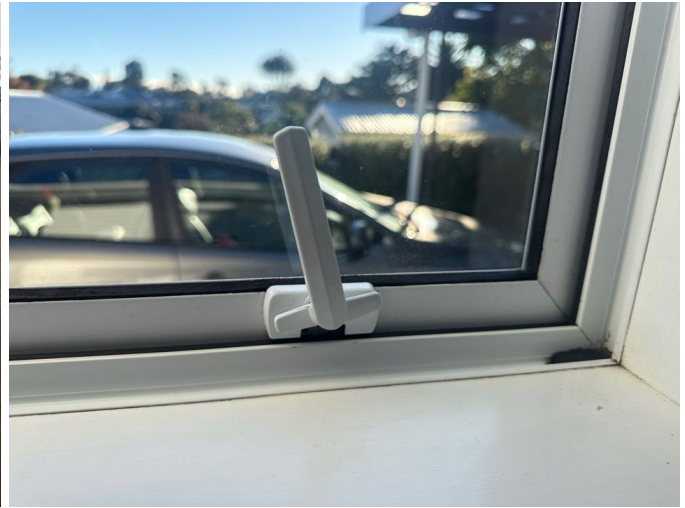
Part of the window hardware is missing from the framing which prevents the window from sealing effectively. These can be retro fitted which will help improve the seal. Maintenance recommended.

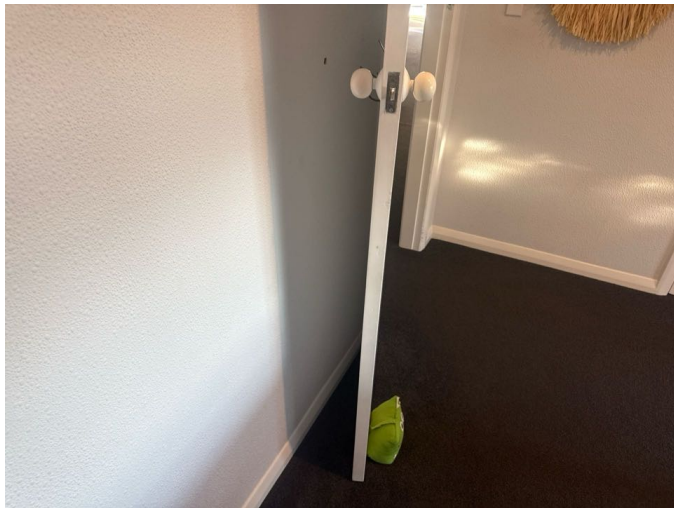
The internal doors are functioning well. Door stops should be installed where missing to prevent the risk of damage to the wall linings (some damage present).
