THERMOGRAPHY REPORT 2.

**151 Durham Dr,
Havelock North.**

Report Information

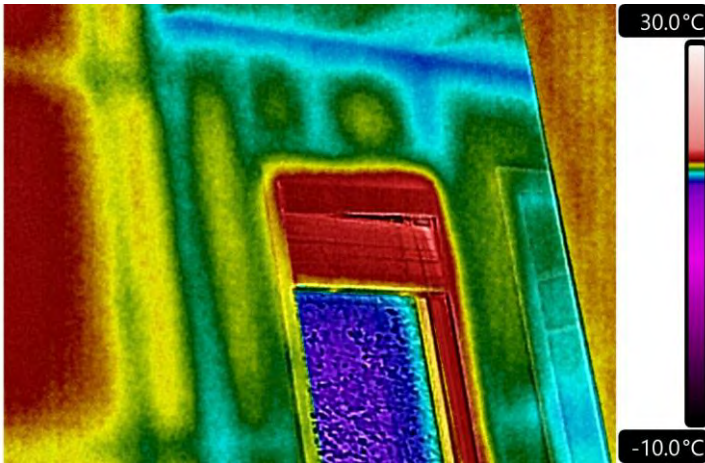
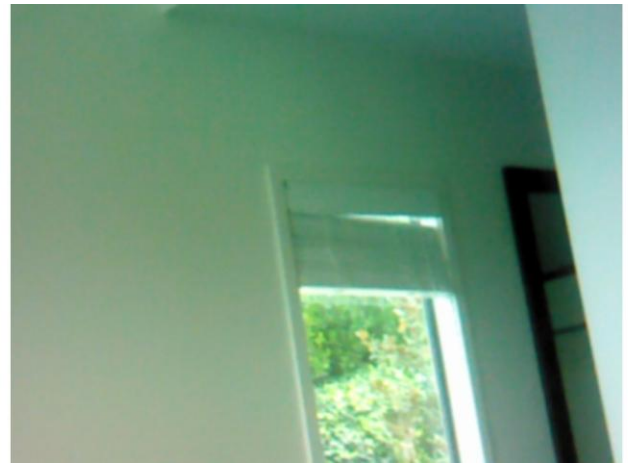
IR_19932.jpg | 20/05/2026 | 1:05 am

No infrared anomaly was seen in this image at the time of inspection.

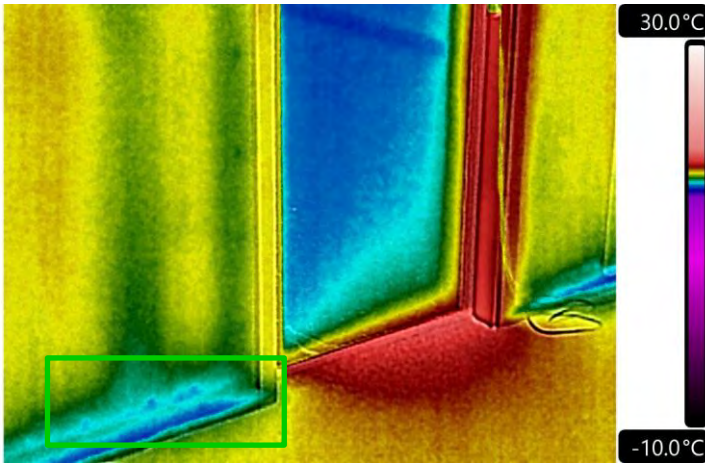
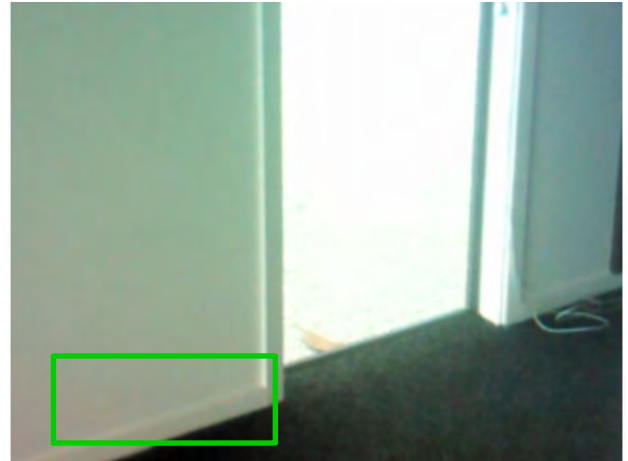
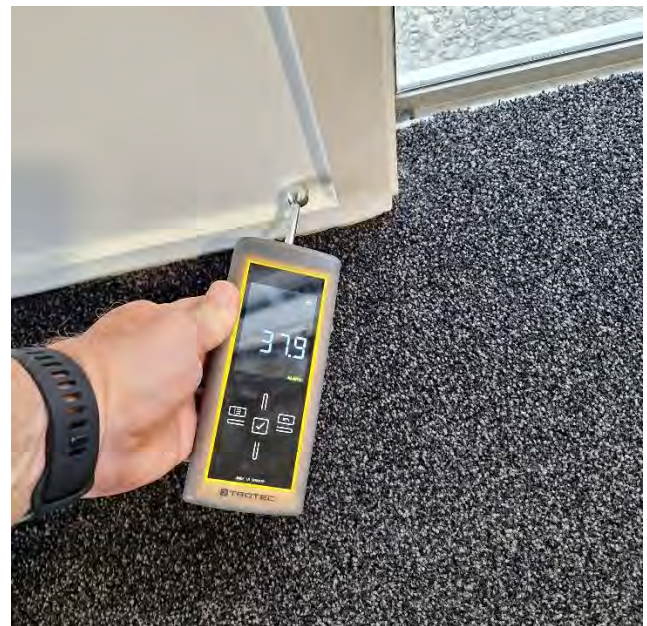
IR_19933.jpg | 20/05/2026 | 1:05 am

A slight infrared anomaly was seen in this image it was investigated further with a Trotec moisture meter and readings were found to be an acceptable level under the threshold of 50 and similar to the surrounding area at the time of inspection.

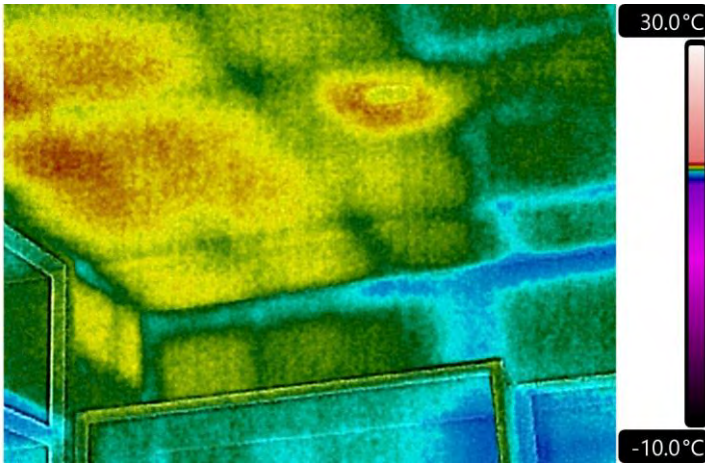
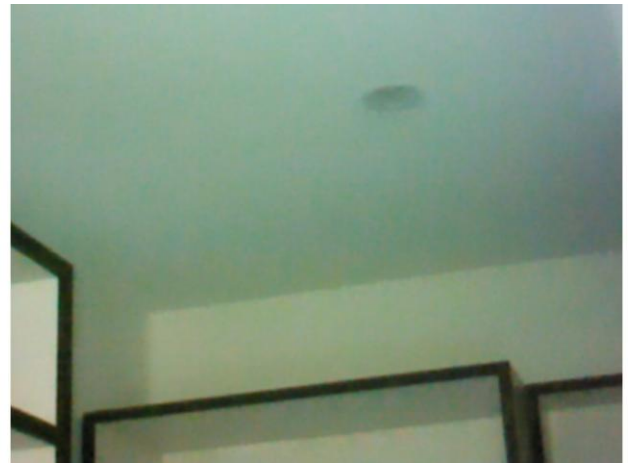
IR_19934.jpg | 20/05/2026 | 1:06 am

No infrared anomaly was seen in this image at the time of inspection.

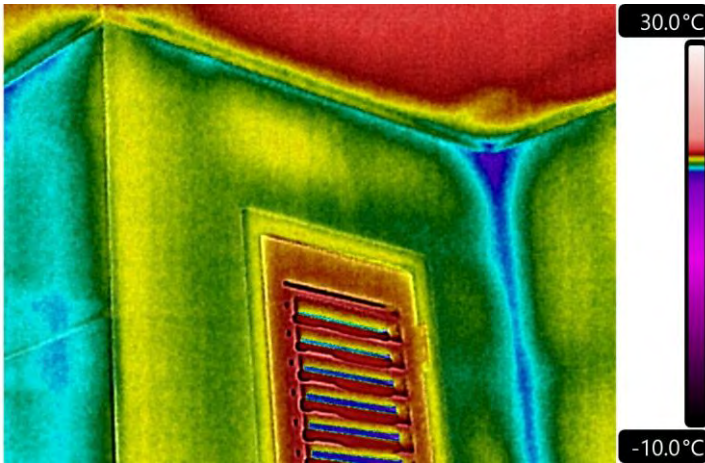
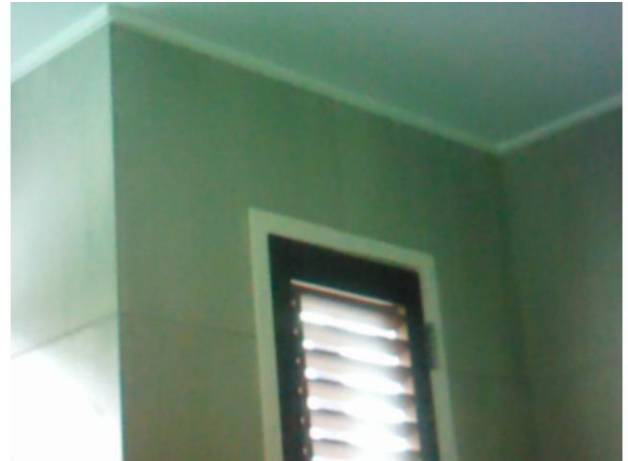
IR_19939.jpg | 20/05/2026 | 1:08 am

No infrared anomaly was seen in this image at the time of inspection.

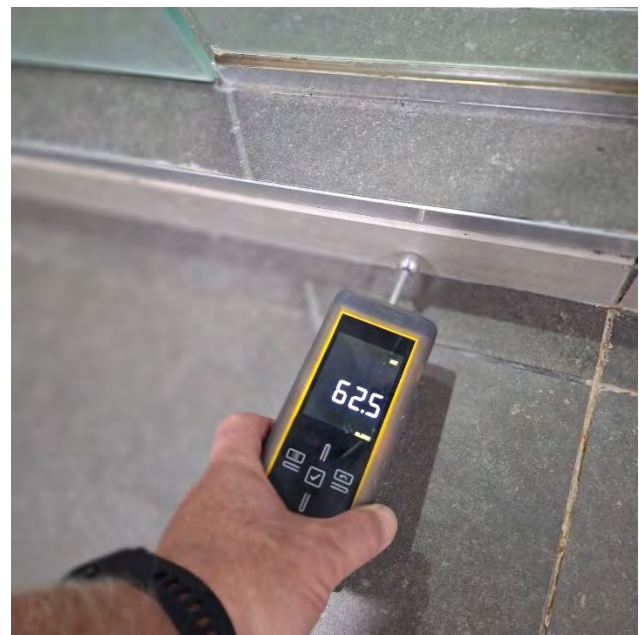
IR_19940.jpg | 20/05/2026 | 1:08 am

Infrared and or moderate moisture meter readings suggest a possible moisture issue.

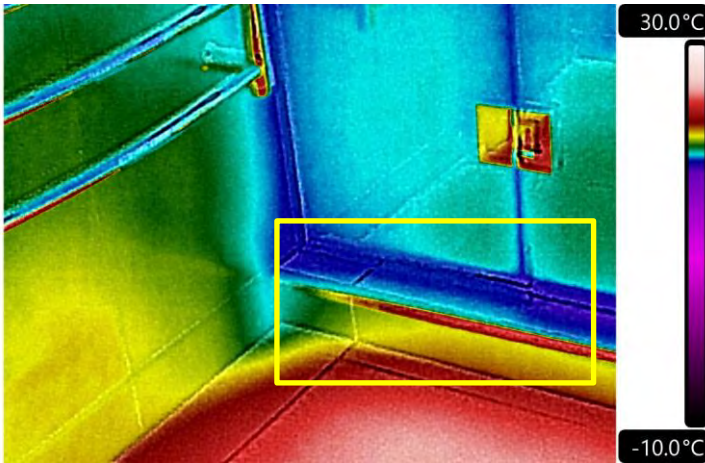
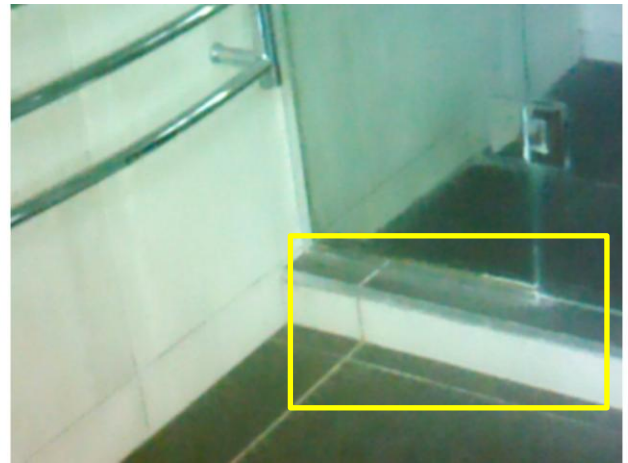
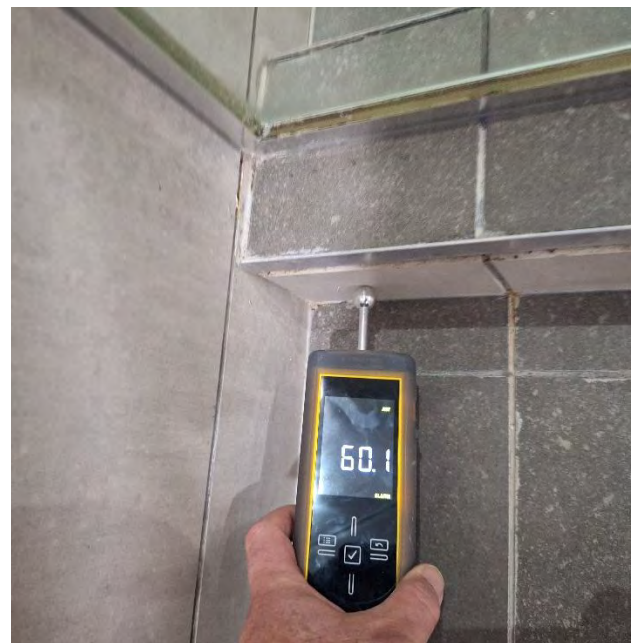
IR_19941.jpg | 20/05/2026 | 1:08 am

Infrared and or moderate moisture meter readings suggest a possible moisture issue.

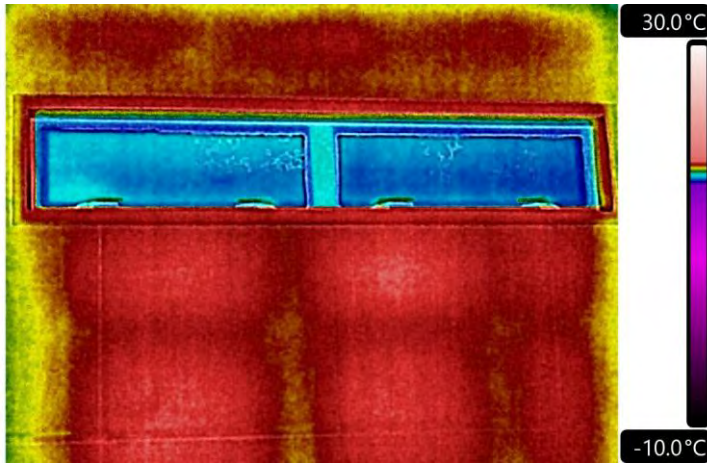
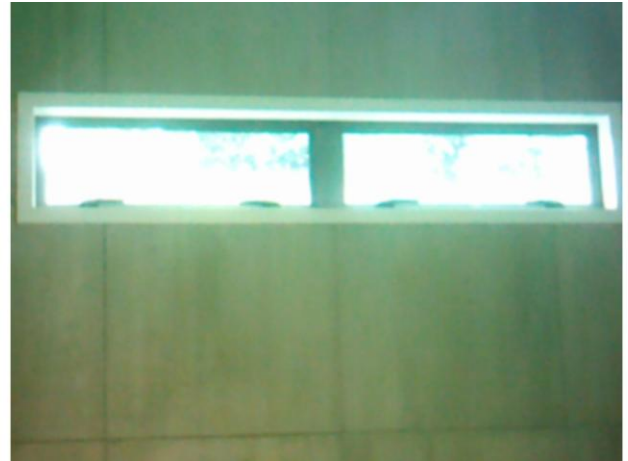
IR_19942.jpg | 20/05/2026 | 1:09 am

No infrared anomaly was seen in this image at the time of inspection.

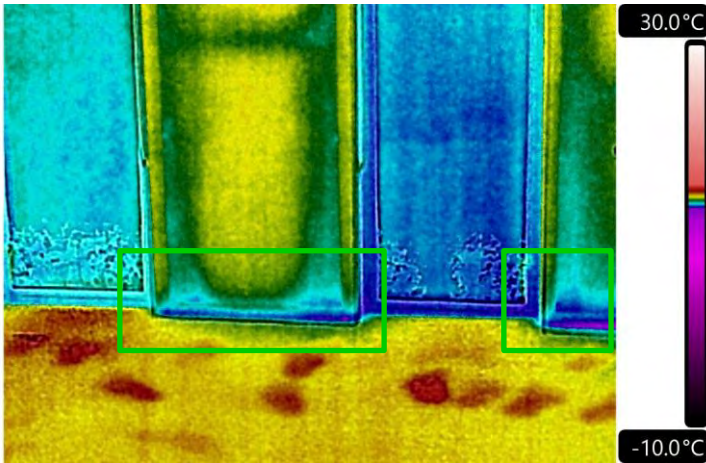
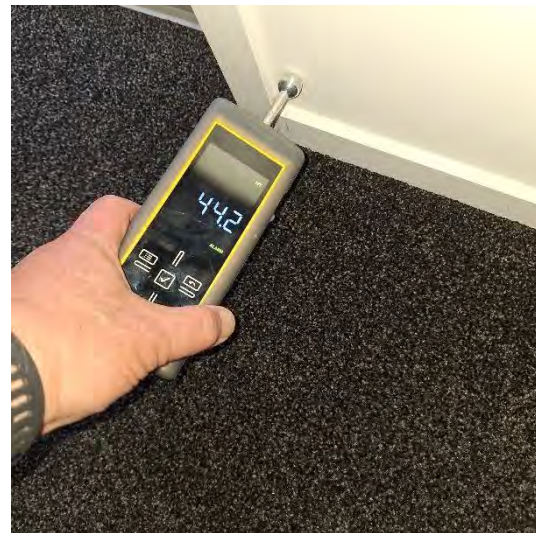
IR_19945.jpg | 20/05/2026 | 1:21 am

A slight infrared anomaly was seen in this image it was investigated further with a Trotec moisture meter and readings were found to be an acceptable level under the threshold of 50 and similar to the surrounding area at the time of inspection.

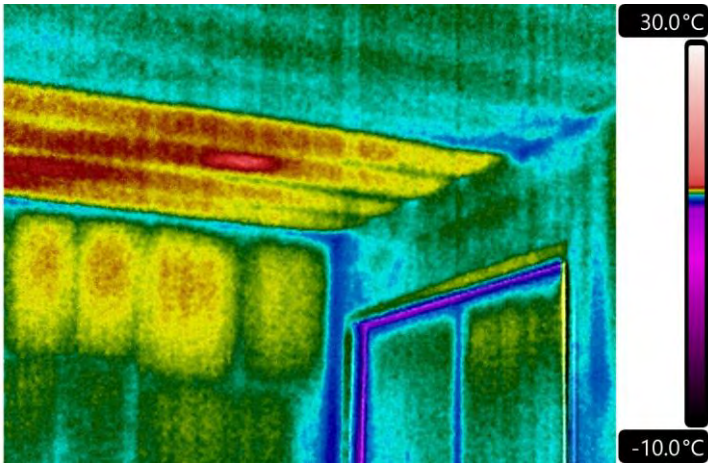
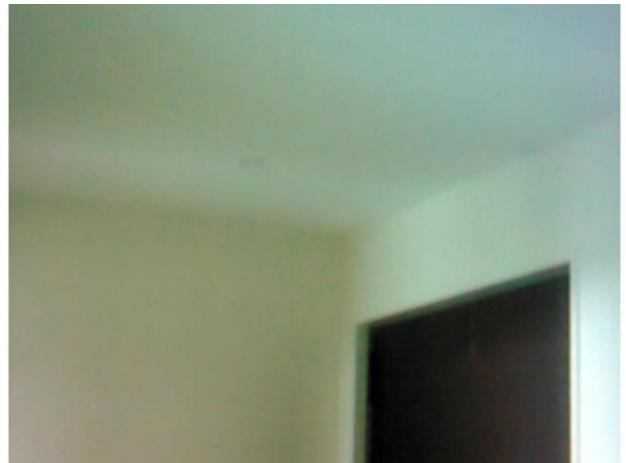
IR_19946.jpg | 20/05/2026 | 1:21 am

No infrared anomaly was seen in this image at the time of inspection.

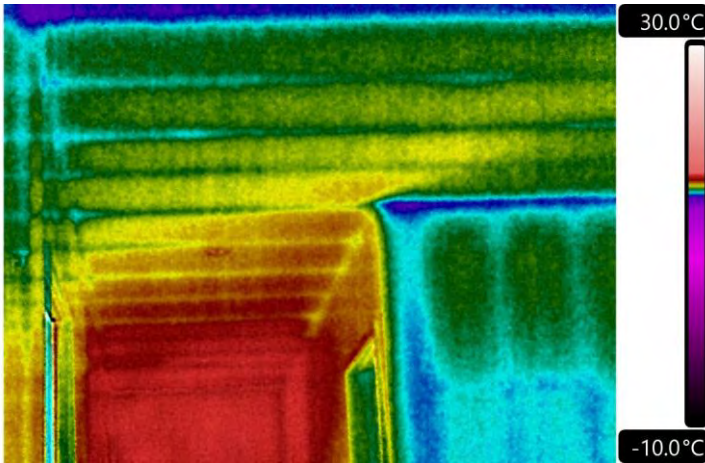
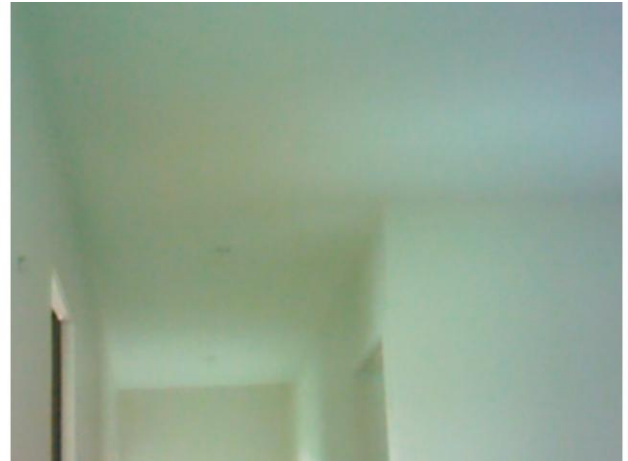
IR_19947.jpg | 20/05/2026 | 1:22 am

No infrared anomaly was seen in this image at the time of inspection.

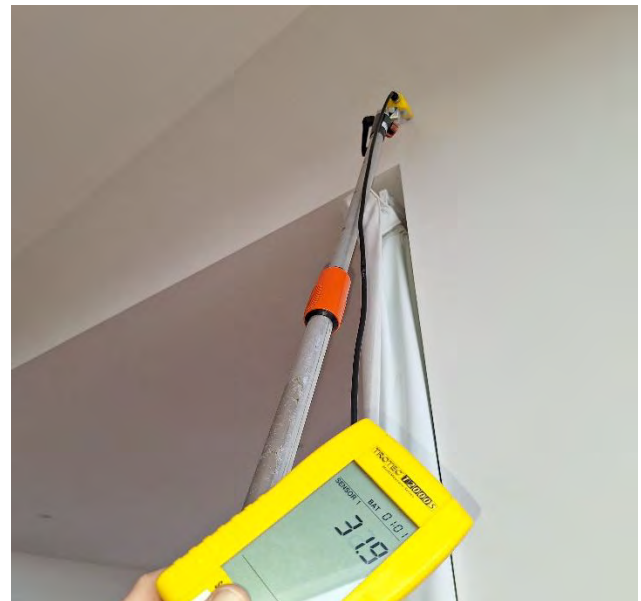
IR_19956.jpg | 20/05/2026 | 1:30 am

A slight infrared anomaly was seen in this image it was investigated further with a Trotec moisture meter and readings were found to be an acceptable level under the threshold of 50 and similar to the surrounding area at the time of inspection.

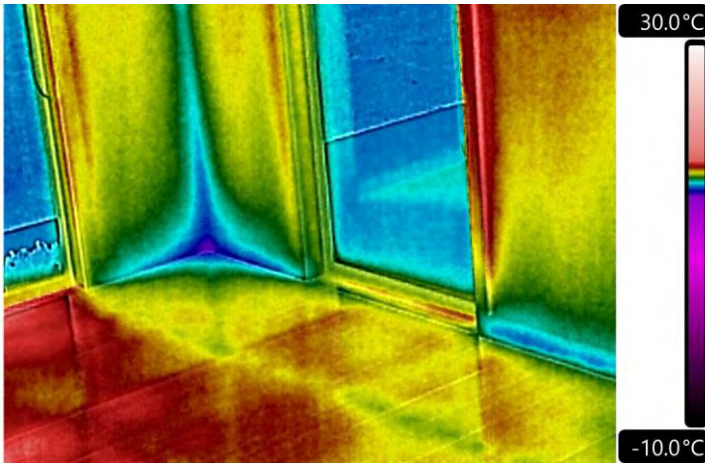
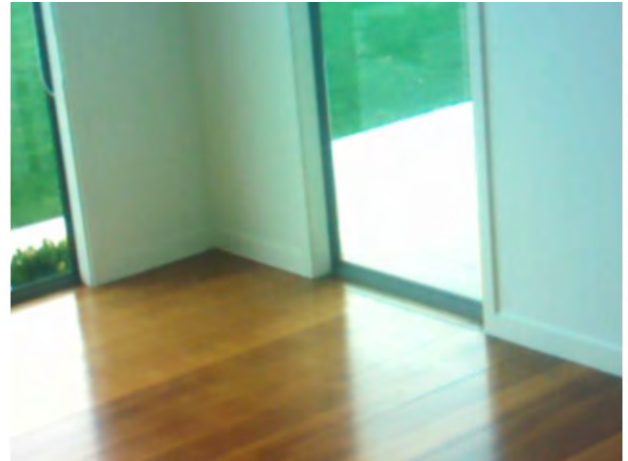
IR_19957.jpg | 20/05/2026 | 1:30 am

No infrared anomaly was seen in this image at the time of inspection.

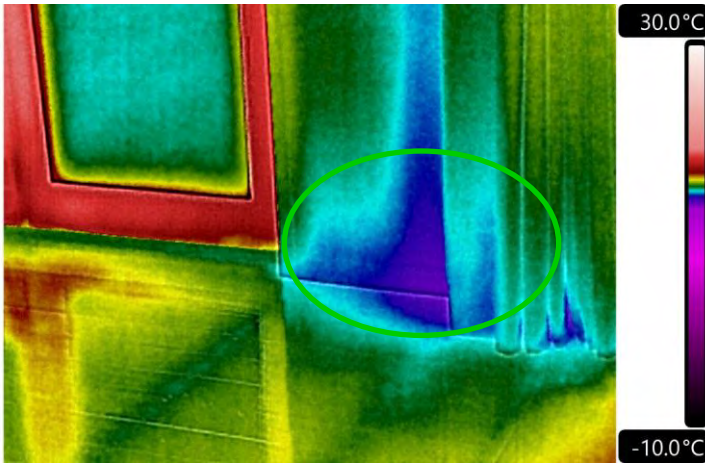
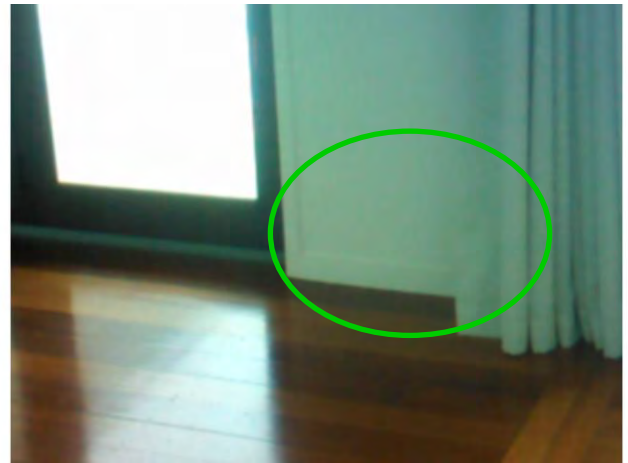
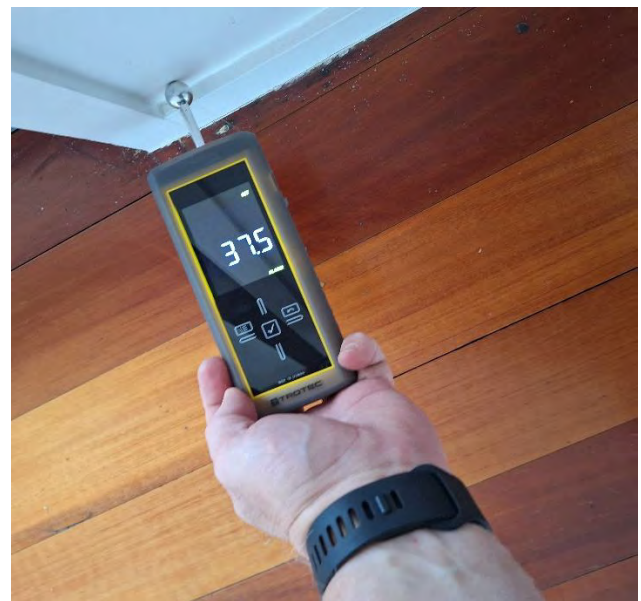
IR_19961.jpg | 20/05/2026 | 1:33 am

A slight infrared anomaly was seen in this image it was investigated further with a Trotec moisture meter and readings were found to be an acceptable level under the threshold of 50 and similar to the surrounding area at the time of inspection.

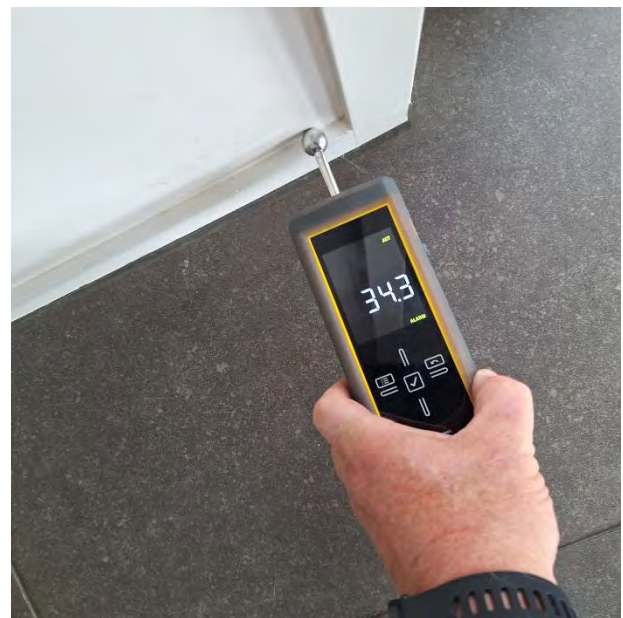
IR_19967.jpg | 20/05/2026 | 1:40 am

A slight infrared anomaly was seen in this image it was investigated further with a Trotec moisture meter and readings were found to be an acceptable level under the threshold of 50 and similar to the surrounding area at the time of inspection.

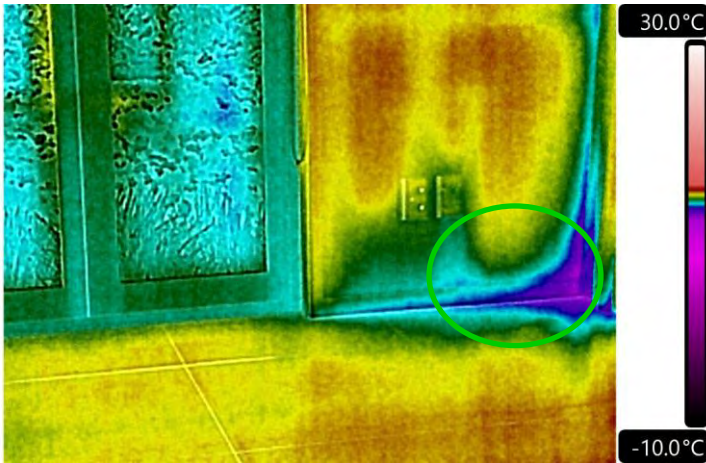
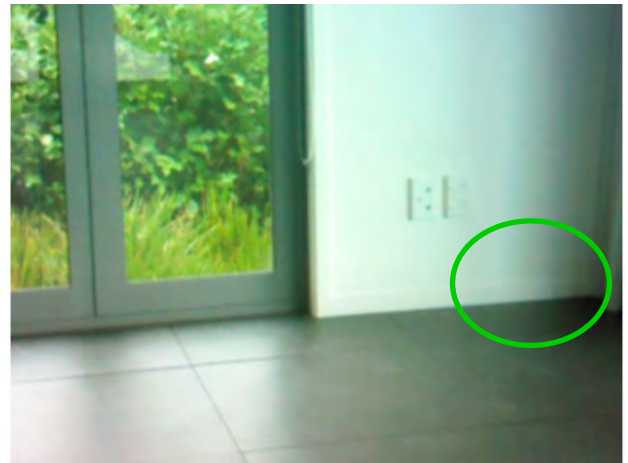
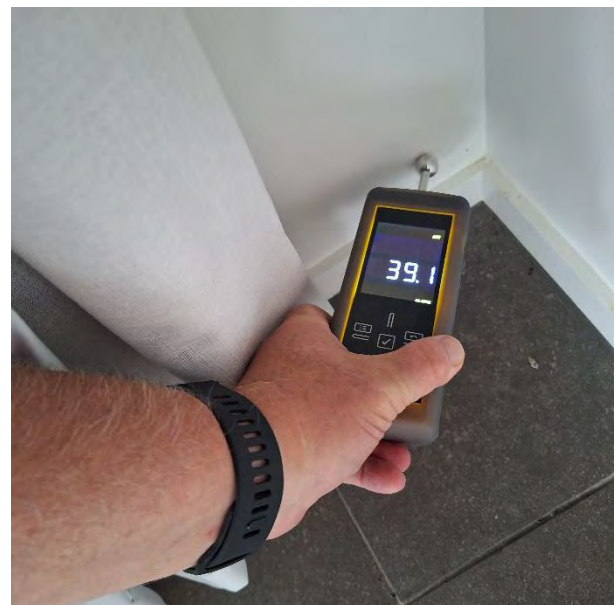
IR_19968.jpg | 20/05/2026 | 1:40 am

A slight infrared anomaly was seen in this image it was investigated further with a Trotec moisture meter and readings were found to be an acceptable level under the threshold of 50 and similar to the surrounding area at the time of inspection.

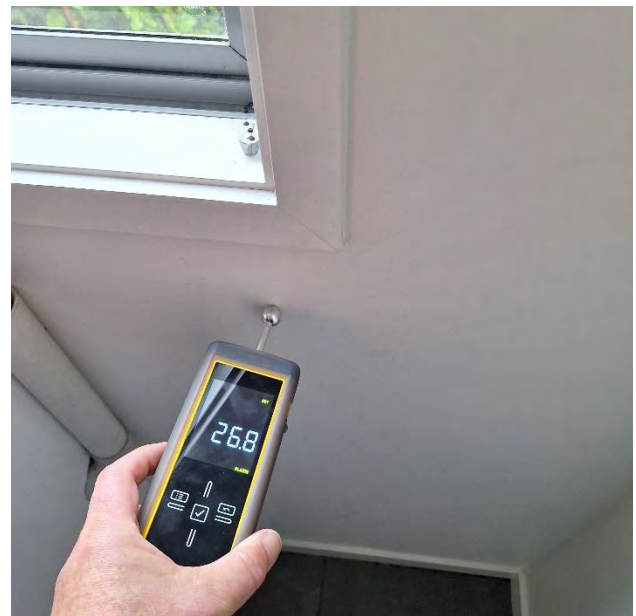
IR_19975.jpg | 20/05/2026 | 1:47 am

A slight infrared anomaly was seen in this image it was investigated further with a Trotec moisture meter and readings were found to be an acceptable level under the threshold of 50 and similar to the surrounding area at the time of inspection.

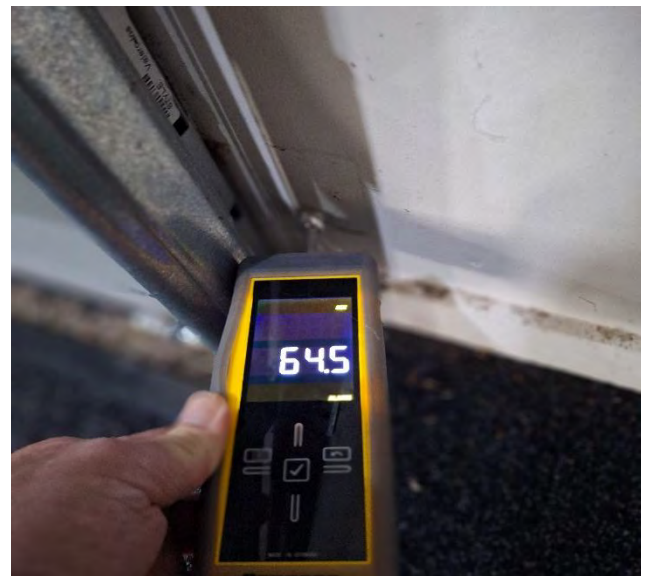
IR_19980.jpg | 20/05/2026 | 1:53 am

Infrared and or moderate moisture meter readings suggest a possible moisture issue.

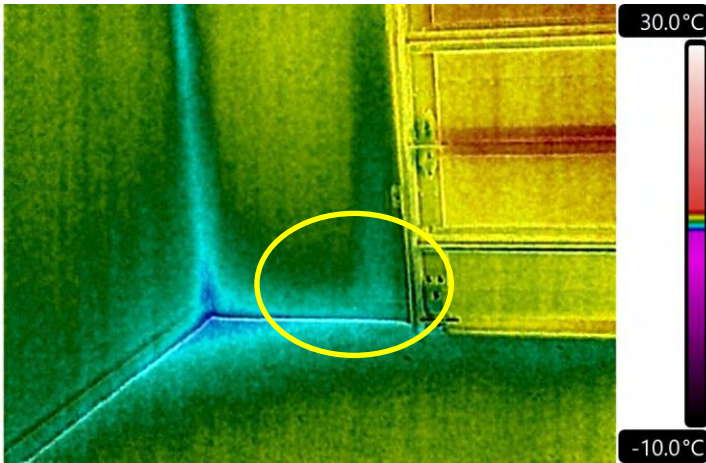
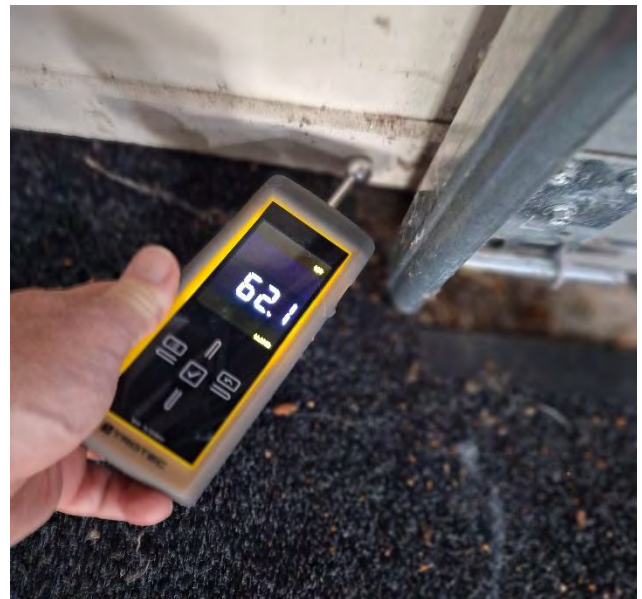
IR_19981.jpg | 20/05/2026 | 1:54 am

Infrared and or moderate moisture meter readings suggest a possible moisture issue.
