THERMOGRAPHY REPORT 1

**151 Durham Dr,
Havelock North.**

Customer	Whistle Trustee Ltd
Site Address	151 Durham Dr, Havelock North
Contact Person	Nic Goodman
Phone Number	+64 21980545
Thermographer	Aaron Bryant
Weather	Overcast - med to heavy rain during the last 5 days.
Date	19 th May 2026

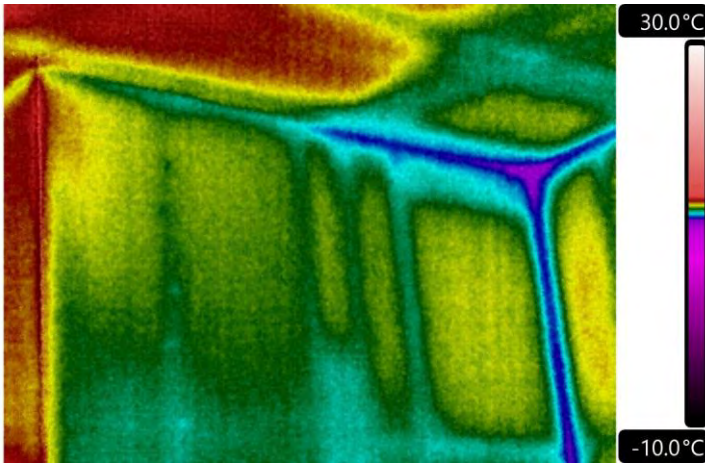
IR_19884.jpg | 20/05/2026 | 12:14 am

No infrared anomaly was seen in this image at the time of inspection.

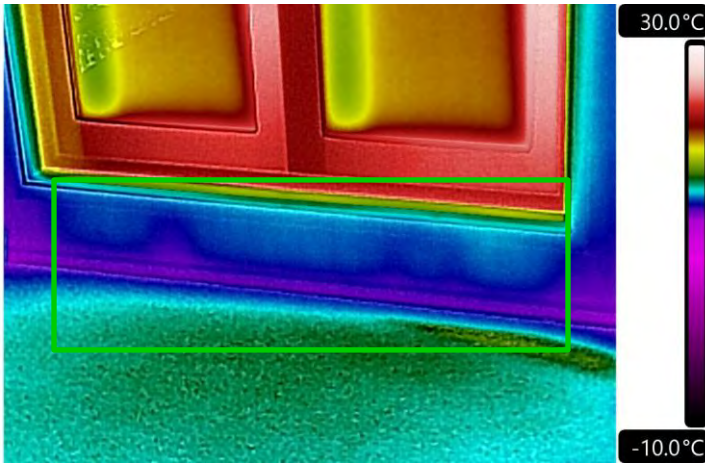
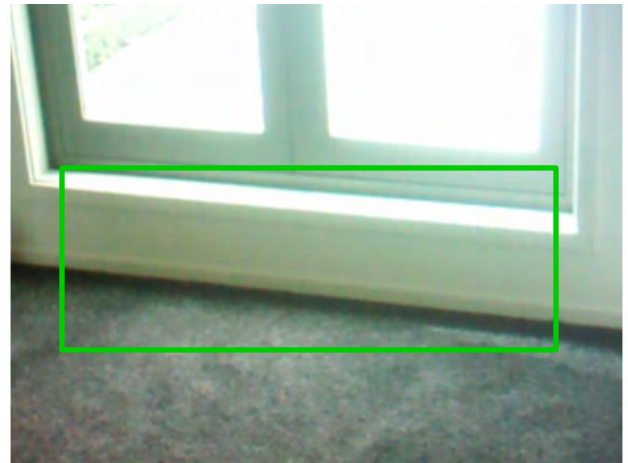
IR_19885.jpg | 20/05/2026 | 12:16 am

No infrared anomaly was seen in this image at the time of inspection.

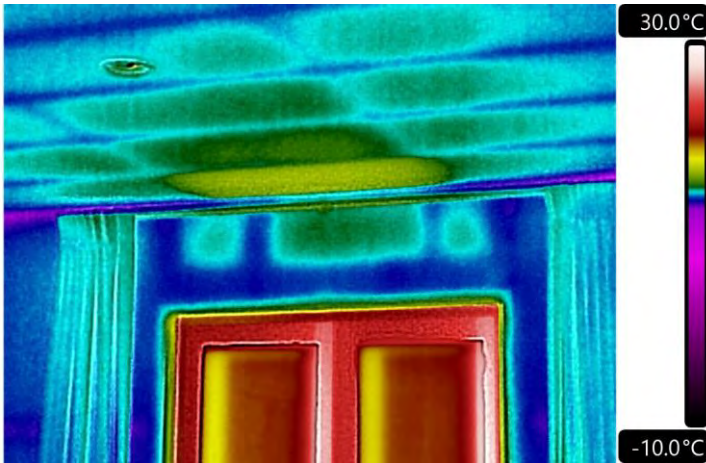
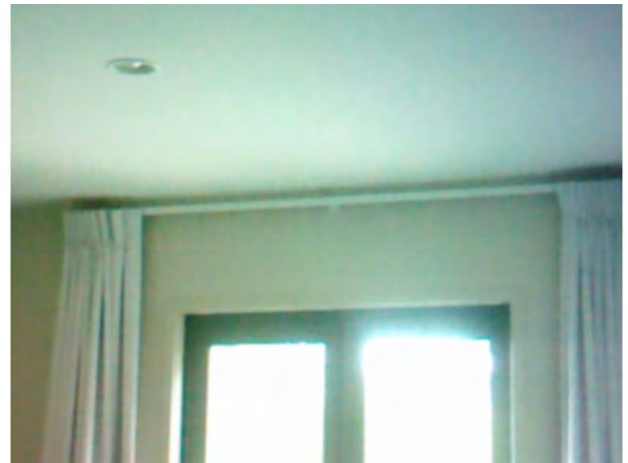
IR_19886.jpg | 20/05/2026 | 12:16 am

A slight infrared anomaly was seen in this image it was investigated further with a Trotec moisture meter and readings were found to be an acceptable level under the threshold of 50 and similar to the surrounding area at the time of inspection.

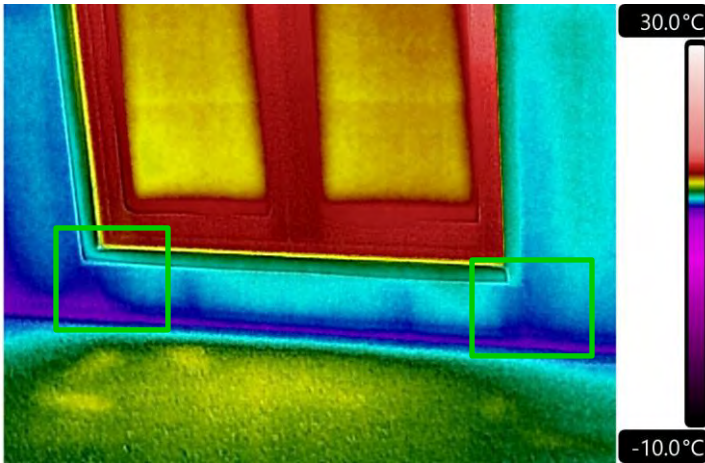
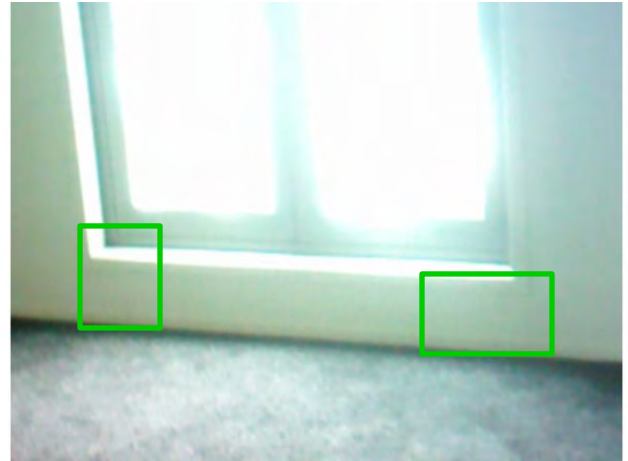
IR_19888.jpg | 20/05/2026 | 12:22 am

No infrared anomaly was seen in this image at the time of inspection.

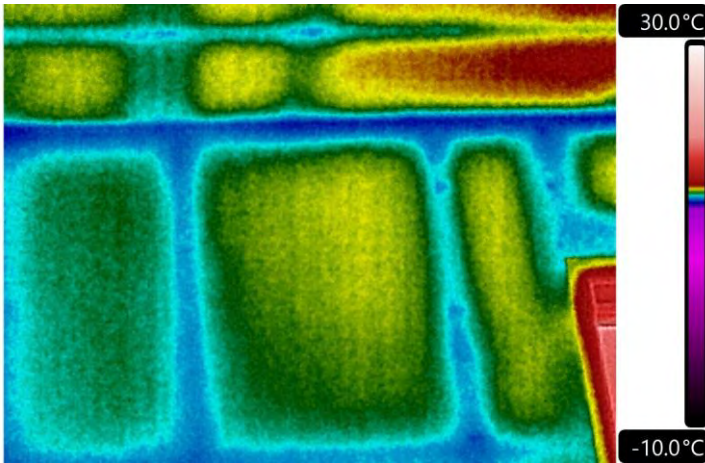
IR_19889.jpg | 20/05/2026 | 12:23 am

A slight infrared anomaly was seen in this image it was investigated further with a Trotec moisture meter and readings were found to be an acceptable level under the threshold of 50 and similar to the surrounding area at the time of inspection.

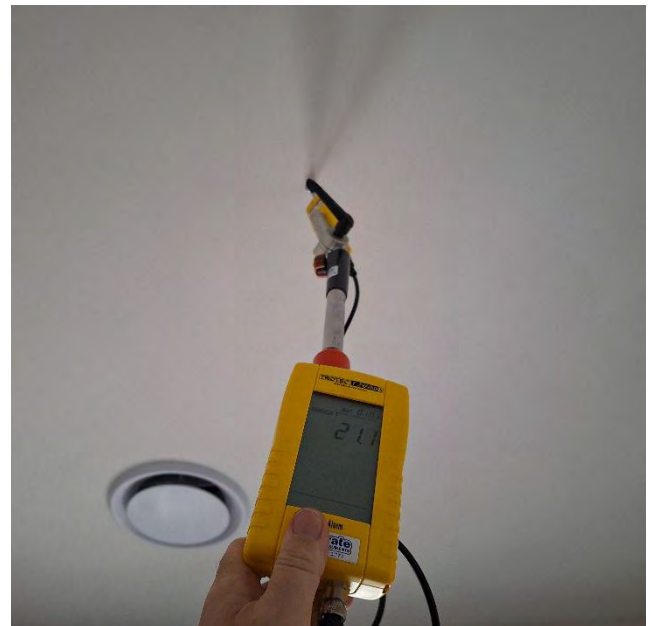
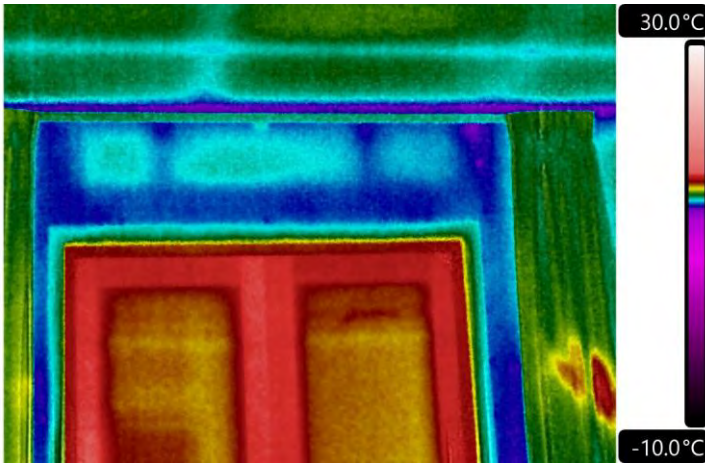
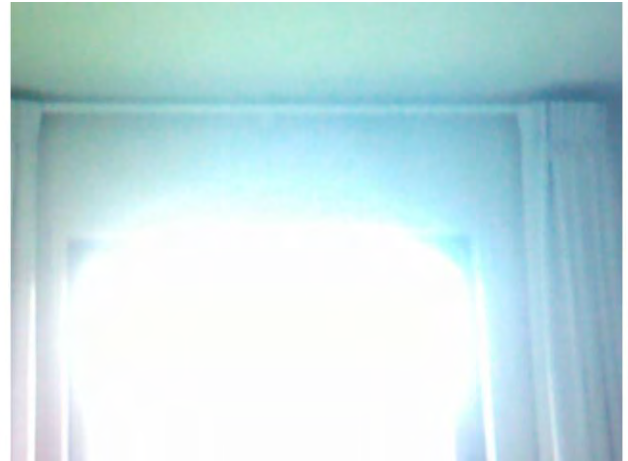
IR_19892.jpg | 20/05/2026 | 12:24 am

A slight infrared anomaly was seen in this image it was investigated further with a Trotec moisture meter and readings were found to be an acceptable level under the threshold of 50 and similar to the surrounding area at the time of inspection.

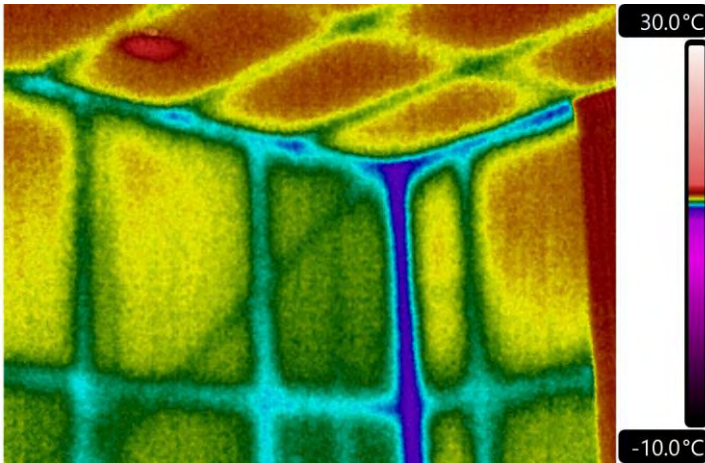
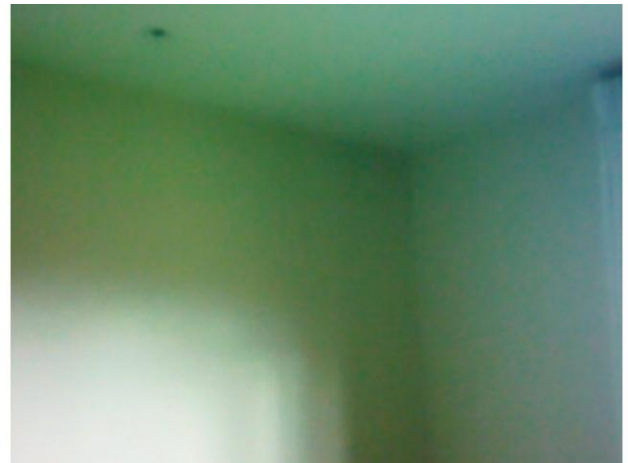
IR_19894.jpg | 20/05/2026 | 12:28 am

A slight infrared anomaly was seen in this image it was investigated further with a Trotec moisture meter and readings were found to be an acceptable level under the threshold of 50 and similar to the surrounding area at the time of inspection.

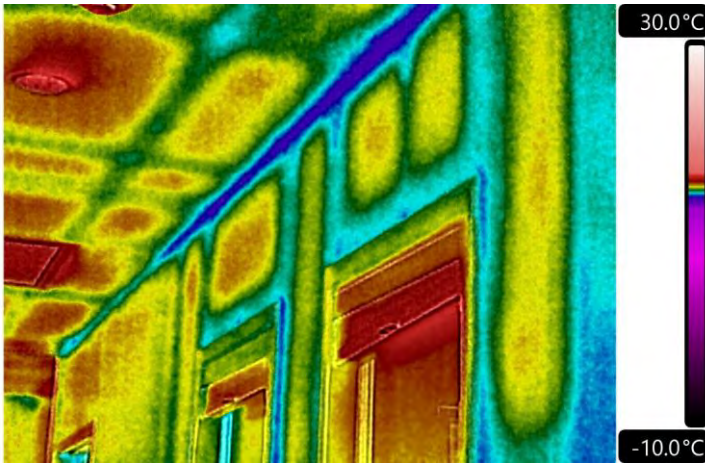
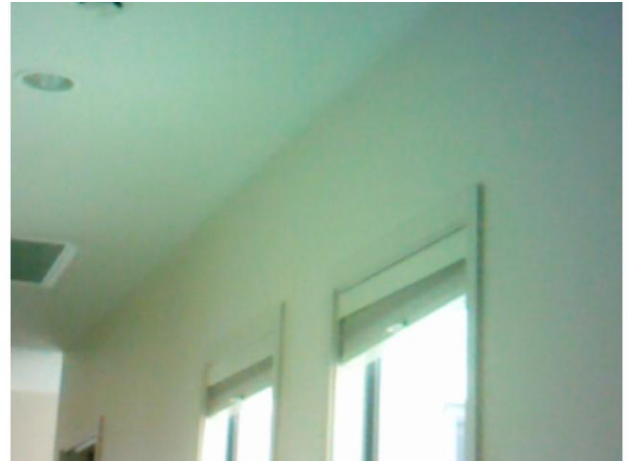
IR_19896.jpg | 20/05/2026 | 12:29 am

A slight infrared anomaly was seen in this image it was investigated further with a Trotec moisture meter and readings were found to be an acceptable level under the threshold of 50 and similar to the surrounding area at the time of inspection.

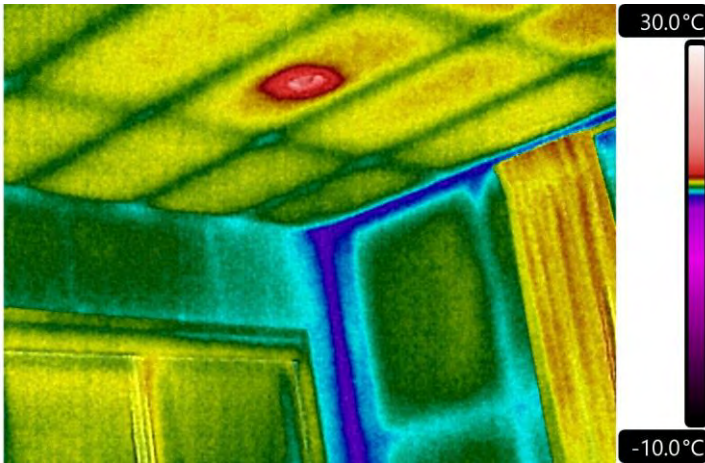
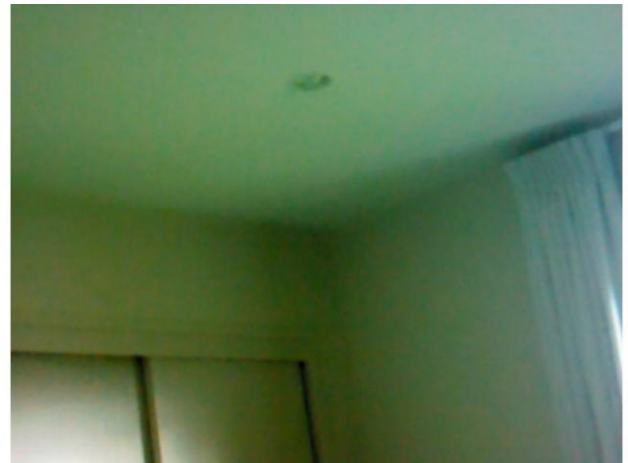
IR_19900.jpg | 20/05/2026 | 12:34 am

A slight infrared anomaly was seen in this image it was investigated further with a Trotec moisture meter and readings were found to be an acceptable level under the threshold of 50 and similar to the surrounding area at the time of inspection.

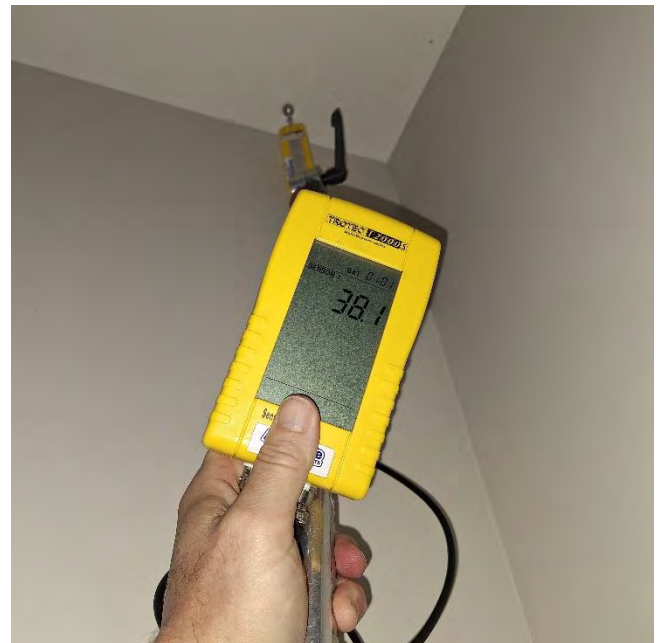
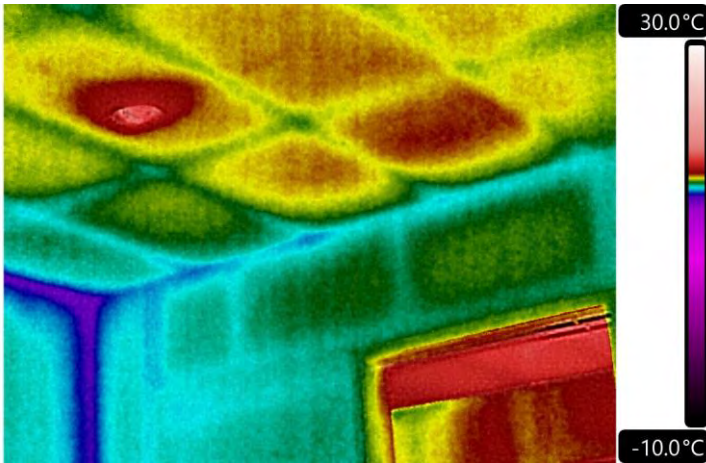
IR_19902.jpg | 20/05/2026 | 12:35 am

A slight infrared anomaly was seen in this image it was investigated further with a Trotec moisture meter and readings were found to be an acceptable level under the threshold of 50 and similar to the surrounding area at the time of inspection.

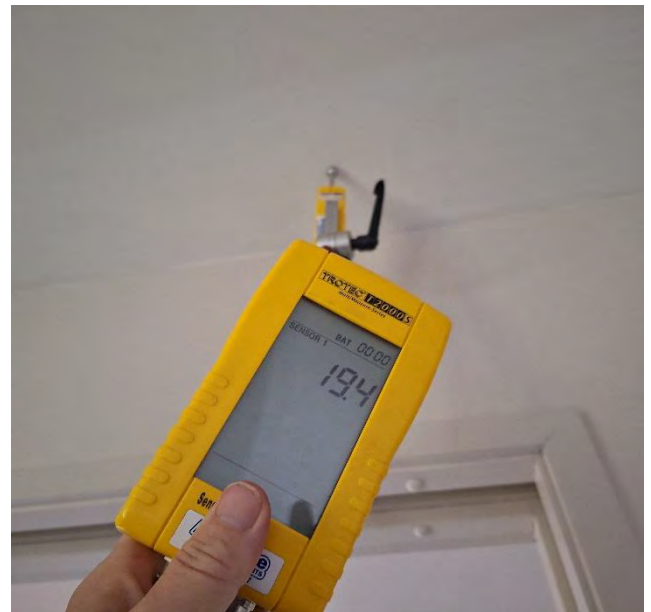
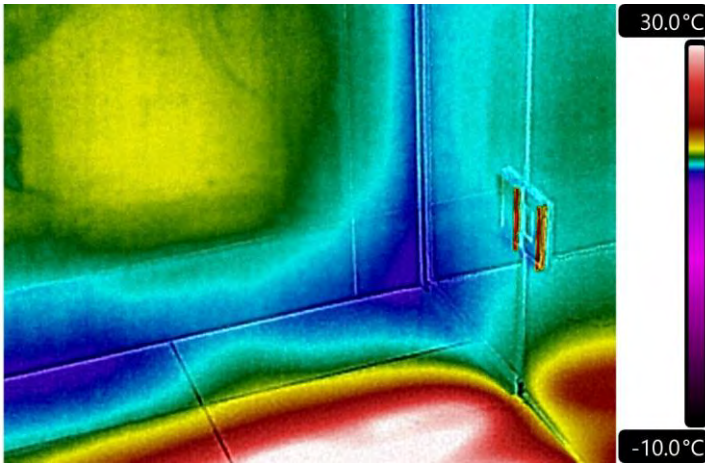
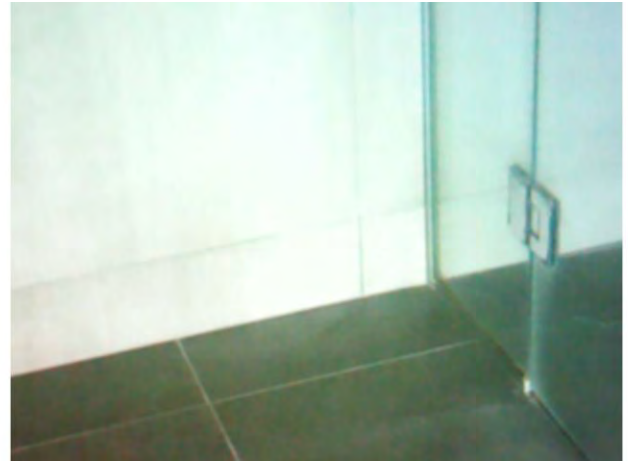
IR_19903.jpg | 20/05/2026 | 12:35 am

No infrared anomaly was seen in this image at the time of inspection.

However as there was evidence of a previous repair, moisture meter readings were therefore taken and found to be within an acceptable range.

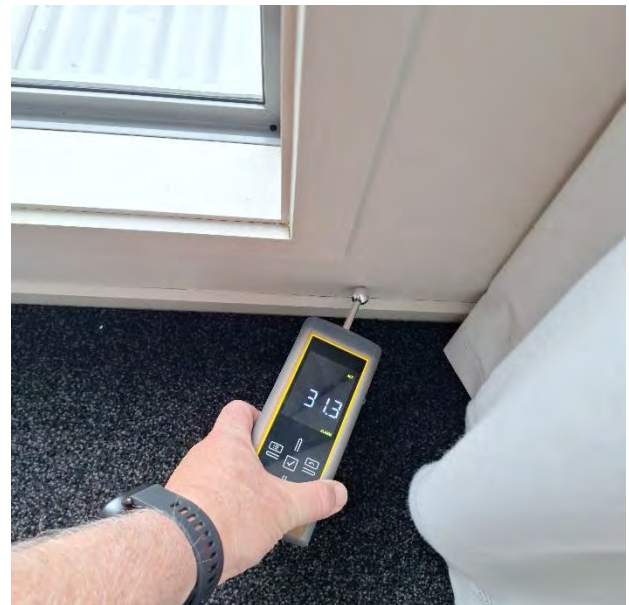
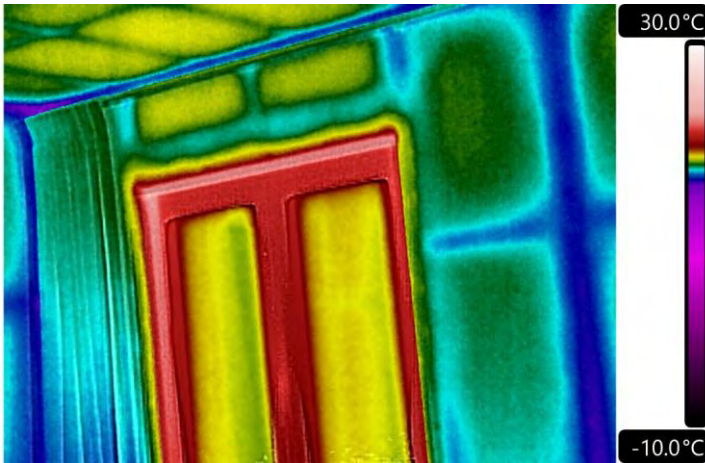
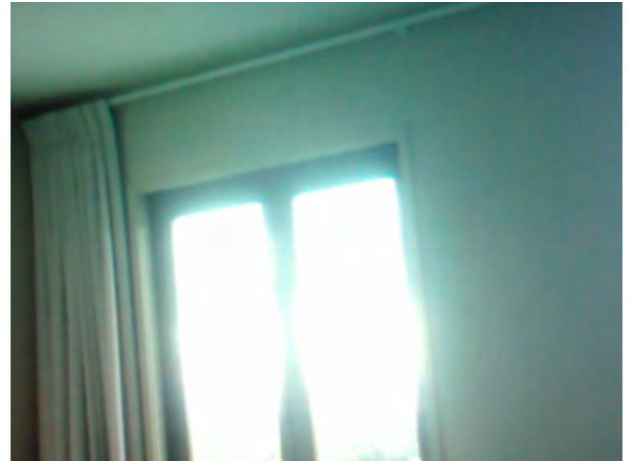
IR_19909.jpg | 20/05/2026 | 12:44 am

A slight infrared anomaly was seen in this image it was investigated further with a Trotec moisture meter and readings were found to be an acceptable level under the threshold of 50 and similar to the surrounding area at the time of inspection.

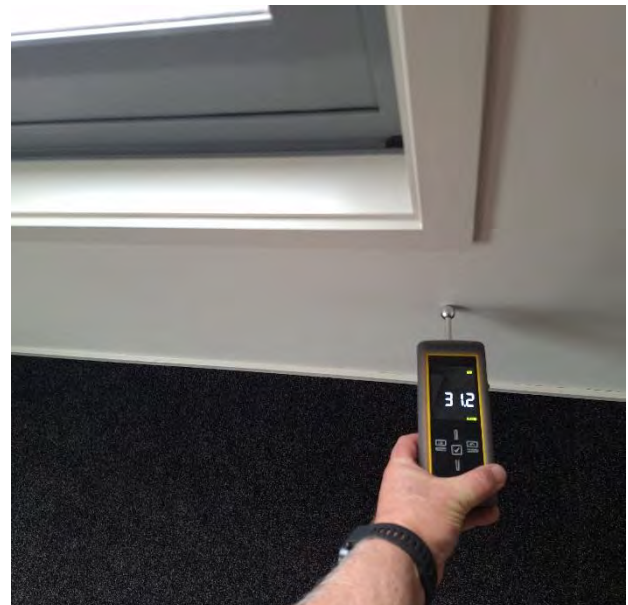
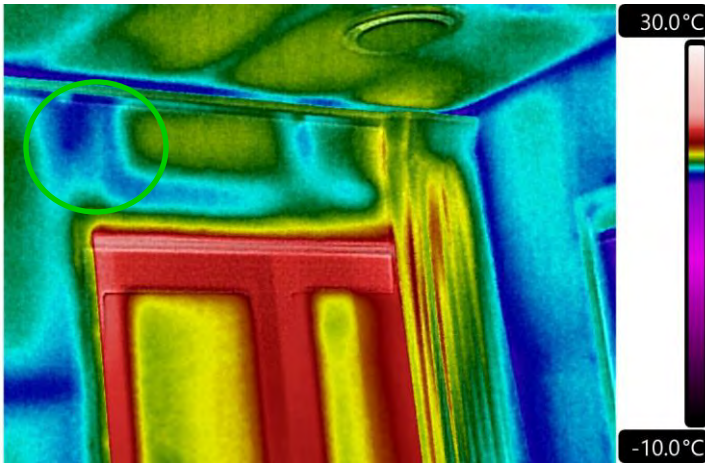
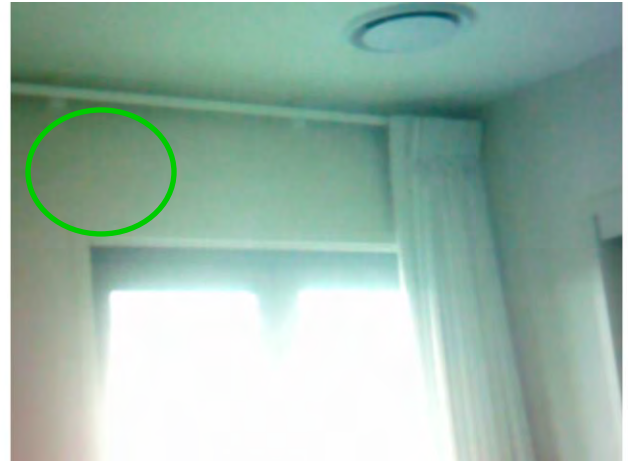
IR_19911.jpg | 20/05/2026 | 12:44 am

A slight infrared anomaly was seen in this image it was investigated further with a Trotec moisture meter and readings were found to be an acceptable level under the threshold of 50 and similar to the surrounding area at the time of inspection.

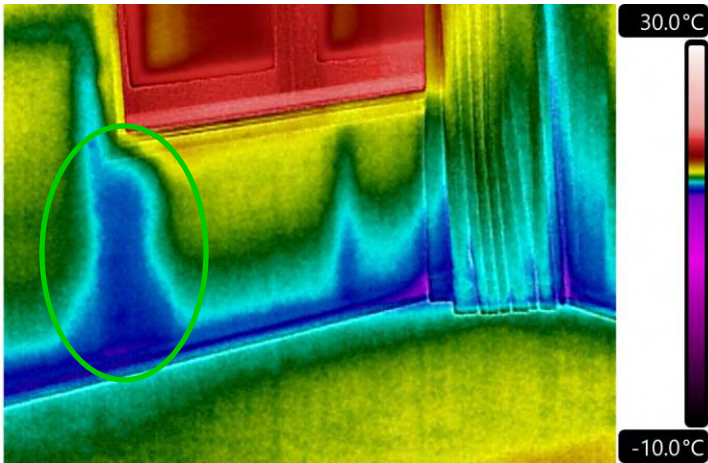
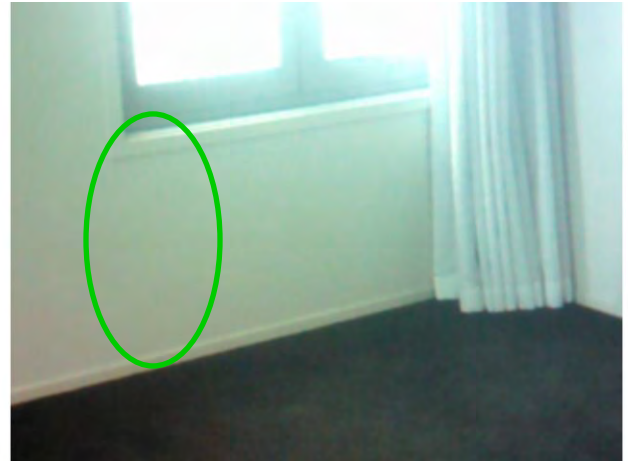
IR_19912.jpg | 20/05/2026 | 12:44 am

A slight infrared anomaly was seen in this image it was investigated further with a Trotec moisture meter and readings were found to be an acceptable level under the threshold of 50 and similar to the surrounding area at the time of inspection.

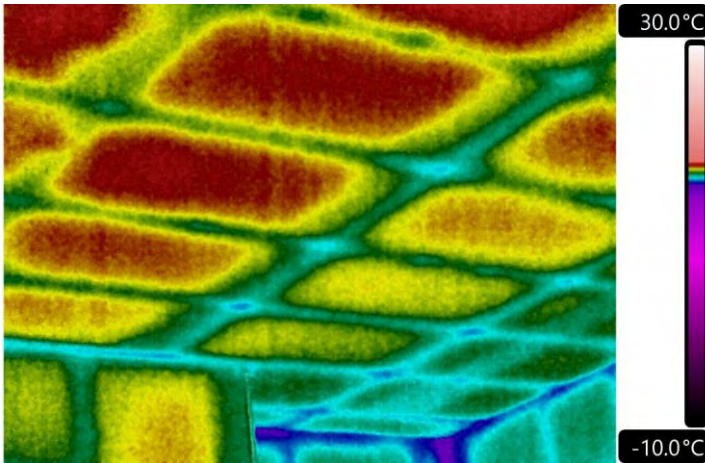
IR_19913.jpg | 20/05/2026 | 12:45 am

A slight infrared anomaly was seen in this image it was investigated further with a Trotec moisture meter and readings were found to be an acceptable level under the threshold of 50 and similar to the surrounding area at the time of inspection.

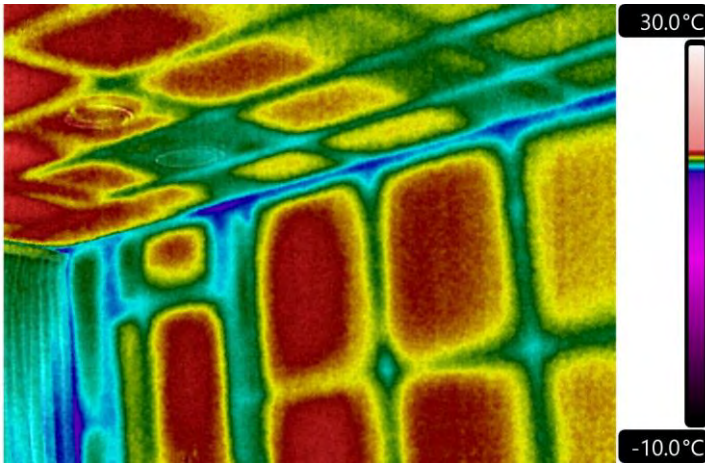
IR_19916.jpg | 20/05/2026 | 12:52 am

A slight infrared anomaly was seen in this image it was investigated further with a Trotec moisture meter and readings were found to be an acceptable level under the threshold of 50 and similar to the surrounding area at the time of inspection.

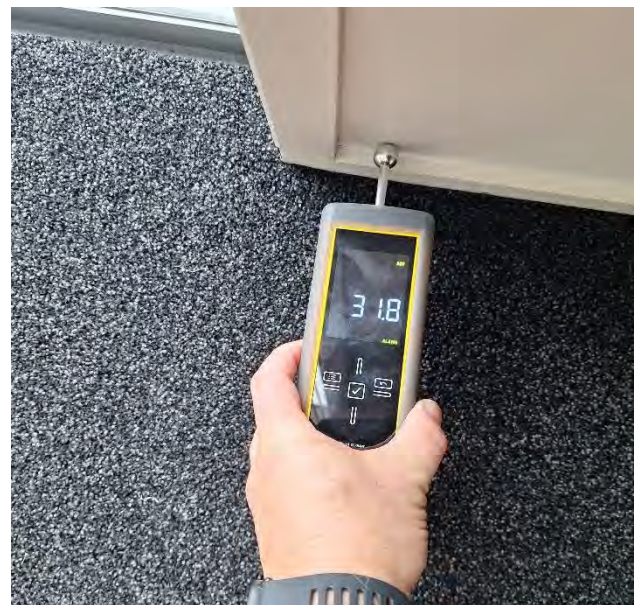
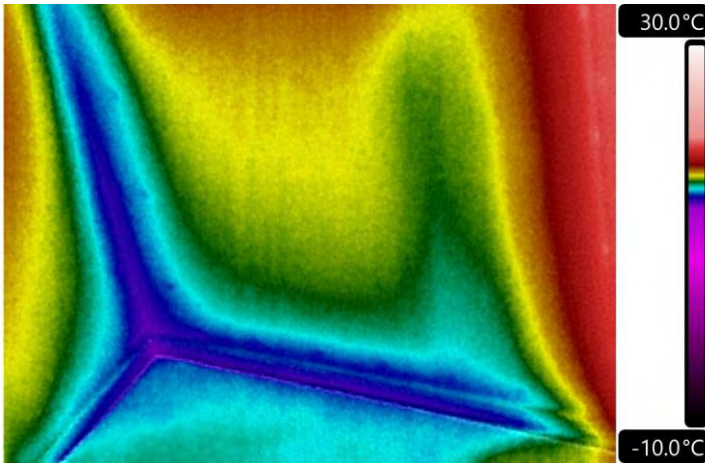
IR_19921.jpg | 20/05/2026 | 12:54 am

A slight infrared anomaly was seen in this image it was investigated further with a Trotec moisture meter and readings were found to be an acceptable level under the threshold of 50 and similar to the surrounding area at the time of inspection.
