Property Inspection Report

- Habit Hawkes Bay Limited -

***20 Aintree Rd
Havelock North***

***This report is for the sole benefit of:
Brittain Family Trust***

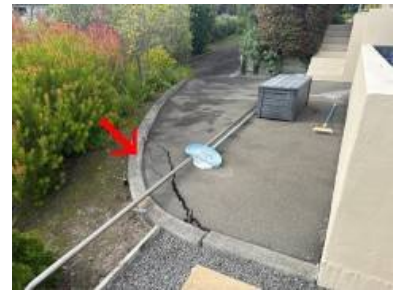
Small corner to path below pool area is subsiding.

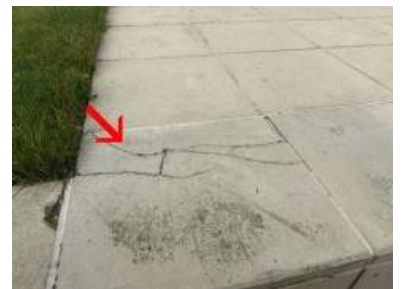
Damage evident to paver here.

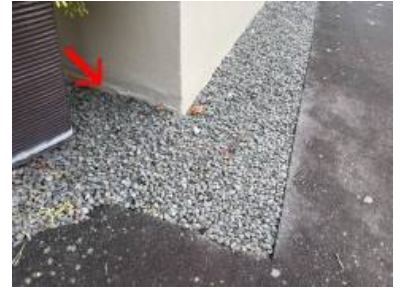
Driveway has been cut back and a retro-fit flashing has been installed here.

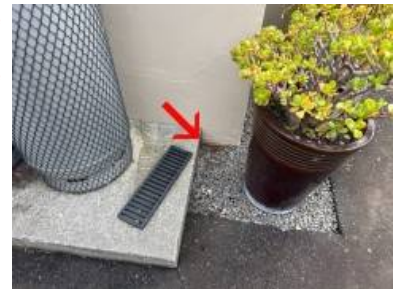
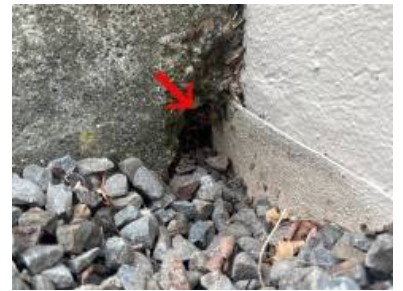
The back corner of the garage has signs of moisture ingress with efflorescence present to the internal block work and elevated moisture readings to the timber joinery. A retrofitted "sill tape" flashing was observed to some areas of the garage where moisture could not be seen internally, however where the moisture staining is visible internally the flashing appears to stop at the slab for the gas bottles and does not extend behind this area. Confirmation of the product used on the side with visible moisture staining could not be determined on our non invasive inspection.

Pictured here is the corner where the moisture was found inside the garage and the retro-fitted flashing product can be seen butting up to the concrete slab that the gas cylinders are sitting on, this suggests the membrane may not have been installed behind this slab, this cannot be confirmed on our non invasive inspection.

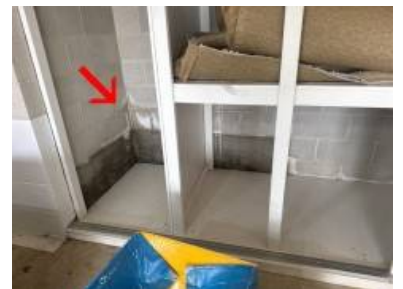
Moisture ingress visible to this corner.

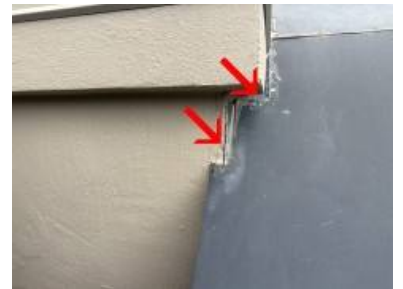
I suggest this roof to wall junction is resealed to prevent future moisture ingress. This is pictured outside the hallway adjacent to the middle wing bathroom where the membrane roof area meets the colour-steel roofing area.

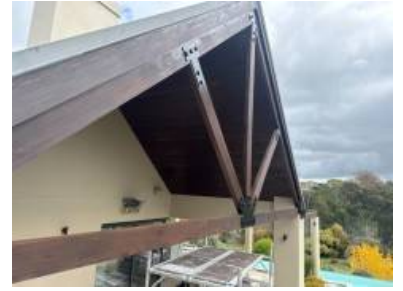
A small piece of fascia has broken off to the pergola above the ground floor patio above the pool area, I suggest this is repaired or replaced.

Damage to fascia here above pool area. Repair or replacement is suggested.

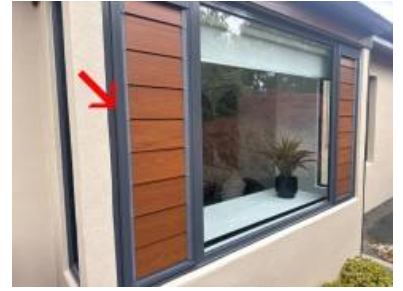
The rubber window seals have shrunken back from the corners of the windows to many windows, I suggest these rubbers are replaced to prevent future moisture ingress, I was advised by the contractor on site at the time of inspection that this will be addressed.

Deteriorated windows seals evident, recommended replacement.

I was advised by the contractor on site that this is on the to-do list and will be completed.

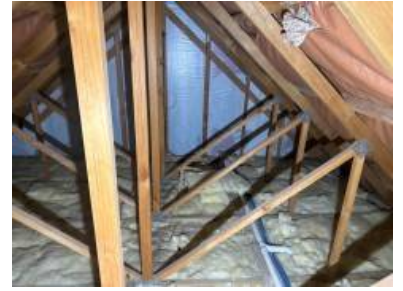
Not every screw for the ridge flashing installed here appear to be fixed to the purlin. I suggest this is re fixed to prevent any future damages.
