BUILDING INSPECTION REPORT

RED LBP PRE-PURCHASE REPORT

PRE-PURCHASE BUILDING REPORT

Property Address	20 Robin Street, Burwood, Christchurch 8083
Client	Ben Brook
Date of Inspection	19th May 2026
Time	8:30 am
Inspector	Jamie Chapman National Certificate in Carpentry
LBP Number	BP137228
People Present	Inspector, Owner
House Occupied	Yes

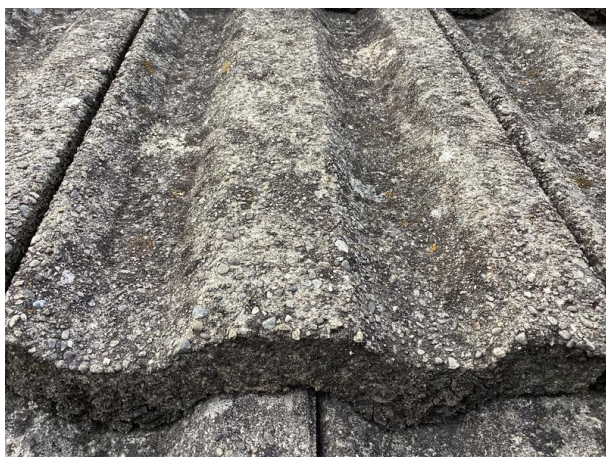
Photo 4

Condition of surface - Deterioration of the surface coating.

Tile condition - Areas requiring maintenance, refer to photos below.

Close-up view of the masonry tiles. Note the rough aggregate surface of the tiles. This indicates surface deterioration. See the next photo.

The masonry tile roof cladding has surface deterioration and requires cleaning and recoating to help restore weathertightness. An LBP specialising in tile roof cladding should be engaged to assess and report on necessary repairs and maintenance.

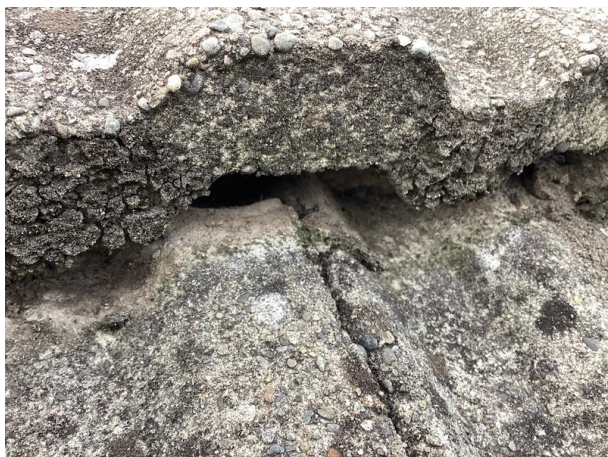
Photo 5

When lifting up the tile lap it exposes a smooth surface underneath. This was the original condition of the masonry tiles.

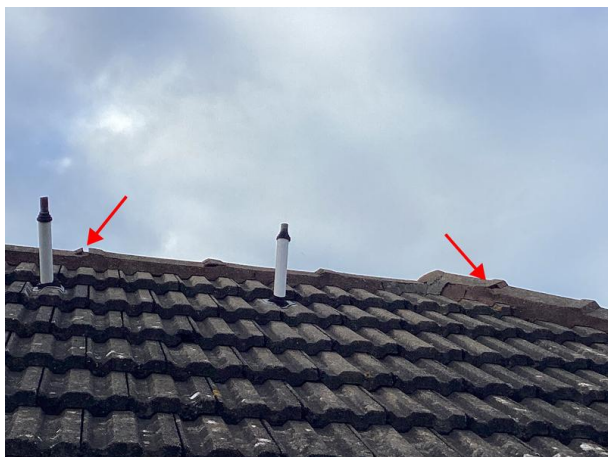
Photo 10

A couple signs of mortar displacement was noticed on the masonry tiled hips and ridges. Future maintenance would include re-pointing the mortar joints where required.

As previously detailed the roof system is due for maintenance and repairs. It is recommended to have a licensed roofer to advise further.

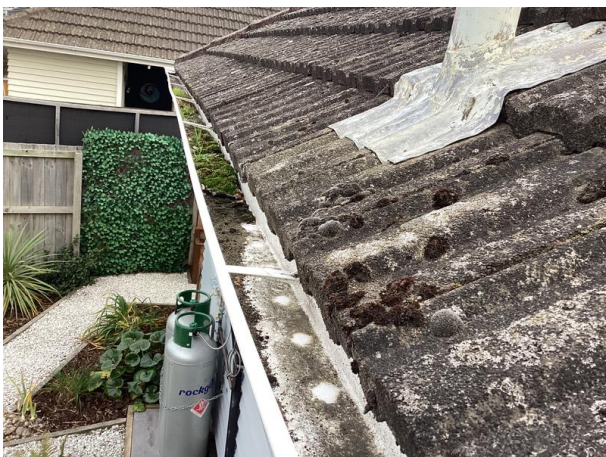
Photo 11
A couple areas of debris were noticed inside the gutter system.

To maintain proper drainage, it is crucial to ensure gutters remain free of debris. Blocked gutters can result in water overflowing and accumulating on the roof or other parts of the building, potentially causing water damage, leaks, and structural issues. Regular maintenance, such as removing leaves, twigs, and other debris, prevents blockages and ensures efficient water flow away from the roof, protecting the building's integrity.

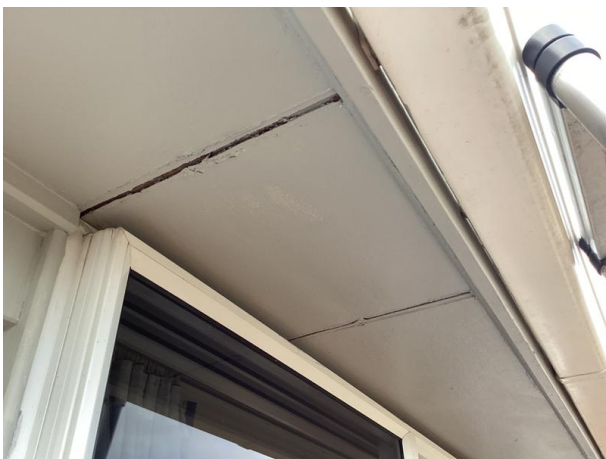
Photo 13
A couple of soffit scribes were missing outside of the living area.

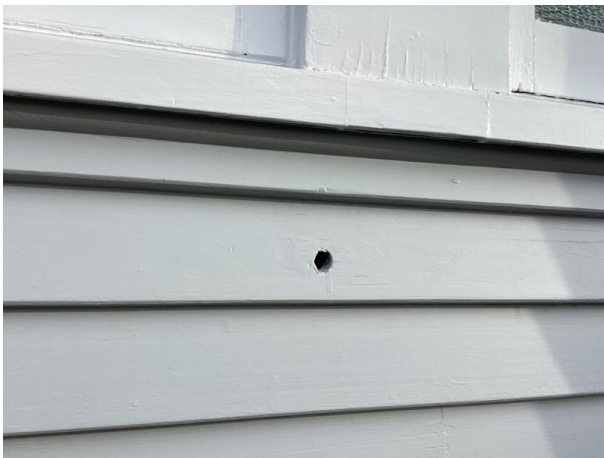
Photo 18
Unsealed penetration hole noticed outside of the bathroom area.
Recommend sufficiently sealing.

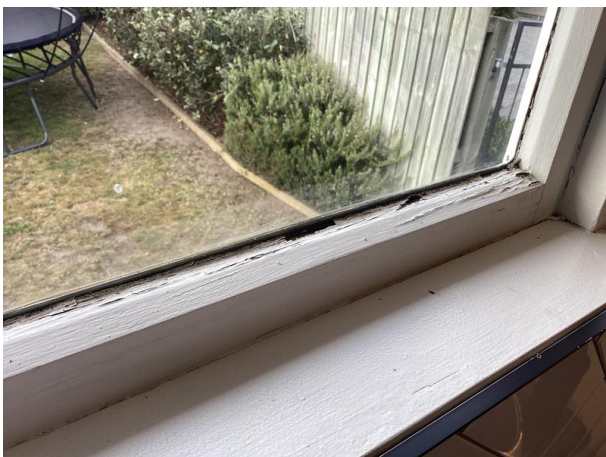
Photo 21
However, a few areas inside the dwelling are due for maintenance with paint flaking and cracking noticed.

Keep up regular maintenance to the coating of the timber windows and ensure condensation is kept to a minimum.

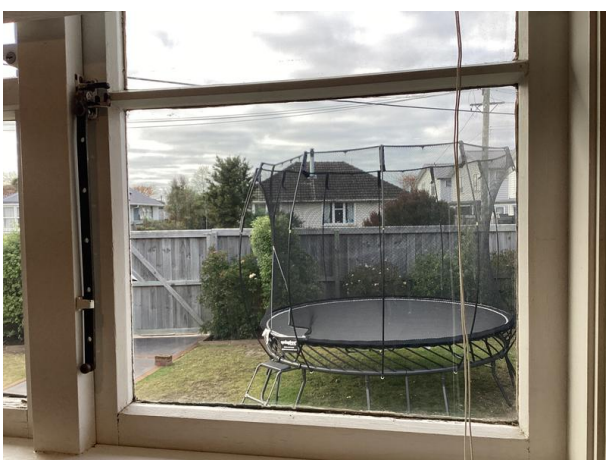
Photo 22
Window sashes around the dwelling were difficult to open and would benefit from adjustments for better functionality.

Some opening sashes require repair to restore functionality and reduce draughts.

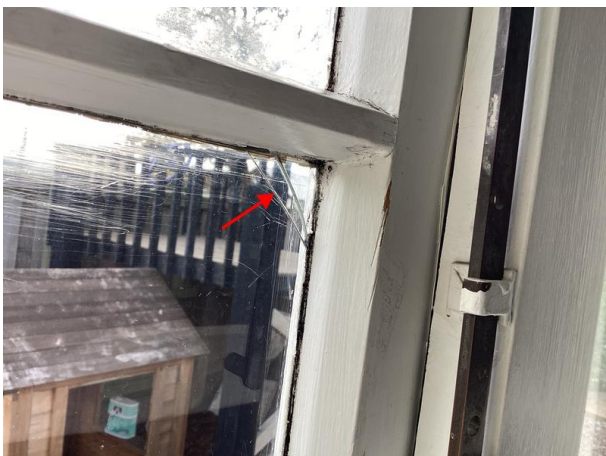
Photo 23
Cracked window glass panel visible in bedroom one. Recommend replacing.

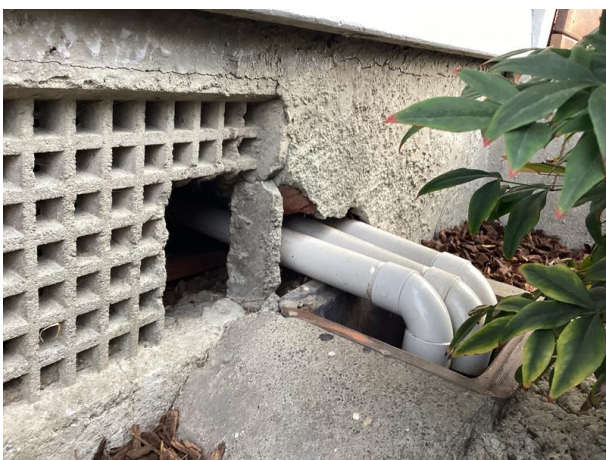
Subfloor ventilation - Some broken vents.

Photo 26
Broken vent visible below the bathroom as well as concrete breakage to allow for the waste pipes.

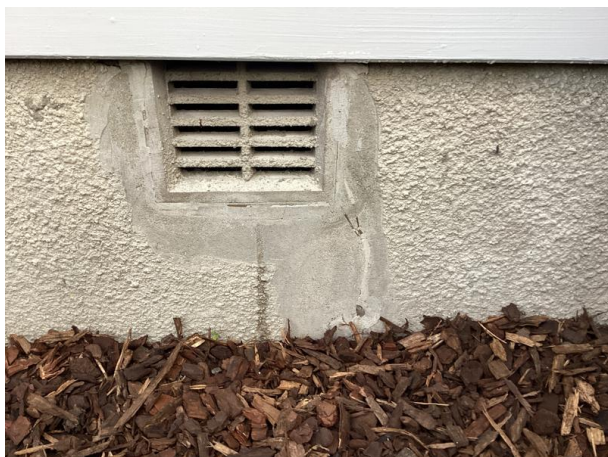
Photo 28
Signs of concrete crack repair work were noticed around the ring foundation mainly on the north side of the dwelling.

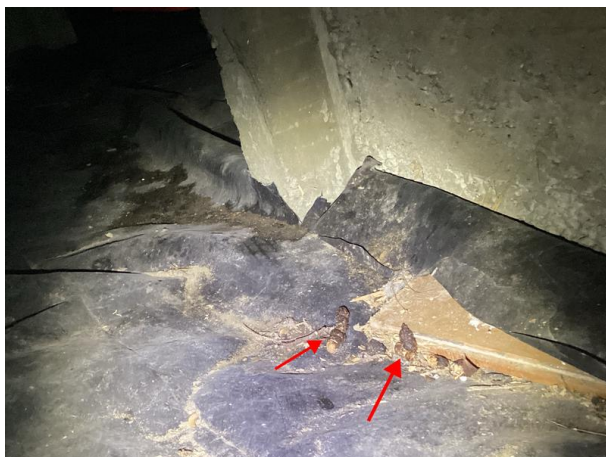
Photo 34
Signs of animals entering into the subfloor were noticed during the inspection. Likely getting through the broken vent holes previously noted.

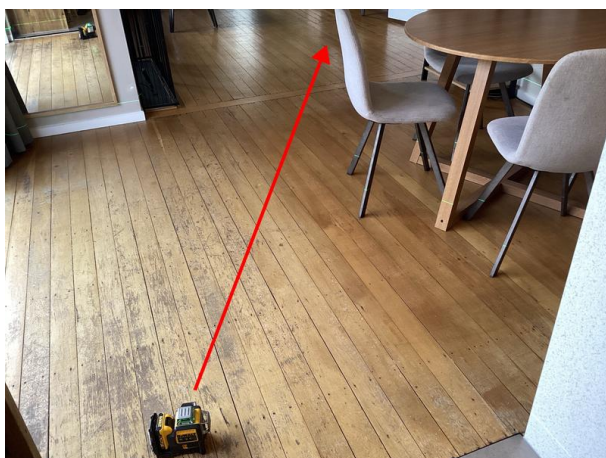
The overall level difference measured in the sampled areas was approximately 30mm. This assessment is limited to a visual, non-invasive spot-check and is not a full floor-level survey or certification of compliance.

Photo 36
A 30mm difference was noticed over a 5.7m distance from the dining to living room.

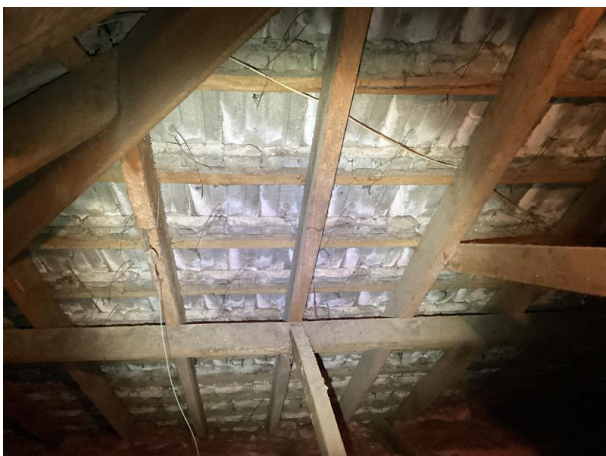
Photo 41
Signs of efflorescence were noted on the underside of the masonry tiles. Refer back to the roof system section of this report to view the condition of the masonry tiles.

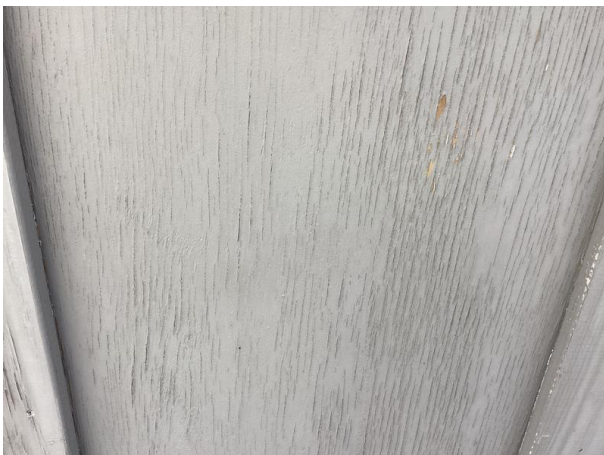
Photo 57
The timber boards and batten on the exterior of the garage are overdue for maintenance with paint and timber cracking starting to appear.

The detached garage were observed only as ancillary structures. General defects, deterioration, and maintenance items should be repaired as required by a competent trade professional as part of normal upkeep.

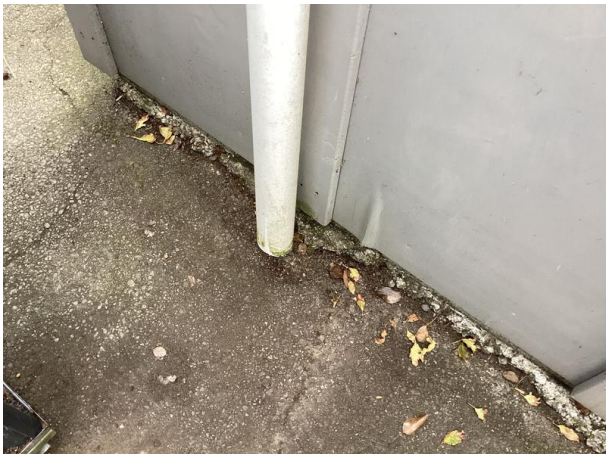
Photo 58
The garage stormwater discharges onto the ground and not into an approved stormwater system.

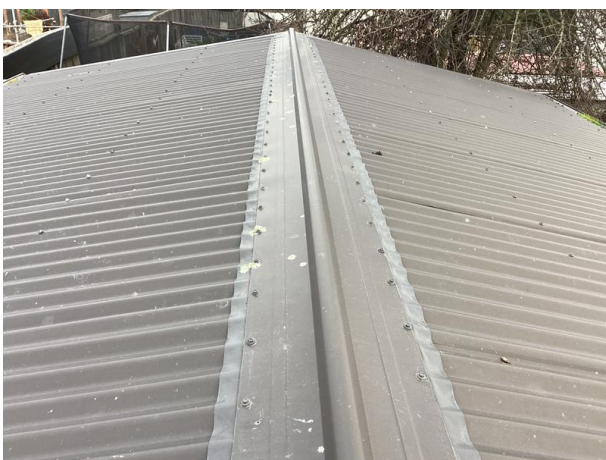
Photo 59
Profiled metal roof with screw fixings located over the garage. Minor areas of moss/lichen spots were noticed.
