## BUILDING INSPECTION REPORT

## RESIDENTIAL HOUSE INSPECTION

191 Westminster St 1  
Christchurch, Canterbury Region 8013

28/05/2026

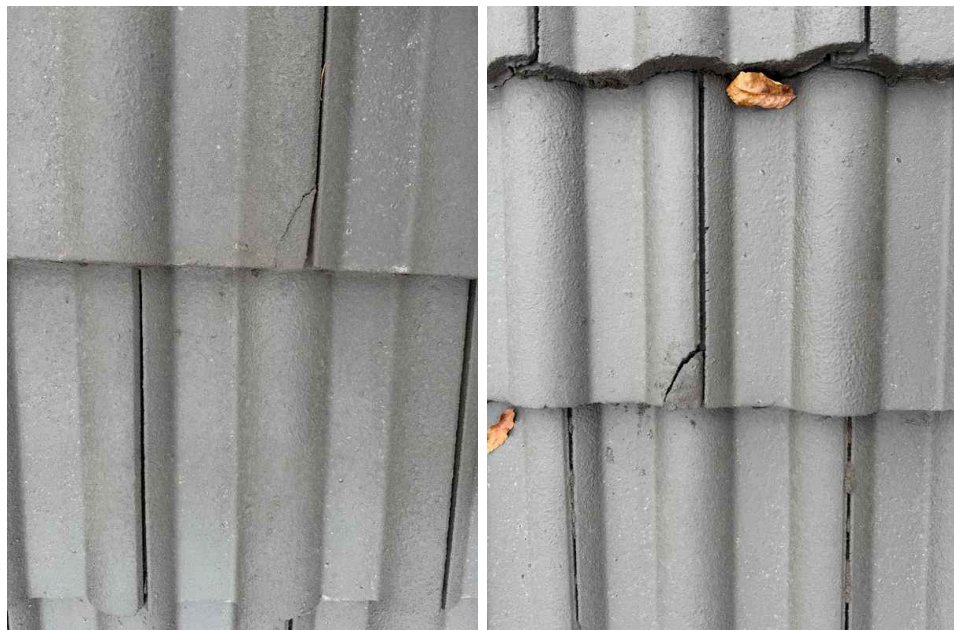
**EDGE DAMAGE TO CONCRETE TILES OBSERVED**

Cracking to the tile edges has been observed, This can occur with age and roof traffic, while weathertight it is best practice to replace damaged tiles to prevent water ingress from rain events.

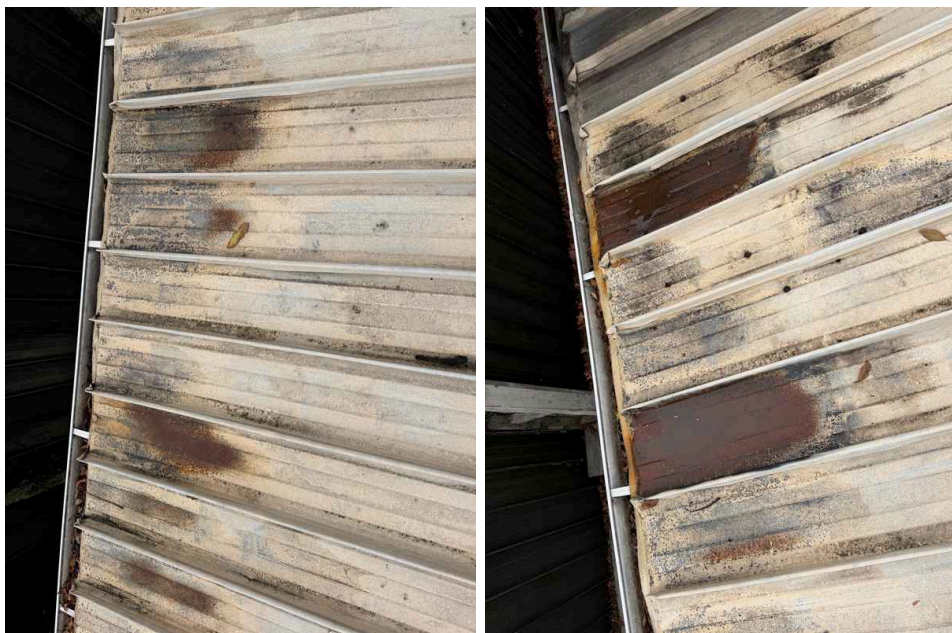
**SURFACE CORROSION TO ROOF SYSTEM OBSERVED**

Surface corrosion is noted to the roof system, Maintenance required, as a minimum the areas should be prepared and treated, any significant rust may require iron to be replaced. The roof is of an older age and will require regular maintenance. The roof is of an older design with minimal falls.

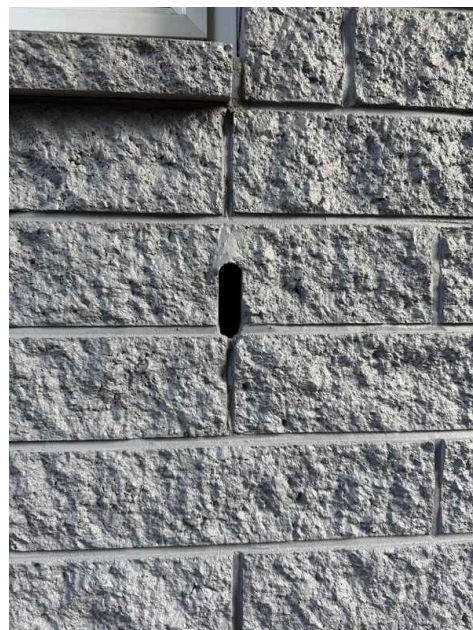
### **UNSEALED PENETRATIONS IN MASONRY VENEER**

Unsealed penetrations were observed in the masonry veneer during inspection. Seal all penetrations with appropriate caulk or flashing materials to prevent moisture from entering the wall assembly.

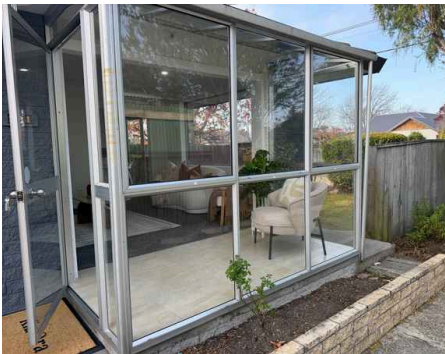
**Conservatory: A Conservatory has been constructed to the west elevation**

It is recommended that council records are checked to ensure compliance has been obtained.

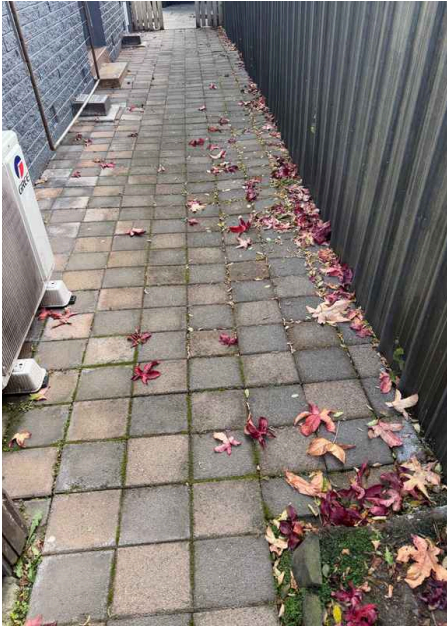
**CRACKING TO CONCRETE SURFACES NOTED.**

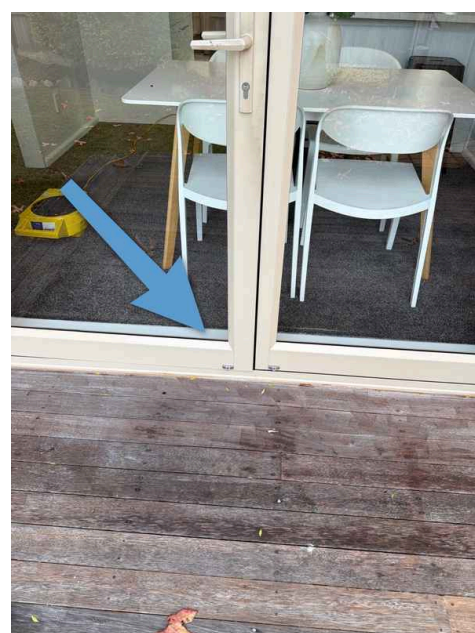
16.2.1 Exterior Joinery

BEDROOM

Adjust and complete maintenance as required to restore functionality.

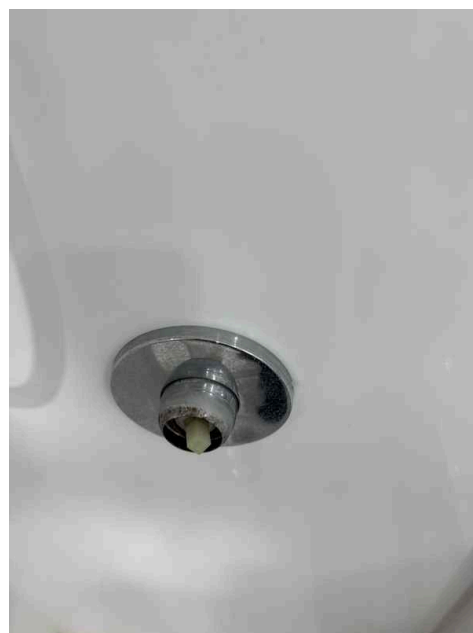
21.7.1 Shower

### MIXER HANDLE LOOSE

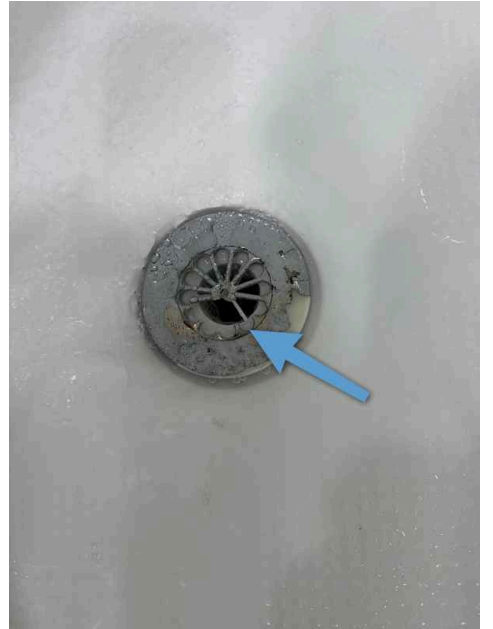
21.7.2 Shower

**WASTE COVER DAMAGED**

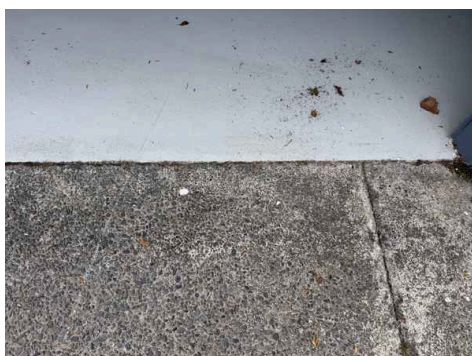
### 25.2.1 Defects Floor

Water ingress may occur under the garage door, a strip drain would minimize this occurrence or risk.
