BUILDING INSPECTION REPORT

RESIDENTIAL HOUSE INSPECTION

191 Westminster St 2
Christchurch, Canterbury Region 8013

28/05/2026

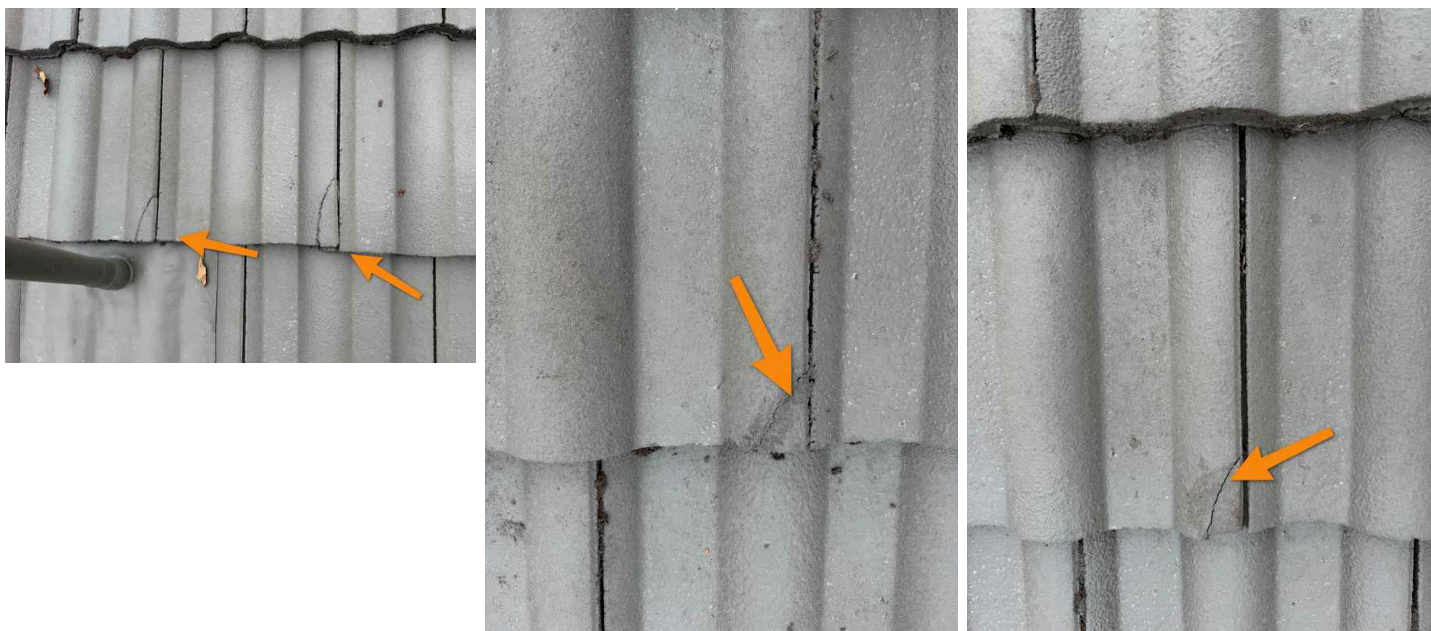
CRACKED TILES NOTED

Replacment of damaged roof tiles is recommended to prevent water ingress.

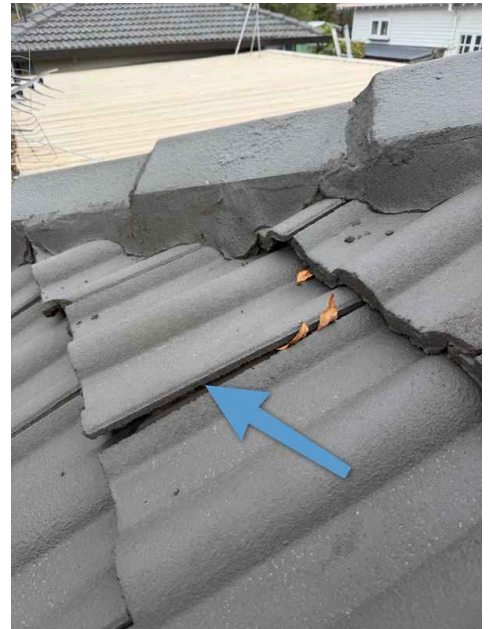
Southeast

RIDGE TILE IS NOT SEATED CORRECTLY

Maintenance Item

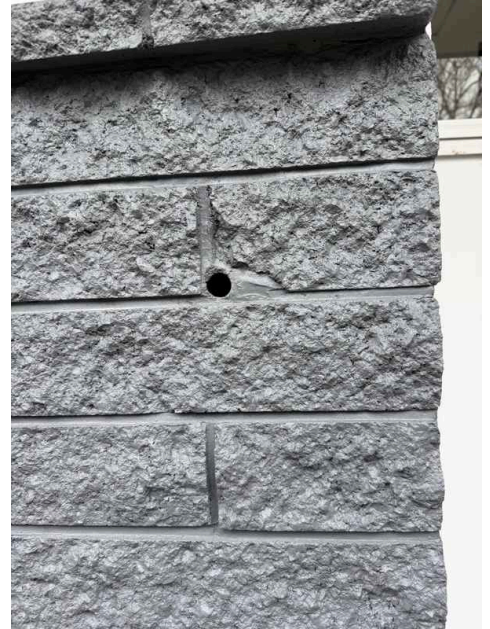
UNSEALED PENETRATIONS IN MASONRY VENEER

Unsealed penetrations were observed in the masonry veneer during inspection. Seal all penetrations with appropriate caulk or flashing materials to prevent moisture from entering the wall assembly.

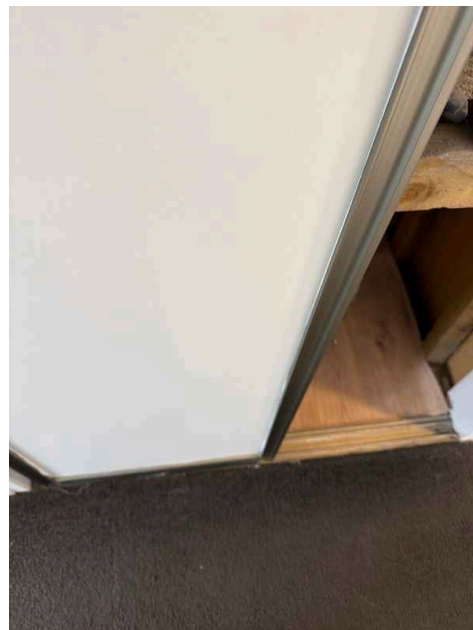
12.1.1 Hot Water Cylinder

SLIDING DOORS REQUIRE MAINTENANCE TO ROLLERS

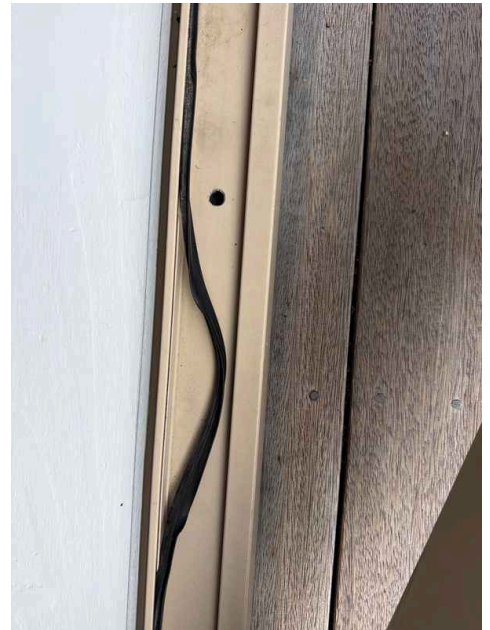
15.3.1 Exterior window
DOOR SEAL LOSE

Maintenance Item

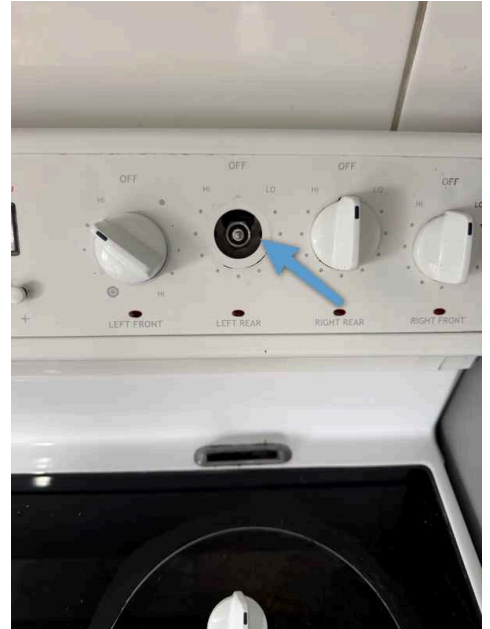
DAMAGED CONTROL KNOB NOTED

Maintenance Item

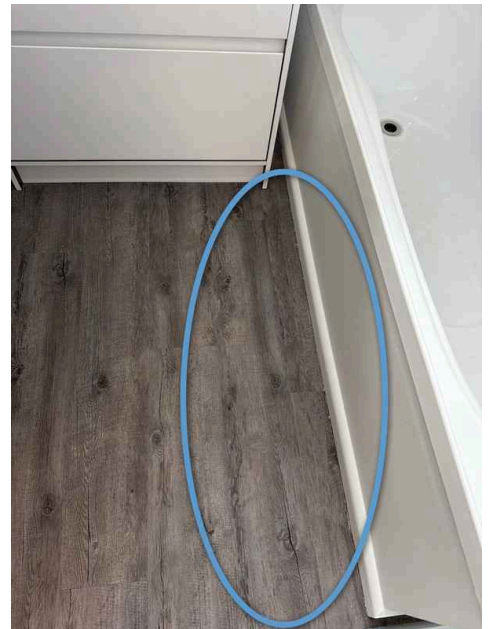
20.4.1 Floor Coverings

MINOR DEVIATION OF FLOOR LEVEL

Maintenance Item

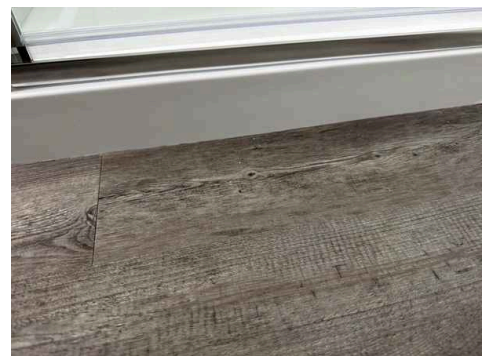
20.7.1 Shower

**SHOWER BASE TO FLOOR NOT
SEALED**

Recommendation

- Recommendation made in Section 20.7.1 will be attended to prior to settlement.
- The building report refers to roof tiles requiring maintenance. A report from the roofing contractor confirming repairs were completed and replacement tiles laid where appropriate is included at the end of this report.

Sealing of the shower base to floor junction is required to prevent water ingress and damage to floor and subfloor timbers.

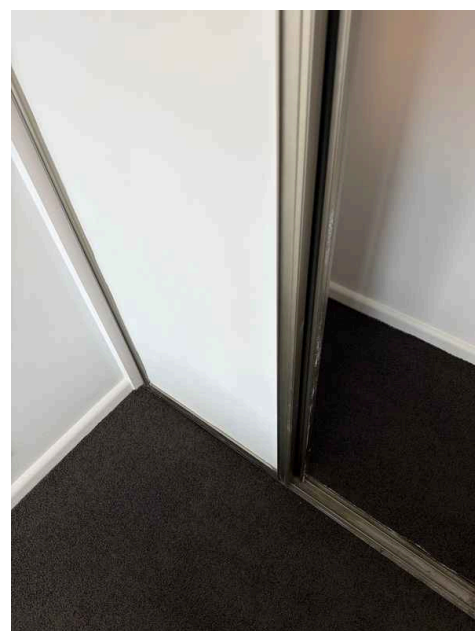
23.3.1 Internal Doors

WARDROBE DOORS

Maintenance to the doors is suggested to restore functionality.

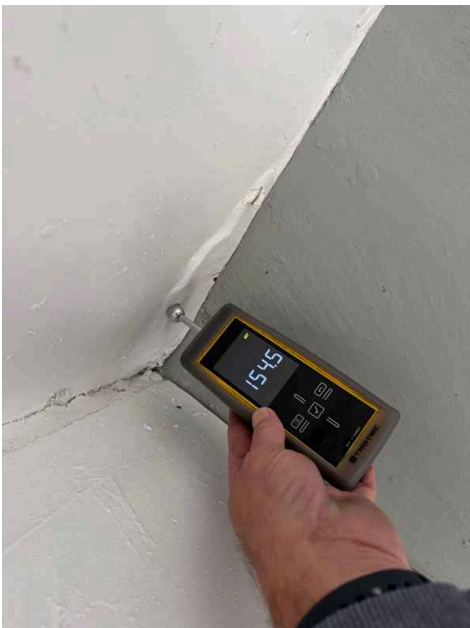
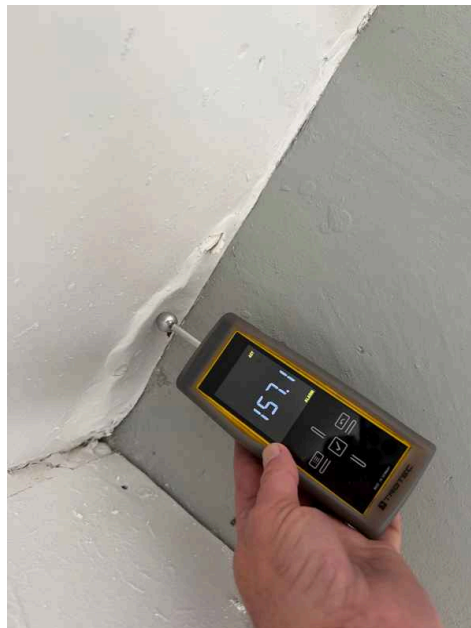
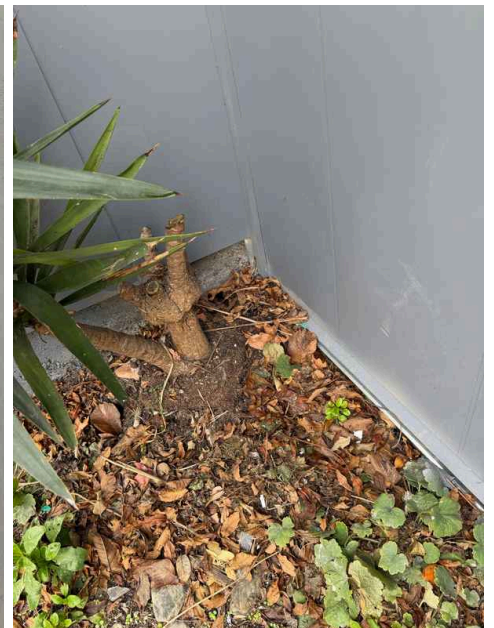
24.1.1 Moisture

ELEVATED MOISTURE

Elevated moisture was located to the right hand side of the garage door, further investigation required

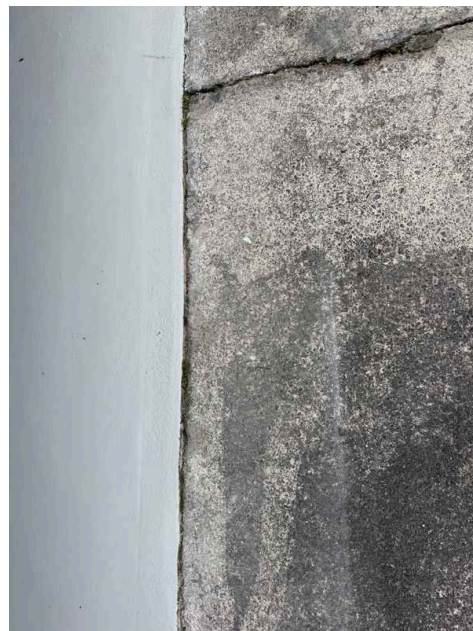
25.2.1 Defects Floor

GARAGE FLOOR/DRIVE SAME OR SIMILAR HEIGHTS

Water ingress may occur under the garage door, a strip drain would minimize this occurrence or risk.

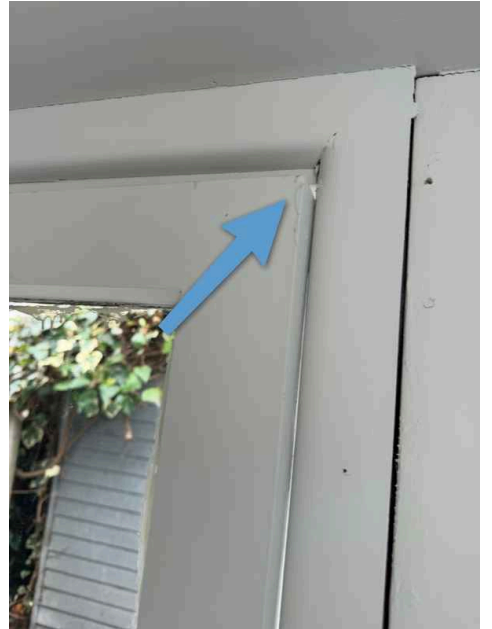
25.4.1 Defects Wall System

Maintenance Item

GARAGE DOORS REQUIRE MAINTENANCE TO RESTORE FUNCTIONALITY
