EQC CLAIM DOCUMENTATION CAVITY CRITTER REPORT

Under floor Inspections

Property address: 191 Westminster Street

Property address: 191A Westminster Street

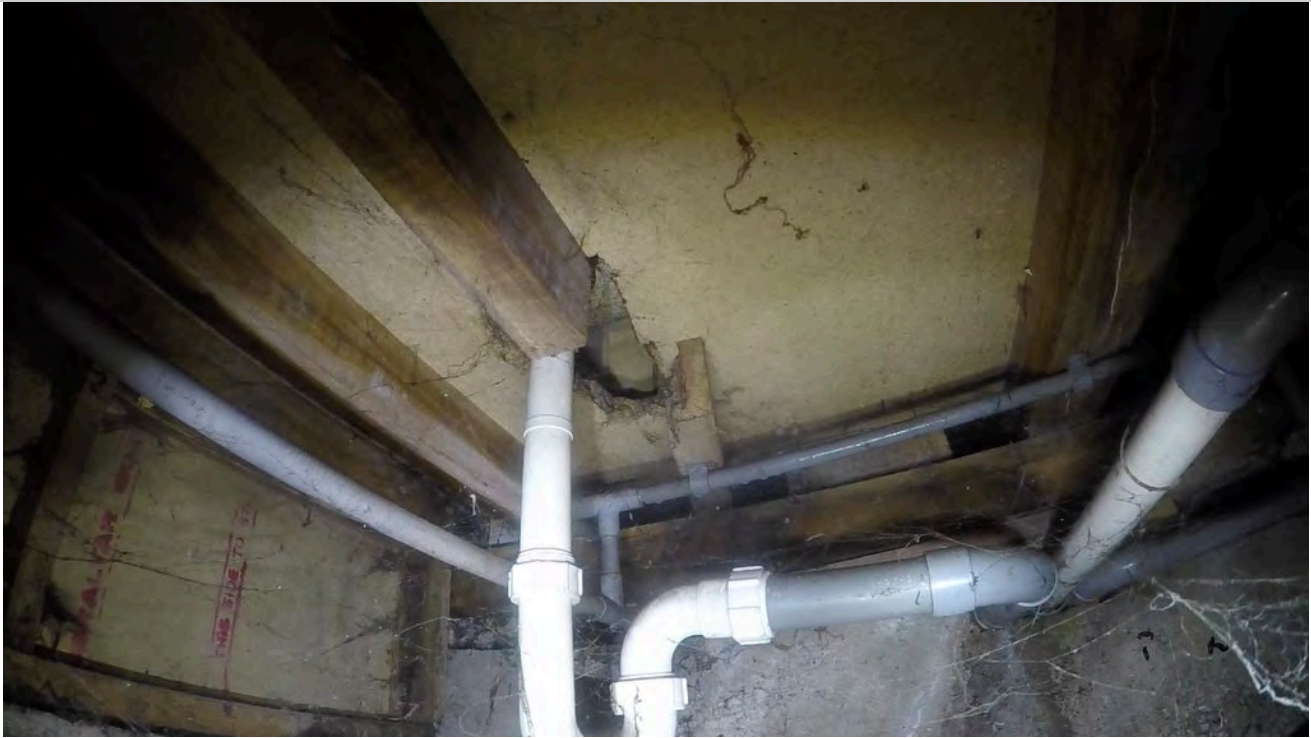
3: The joist has been cut for the waste. Both joist ends are now unsupported.

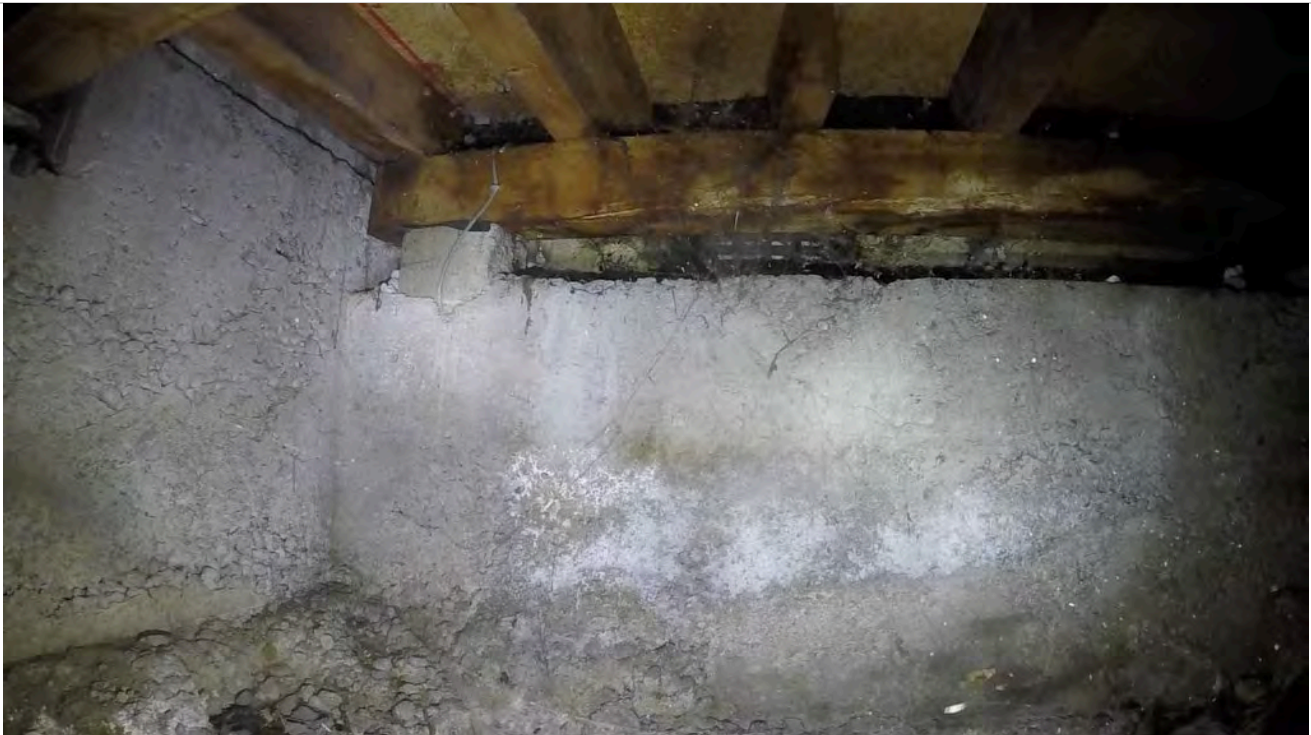
6: The home has outside bearers supported on concrete blocks embedded into the foundation and connected with stapled off wire. The outside bearers show signs of water damage in several areas along the foundations.

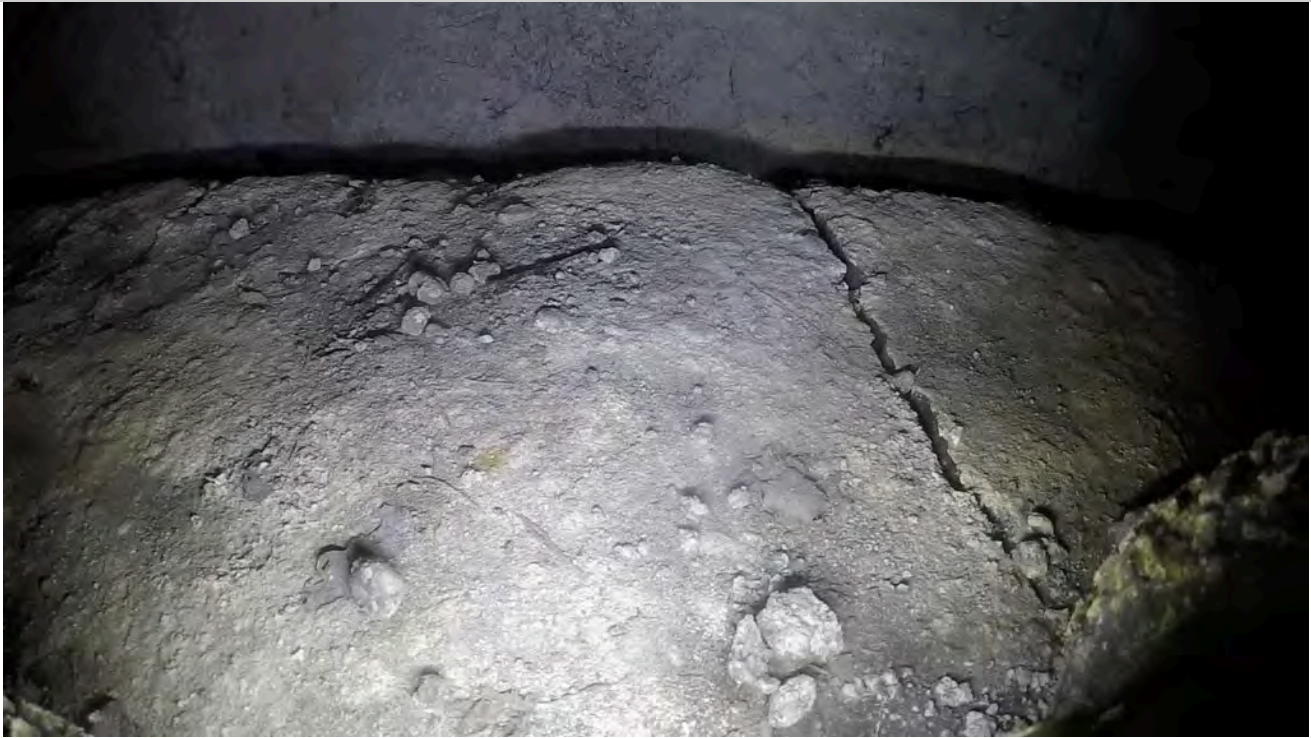
9: Large ground crack heading towards the foundation.

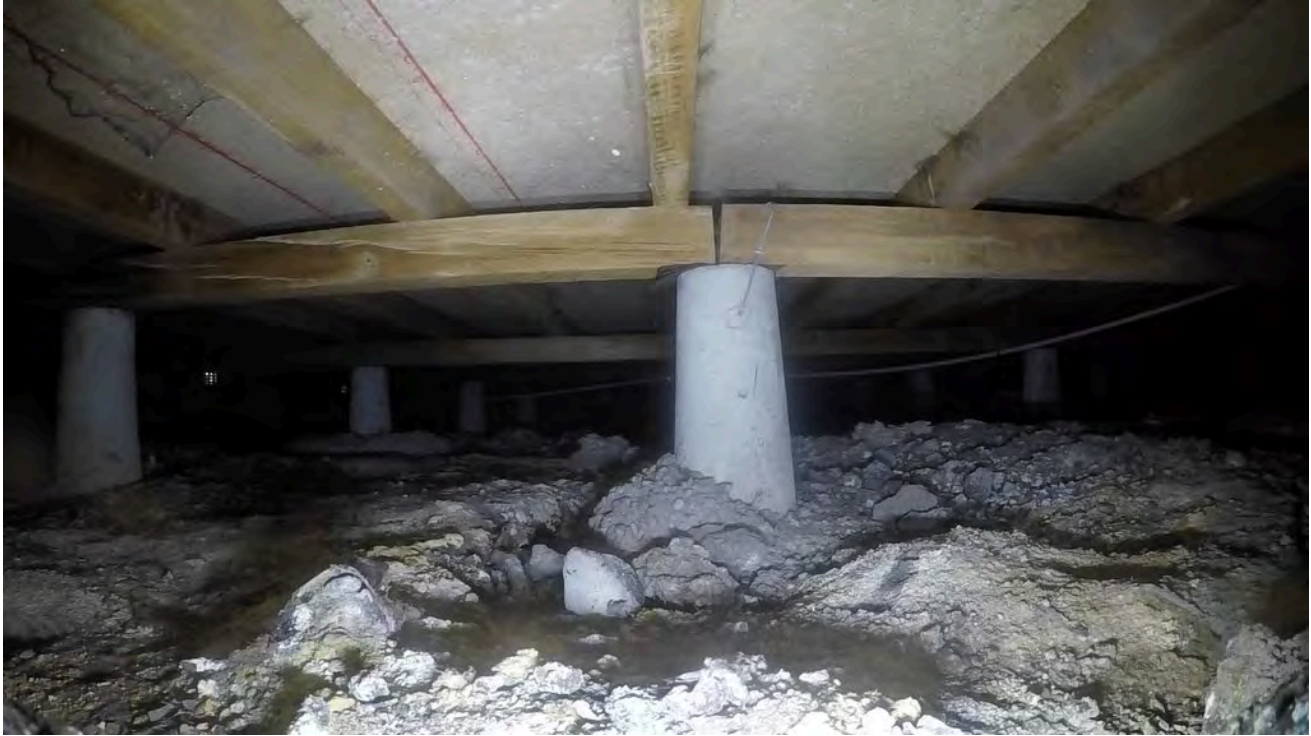
13: The bearer join has pulled apart. This is most likely caused by timber shrinkage. The subfloors were generally constructed from wet timber, which reduces in size when dry. There are several of these bearer joins.

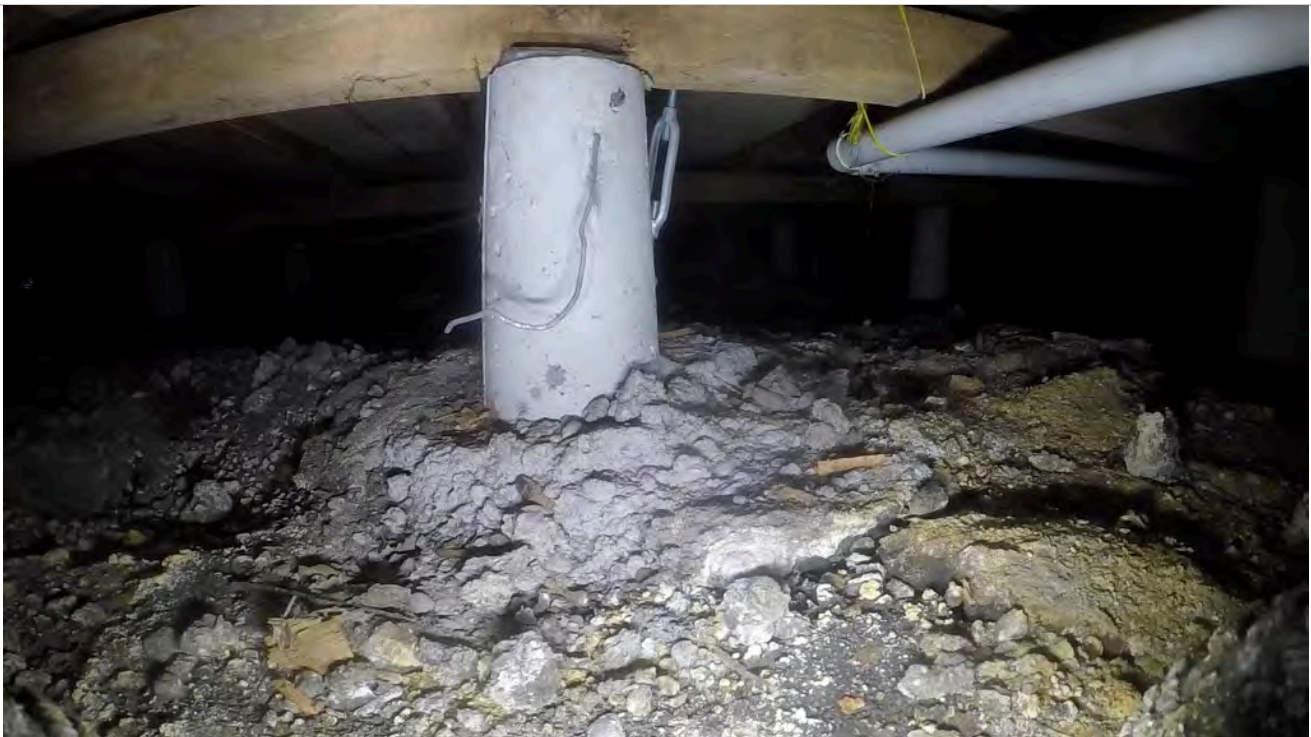
14: It appears the bearer has been notched and a turnbuckle has been used to pull the bearer down to meet the pile. No compliant connection has been used.

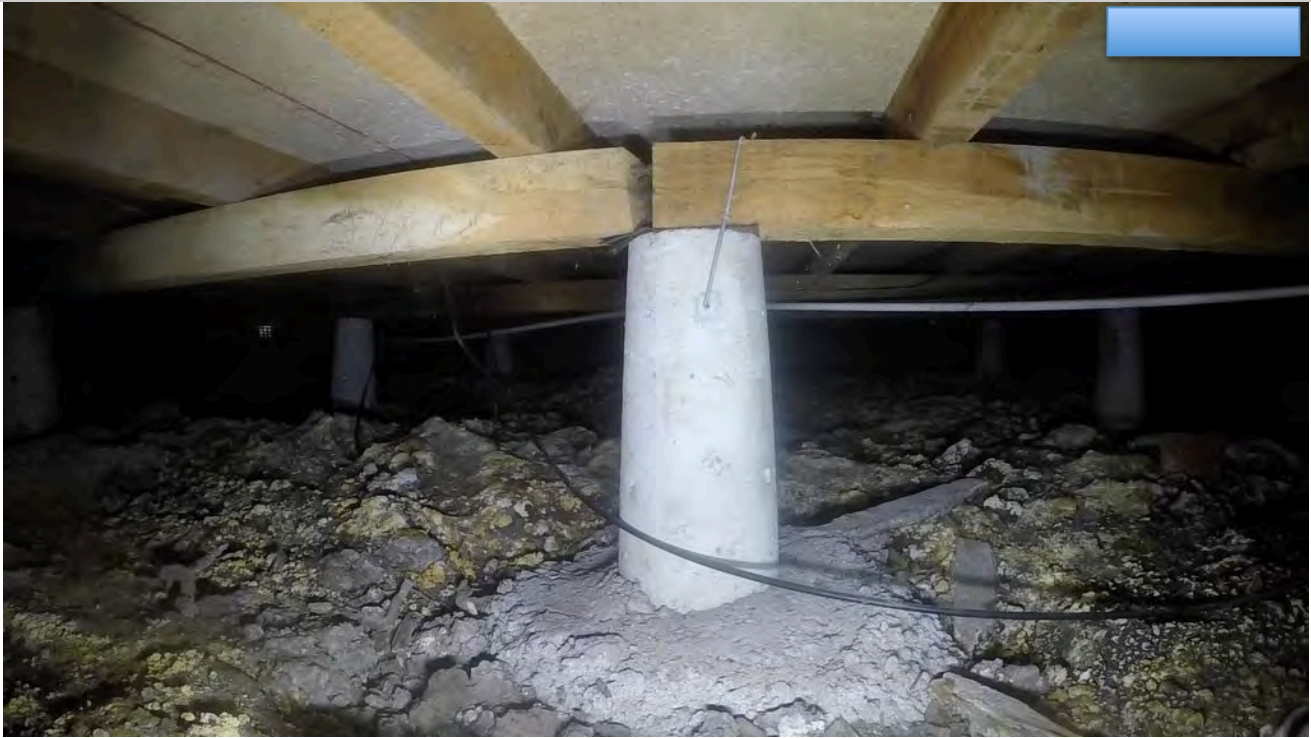
23: Pile with bearer join. The pile poorly supports the left bearer. The bearer appears to be supported by roughly 10mm.

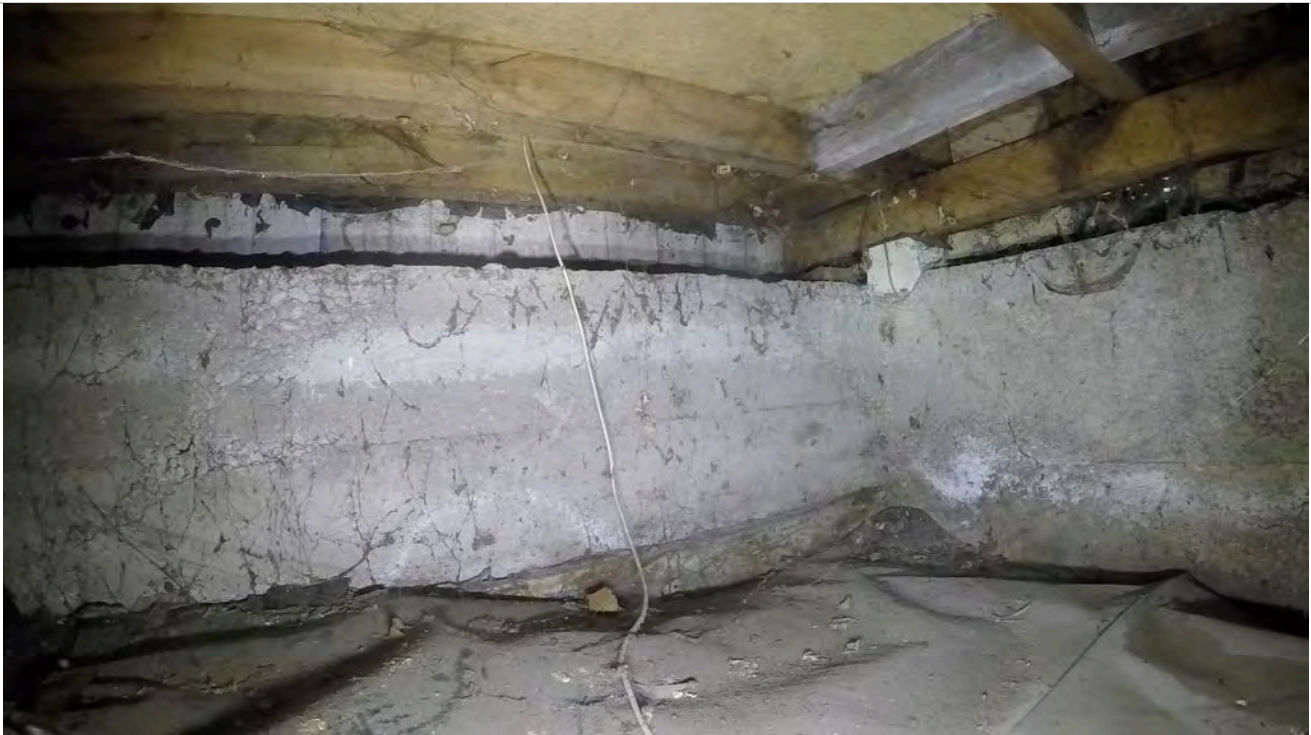
2: The home has outside bearers supported on concrete blocks embedded into the foundation and connected with stapled off wire.

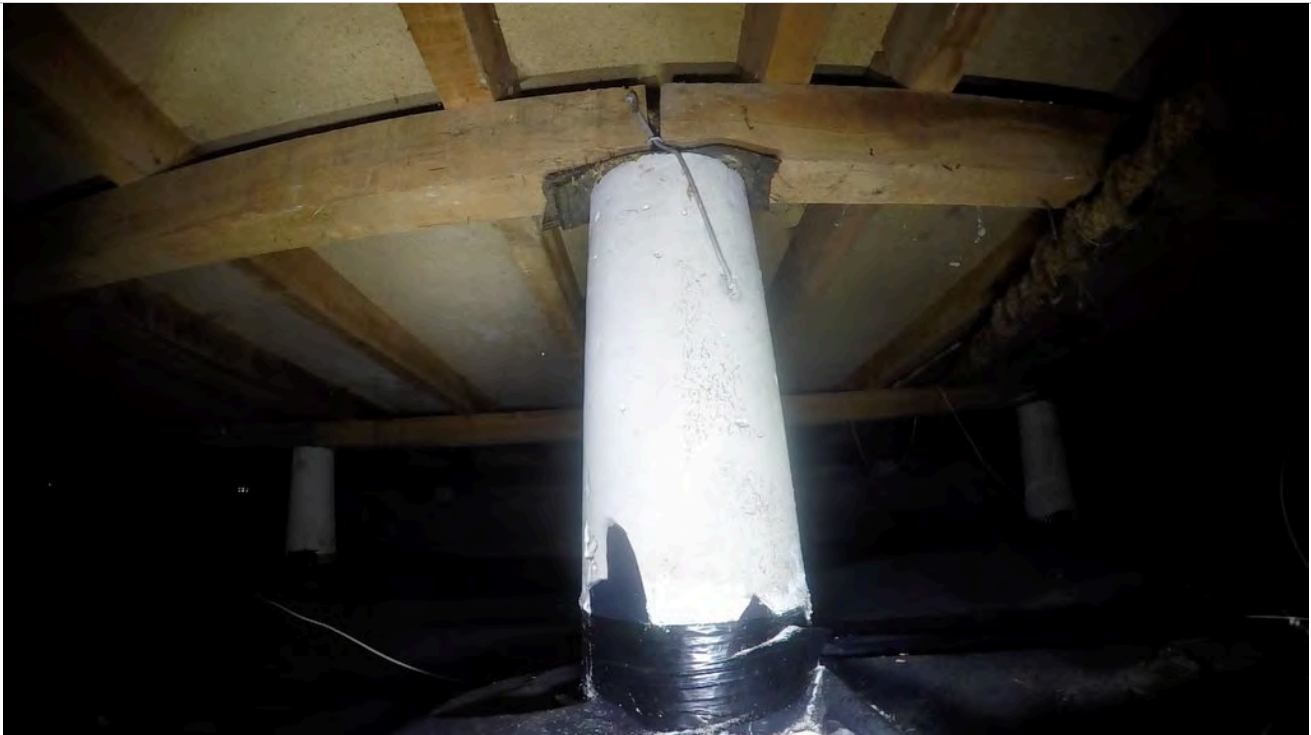
20: Pile with bearer join. The bearer join has pulled apart. This is most likely caused by timber shrinkage. The subfloors were generally constructed from wet timber, which reduces in size when dry.

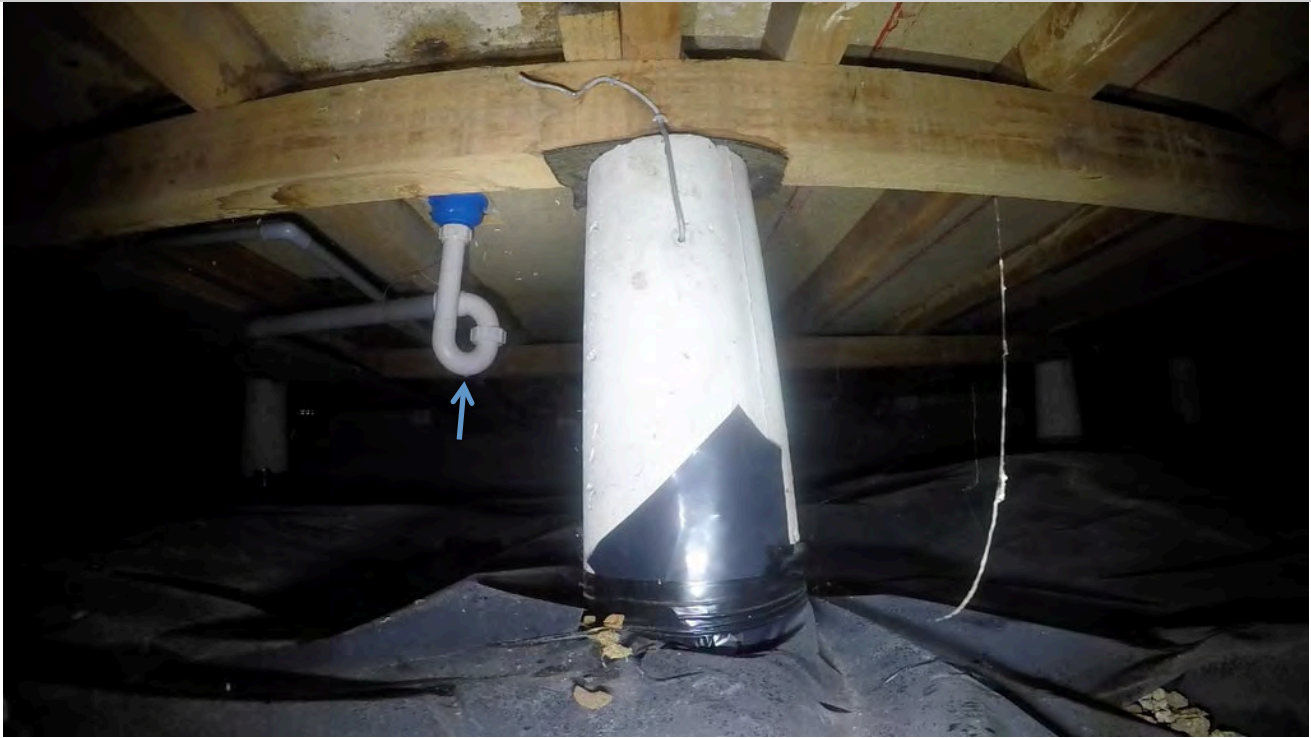
31: Pile with connection. The arrow shows evidence of the waste leaking. The polythene shows signs of dampness.

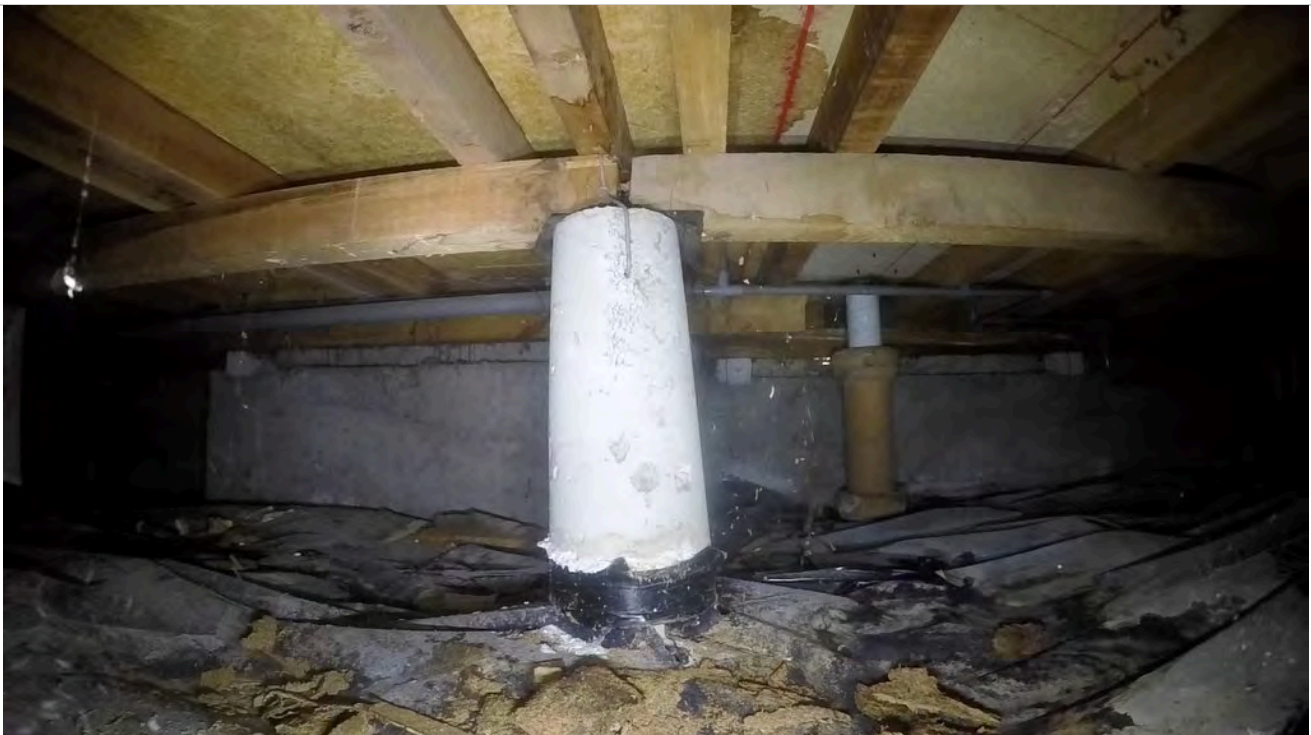
38: There are indications of an above floor water leak here and the timber is showing signs of water damage.

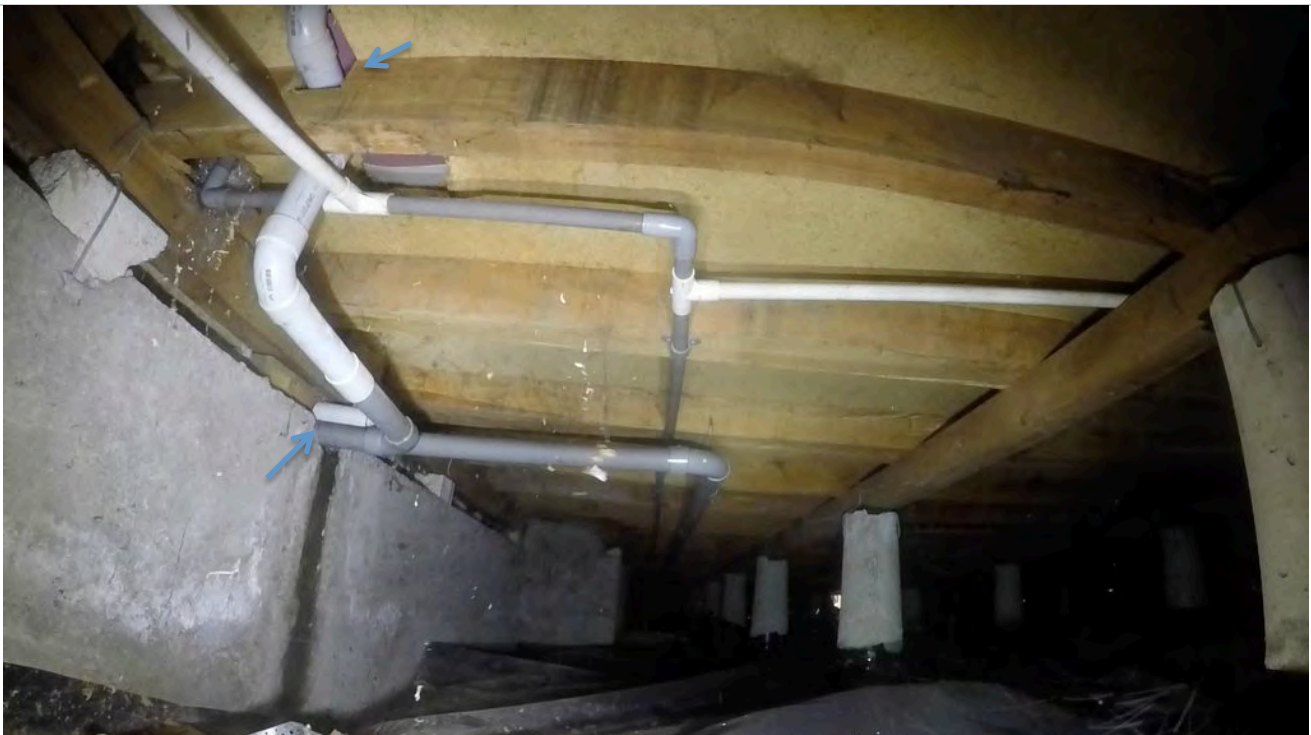
44: View of ring foundation with services. The joist has been notched by at least 40mm. There is evidence that the wastewater is flowing back into the foundation from the gully.
